WATER OPERATION AND MAINTENANCE BULLETIN

No. 180

June 1997

CONDITION ASSESSMENT OF PARSHALL FLUMES IN COLORADO

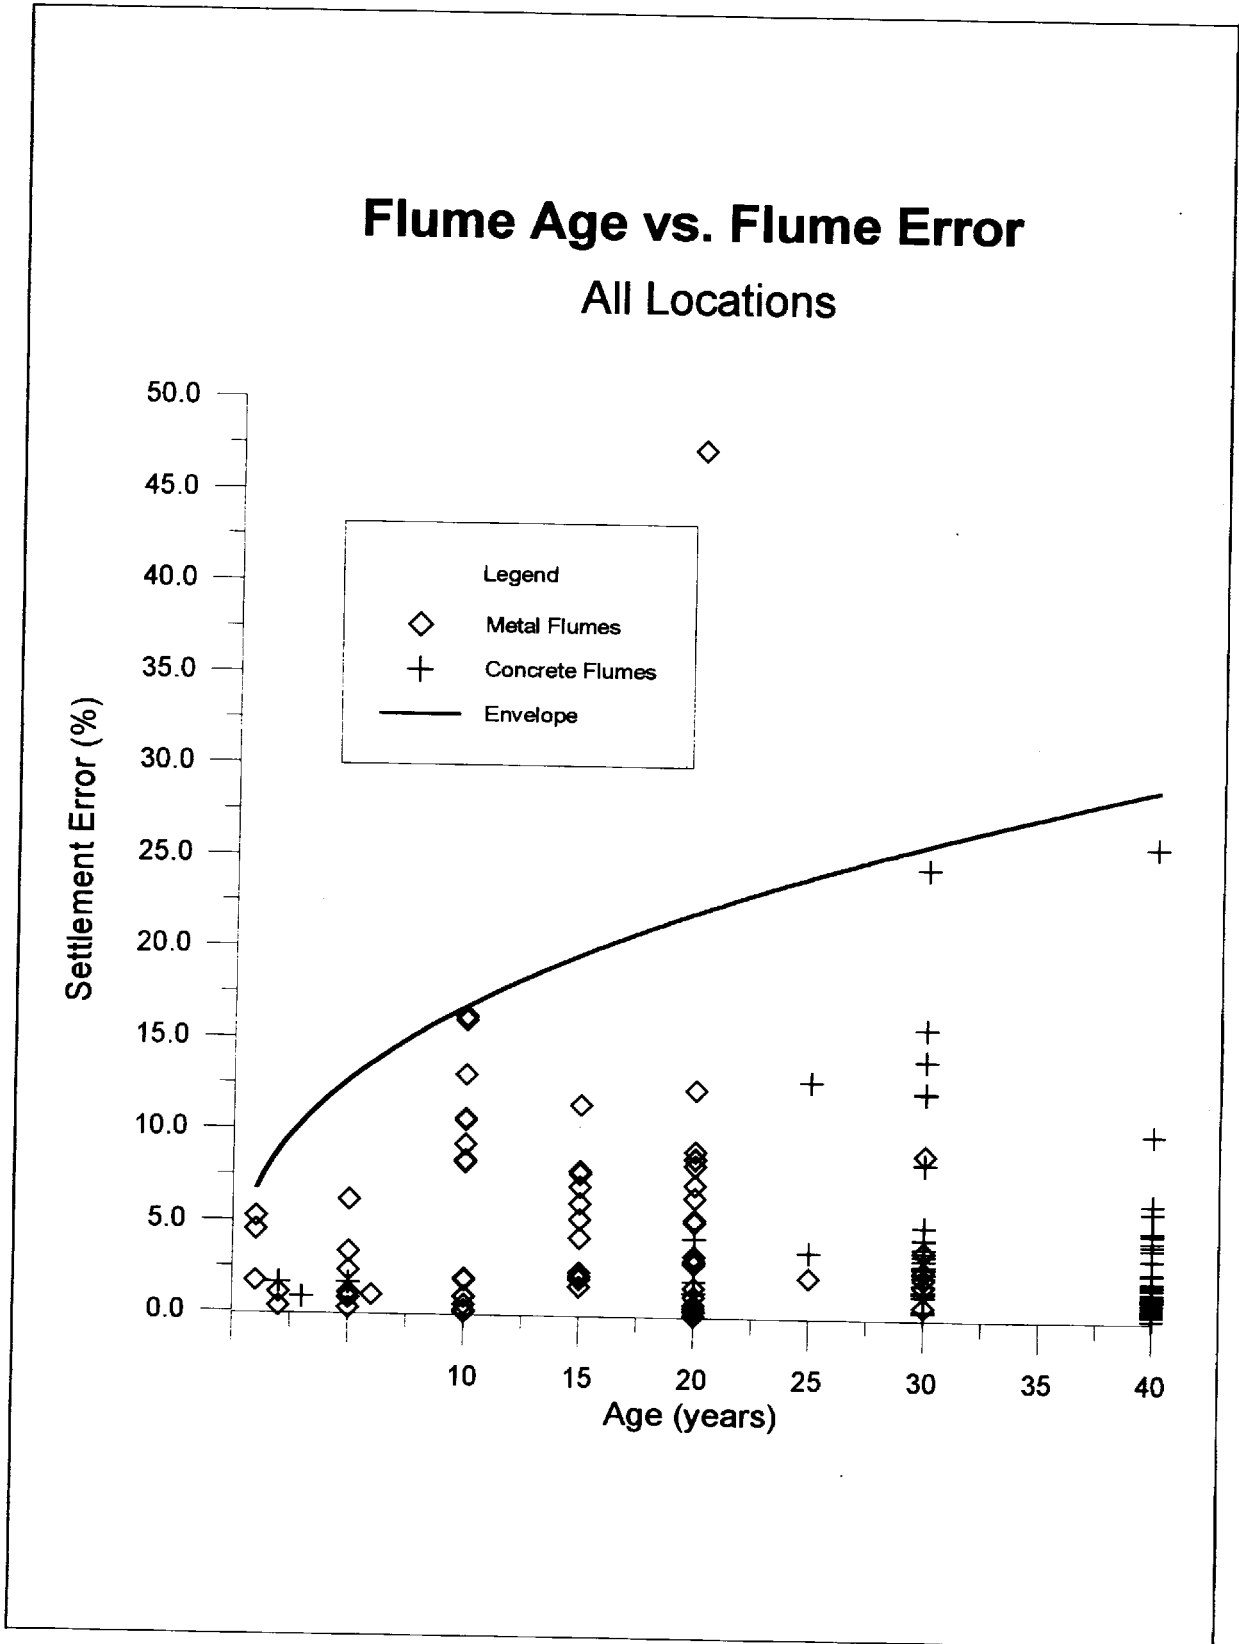
Figure 11.—Flume age vs. flume error.

An analysis was performed relating the approximate flume age to the settlement error (%) as presented in Figure 11. An envelope curve (one outlier) was fit to the data indicating the

trend of the potential flume water measurement error (worst case) as a function of age. Although the data base is biased toward flumes less than or equal to 30 years of age, it is evident that potential measurement error increases with the age of the flume.

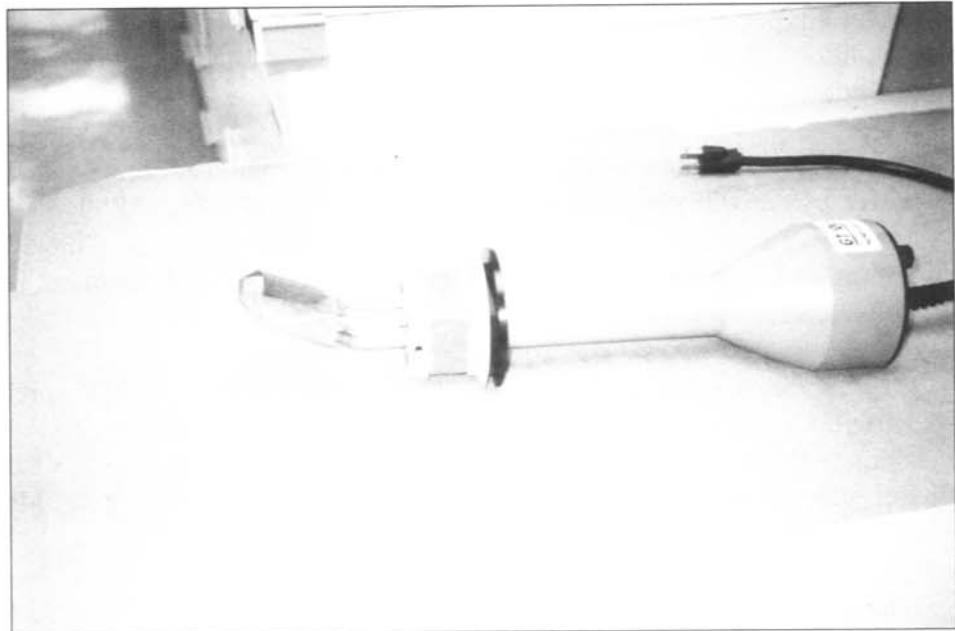
The original cost of the Novaweld GT-100 welder in 1995 was about \$2,000. The welder (pictured in figure 1) was originally designed to seam together geotextile (filter fabric) materials but can also be used on geomembranes. John Schaffer (D-8180) experimented with the hand-held welder both inside and outside the Denver labs. Table 1 records preliminary laboratory test data using the GT-100 welder.

Figure 1.—The GT-100 welder.

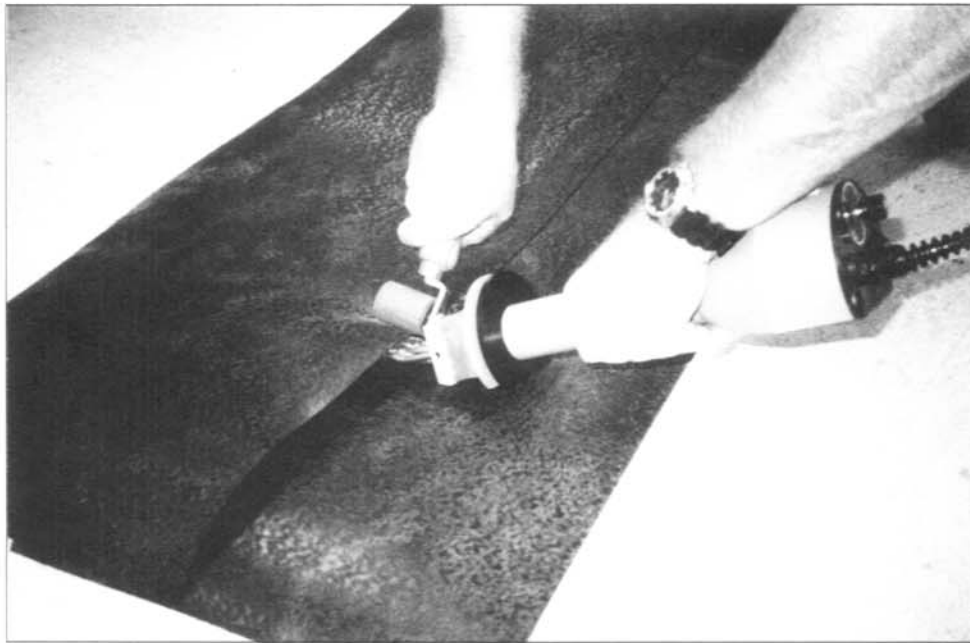
strength and peel strength; however, seam quality is highly dependent on operator skill and temperature setting. Figure 2 shows Mr. Schaffer demonstrating the seaming technique. Good peel strength was not attained until the welding temperatures and pressures used were high enough. When the temperatures are high enough to produce a good weld, the material smokes and gives off a noxious odor, requiring the need for good ventilation or the use of a respirator. The values for 60-mil smooth HDPE in the table show extremely low peel strength when the temperature setting of the welder was 3.5 but excellent values when the

Figure 2.—John Schaffer demonstrates seaming technique.

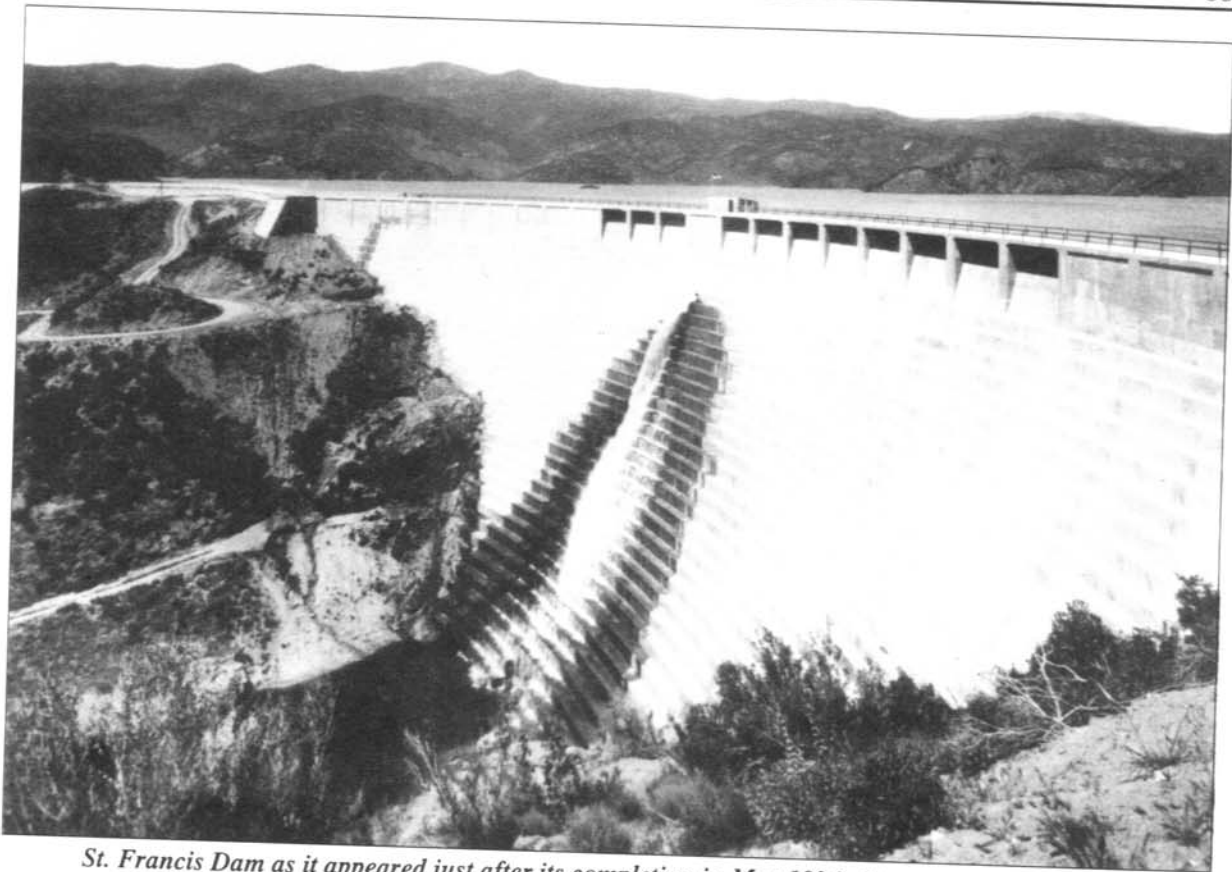
What was interesting about the St. Francis Dam was that it failed within days of the water getting at the crest, meaning water moved through the abutment rapidly. This action was similar to the Teton Dam failure in Idaho in 1976, the last major dam built in the U.S., according to Rogers.

St. Francis Dam as it appeared just after its completion in May 1926. It was a curved concrete gravity section, standing approximately 200-feet high and was comprised of 130,000 cubic yards of concrete without benefit of any contraction joints, drainage galleries, cut-off walls, or grout curtain. The Pelona Schist made up the east abutment, on the right side of the photo, while the Sespe formation red beds comprised the upper two-thirds of the west abutment (shown at left). Photo from Huber Collection, University of California Water Resources Center Archives, Berkeley.
