# WATER OPERATION AND MAINTENANCE BULLETIN

No. 181

September 1997

# **CAN FROST HEAVE ON A DRAINAGE CULVERT CAUSE A CANAL BREAK?**

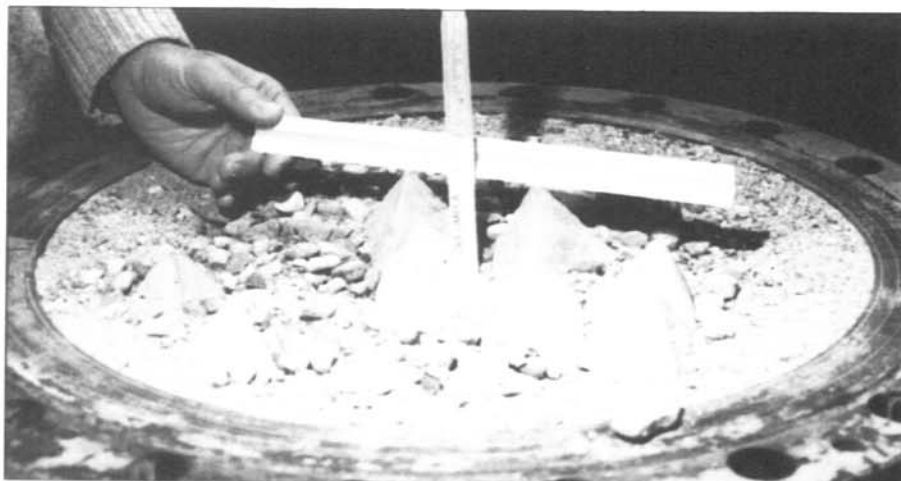
Various types and thicknesses of geomembranes were tested to determine their conformability, burst resistance, and puncture resistance in the presence of a very rough substrate (figure 1). Samples of membrane were placed in a pressure vessel that was sealed and pressurized to a maximum pressure of approximately 150 psi (1 MPa). Samples of membrane that did not rupture during pressurization were subjected to the maximum pressure for 24 hr. The specimens were then removed from the pressure chamber and inspected. A sample of reinforced polyvinyl chloride (PVC) after testing is shown in figure 2. Obviously, the membrane conformed to the very irregular substrate without puncturing.

*Figure 1.—Simulated substrate in the puncture test.*

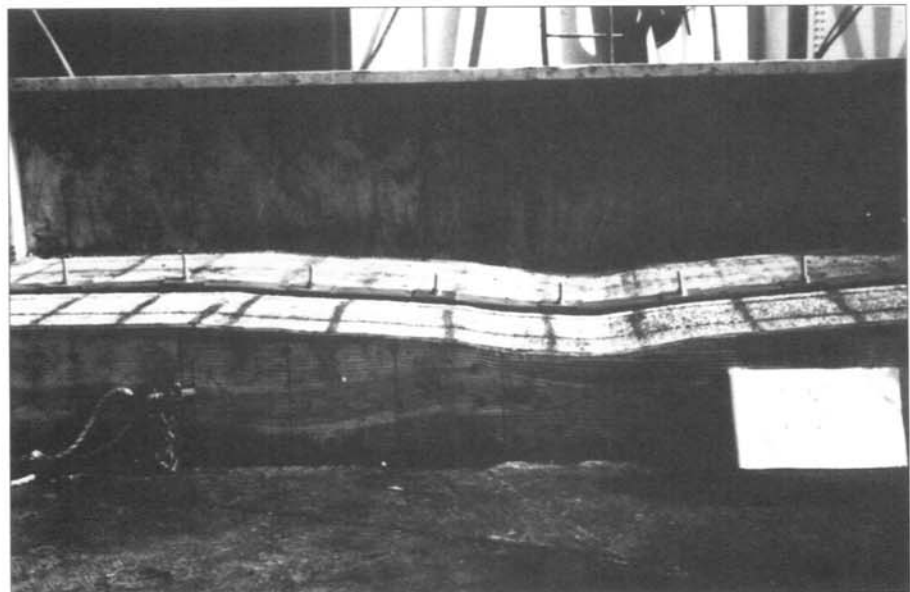
The mechanical fastening system that secures and seals the membrane system to the surface of the structure also received considerable attention in the design phase. The stainless steel profiles must be flexible enough to conform to the substrate, yet stiff enough to ensure continuous compression of the gasket without an excessive number of anchor bolts. The performance of both chemically grouted and mechanical anchors installed under submerged conditions was evaluated. A profile and gasket conformability test is shown in figure 3. In this test, a 1-in. (25-mm) -thick, open-cell neoprene gasket is being compressed by a 1/4-in. (6-mm) -thick stainless-steel profile with anchor bolts on 12-in. (305-mm) centers.

*Figure 3.—Profile and gasket conformability test.*

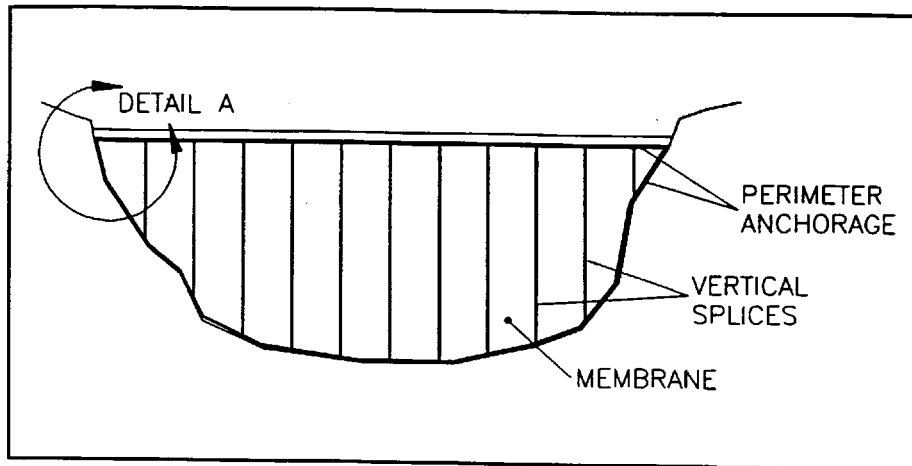
Figure 4.—System general scheme.

The geomembrane system designed for underwater installation on the upstream face of a dam consists of a high-density polyethylene (HDPE) geonet drainage layer, and a PVC geomembrane backed with geotextile reinforcement, anchored and sealed around the perimeter and along vertical splices (figures 4 and 5). Development of the system is described in detail by Christensen et al. (1995).

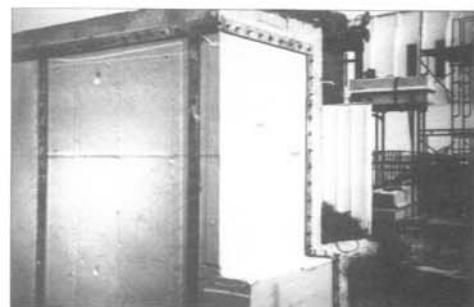
After a successful installation in the dry (figure 7), the wall was lifted with a 60-ton crane and lowered into the test tank to a depth of 20 ft (6.1 m). Multiple installations were performed underwater. The profiles were used as templates for the anchor-bolt holes. Holes were drilled with a hydraulic hammer drill, and the bolt holes were cleaned with water and a plastic brush. Three types of anchor bolts were installed: torque-set wedge bolts, chemical anchors which use a two-part epoxy, and chemical anchors which use two-part epoxy and a glass encapsulated resin cartridge. Underwater epoxy was applied to smooth the rough concrete at the perimeter. The geonet drainage layer was positioned and secured to the wall with small expansion anchors. The gasket was placed over the anchor bolts along the perimeter, and the membrane sections were rolled down the face of the wall. Bolt holes were punched in the membrane by tapping the membrane over the bolts with a hammer. A second gasket layer

Figure 7.—Completed dry installation.

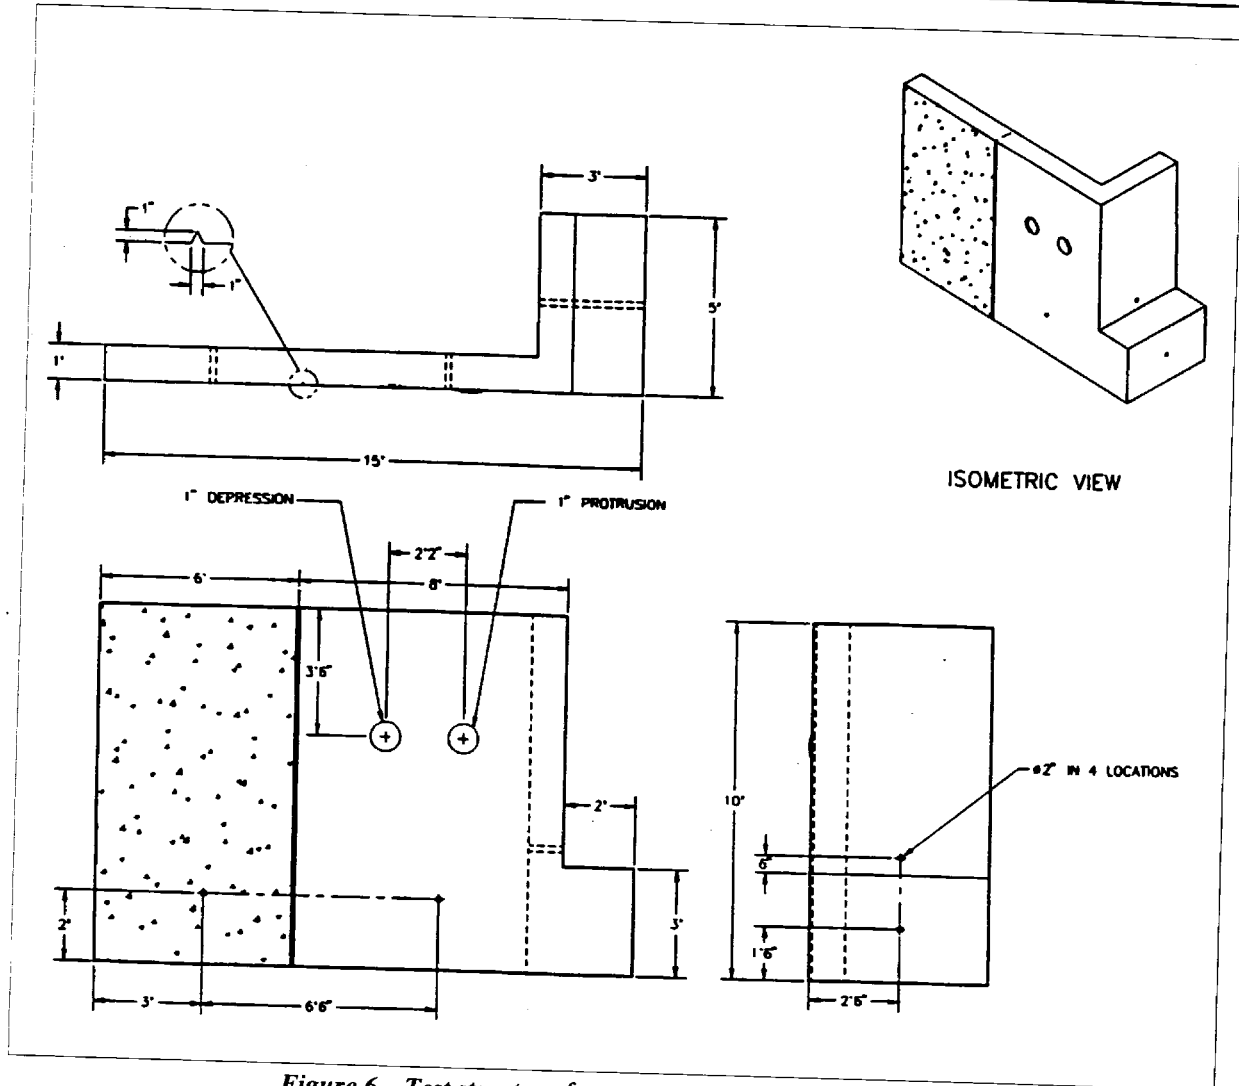
The demonstration required a test structure that simulated a concrete hydraulic structure in need of repair. In an effort to make the constructibility demonstration comprehensive, the test structure was designed and built with features that replicate possible situations which could complicate the underwater installation of the geomembrane system. These features included rough surfaces, complex corners, depressions and protrusions, a V-shaped notch representing a construction joint, and various holes simulating discrete leakage points. The concrete structure was designed and constructed in the configuration of an L-shaped wall as shown in figure 6.

Figure 6.—Test structure for constructibility demonstration.

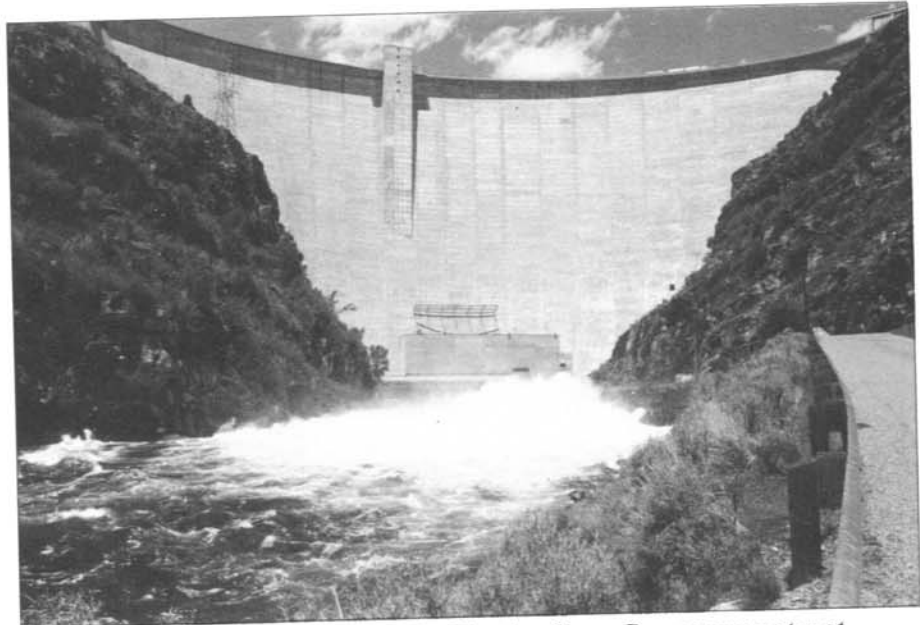
*Rising 502 feet above bedrock, Flaming Gorge Dam spews water at 4,000 cubic feet per second from the spillway and the remaining outlet tube.*

When crews arrived at the dam, there were six inches of water on the main floor of the powerplant, and an additional three to four feet of water on the level below. The releases from the bypass tubes were decreased by half as crews worked to determine which tube was leaking.
