National Transportation Safety Board

CONCLUSION

The joint bars at the east end of the rail plug fractured under the previous train or as the accident train passed over the joint, and after the joint bars fractured, the rail itself also fractured and broke away, causing the train to derail.

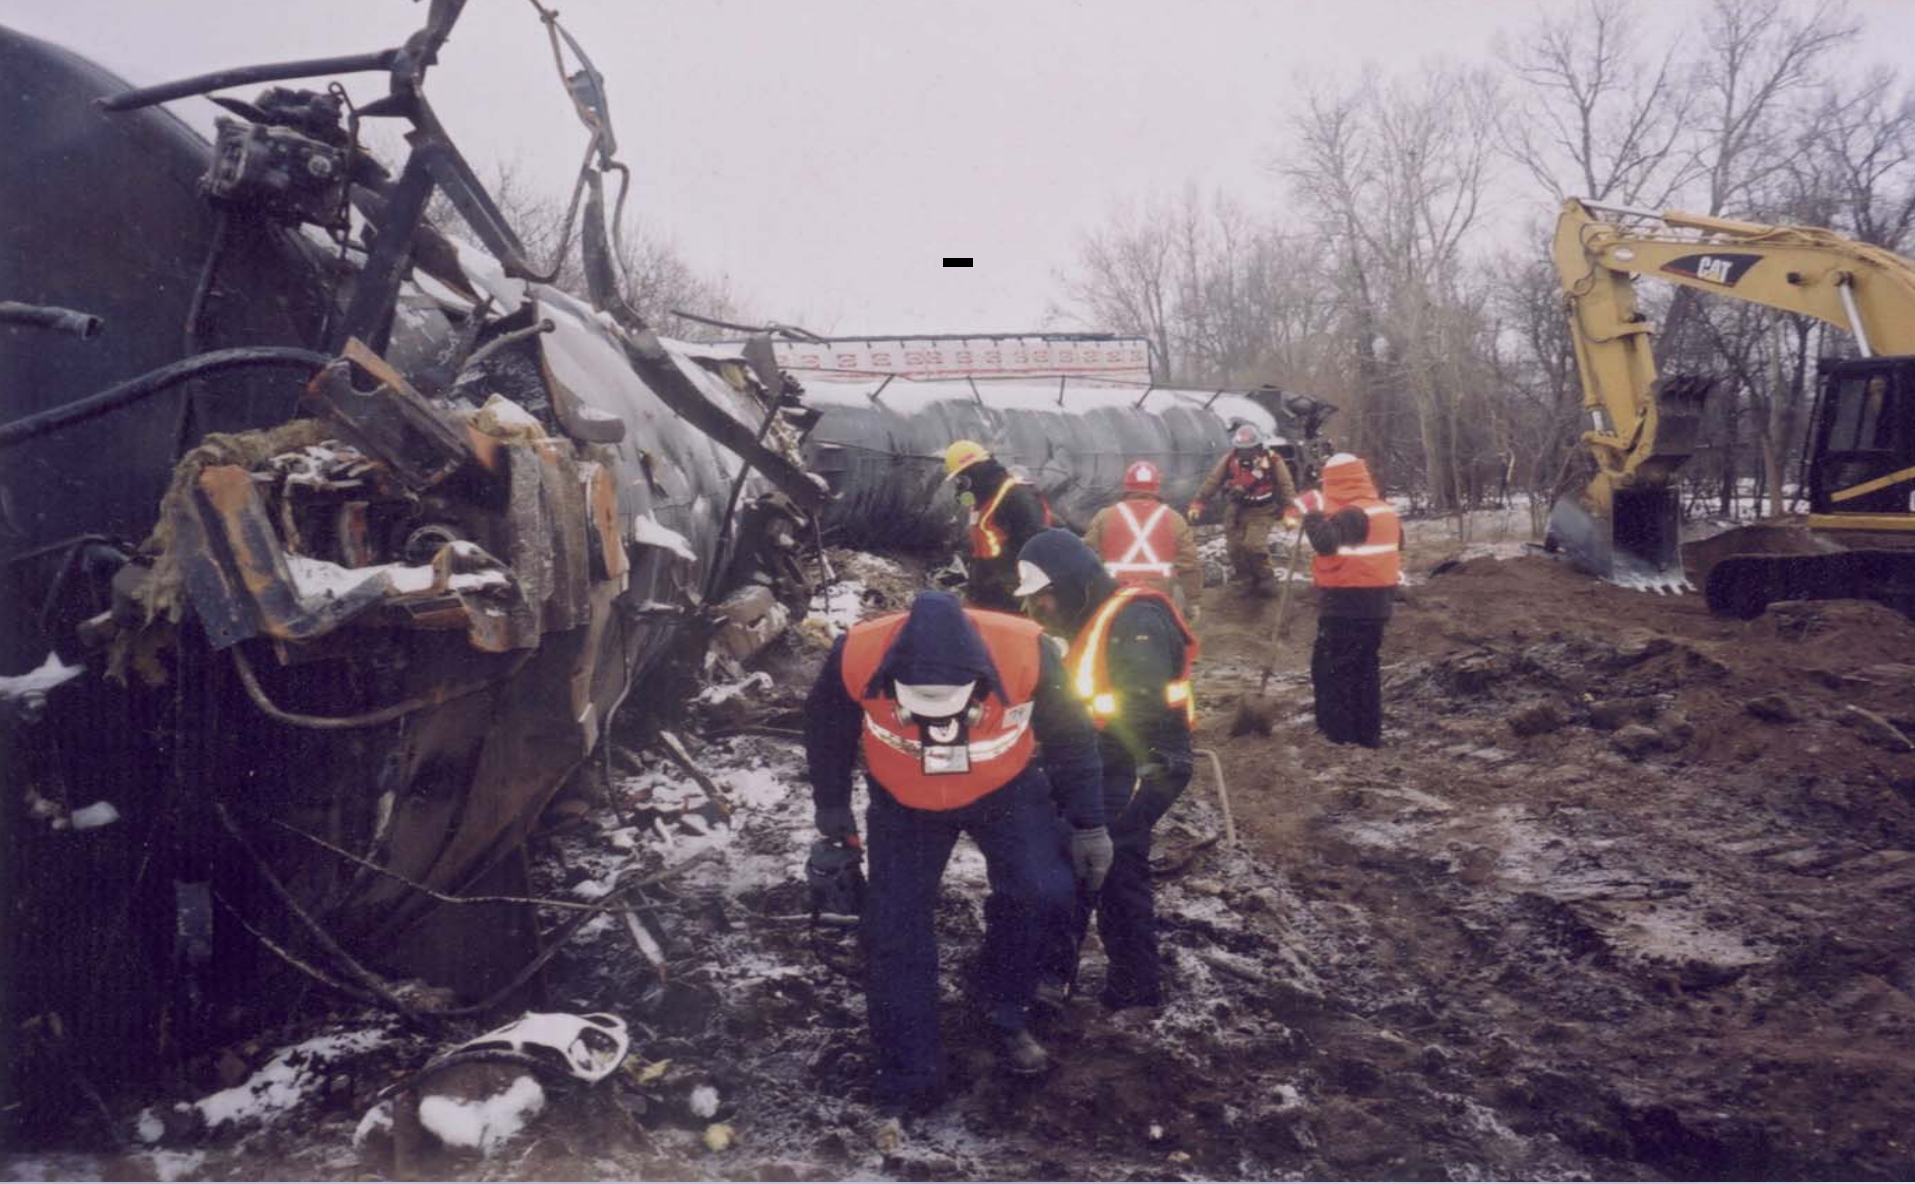
West Joint

East Joint

36-foot piece of rail

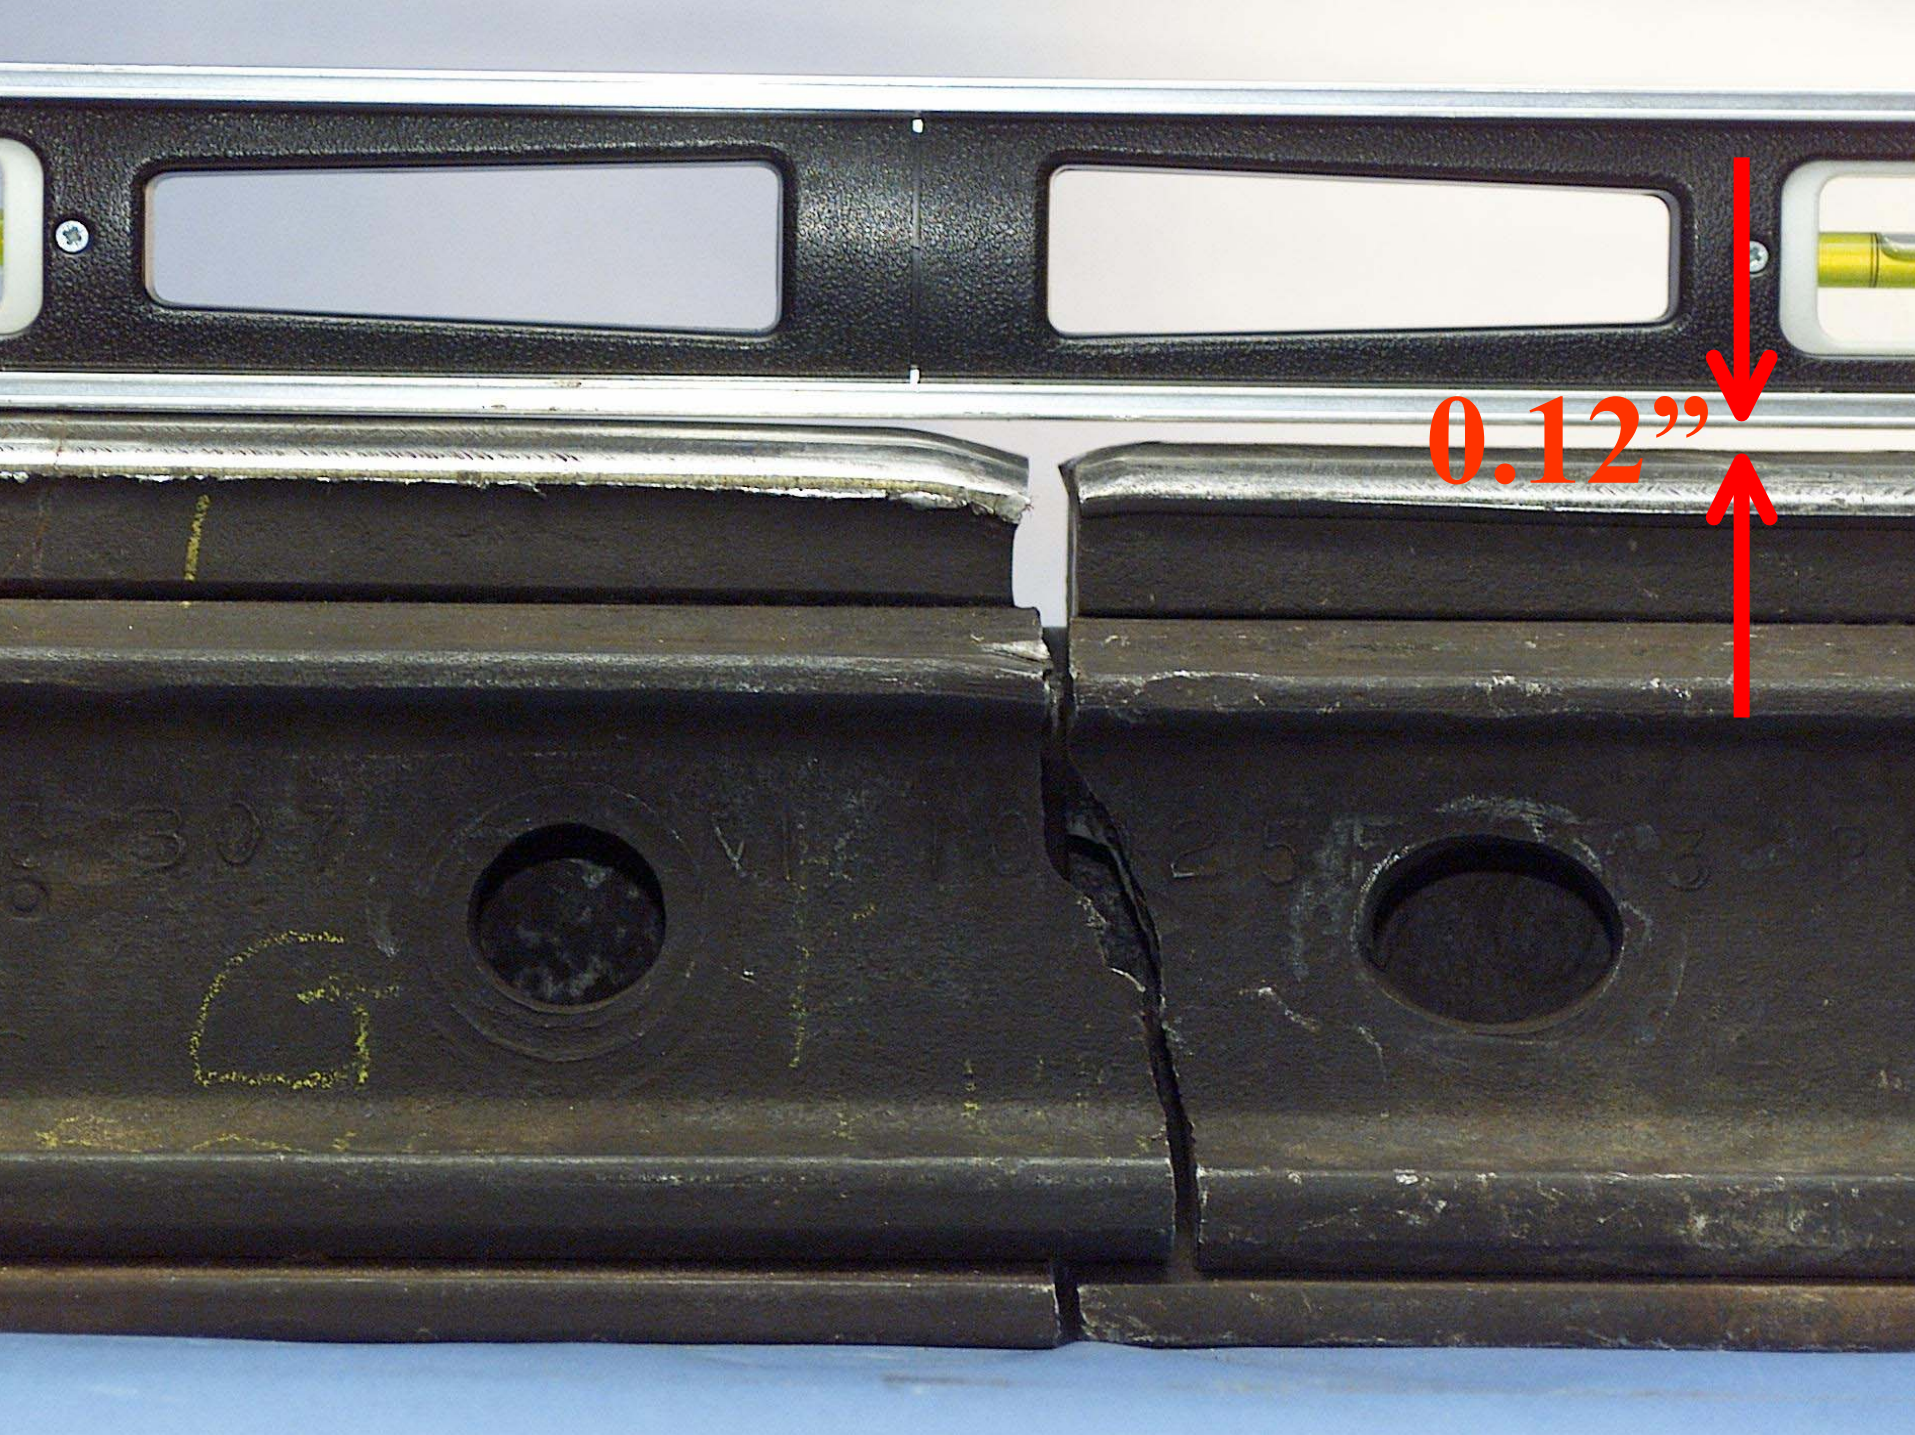
0.12''

- **Wider ballast crib (25” vs. 11½” in standard ballast crib)**
- **Difference in rail height (0.12”)**
- **Rail end gap (0.359” minimum to 0.659” maximum)**
- **Loose bolt gap (torque range from 54 ft/lbs to 402 ft/lbs.)**
- **Add “fly-ins” to this slide!!**

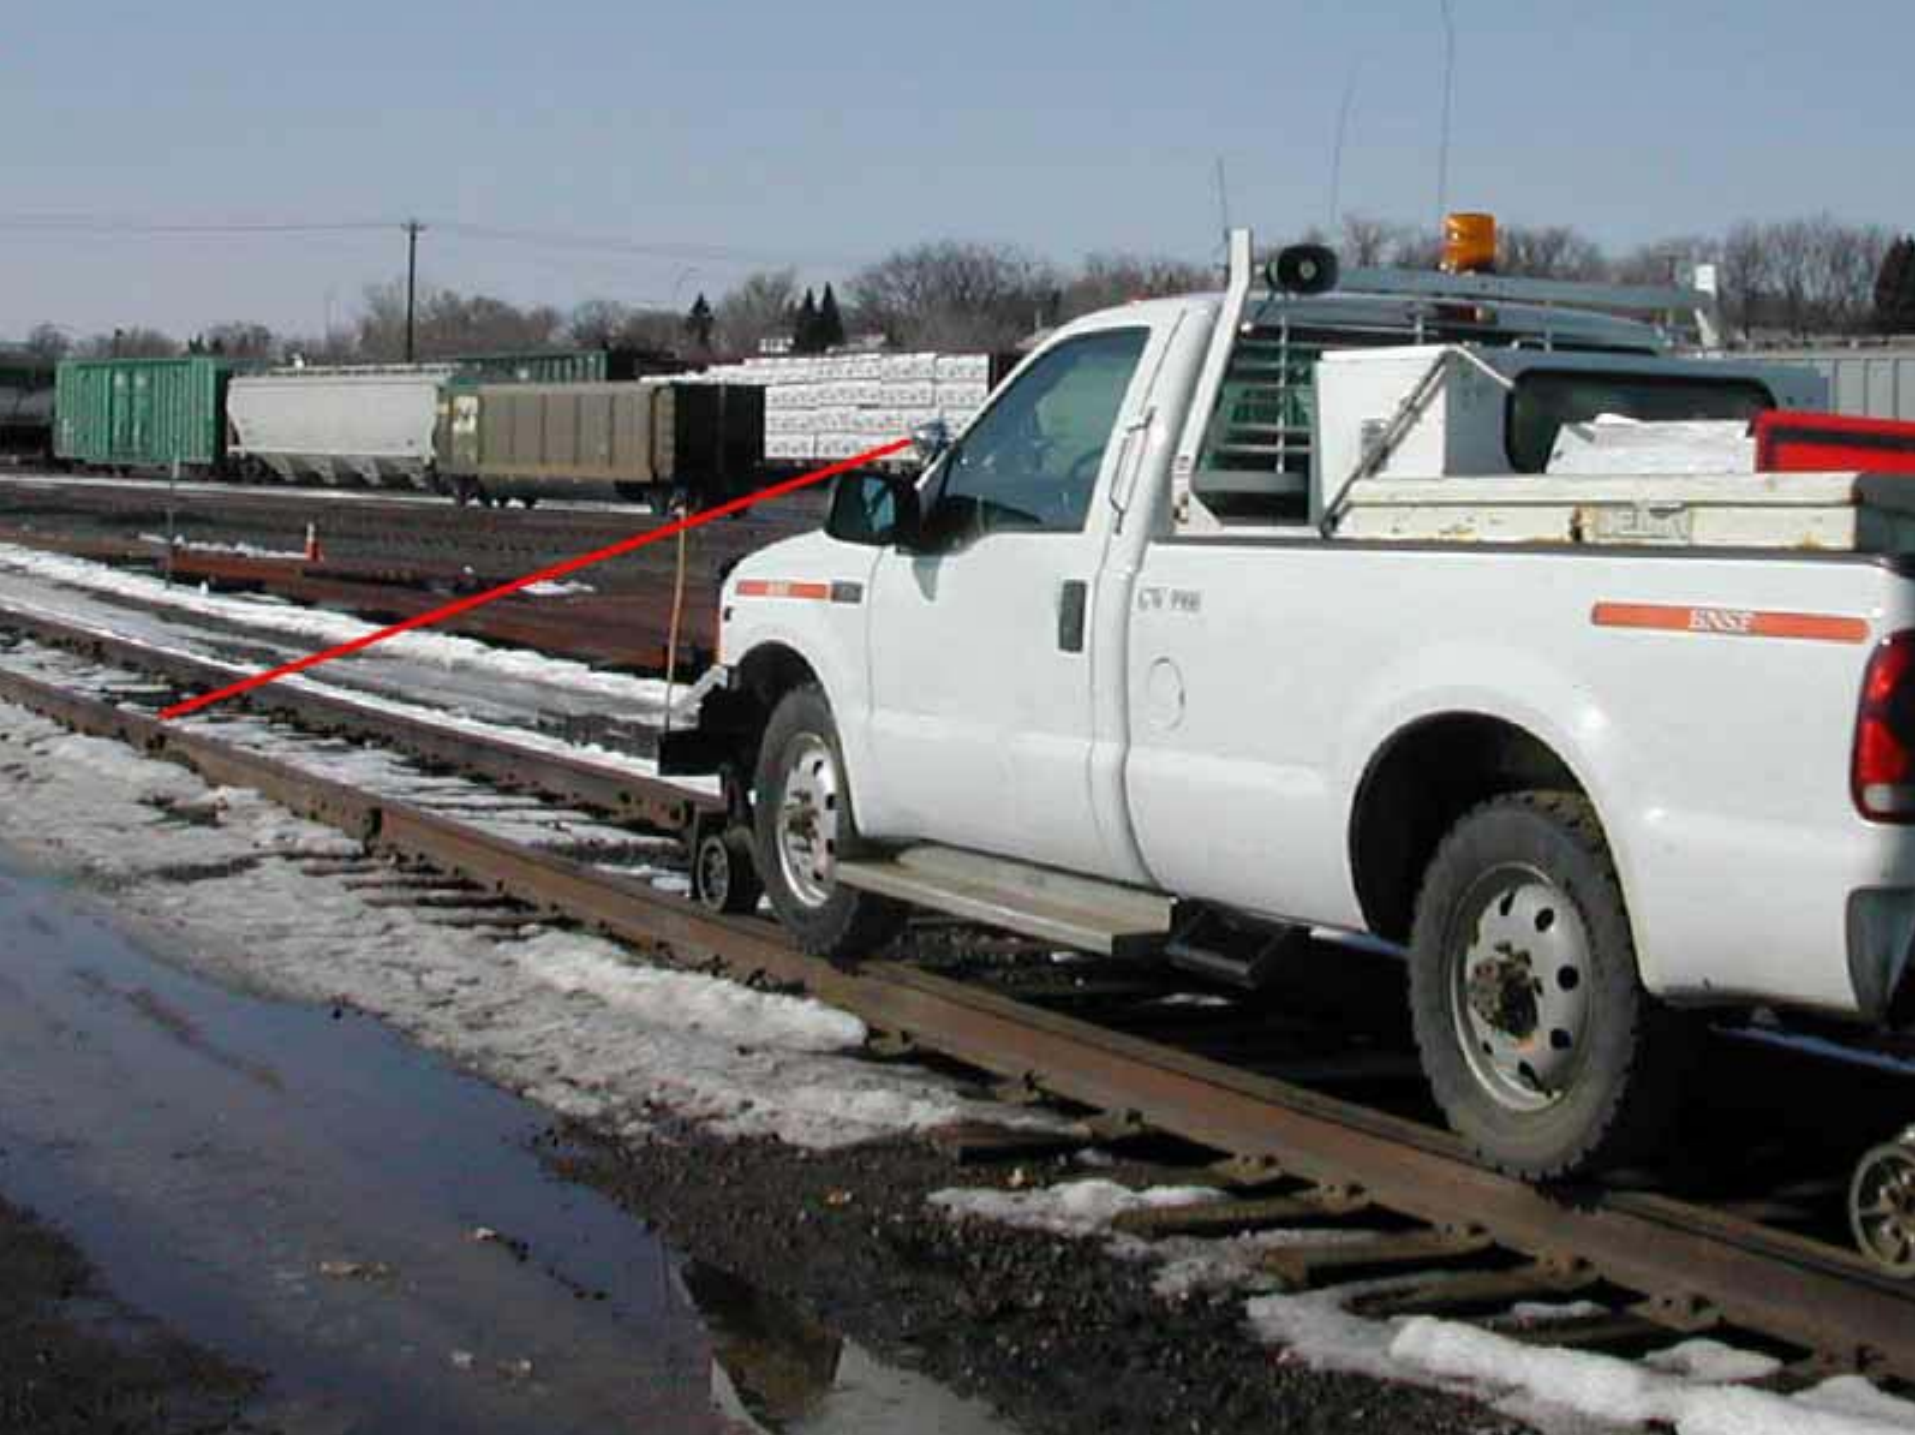
On-the-ground joint bar inspections

Visual inspections from a moving vehicle are inadequate because:

- Not all joint bars are visible**
- Small fatigue cracks are not visible**
- Requires an on-the-ground inspection**

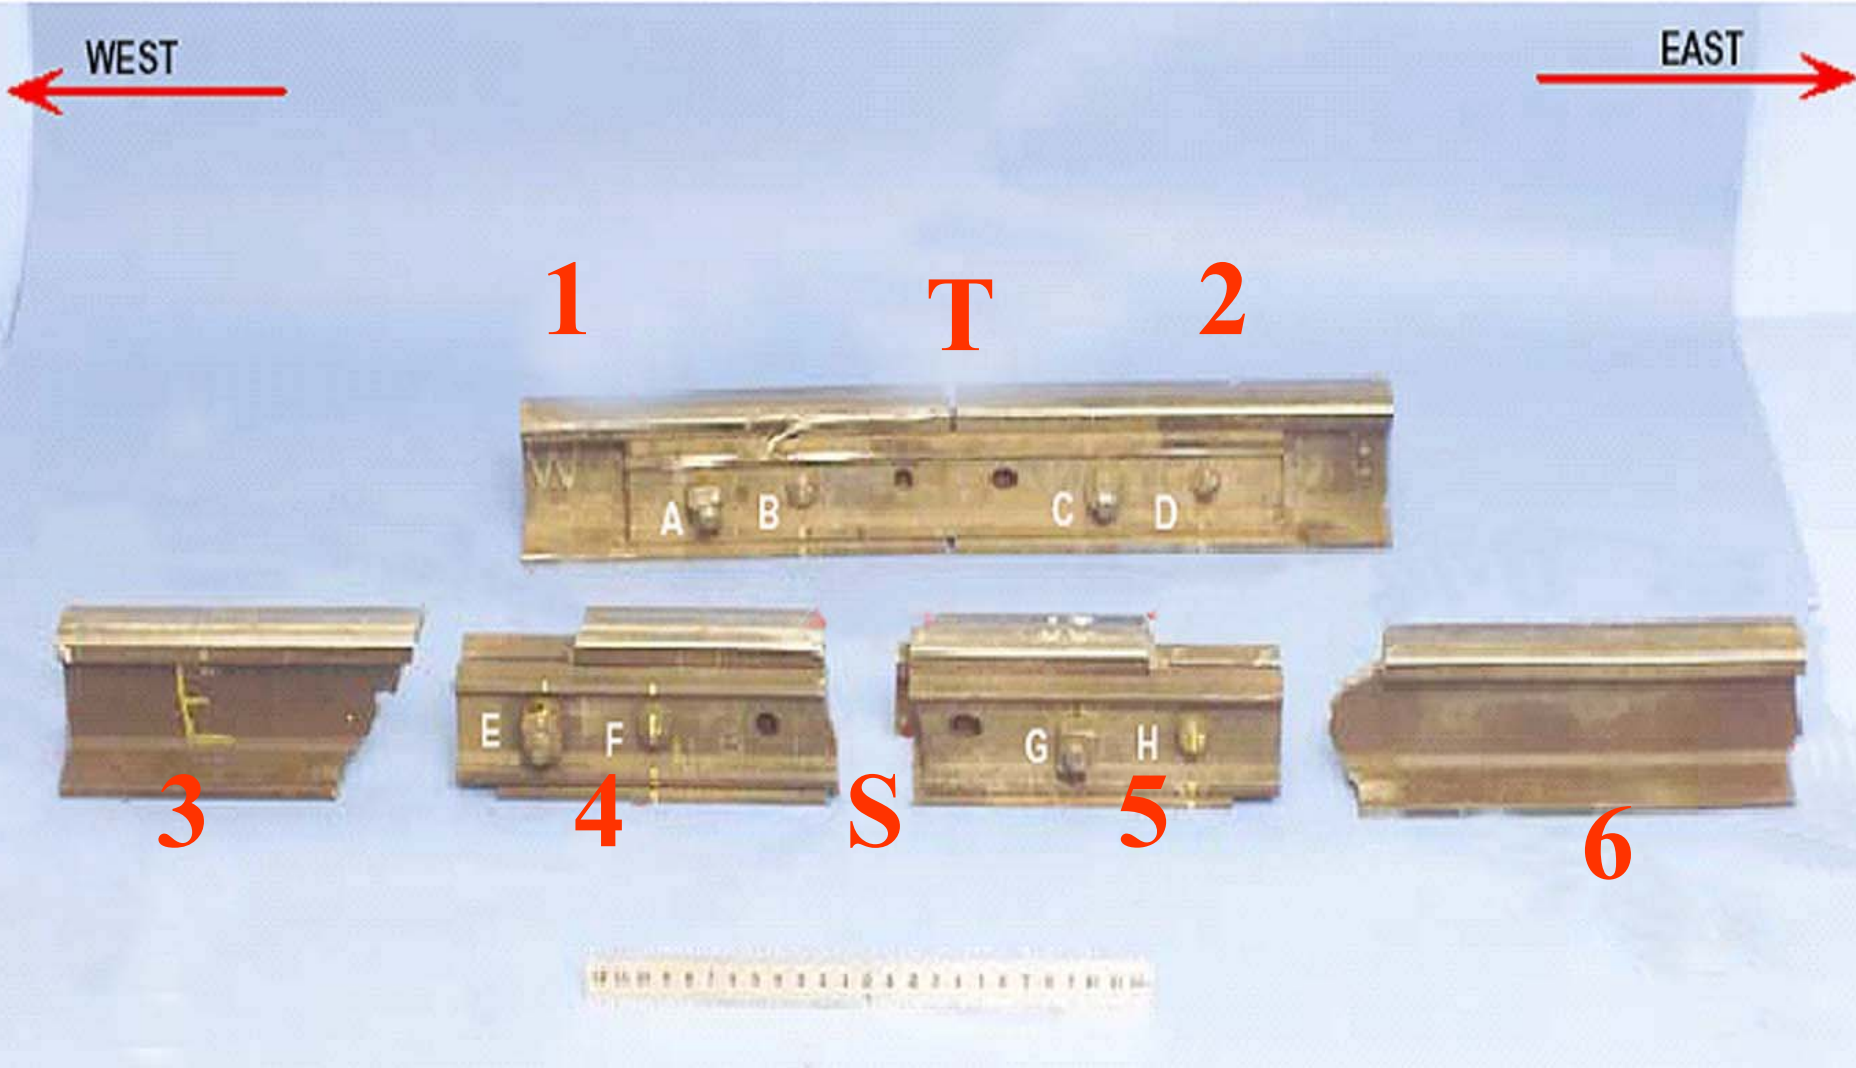
East Rail Joint Pieces

Figure 10. Recovered pieces of rail and joint bars from the north side of the track. Arrows "S" indicate the location of the fracture on the pair of joint bars from the east end of the rail plug. Arrows "R" indicate the joint between rail pieces 4 and 5. Arrow "T" indicates the joint between rail pieces 1 and 2.

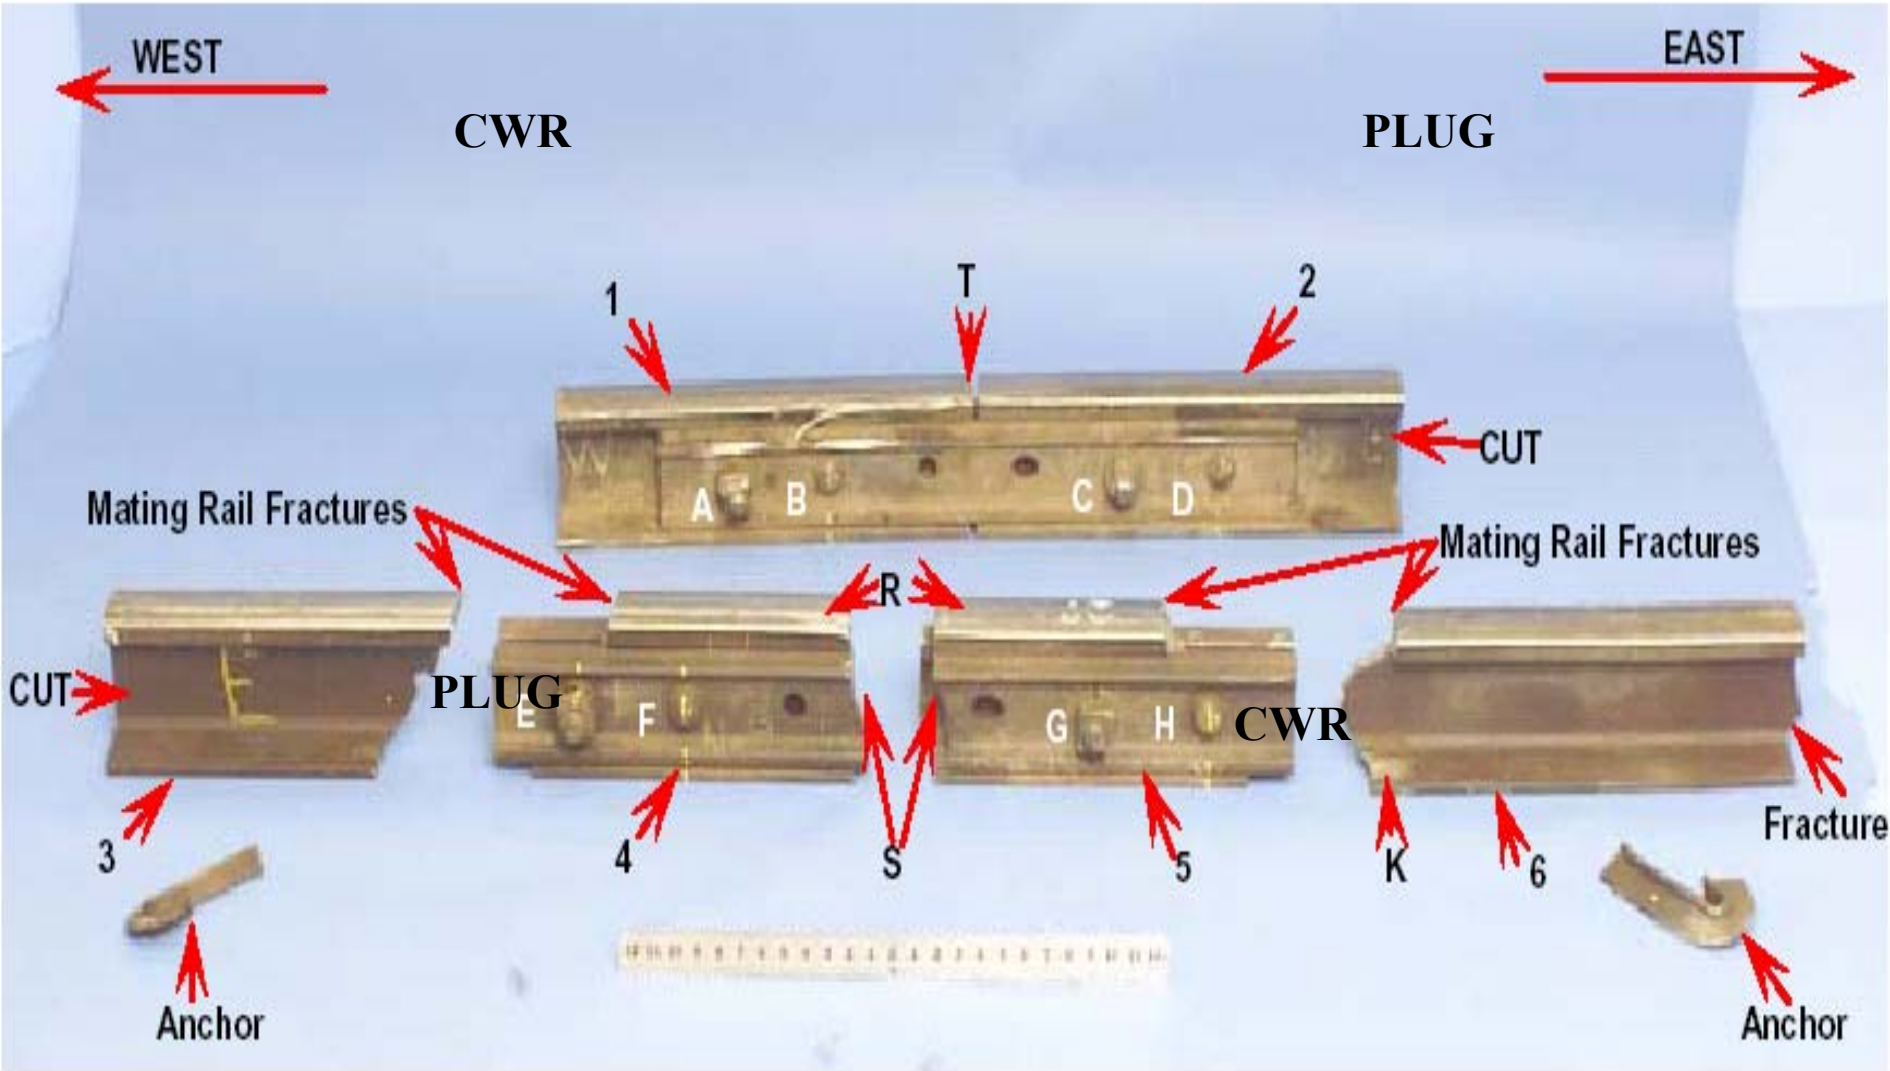
East Rail Joint Pieces

Figure 9. Underside of the recovered pieces of rail from the north side of the track. Pieces placed as they were before they were fractured. The numbers indicate the distance in inches from the “0” arrows.

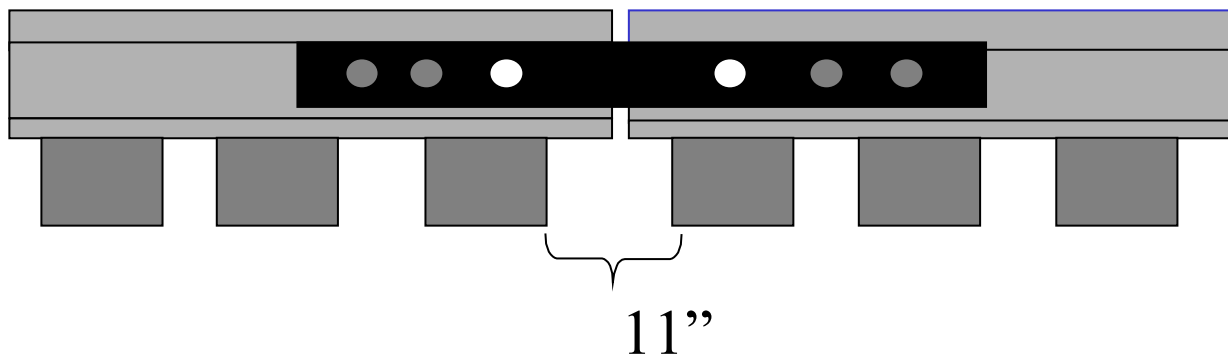
West Joint

- **In comparative analysis, the west joint of the same rail plug exhibited three bolthole cracks, which did not fracture under the exact same operating, tonnage, and climatic conditions.**
- **Laboratory analysis determined that the fractures faces of the rail pieces exhibited sudden rupture characteristics not typical of long term bolthole cracking.**
- **Suspect rail joint bars received separate tensile and bending, as well as, material composition testing.**
- **Material examinations met specification.**
