Solar Turbines

Ceramic Stationary Gas Turbine Development Program

Ceramic Stationary Gas Turbine (CSGT) Program

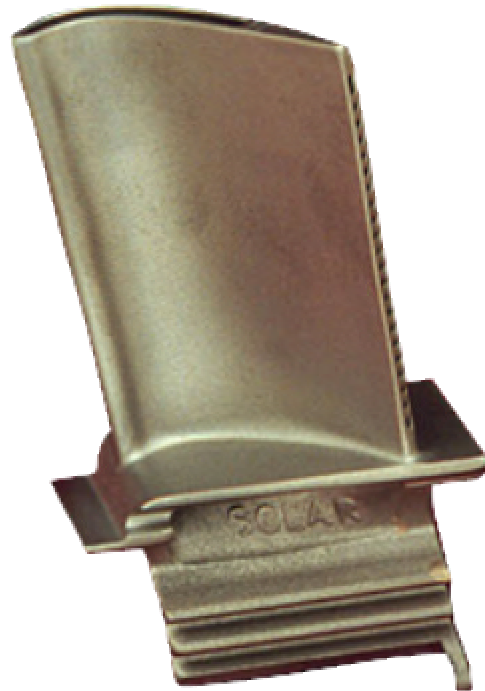
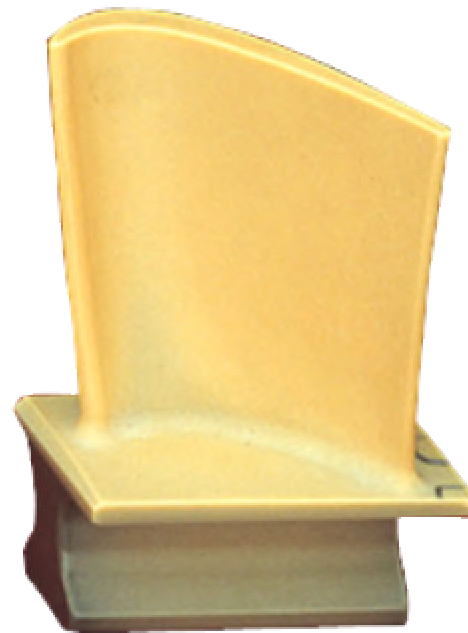
Metallic and AS-800 Ceramic Blades

- **May 1997, AS-800 Blades**
 - Terminated after 948 Hours
 - Foreign Object Damage
- **May 1998, AS-800 Blades**
 - Terminated after 352 Hours
 - Foreign Object Damage

- **Improve Impact Resistance of Ceramic Blade Materials**
 - **Conduct Impact Study**
 - **Improve Material Properties**
 - **Energy Absorbing Coatings**
 - **More Robust Airfoil Designs**
- **Evaluate Alternate Attachments**
 - **More Robust Attachments**
 - **Non-Compliant Layer Designs**

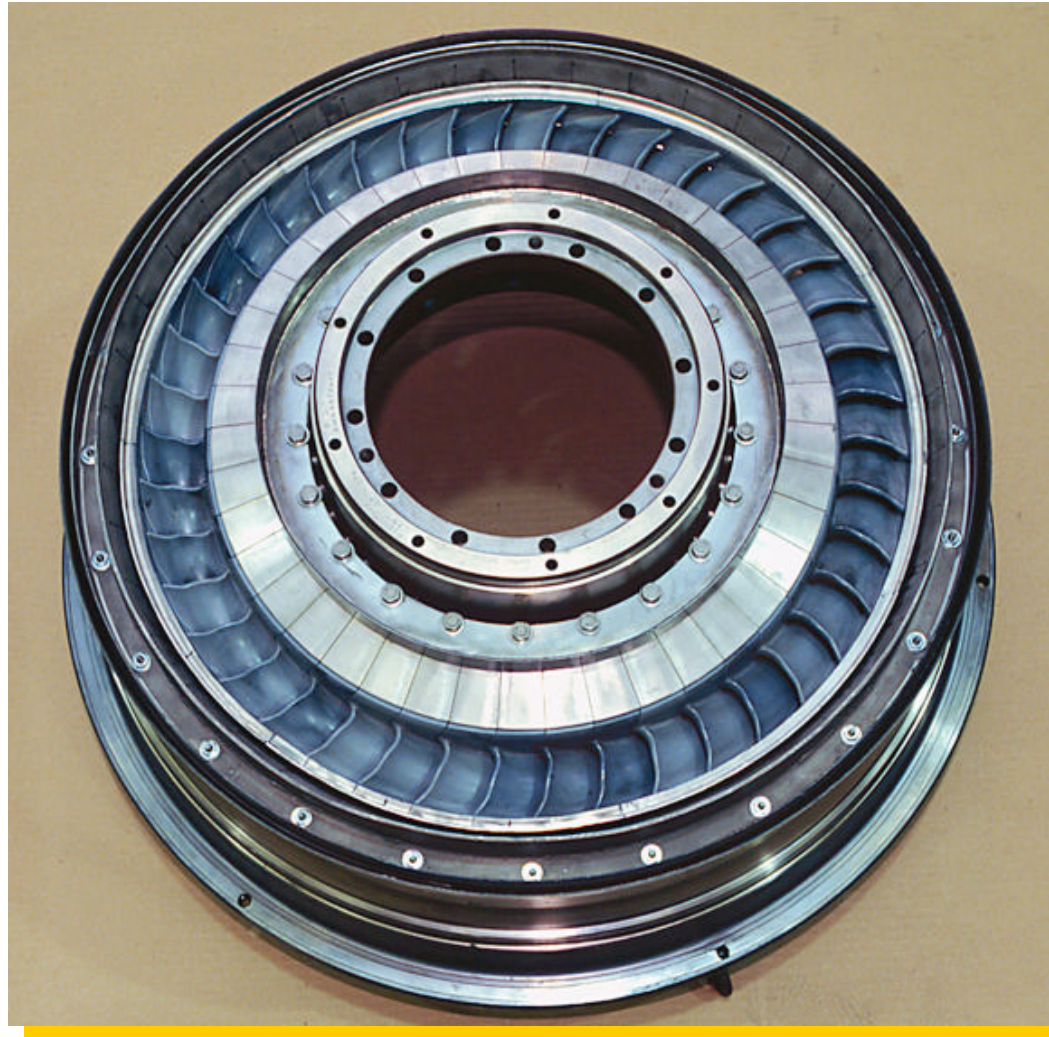
SN-88 Silicon Nitride Nozzle Assembly

- **Short-Term Engine Test - 1 Hr at Full Load**
- **No-Load Idle, 50% Load, 100% Load**
- **Nozzle Airfoil Performed Well**
- **Chipping in Nozzle Attachment and Outer Shroud Area**

- **2nd Short-Term Engine Test
- 1 Hr at Full Load**
- **Design Modifications to
Attachment Structure**
- **Chipping Was Eliminated
during Second Test**
- **100-Hr Cyclic Engine Test**

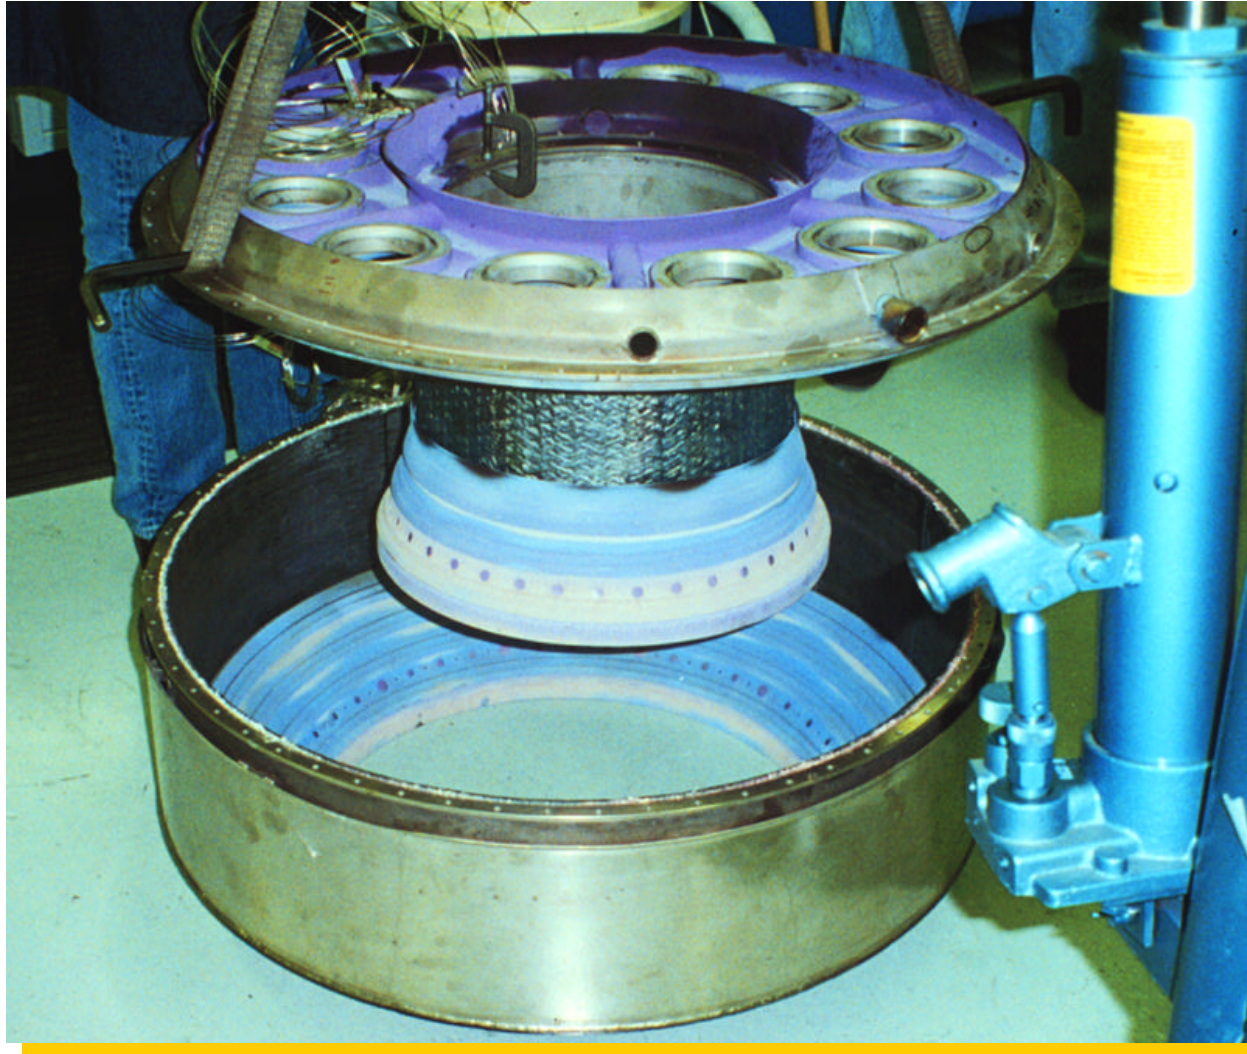
CFCC Combustor Liner Assembly

- **> 400 Hr of In-House Engine Test Time**
 - **100 Hr - Max. Time on Single Build**
- **Excellent Durability**
 - **NDE Inspection Before and After Tests**
- **Emissions**
 - **50 - 100% Load Range**
 - **NOx < 15 ppmv**
 - **CO < 10 ppmv**

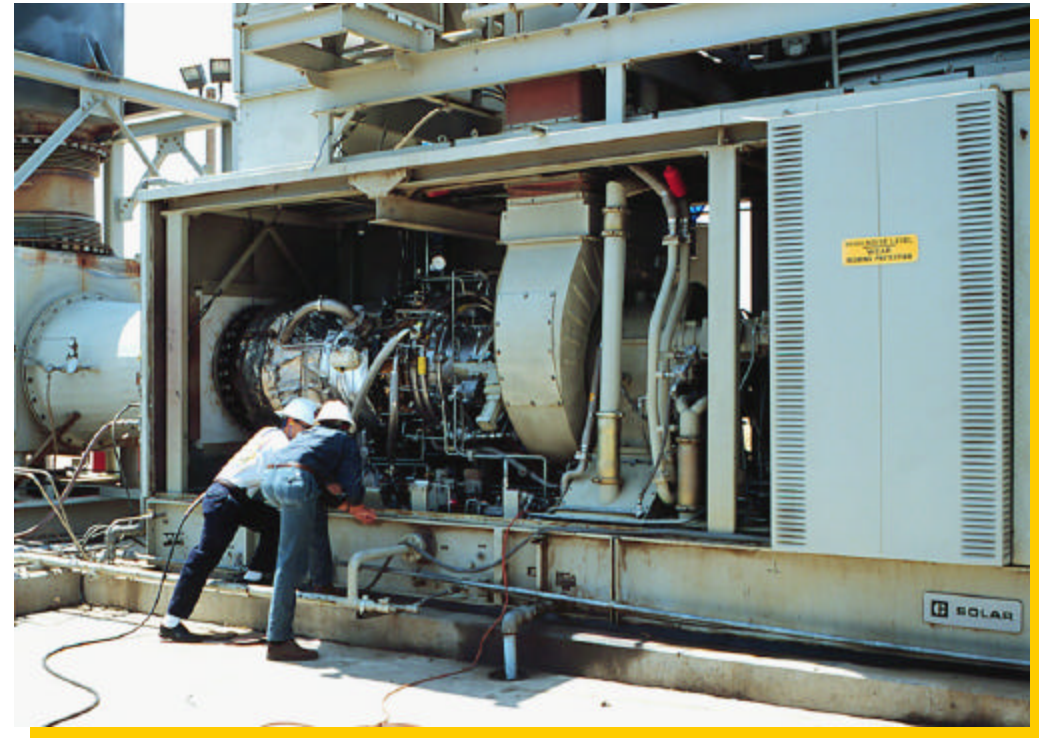
- **World's First Commercial Installation**
 - **May 21, 1997**
 - **1st-Stage AS-800 Silicon Nitride Blades**
 - **Ceramic-Grade Nicalon Enhanced SiC/SiC Liners**
- **Test Terminated after 948 Hrs of Field Operation**
 - **Failure of 1st-Stage AS-800 Blades Attributed to Foreign Object Damage**
