NASA TN D-6722

APOLLO EXPERIENCE REPORT -  
LUNAR MODULE DISPLAY AND  
CONTROL SUBSYSTEM

*by Andrew J. Farkas*

*Manned Spacecraft Center*

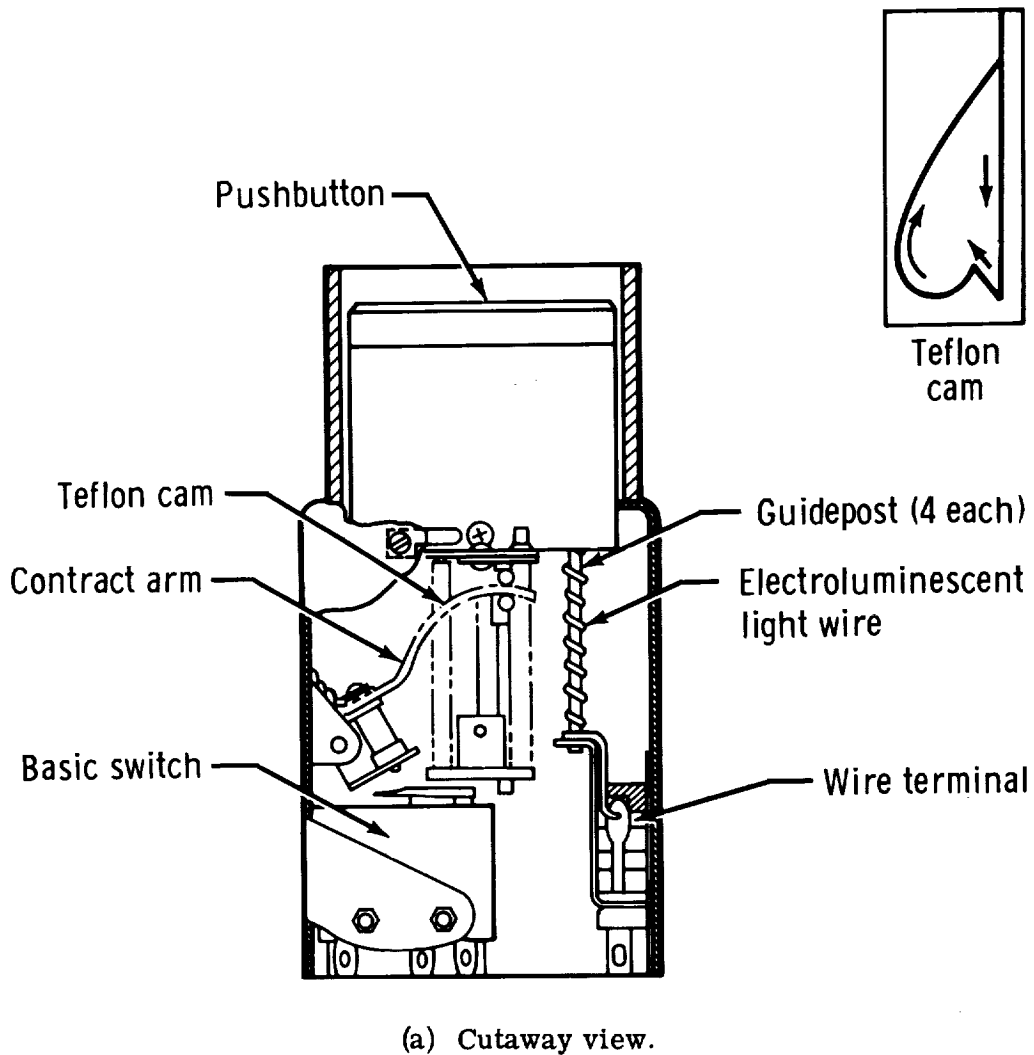
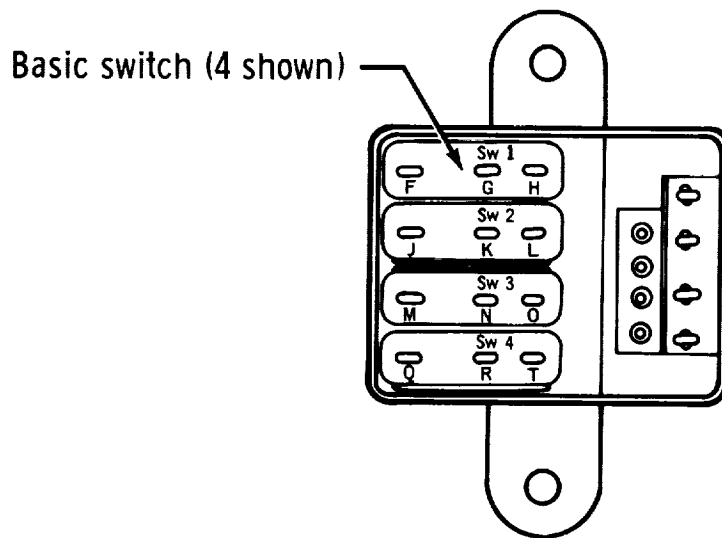
Figure 2. - Schematic diagram of a typical pushbutton switch.

The pushbutton switches have been marked by numerous failures, including the following.

In addition to these minor problem areas, more significant failures were experienced: contamination and stop-switch latching.

Contamination found in many of the switches prohibited proper switch actuation. Contamination included the following.

During vehicle testing, it was determined that when the engine stop switches were depressed, they could be inadvertently reset, which caused the engine to start again. To preclude this action, an external latch mechanism was added to this switch. The external latch mechanism was designed so that two actions were required to reset the stop switch, thereby eliminating the possibility of an engine restart. The design of this latch mechanism created many other problems before the latch could be properly installed in the vehicle. At present, this mechanism is working properly and has not caused any problems.

2. A new design rubber (Silastic) seal was added at the rear of the switch. This rubber seal provided better adhesion to the cement, therefore preventing a flow of the potting which could cause contamination.

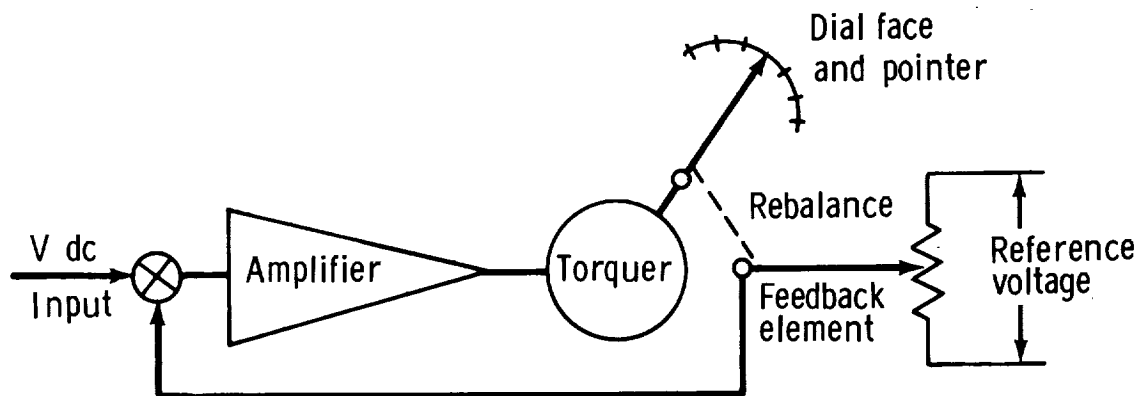
Figure 3. - Servomatic meter concept.

3. Cleanliness — Foreign materials of many types were found inside the meters. The materials included metal shims picked up by the torquer magnet. Corrective action included the use of brass shims and tighter control to keep work areas clean.

4. Sealing cases — The most significant problem during early testing of meters was in sealing the front glass within the case. Failures occurred during thermal vacuum testing. Specifically, breaks occurred in the bond between the glass and the case. During the thermal vacuum test, stresses developed which pulled the bond apart. Changing the potting to a stronger, more rigid material improved the bond, but caused the glass to crack. In analyzing the problem (fig. 4), the determination was made that a material had to be selected that had the proper shear strength, yet was flexible. The potting material between the meter case seal, the glass, and the case was changed to a flexible polyurethane, and the glass was made smaller to allow more potting. This change reduced the stress at the bond line so that seal breaking was prevented and the bond was flexible enough at a low temperature to prevent the glass from breaking.

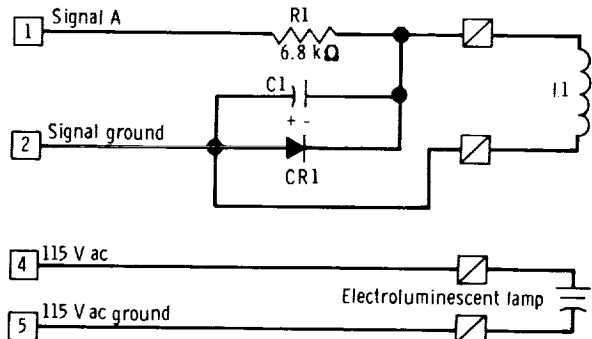
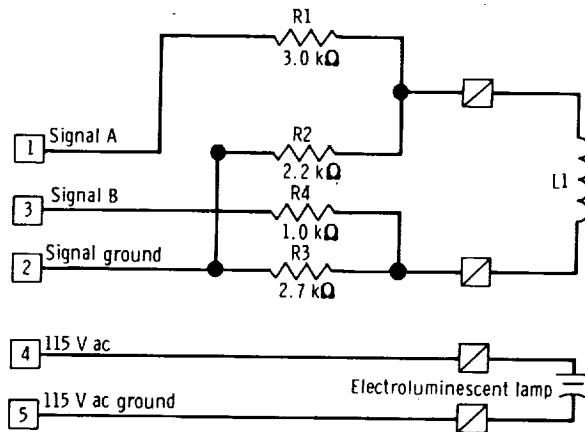
Figure 9. - Flag indicator circuit diagram.

The flag program, from initial development to present usage, has had many problems. The most annoying problem has been flag hangup, or hesitation. Although many corrective actions have been taken, this problem has never been solved. An analysis of acceptance and qualification failures identified the following failure modes.

1. Bearing bridge resonance — The bearing bridge resonated under random vibration, causing the flag to hang up. Design changes were made to the bridge to increase the resonant frequency above the critical level.
2. Coil clearance — The clearance between the coil and the pole piece or magnet (or both) was not sufficient; under random vibration, the coil would bind. Corrective action included increasing clearance and more accurate part alignment.
3. Spring system — Many flag hangups were caused by improperly formed springs. Procedures were implemented for proper spring formation and for spring tension measurement.

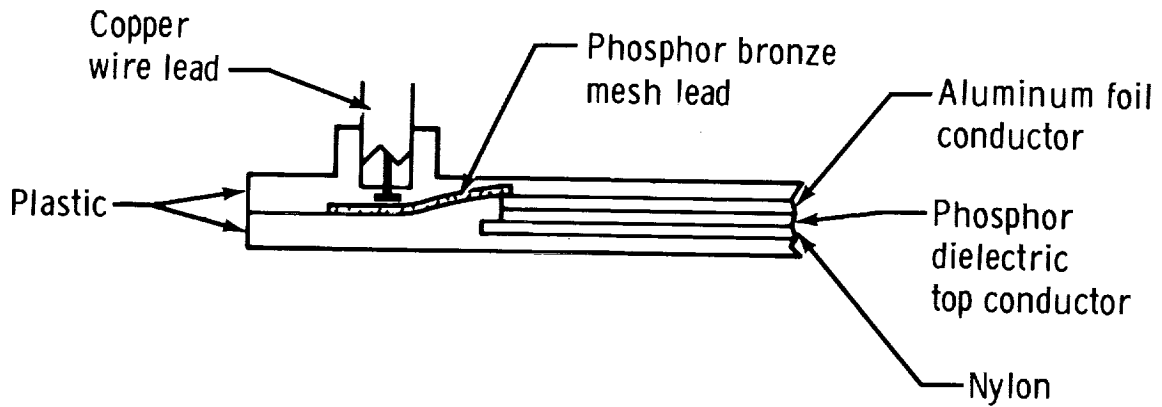
Figure 10. - Electroluminescent panel.

The procurement of electroluminescent lamp panels has been relatively free of problems since the start of the program. Initially, electroluminescence was state of the art, which led to problems in manufacturing techniques. When these initial problems were corrected, only two additional difficulties developed. The first concern was the development of dark spots in the electroluminescent lamps after extensive periods at high temperature. This problem was brought to the attention of the manufacturer, and corrective action was taken. Because fabrication of electroluminescent lamps is proprietary information, corrective action details could not be obtained. The only other concern was high-resistance shorts that developed around the leads. This problem was caused by the phosphor bronze mesh lead floating to the top of the plastic covering during processing. Corrective action included process specification revision and changing of the mesh material. Testing has proved this and all other corrective actions acceptable.

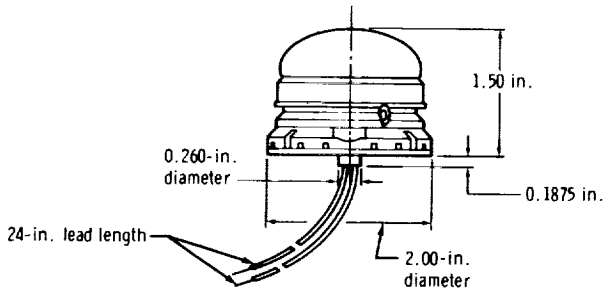
Figure 11. - Exterior docking light.

This program has been quite successful. Three failures that occurred during qualification tests were attributed to an easily corrected manufacturing defect. There have been no failures on vehicles during testing or in flight. The initial contract for docking lights was terminated after many serious design problems occurred. The history outlined relates only to the second contractor.
