# **Heat Pipe Corrosion Test Report EPRI/NYSEG HSTC Unit**

Report prepared by ABB API for NYSEG, EPRI, and Radian Corporation.

# Heat Pipe Corrosion Test

## EPRI/NYSEG HSTC Unit

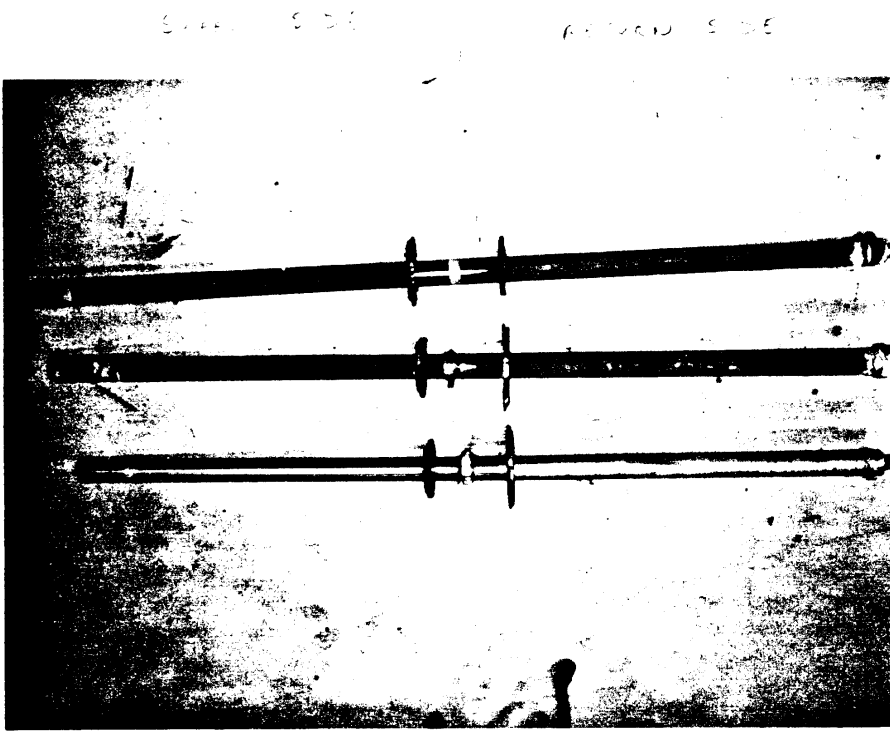
**Figure 4**

Showing all of the test heat pipes from Location A.

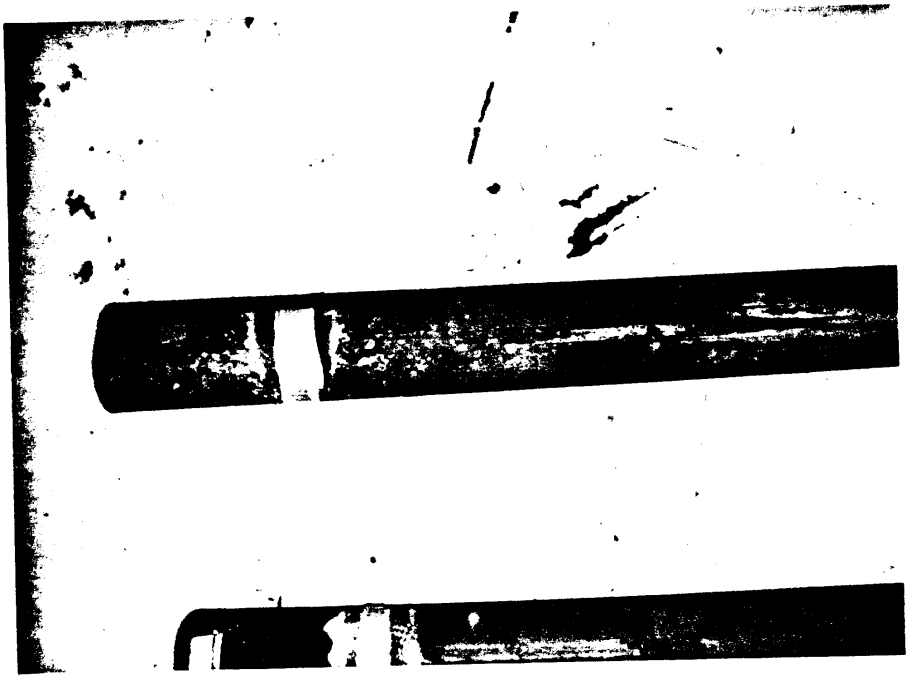
**Figure 9**

Showing the end of the carbon steel heat pipe. Location A, supply side.

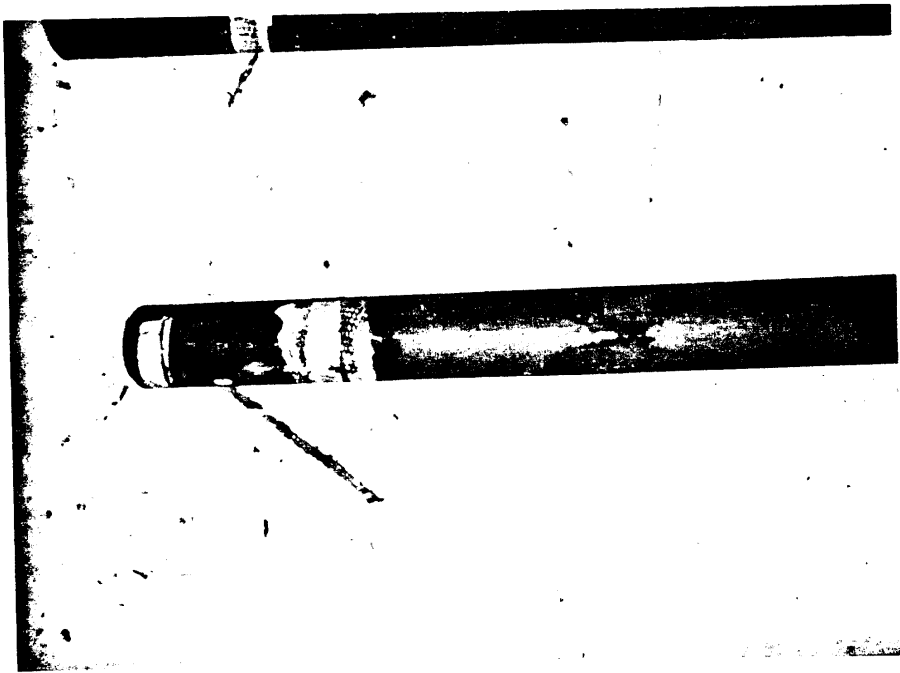
**Figure 10**

Showing the end of the Cor-Ten B<sup>®</sup> heat pipe. Location A, supply side.

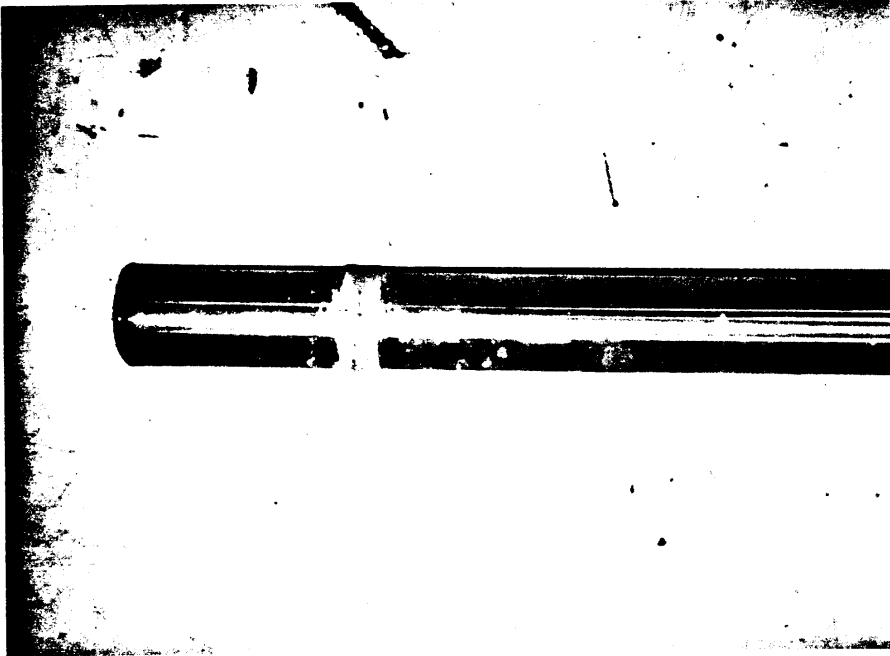
**Figure 11**

Showing the end of the AL-6XN<sup>®</sup>. Location A, supply side.

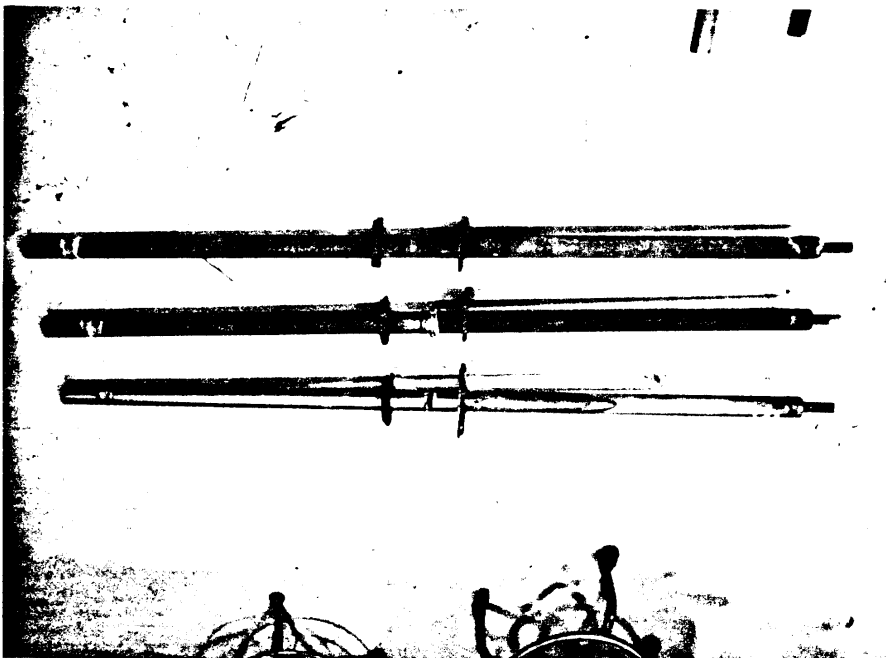
**Figure 12**

Showing the three heat pipes from Location B.

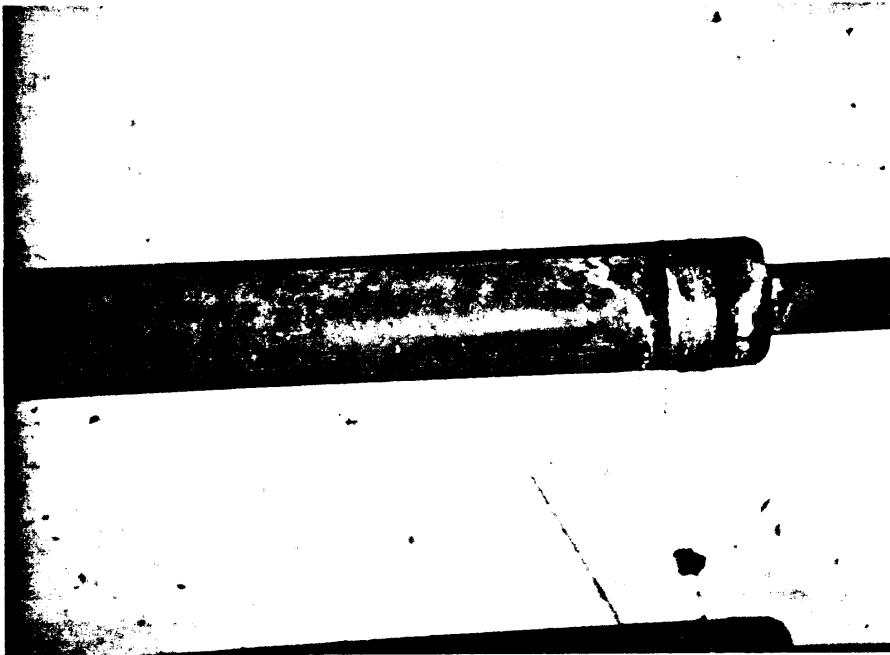
**Figure 13**

Showing the end of the carbon steel heat pipe. Location B, return side.

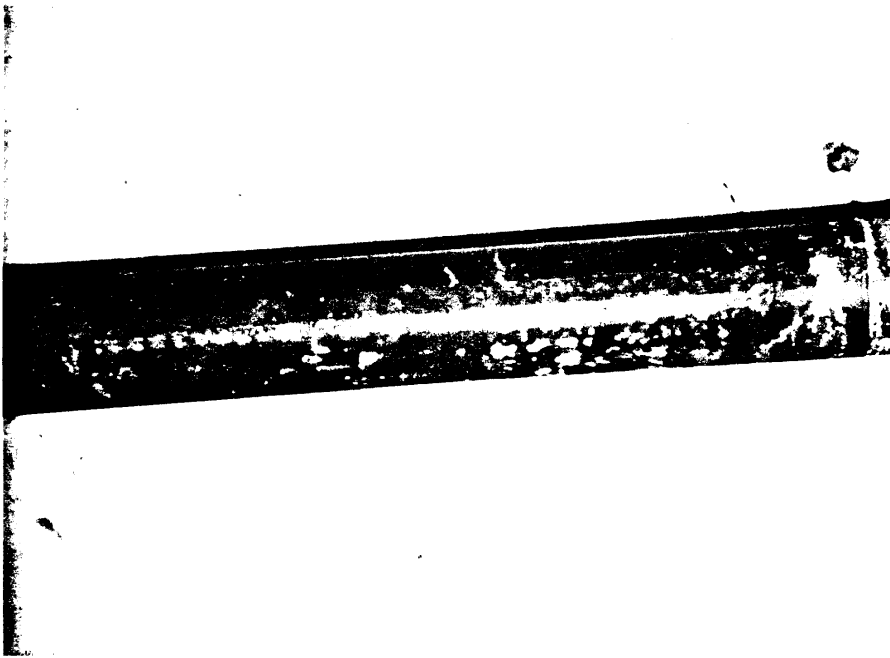
**Figure 14**

Showing the end of the Cor-Ten B<sup>®</sup> heat pipe. Location B, return side.

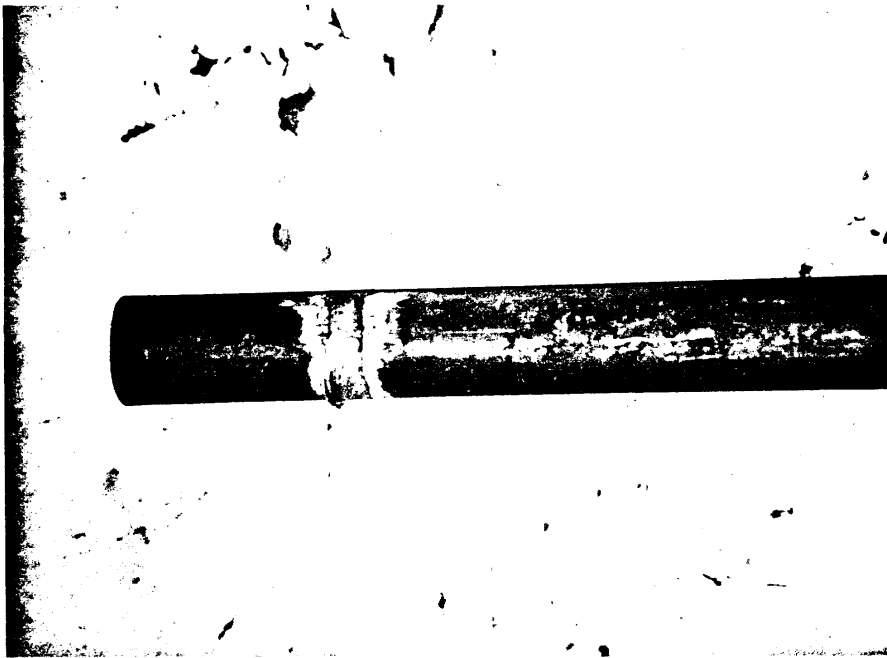
**Figure 16**

Showing the end of the carbon steel heat pipe. Location B, supply side.

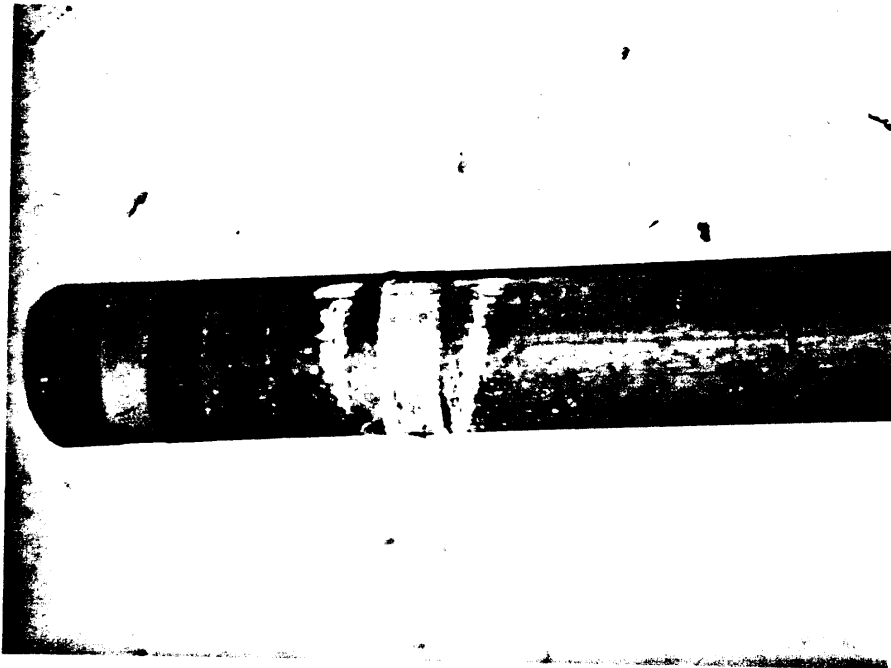
**Figure 17**

Showing the end of the  
Cor-Ten B® heat pipe.  
Location B, supply side.

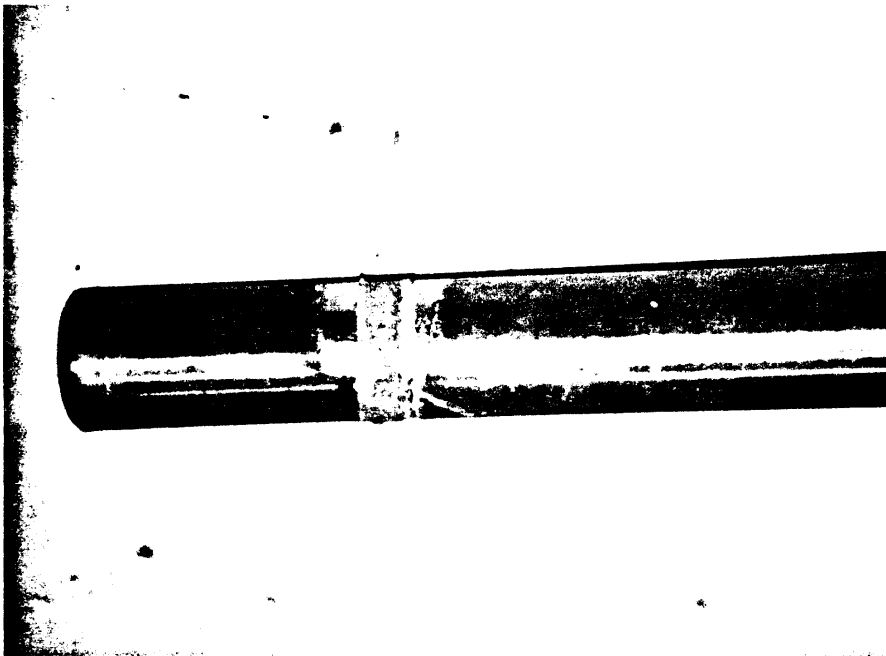
**Figure 18**

Showing the end of the  
AL-6XN® heat pipe. NOTE the  
mill's line marking. Location B,  
supply side.

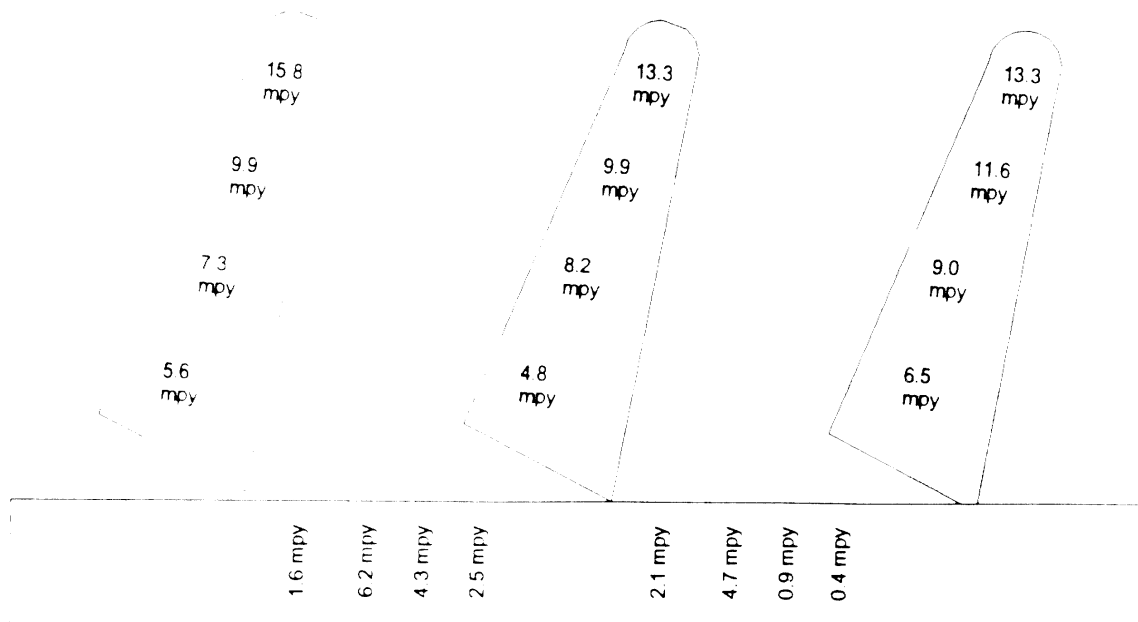
# Figure 26

Thickness and Corrosion Results - Return Side - Trailing Edge of Tube  
(Alloy 2205 Tube/AISI 409 Fin Materials)

<u>1/4</u>	<u>midpt</u>	<u>3/4</u>	<b>Corrosion Rate, mpy</b>		
				<u>1/4</u>	<u>midpt</u>	<u>3/4</u>
A	0.0788	0.0784	0.0784	-0.1	0.3	0.3
B	0.0787	0.0786	0.0784	0.0	0.1	0.3
C	0.0788	0.0787	0.0787	-0.1	0.0	0.0

<u>Base</u>	<u>1/3</u>	<u>2/3</u>	<u>Tip</u>	<b>Corrosion Rate, mpy</b>		
					<u>1/3</u>	<u>2/3</u>	<u>Tip</u>
1	0.0512	0.0396	0.0347		9.6	13.8	
2	0.0505	0.0384	0.0346	0.0304	10.6	13.8	17.4
3	0.0511	0.0411	0.0342	0.0303	8.3	14.2	17.5

Showing the corrosion rates on a graphical representation of the examined section.

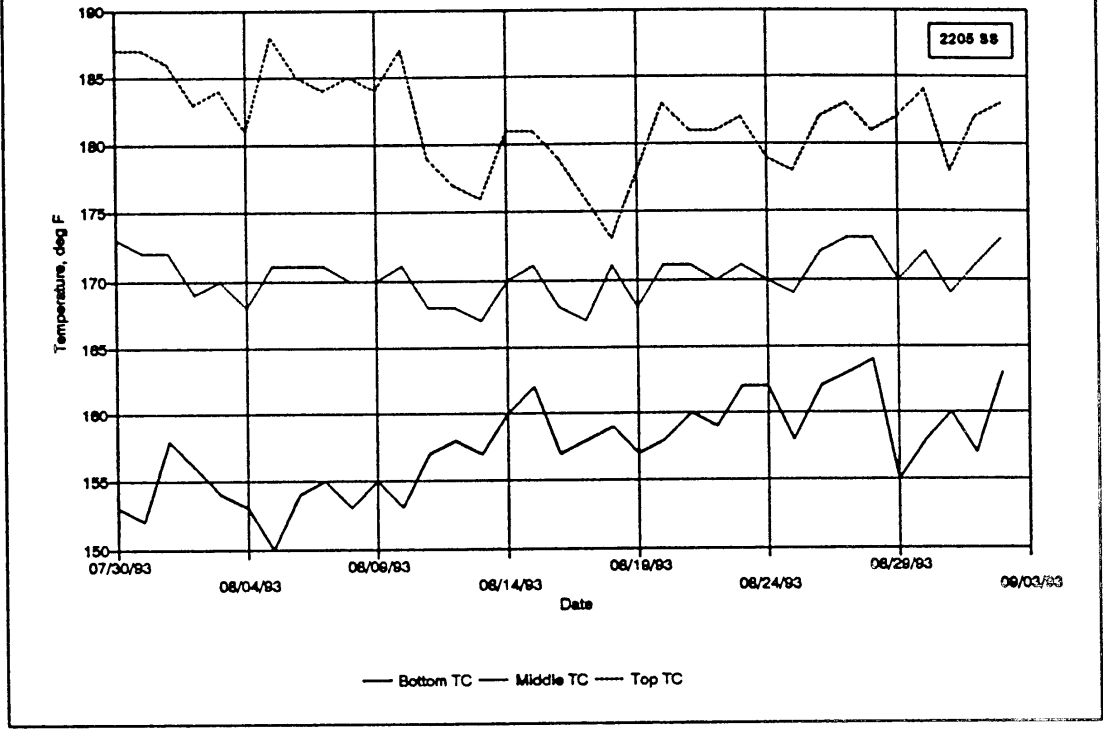
**Figure 8**  
**#3 Air-Cooled Probe Skin Temperatures**

Figure 8 presents the temperature data for the No. 3 air-cooled probe. As for the other two probes, the temperature control was tight and stable.

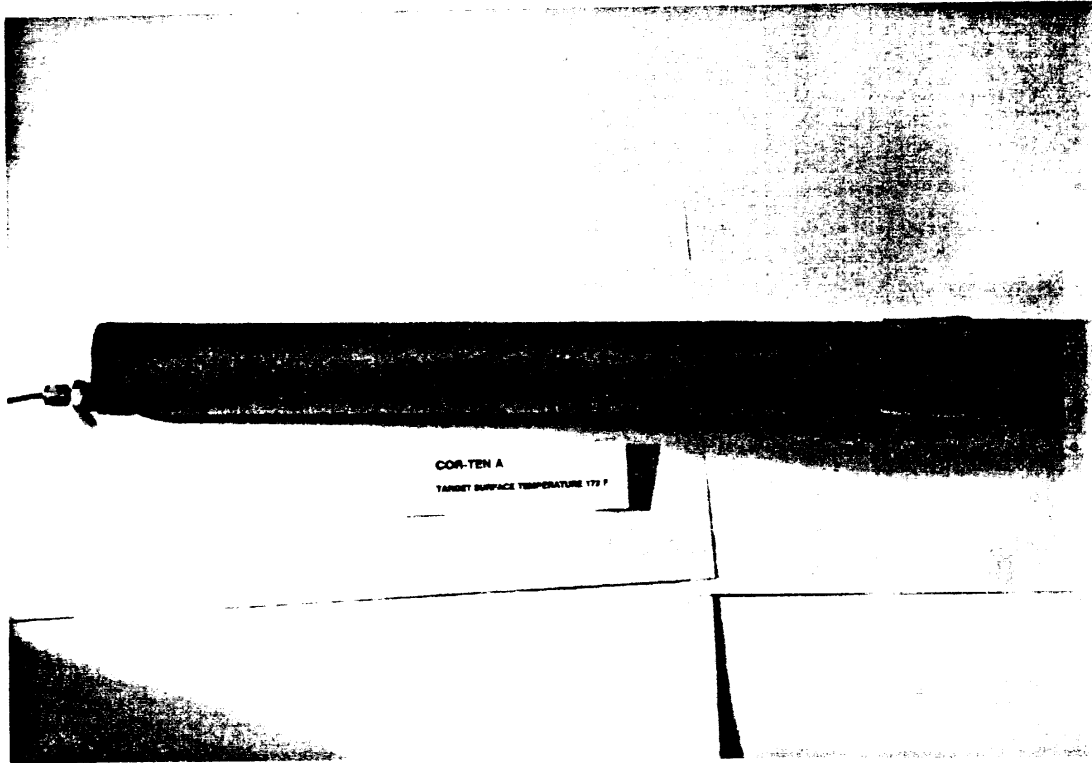
Overall and close-up views of the cleaned air-cooled probes after the first inspection for dimensional measurements are shown in Figures 38 to 43. Figures 38 and 39 show little or no corrosion on the No. 1 air-cooled probe. The machine marks on the No. 1 probe are clearly visible in Figure 39. Because of short notice for construction, two machinists were used to manufacture the probes. This resulted in differences in the probe surface dressings with the No. 1 probe being coarse and the other two fine.

Figure 38. Overall view of cleaned No. 1 air-cooled, Cor-Ten A corrosion probe (1168 hours in service).

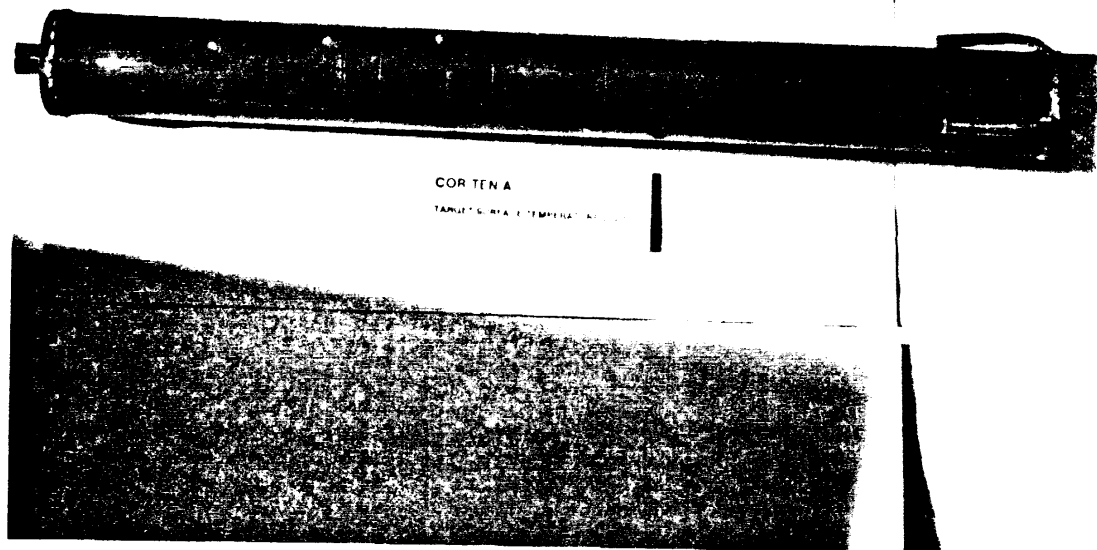
Figures 40 and 41 also show very little surface attack of the No. 2 air-cooled Cor-Ten A probe after 832 hours of service. Only a slight discoloration of the cold-end tip can be seen in Figure 41, where temperatures were below about 185°F (see Figure 7). However, for this same short test period, severe corrosion of the 2205 SS probe is clearly indicated in Figures 42 and 43. The pitting extended the entire length of the probe. The probe was not tested further because the corrosion resistance was not adequate for the test environment.

Figure 40. Overall view of cleaned No. 2 air-cooled, Cor-Ten A corrosion probe (832 hours in service).

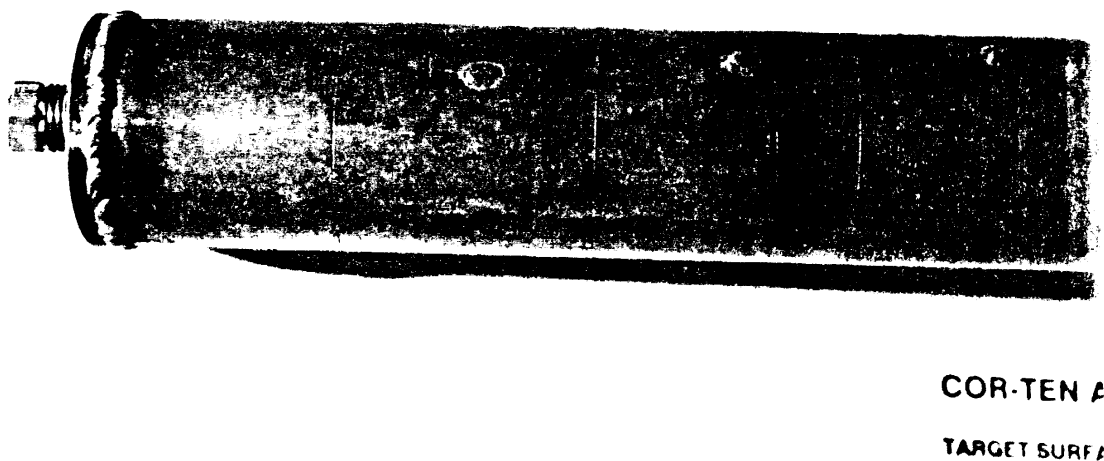
Figure 41. Cold-end close-up view of No. 2 air-cooled, Cor-Ten A corrosion probe (832 hours in service). Finely machined surface is still smooth with minor discoloration at the tip (coldest area of probe).

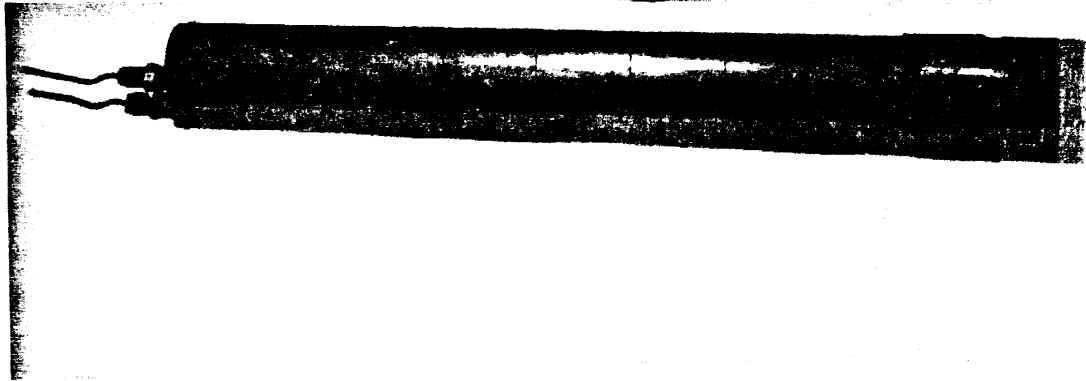
Figure 44 is an overall view of a cleaned No. 1 air-cooled Cor-Ten A probe taken at the end of all testing. The probe had been operated (middle thermocouple) at nominally 172°F for 3832 hours and at 192°F for 2474 hours. As shown in the figures, this probe suffered little corrosion. At the end of testing, the coarse machine marks were still clearly visible for this probe.

Figure 44. End-of-test overall view of cleaned No. 1 air-cooled, Cor-Ten A corrosion probe (3832 hours at 172°F and 2474 hours at 192°F).

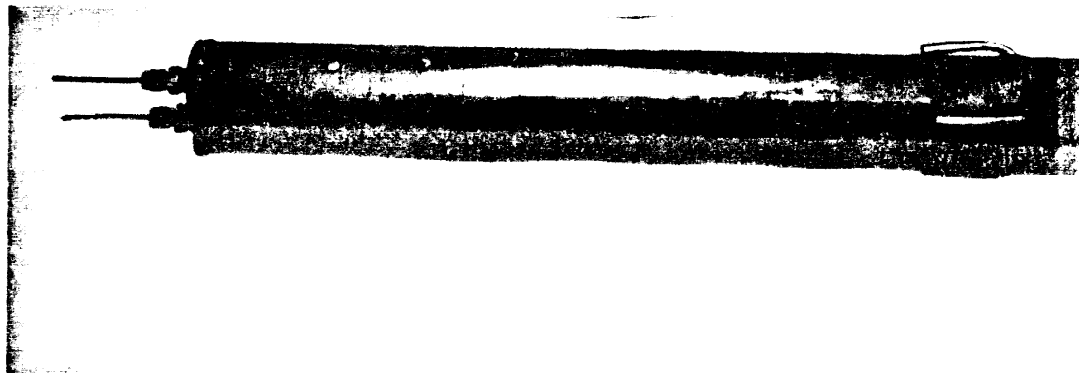
Overall and close-up views of the No. 2 air-cooled probe are shown in Figures 46 and 47, respectively. This probe had been operated at nominally 201°F for 3496 hours and at 174°F for the last 2378 hours. Generally, the probe showed little or no corrosion except for the bottom 4" and in one other area 10"-12" from the bottom end. Corrosion of the bottom end was not unexpected since temperatures were below 160°F over the last 2378 hours of operation. During the period when the No. 1 air-cooled probe was operated at 172°F, the probe was installed in an area where flue gas temperatures were low due to the operation of the upstream Ljungstrom air heater (see Figures 3 and 4). In such downstream areas from Ljungstrom units, flue gas SO<sub>3</sub> levels are often greatly reduced because of condensation in the Ljungstrom. A lower SO<sub>3</sub> flue gas level would explain why the No. 2 air-cooled probe shows less corrosion than the No. 1 probe.

Figure 46. End-of-test overall view of cleaned No. 2 air-cooled Cor-Ten A corrosion probe (3496 hours at 201°F and 2378 hours at 174°F).

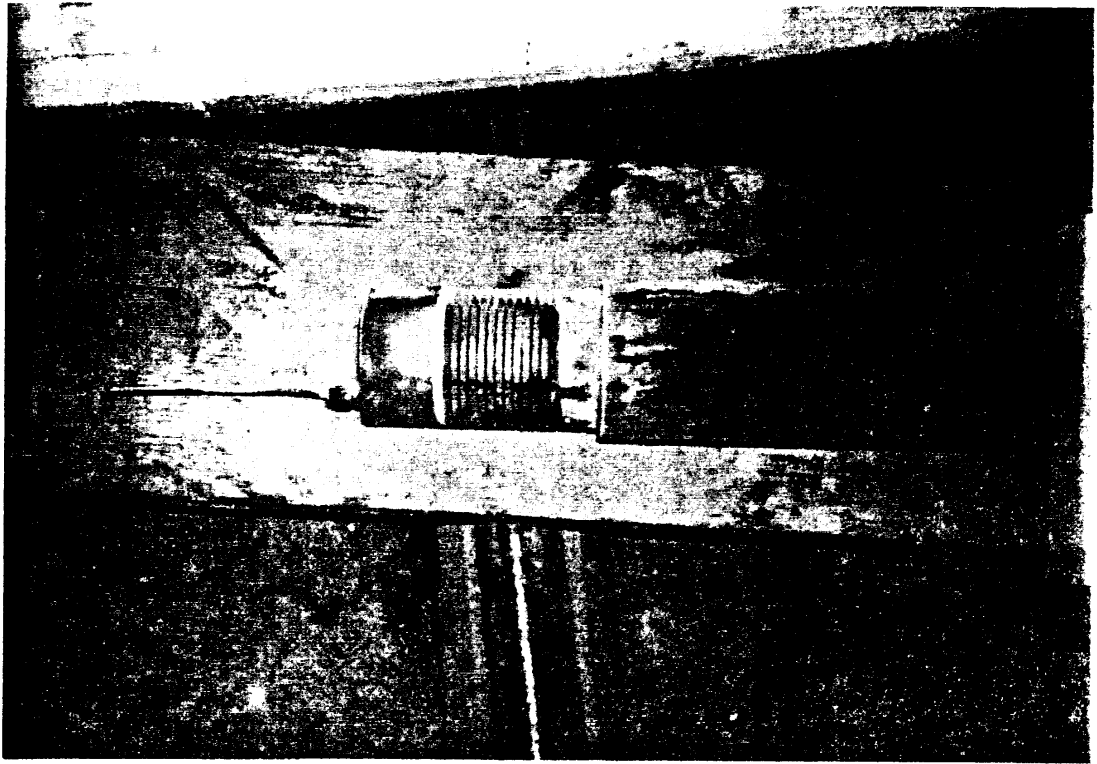
The conditions of the CAPCIS probes immediately after removal from the system following the ESP and slipstream heat pipe tests are shown in Figures 50 to 52. Each time the probes were removed for sensing element dimension measurements, the elements had a uniform corrosion scale. This scale, the rust-colored coating shown in the figures, is required for proper operation. For the ESP tests, only the SA-178A probe was installed. As expected, there were never any ash deposits on the probe. The probes removed from the slipstream heat pipe outlet were, however, coated with fly ash solids.

Figure 50. Condition of SA-178A CAPCIS corrosion probe at end of ESP test period (1609 hours in service since last cleaning).

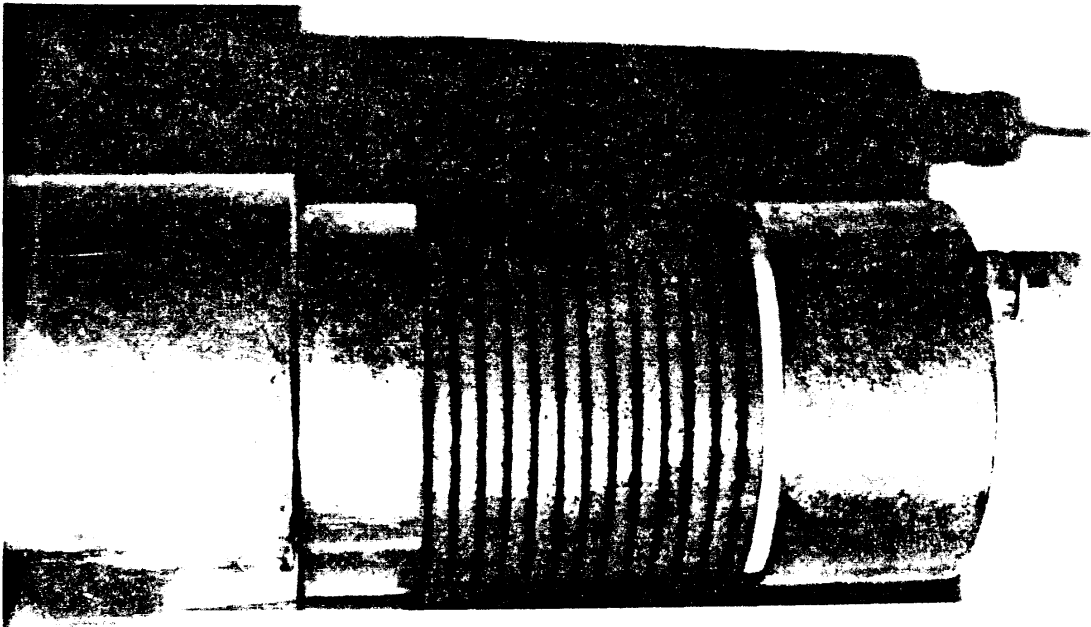
### SA-178A CAPCIS Probe

Figures 53 and 54 are close-up views of the cleaned sensing elements for the SA-178A and Cor-Ten A probes, respectively. The photographs show the final condition of the probes at the end of the testing. The surface of the SA-178A probe appears slightly rougher than that of the Cor-Ten A probe. This is to be expected since the probe was in operation longer and the manually measured corrosion rates for the SA-178A probe are about double those of the Cor-Ten A probe.

Figure 53. Close-up, final condition of cleaned SA-178A CAPCIS corrosion probe sensing elements (2487 hours in service at slipstream heat pipe outlet). Black marks on probe are ink marks used by technician to note which elements had been measured.
