14.1.10 Data Recorder Tape Deterioration

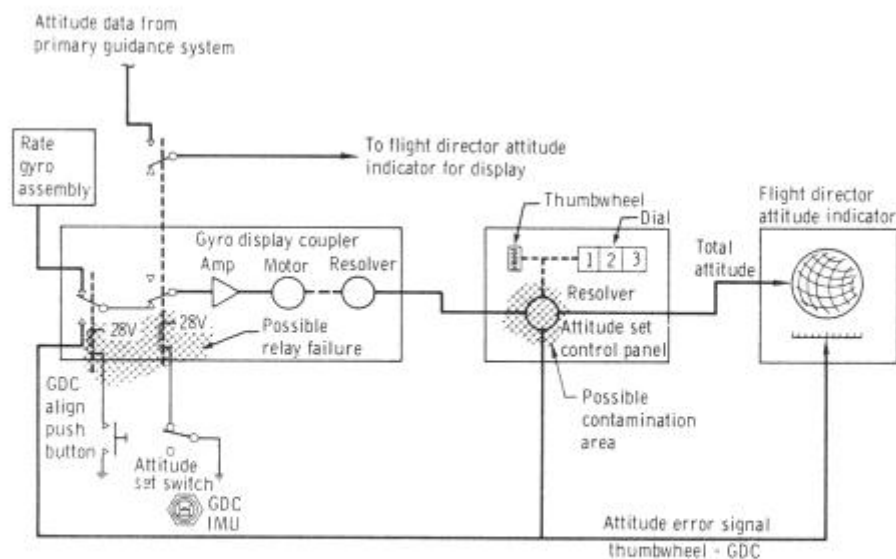
Figure 14-21.- Simplified align loop.

alignment pushbutton was pressed. The roll axis error was not nulled, whereas, the pitch and yaw axes were. Only by depressing the align pushbutton for progressively longer periods, and eventually, by moving the roll-axis thumbwheel, could the roll error be nulled.

For normal operation during alignment, resolvers in the gyro display coupler electronics are compared to resolvers, one for each axis, on the thumbwheels used to set desired attitude. The difference is an error signal. The error is displayed on the attitude error needles, and the signal is used to drive the resolvers to match the attitude set on the thumbwheels. The anomaly could have been caused by either of two failure modes. An intermittent open in the roll axis align loop or a low gain problem in the electronics (**Fig. 14-21**).

The gyro display coupler and attitude set control panel were put into the hardware evaluator simulator and functionally tested at the systems level in the actual spacecraft configuration in an attempt to repeat the flight problem. During this testing, an out-of-tolerance condition was observed on the attitude set control panel. This condition could have caused a gain type problem and been the cause of the flight anomaly. The measured resistance of the thumb wheel resolvers increased from the nominal in all three axes by as much as 1000 ohms. Normally, this value does not vary by more than 1 ohm. In order for this condition to have been the cause of the anomaly, a resistance change in the roll axis would have had to be an order of magnitude larger than that measured postflight. The resistance change is caused by contamination between the slip rings and the thumbwheel resolvers. As a result of the flight anomaly, several resolvers were examined and contamination was detected. The corrective action is to wipe the resolvers clean by rotating them several hundred revolutions. The attitude set

The flight condition could also have been caused by either of two golden-g" relays failing to close. Two failure modes have been determined. One failure mode is "normally open-failure to close", and other, "normally closed - failure to open", both caused by contamination. "Golden-g" relays were the subject of an extensive review in 1966 and 1967. Relays were classified as (1) critical, (2) of major importance, (3) of minor importance, and (4) having no effect. It was decided at that time to (1) make critical relays redundant, (2) improve screening tests, and (3) take no corrective action for non-critical relays. Both of the suspect relays are of major importance in that either one would cause loss of the normal alignment capability of the backup attitude reference system. The attitude reference system could be aligned, but extensive work-around procedures would have to be used.

Tests performed on the roll axis align enabling relay revealed contamination which could have caused the flight anomaly. The rationale developed during the "golden-g" relay review is applicable at this time.

control panels in Apollo 16 and 17 will be checked and the resolvers will be wiped clean, or will be replaced if necessary.

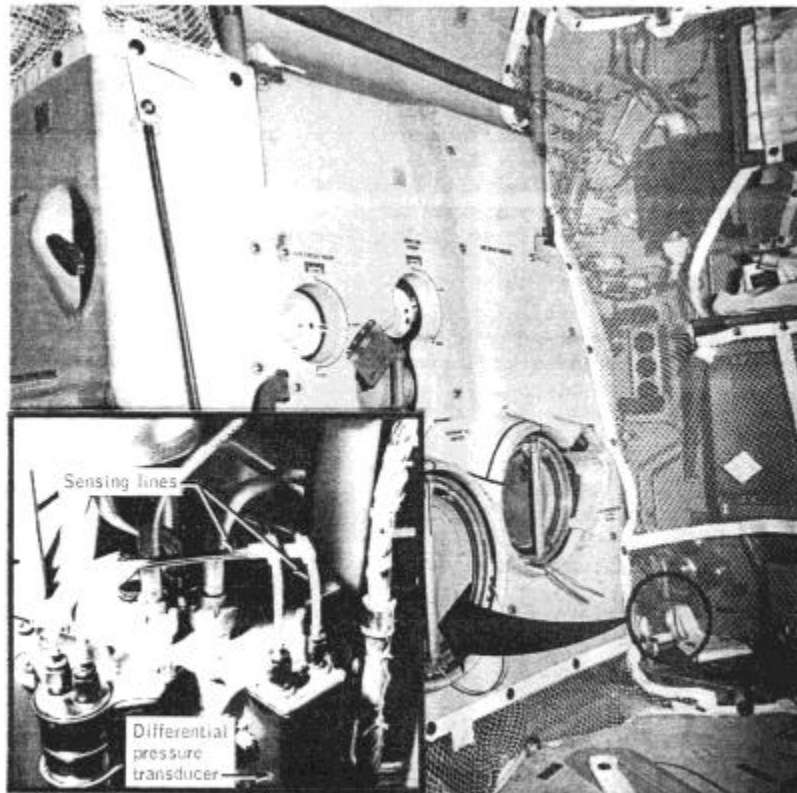
Figure 14-25.- Glycol pump sensing lines.

The lunar module cabin humidity was high at the initial manning for descent because the command module cabin humidity was high. Furthermore, a water spill in the lunar module cabin after the first extravehicular activity again produced high humidity. Consequently, water would have condensed on the cold 1/8-inch water/glycol sense lines between the pump assembly and the pressure transducer (**Figs. 14-25 and 14-26**), and the water would have frozen and sublimed at the next cabin depressurization. Since there is no flow in the sense lines, as little as 0.002 inch of condensed moisture on the outside of these lines would freeze the fluid and cause the fluctuations in the indicated differential pressure, but would not affect system operation. Consequently, no corrective action is required.

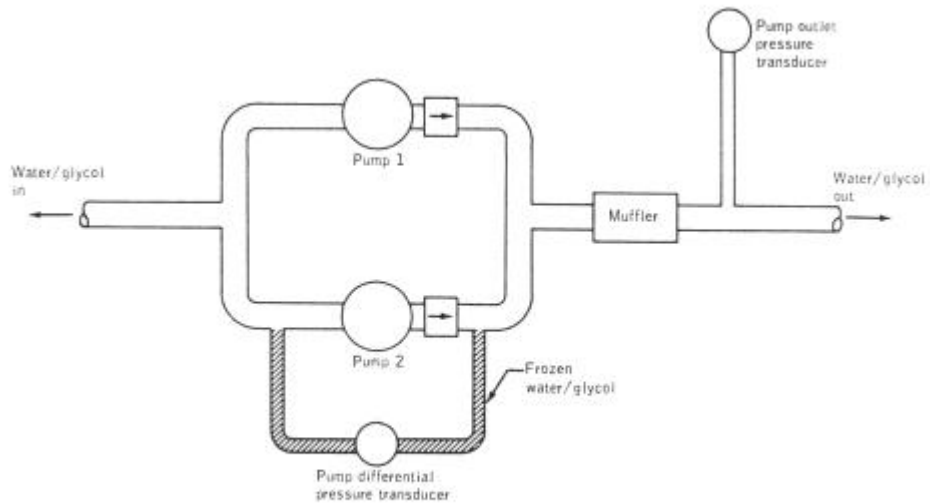
Figure 14-26.- Water/glycol pressure measurements.

Variations were noted in the water/glycol pump differential pressure shortly after the cabin depressurizations for the standup extravehicular activity and the second extravehicular activity. The variations were similar on both occasions. The pressure differential decreased from about 20 psid (normal) to about 15 psid, then increased to about 27 psid and returned to normal (**Fig. 14-24**).

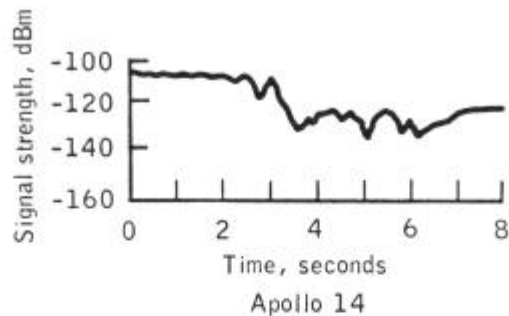
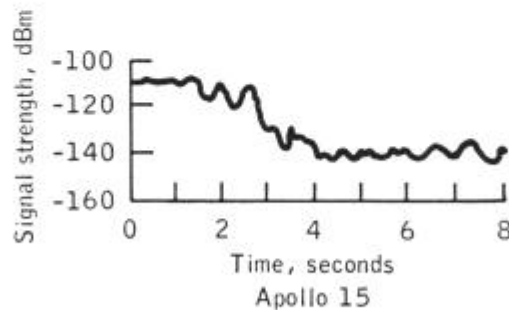
Figure 14-31.- Ground-received signal strength showing spacecraft antenna oscillation characteristics.

All oscillations indicated characteristics similar to the conditions experienced on Apollo 14 (Fig. 14-31). After Apollo 14, one of the prime candidates considered as a possible cause was incidental amplitude modulation on the uplink signal. A monitor capable of detecting very small values of incidental amplitude modulation was installed at the Manned Space Flight Network Madrid site for Apollo 15. The data from this monitor indicated that no amplitude modulation existed on the uplink at the frequencies critical to antenna stability during the problem times. Consequently, incidental amplitude modulation has been eliminated as a possible cause of the antenna oscillations, and the problem must be in the spacecraft.

There are two possible causes of the problem in the spacecraft. The first is that electrical interference generated in some other spacecraft equipment is coupled into the antenna tracking loop. A test performed on the Apollo 16 lunar module showed that no significant noise is coupled into the tracking loop during operation of any other spacecraft equipment in the ground environment. The second is that temperature or temperature gradients cause an intermittent condition in the antenna which results in the oscillations. The acceptance tests of the antennas do not include operation over the entire range of environmental temperatures; therefore, a special test is being conducted on a flight spare antenna to determine its capability to operate over the entire range of temperatures and gradients.

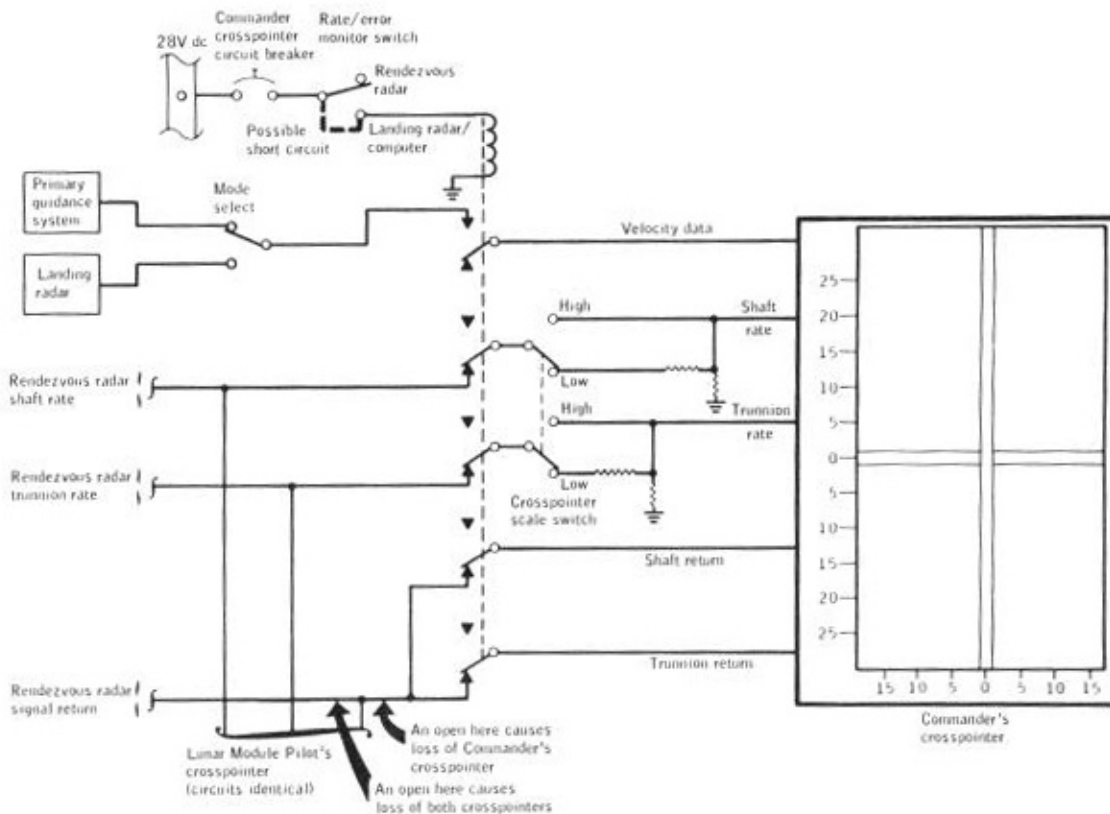
Figure 14-33.- Simplified schematic of crosspointer circuits.

Four possible conditions could have affected the display of radar antenna rate data (**Fig. 14-33**).

- c. An open in the return line would cause loss of rate data to one or both meters, depending upon the location of the open. The signal return lead from the Commander's meter in panel 1 is routed to panel 2 where it is connected to the signal return from the Lunar Module Pilot's meter and routed to the rendezvous radar.

- d. An open in the wire in the rendezvous radar electronics assembly which connects 15 volts at 400 hertz to two velocity filters (one each for shaft and trunnion rate) could cause the loss of shaft and trunnion rate data to both sets of crosspointers.

The most probable failure is an open in the signal return line. Information could still be deduced from antenna position data which is displayed on the flight director attitude indicators. Ground tests and checkout may not show this type of failure. If the open is temperature sensitive, a complete vehicle test involving vacuum, temperature, and temperature gradients would be required to insure that failures of this type would not occur in the flight environment. This type of testing is not practical at the vehicle level. Consequently, no corrective action is planned.
