## **NIOSH HEALTH HAZARD EVALUATION REPORT**

**HETA #2005-0033-2984 and 2005-0234-2984  
Liberty Central School District  
Liberty, New York**

**November 2005**

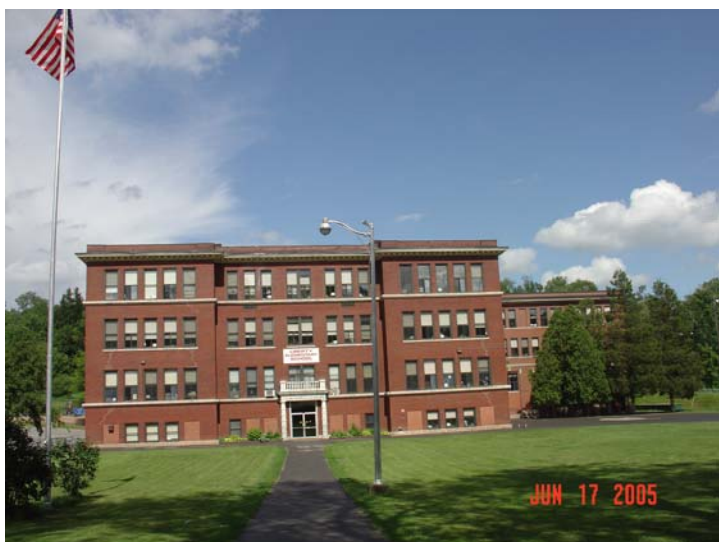
Figure 1. Front view of Liberty Elementary School.

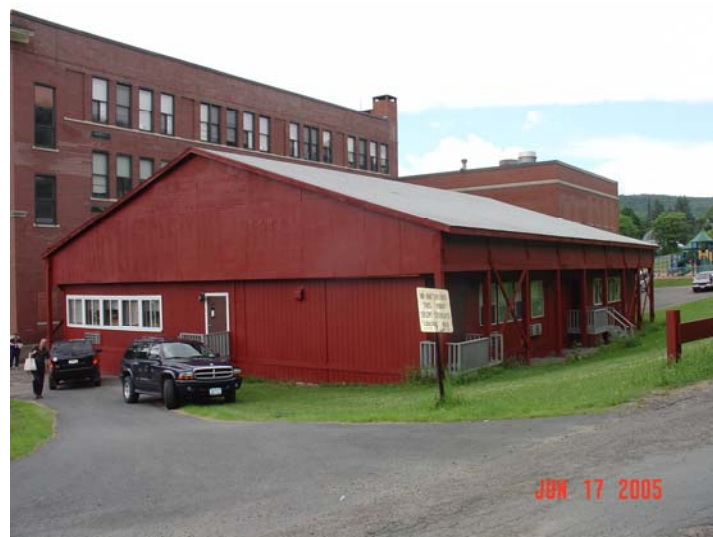
The school also has four modular classrooms that were added in 1987 (Figure 2). A single roof constructed above the individual modular roofs encloses the four units and allows for a central hallway connecting the modular units to one another and the 1938 portion of the building. Restrooms are located off the central hallway. Unit ventilators heat and cool the modular classrooms while electric baseboards heat the hallway. Windows were operable and each classroom has two exit doors, one to the hallway and one to outside.

Figure 2. Liberty Elementary School modular classrooms.

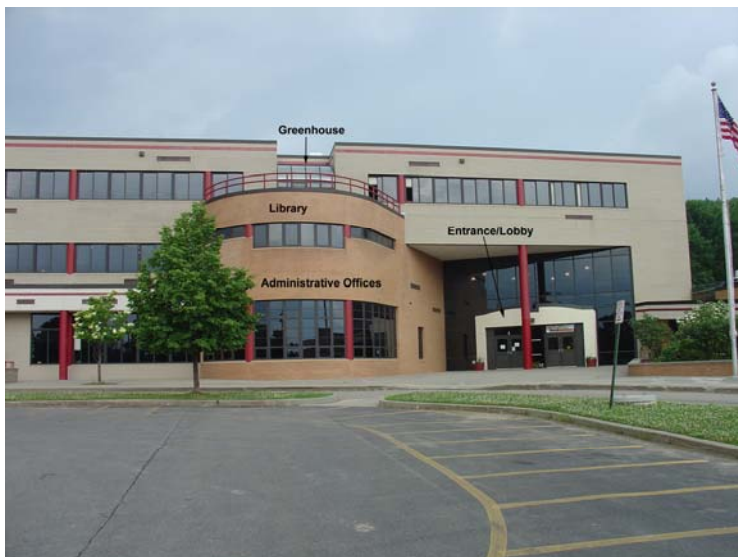
Liberty Middle School is a 90,000-square foot school built in 1991 with approximately 82 employees and 450 students in grades 5-8. This school is located in a residential neighborhood and consists of two buildings – one building contains classrooms and the cafeteria (Figure 3), the other building houses the gymnasium, band rooms, and boiler room. The buildings are constructed of concrete block with a brick veneer. The rubber-membrane and gravel roof is original to the building. The two-story, semi-circular portion of the building extends beyond the classroom building and houses the administrative offices and library. The greenhouse is located on the roof above the library. The buildings are connected to each other and Liberty High School by an enclosed hallway (Figure 4). The classroom building was built into a hill with three floors above grade in the front and two above grade in the back. The gymnasium building is above grade. The school grounds behind the classroom building flood during heavy or long rains. The wall adjacent to

Figure 3. Liberty Middle School classroom building.

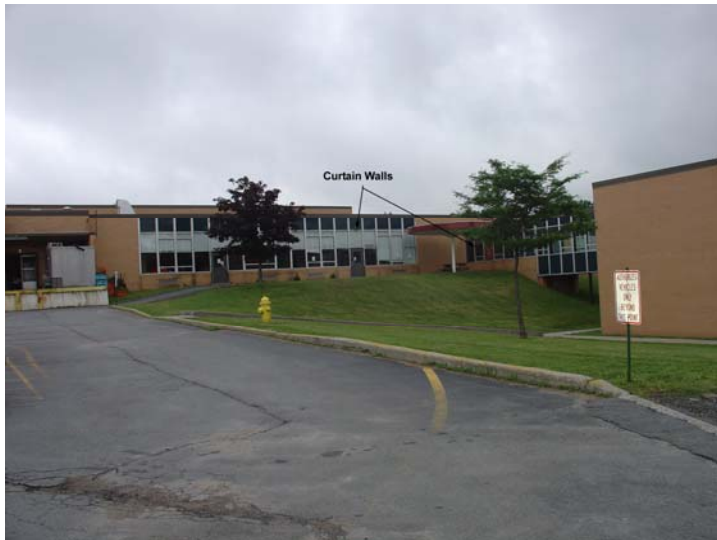
Liberty High School was built in 1963 with an addition built in 1986 and has approximately 97 employees and 775 students. The school consists of two buildings, both constructed with concrete block with brick veneer and curtain walls (Figure 5). Curtain walls are panels made of metal and glass that are suspended from metal supports and comprise the sides of buildings. The two buildings are connected by two bridges of curtain wall construction. Windows are operable with Plexiglas storm windows retrofitted to the interior in 1990 or 1991. The building is heated by three hot-water boilers fueled with No. 2 fuel oil that supply a closed-loop pipe system supplying unit ventilators in each classroom. These units also provide fresh air from the outdoors. The louvers on the unit ventilators are set to bring in a minimum amount of fresh air during the day and are closed at night. An outside contractor services the units in the Middle and High Schools once each year. The rubber-membrane and gravel roof was replaced in 1986. This school had no history of on-going water incursion, other than minor pipe and window leaks.

Figure 5. Liberty High School's curtain wall and brick veneer construction.
