United States-
Environmental Protection
Agency

CHEMICAL ACCIDENT INVESTIGATION REPORT

TERRA INDUSTRIES, INC. NITROGEN FERTILIZER FACILITY PORT NEAL, IOWA

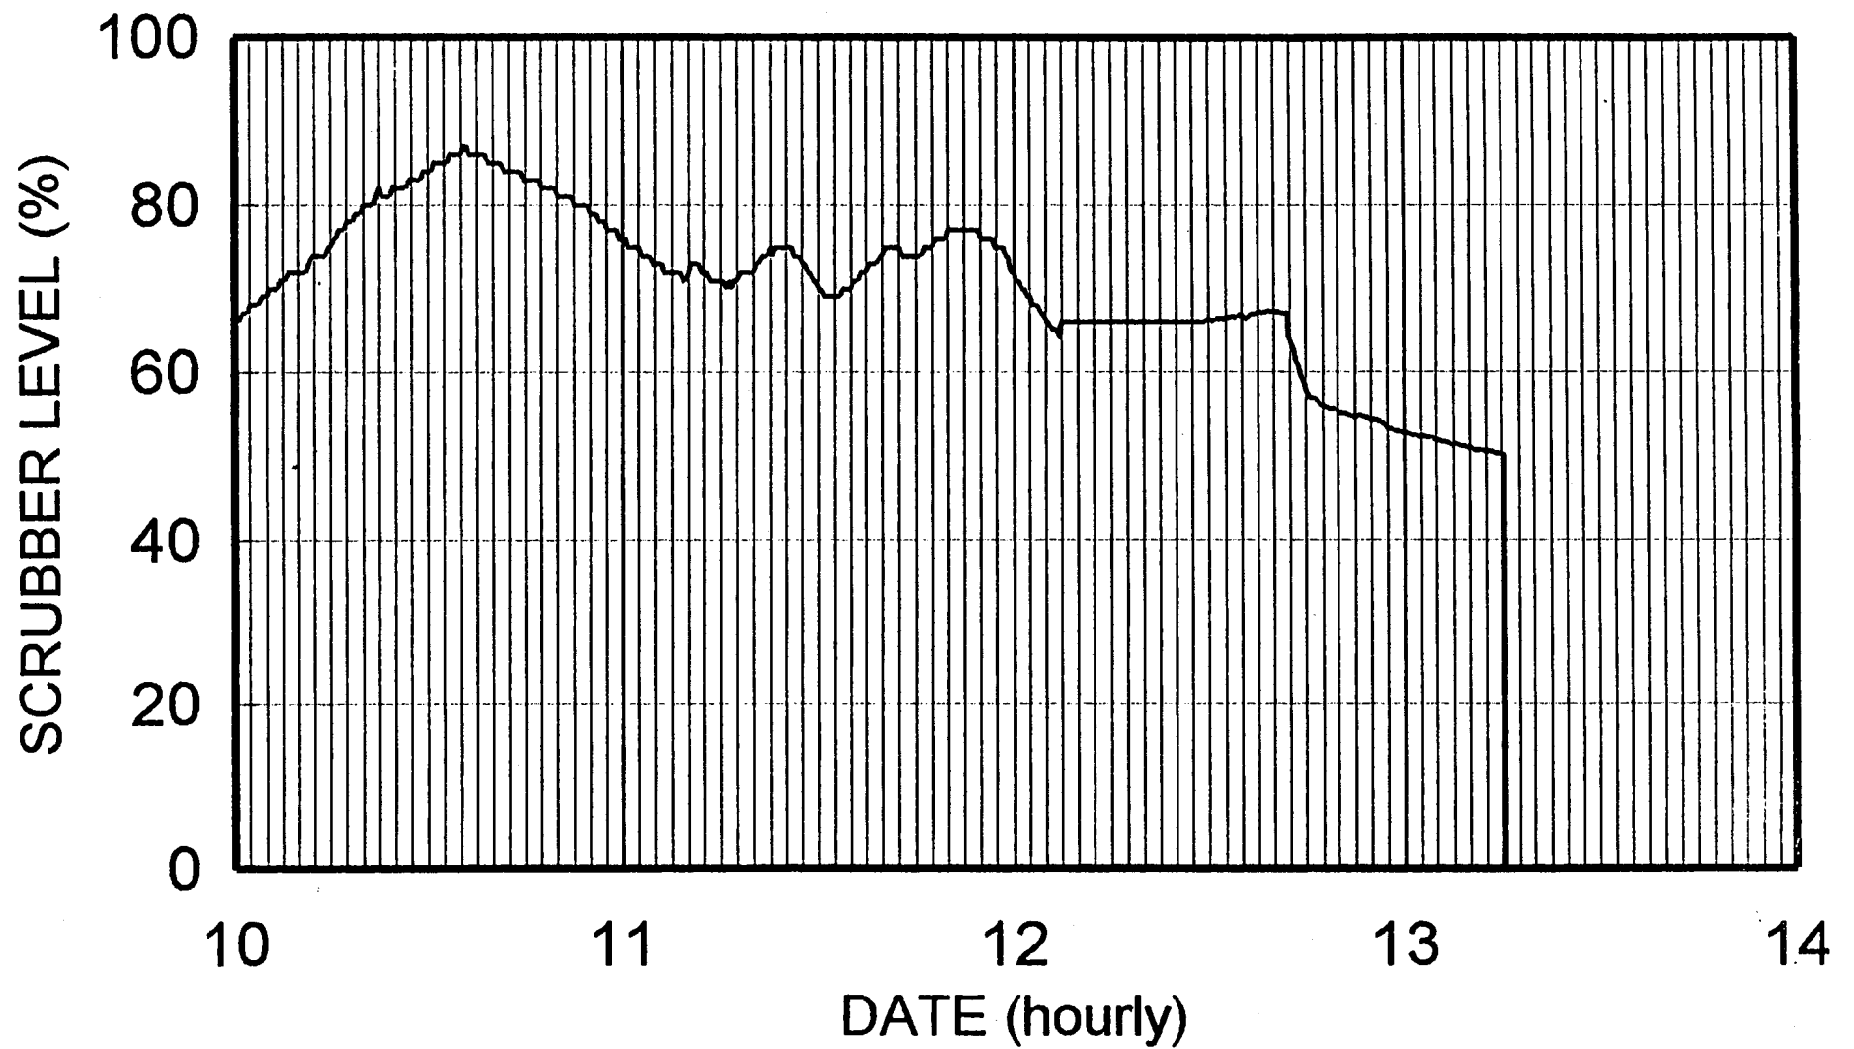
FIGURE 8-2

The investigation team reviewed DCS data pertaining to the AN scrubber. The data indicated that the scrubber level declined at a steady rate following the blowdown event occurring on December 12 through the time of the explosion (*Figure 8-2*). The investigation team determined that two plausible scenarios for this decline were:

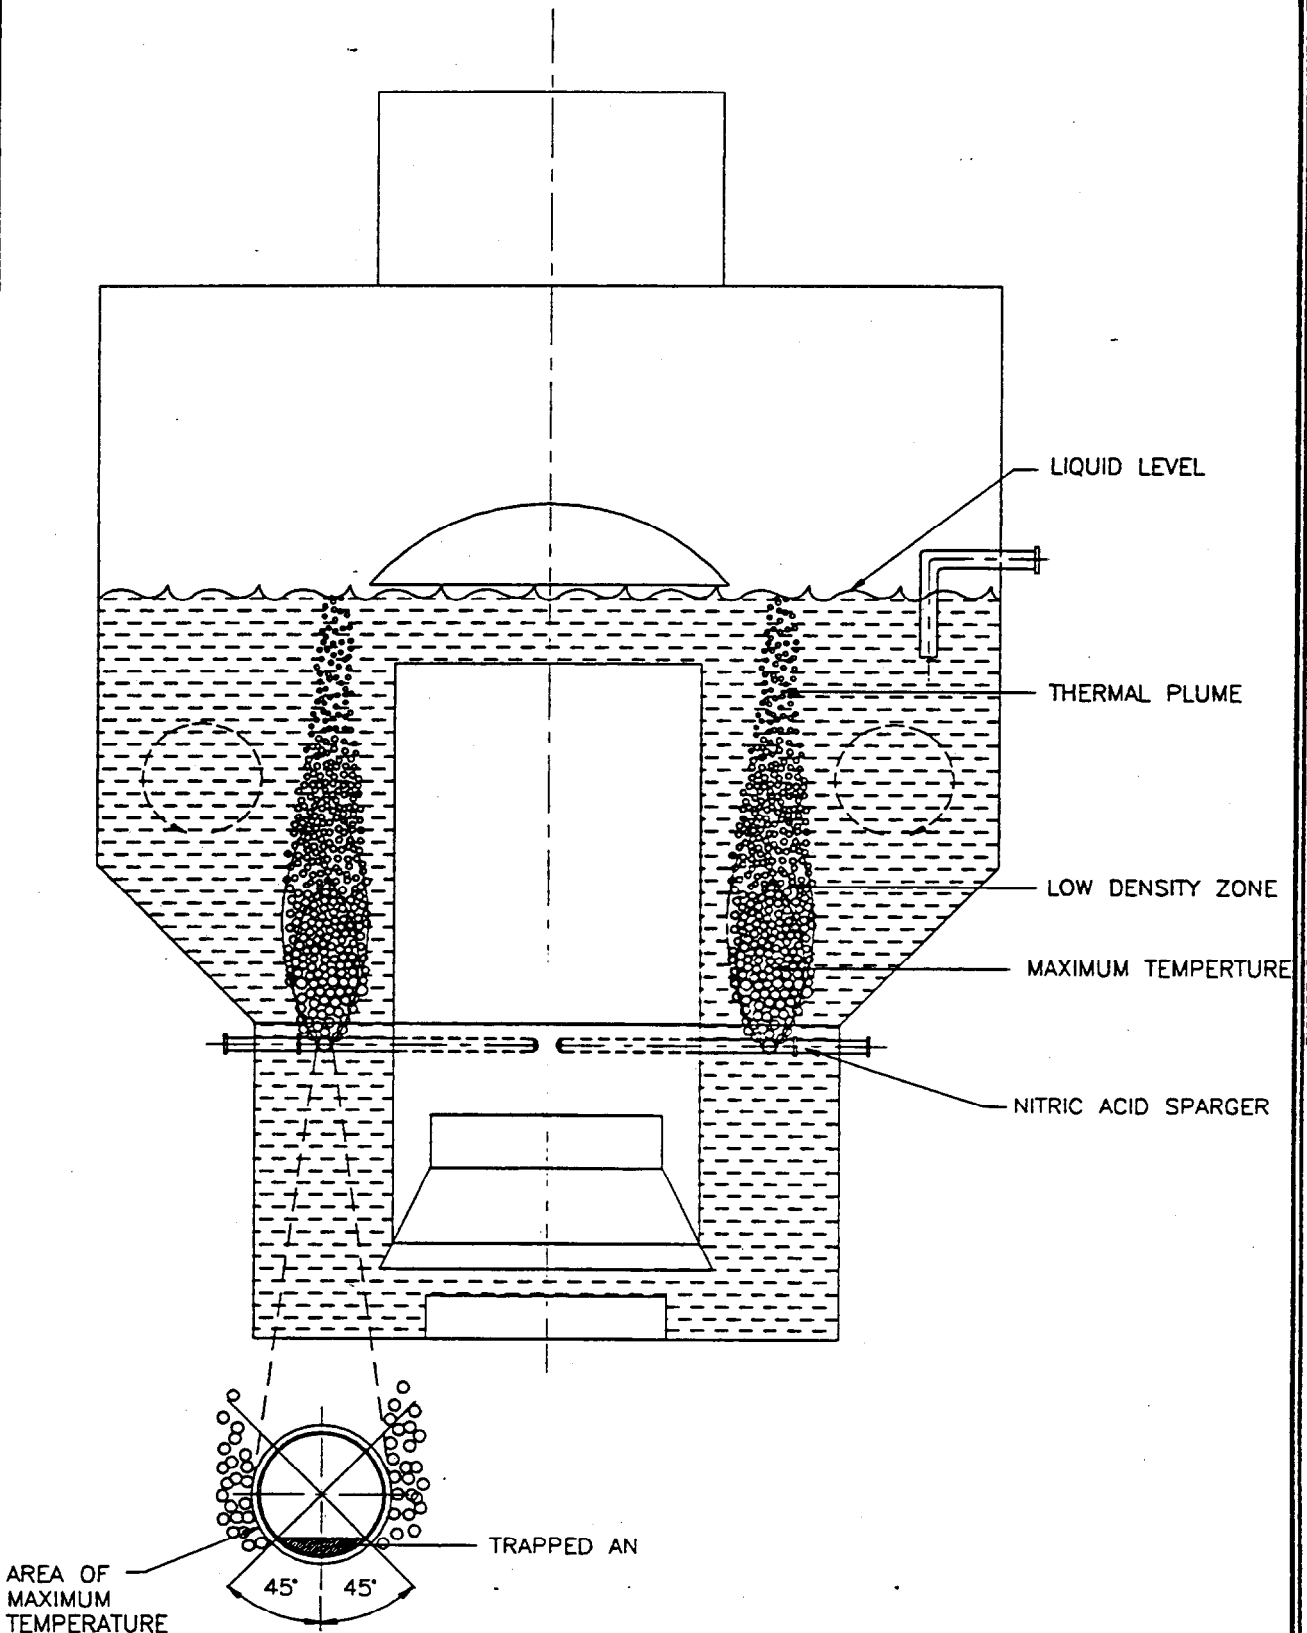
FIGURE 8 - 4
THERMAL AND LOW DENSITY ZONES IN NEUTRALIZER

Calculations indicated that continued steam heating would have resulted in a high temperature (near the temperature of the steam) and a low-density zone to develop directly around or above the sparger. Sensitizing factors lowered the thermal decomposition activation energy of the AN. The combination of energy in the input steam and the addition of superheat (possibly due to high steam demands in the nitric acid plant) exceeded the activation energy of the AN, resulting in the onset of thermal decomposition. The initial dissociation reaction was endothermic, and would have been quickly overcome due to its close proximity to the heating source. As heat continued to be transferred into this zone, the reaction became exothermic and self-sustaining [13]. At this point, large volumes of gases would have been formed. The effect of the rapidly expanding gas would have been twofold:

1. Adiabatic compression of the bubbles in the AN solution resulted in a more rapidly expanding wave front (deflagration propagation) [1]; and
2. Overcoming the vent capacity of the neutralizer, rundown tank, and scrubber system that, in turn, resulted in additional confinement until the vessels failed [21].

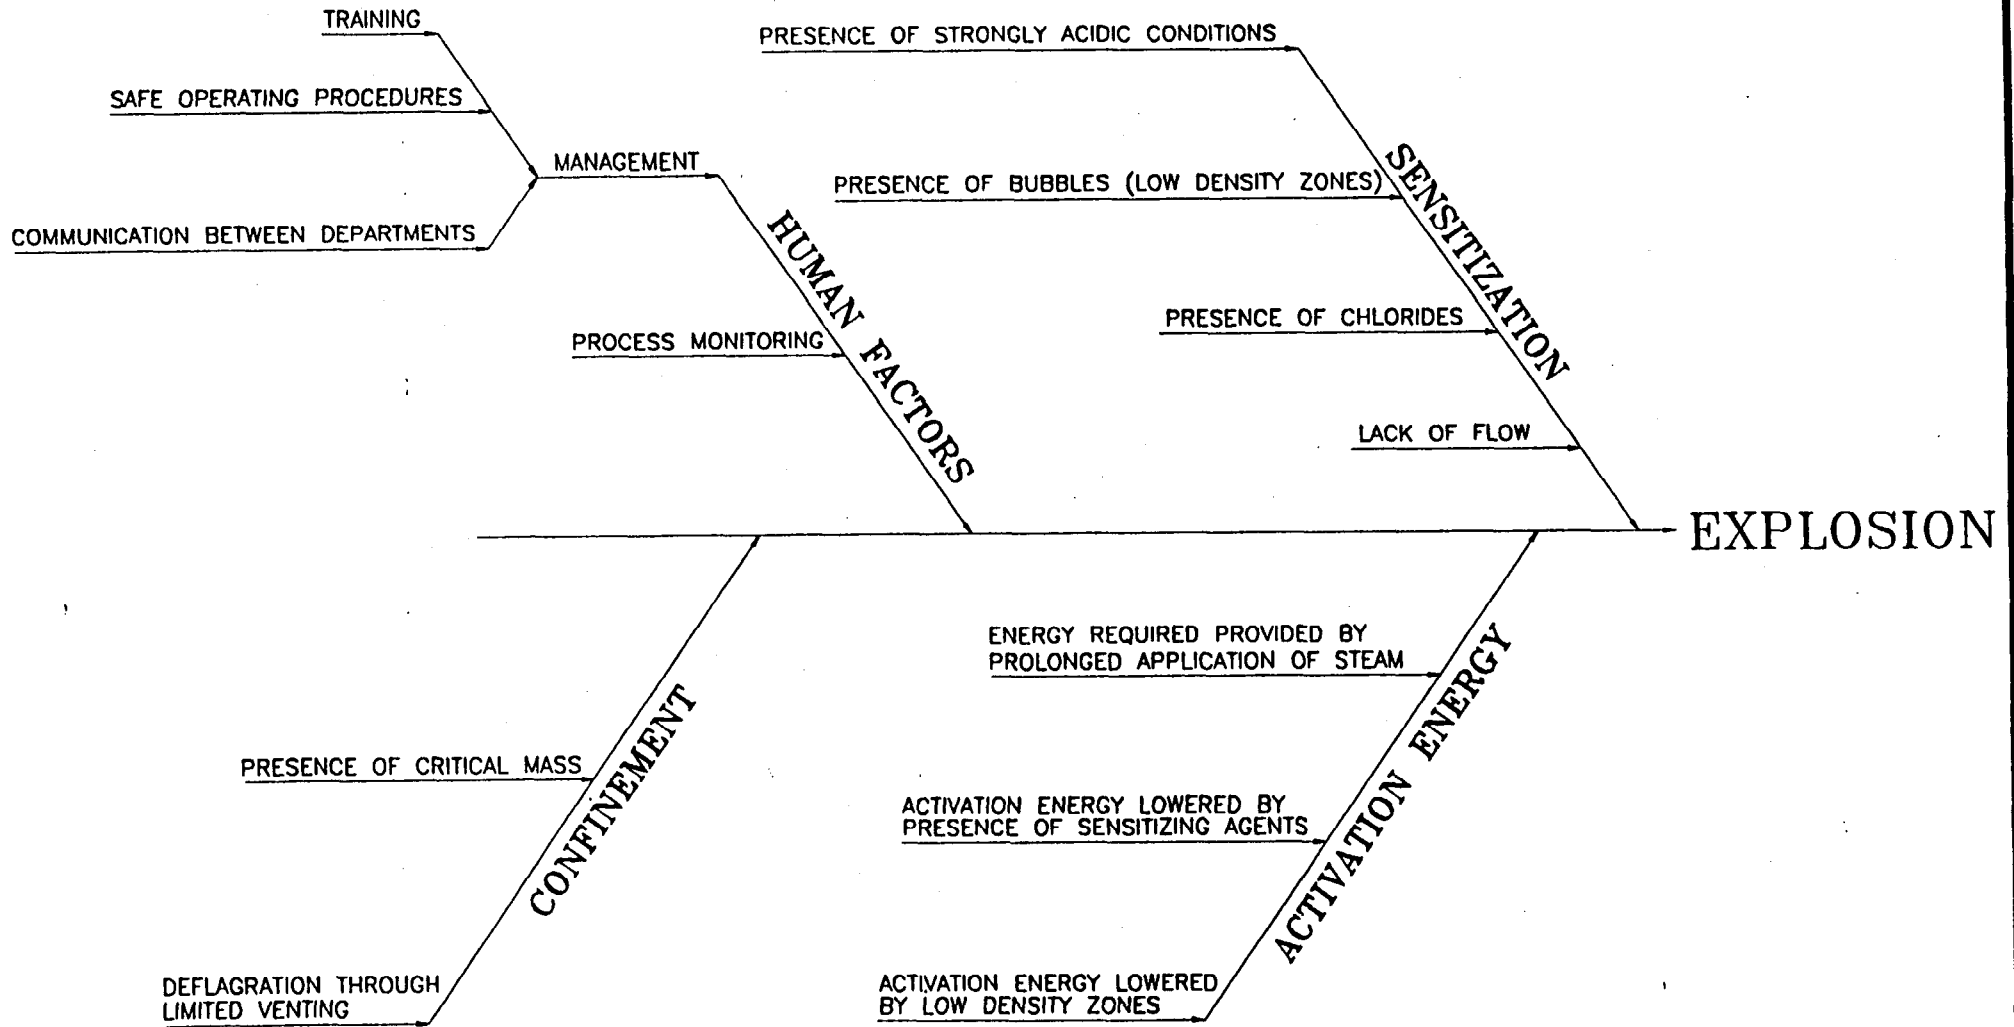
FIGURE 10 - 1
EXPLOSION FACTOR FLOW CHART

The investigation team concluded that the explosion occurred as a direct result of a series of unsafe operating procedures and conditions at the Terra Port Neal Complex. The team concluded that the explosion could not have occurred without the presence of the following conditions. The conditions were a direct result of unsafe operating procedures. They are as follows:
