General  
Technical  
Report  
FPL-GTR-161

# Feasibility of Using Building Deconstruction at Wisconsin's Badger Army Ammunition Plant Salvaging Lumber for Reuse in Low-Income Home Construction

Robert H. Falk

December 2005

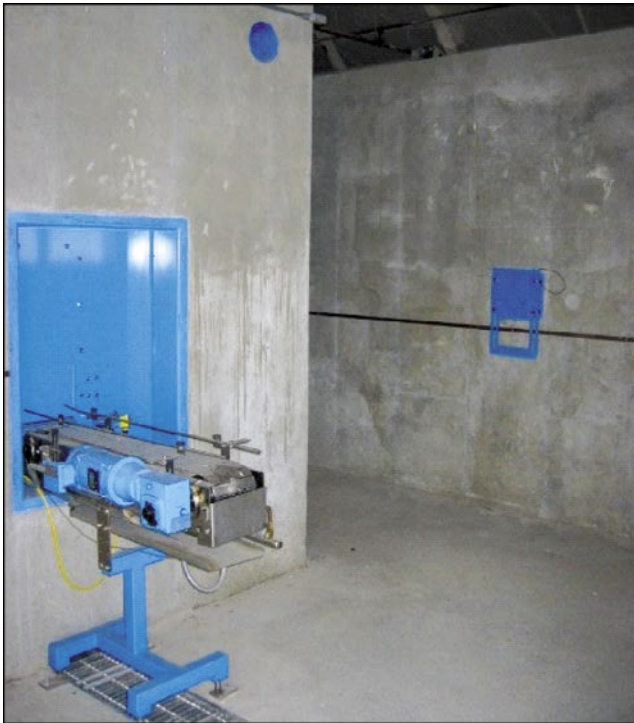
**Figure 19—6864-1 cementing house.**

Building 6864-1 (Fig. 19) has light wood-frame exterior walls and interior walls entirely cast-in-place concrete. It has minimal salvage and was qualitatively rated 2 and therefore not considered for further analysis.
