Project name: Little Chippewa Creek Dam

Summary: Separation of spillway conduit joints due to foundation movement

Conduits through Embankment Dams

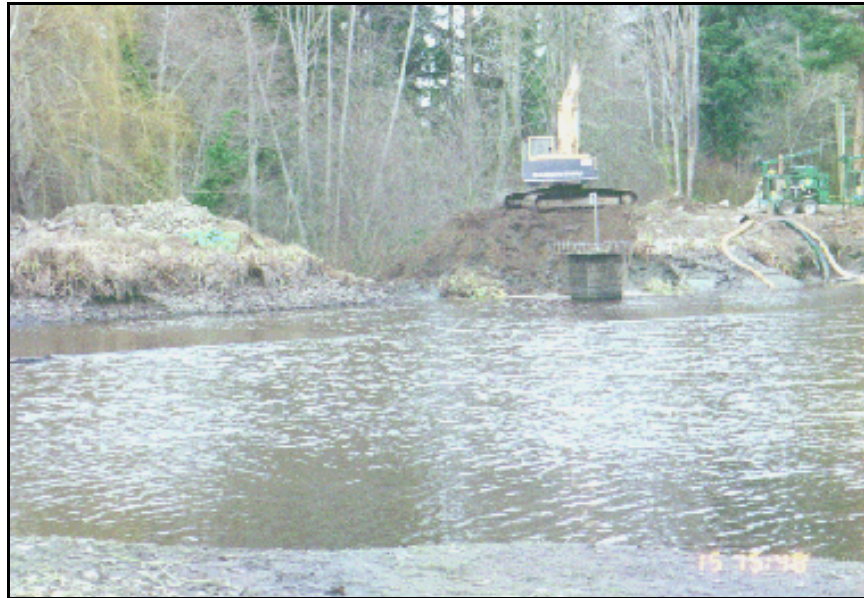
Damage downstream was limited to the streambed. Primarily, it occurred in the form of stream habitat degradation from sediment deposition. Many of the salmon eggs in this fish-producing stream were smothered under sediments for several hundreds of yards downstream of the embankment dam. As bad as it was, the emergency action prevented a likely failure of the embankment dam. Thus, the

Figure B-57.—View of upstream dam crest nearing completion of breach.

As an immediate response to the threat of an embankment dam breach, county maintenance staff filled the sinkhole with some 200 yards of angular cobbles and boulders. The State dam safety staff saw no viable alternative to the county's scheme to address the immediate crisis. Finer grained soils would likely have been sluiced through the top of the collapsed box conduit. This could have worsened the situation by plugging what limited outlet capacity remained after sediment had largely blocked the conduit. Nonetheless, it was obvious that the rockfill was but an interim measure, and immediate follow-up action was necessary to lower the reservoir and permanently resolve the public safety threat. Three days of pumping were necessary to lower the reservoir to allow excavating a trapezoidally shaped breach of the embankment dam (figure 57). The floor of the breach was armored with a geotextile fabric and capped with much of the rock originally dumped into the void the night of the failure. To improve fish passage, an attempt was made to include a number of pools along the breach channel at the direction of the Washington State Department of Fish and Wildlife. The Washington State Water Quality staff assisted in blanketing the disturbed sections of the embankment dam with hay to minimize further sediments entering the water course.

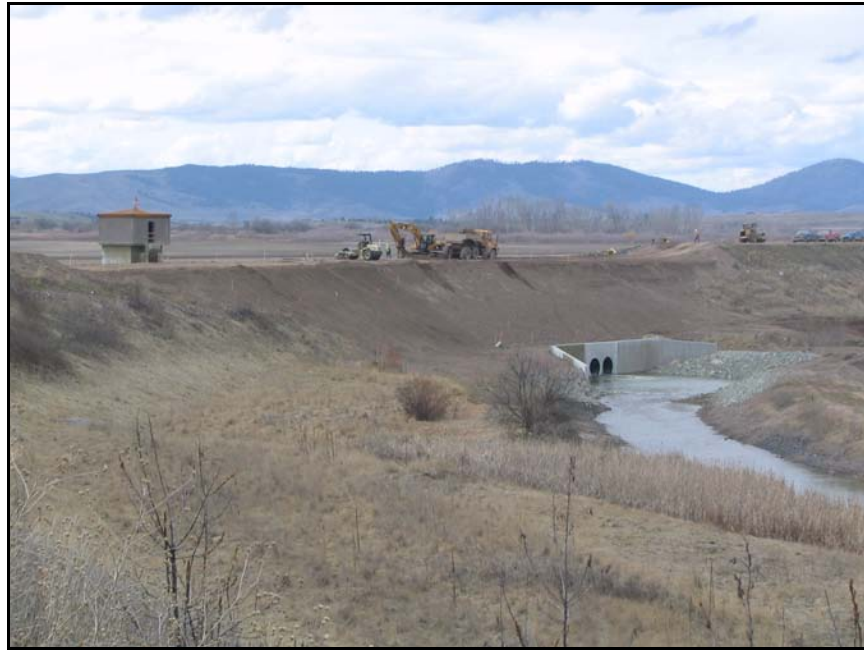
During an inspection of the interior of the conduits in April 2001, it was discovered that material had been deposited inside the middle conduit near an opening in a construction joint. This was occurring through a hole in the floor of the middle conduit at a construction joint near station 1+30. Approximately 1 ft³ of silt and fine sand were deposited on the floor. However, this deposit was observed during the winter when no irrigation releases are made. More deposition may have occurred during irrigation season that was washed downstream and not observed.

Another area of concern was the condition of the north conduit that was reportedly plugged at each end prior to the final raise of Pablo Dam in 1932, but was never confirmed. Therefore, it could be possible that a nearly full reservoir head could exist at the end of the north conduit, which was less than 100 feet from the downstream toe of the dam. After much discussion between all involved parties, it was decided to completely remove and replace the original outlet works.

Figure B-58.—Pablo Dam nearing completion.

The construction of a new outlet works began in November 2004 and was completed in the by the spring of 2005. The major aspects of the work included:

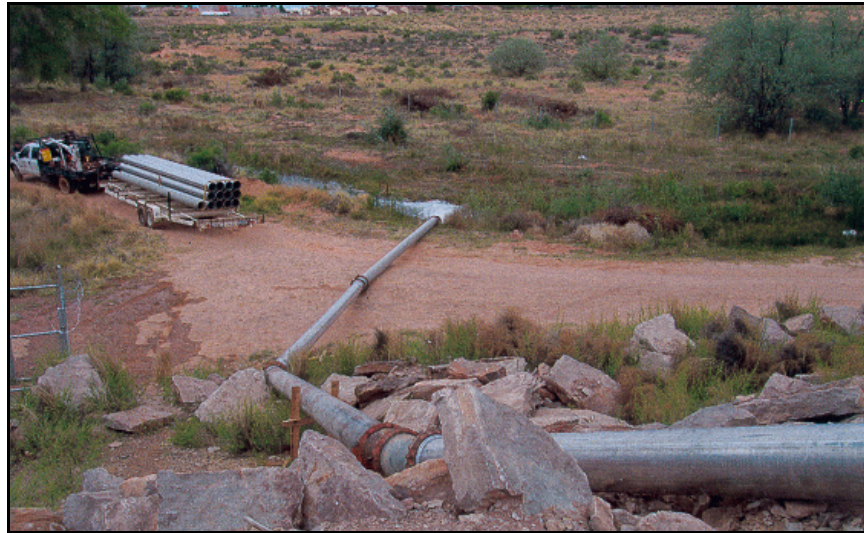
Figure B-61.—Siphon constructed over to crest of the embankment dam for discharging irrigation releases.

A contractor was mobilized to lower the reservoir level to elevation 4880.0 using high capacity, low head pumps (12-inch diameter). The reservoir drawdown was limited to 1 foot per day. After the reservoir was lowered to the desired elevation, a siphon was installed to provide downstream irrigation releases. Figure B-61 shows the siphon discharge irrigation releases. Based on the deteriorated condition of the conduit, the BIA decided to abandon the outlet works by grouting it closed. The

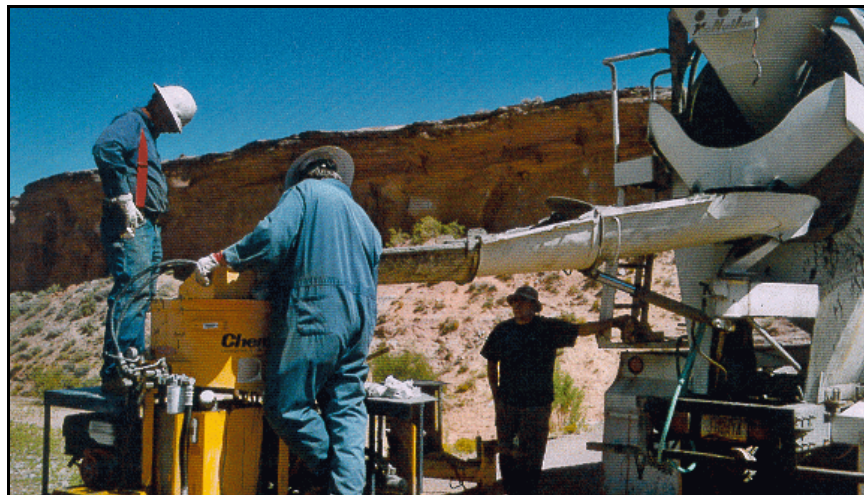
Figure B-62.—Grout mix being conveyed directly into the grout mixer from the transit mixer truck.

Bureau of Reclamation’s Farmington Construction office accomplished the grouting using three 1½-inch diameter PVC schedule 40 pipes. The upstream end was plugged by an inflatable bladder. The downstream end was plugged using a burlap pig sealed with redi-mix dry-pack. The burlap pig acted as a filter to prevent grout leakage, and the dry-pack held the pig in place. Two grout plants were brought onsite. The grout mixers had a volume of 45 gallons each. The plants were powered by gasoline engine over a hydraulic system and were found to be very adequate for the grouting operations. Figure B-62 shows the grout plant used. Type II cement

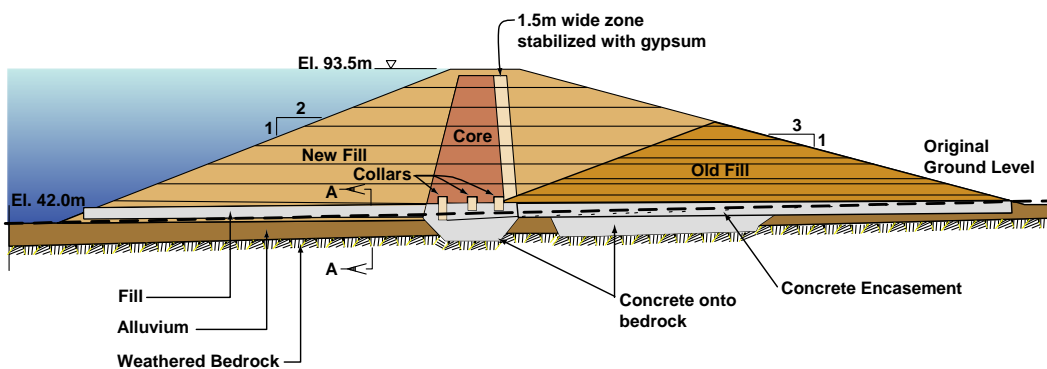
Figure B-63.—Cross section of the dam as designed.

The initial concentrated leaks alongside the outlet conduit are postulated to have occurred due to hydraulic fracture of the earthfill by the rapid rise of the reservoir. The conduit appears to have allowed for a low stress zone to occur in the earthfill next to the wall of the encasement. In essence, the wall "shielded" the adjacent fill from the full weight of the overlying embankment. The stresses in this area were likely lower than the reservoir head. A somewhat compressible foundation material beneath the conduit could have assisted in the formation of the crack completely along the embankment dam's cross section. Once concentrated flow started, the dispersive nature of the embankment fill would have allowed for rapid erosion from the downstream exit of the crack, progressing upstream. Lack of any defensive designs for embankment cracking, such as a filter and drain, contributed to the failure.

Also contributing to the failure was the poor compaction of the earthfill material adjacent to the encasement wall that was found during the forensic investigations. Also thought to contribute to the failure were the potential for differential settlement of the new and old earthfill.

- Utilizing a conduit design that accommodated the likely settlements caused by the foundation.
- If the concrete casement around the conduit had used battered side slopes rather than vertical ones, compacting soils against the conduit would have created more positive pressures and lessened the potential for hydraulic fracture.
- Inclusion of a filter diaphragm.
- Elimination of the cutoff collars.

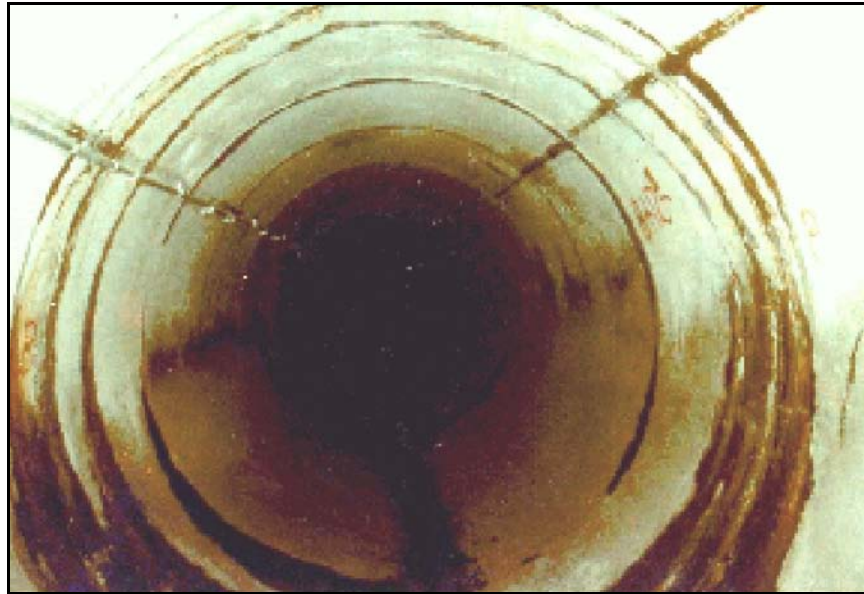
Figure B-66.—View of the interior of the outlet works after grouting.

Settlement and crack surveys were taken, in the upstream and downstream conduits, in January of 1986 and October of 1986. The maximum settlement recorded in January of 1986 was about 0.74 feet at station 11+24 in the downstream conduit. For reference, the station at the centerline of the gate chamber is located just downstream of the centerline of the embankment dam, station 7+50. In October of 1986, an additional settlement of about 0.22 feet was recorded at station 11+24. Settlements of other points in the conduit varied, seemingly based on the stiffness of the foundation. Maximum transverse cracking occurred in the upstream conduit at station 7+80 and station 8+80. The downstream conduit had very little transverse cracking, but a maximum joint opening of about $\frac{1}{2}$ inch occurred at station 10+73. Longitudinal cracking occurred in the crown and invert between stations 6+50 and 7+65 and between stations 11+74 and 14+35 in the upstream and downstream conduits, respectively. The settlement and cracking occurred during or after constructing the dam embankment to elevation 6830 in the 1985 construction season and topping out of the dam in 1986 at elevation 6886.

The settlement and cracking of concrete in the upstream conduit was addressed by required injecting grout in and around the cracks to reduce water leakage and potential backward erosion piping or internal erosion of surrounding soils in the embankment dam, along with protecting the conduit reinforcement from corrosion. Polyurethane resin was used to grout the transverse cracks. Also, the polyurethane resin grout was considered (due to its more flexible characteristics over more rigid epoxy material) for grouting the longitudinal cracks. However, longitudinal cracks were grouted with epoxy material to provide a degree of structural stability. Approximately 500 feet of cracks were designated for grouting. The contractor

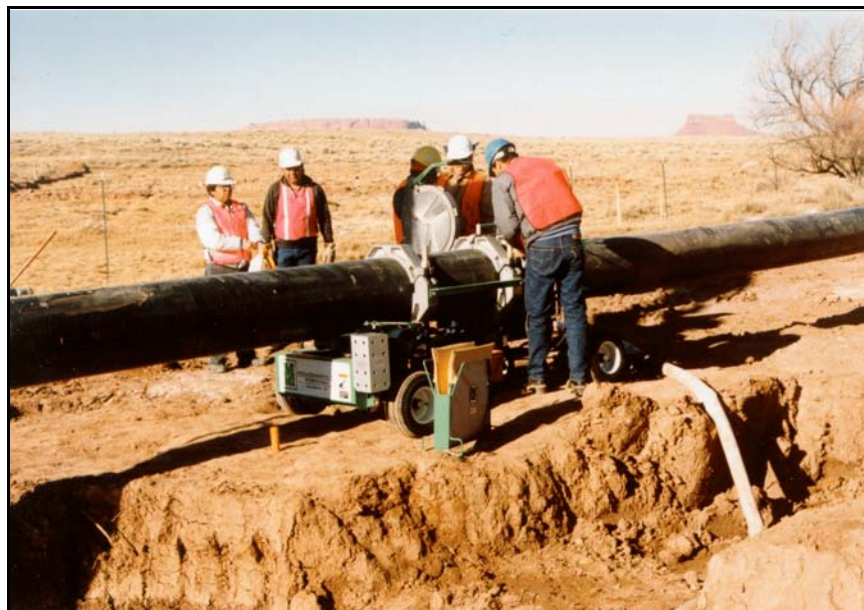
Constructed in 1937 and enlarged in 1953, Round Rock Dam is a 35-foot high embankment dam, located about 3 miles from the town of Round Rock, Arizona on the Navajo Reservation. The original outlet works at Round Rock Dam was constructed by cut and cover methods. Both the upstream and downstream outlet works conduits were constructed of 24-inch diameter CMP. Reservoir releases are controlled by a 24-inch diameter slide gate in a concrete wet well located about 15 feet upstream of the dam crest. In 1991, the Bureau of Reclamation’s Deficiency Verification Analysis identified the structural integrity of the outlet works conduits as a dam safety deficiency. CCTV inspection had detected corroded portions and joint separations in the CMP.

Figure B-68.—Heat fusion of an HDPE pipe joint.

Reclamation designed a modification, to address this dam safety deficiency, which consisted of an 18-inch O.D. HDPE pipe that was sliplined (figures B-68 and B-69) and then grouted into both the upstream and downstream CMP conduits. The HDPE pipe was designed to withstand external loads, disregarding any additional

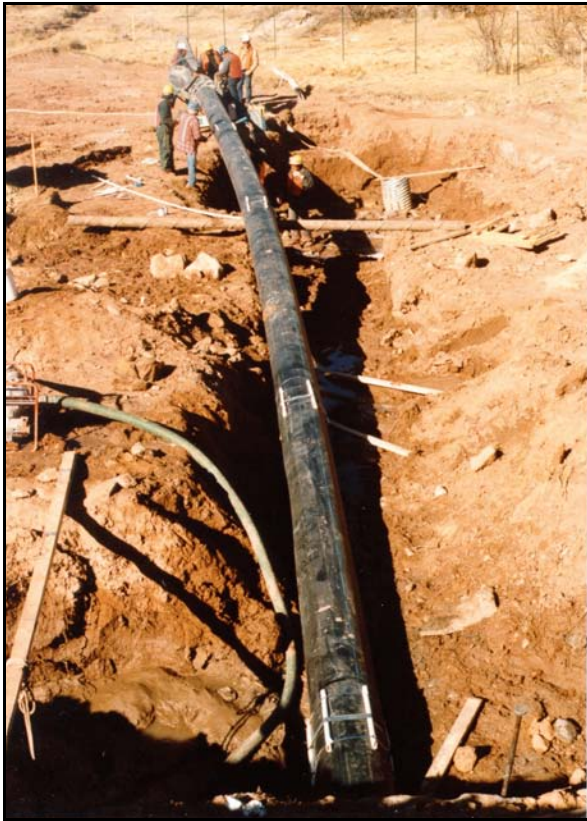
Figure B-69.—Inserting the HDPE slipliner into the existing CMP conduit.

support from the existing CMP. The design called for the HDPE pipe to withstand embankment fill loads of 38.2 feet, hydrostatic loads to 37 feet and a construction surcharge H-20 live load with a minimum of 5 feet cover. The HDPE pipe was also designed to withstand the loads associated with grouting. Installation of the liner was completed in the summer of 1994. The outlet works has operated without any liner-related incidents since that time. CCTV inspection of the slipliner was performed in May 2001, and the liner was found to be in good condition.

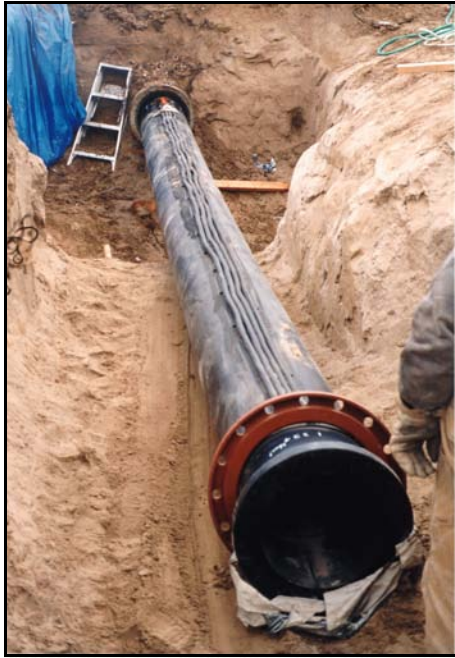
Figure B-75.—HDPE slipliner being installed at Turtle (Twin) Lake Dam. Note the HDPE grout lines welded onto top of new liner. The end flange was used to attach the two different sized liners together.

The HDPE-lined outlet works at Turtle Lake Dam has been in operation since modification without further incident. A CCTV inspection was conducted in April 2001. The inspection indicated that the HDPE slipliner was performing well.

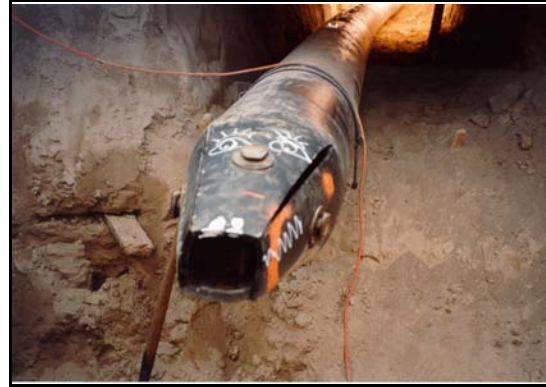
Figure B-76.—Upstream end of the HDPE slipliner modified to act as a pulling head.

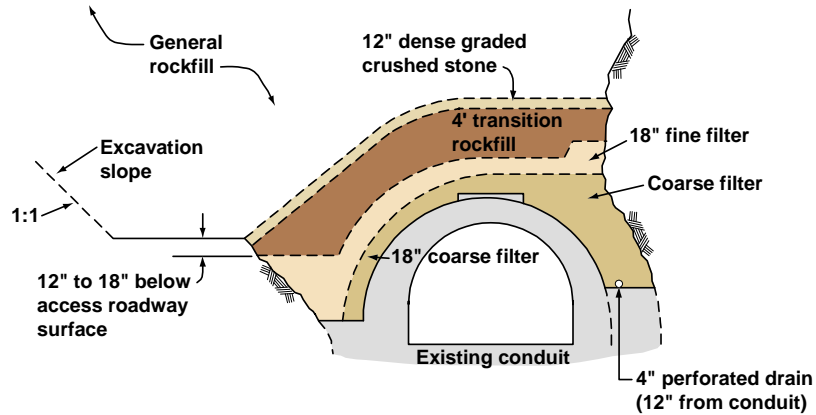
Figure B-78.—Cross section showing filter zone and conduit.

construction, the zones were expanded on both the east and west sides of the conduit to reach to the exposed bedrock surfaces paralleling the conduit before switching back to rockfill materials. A transition zone of smaller rockfill was placed immediately adjacent to the filter before going to general rock fill backfill materials.

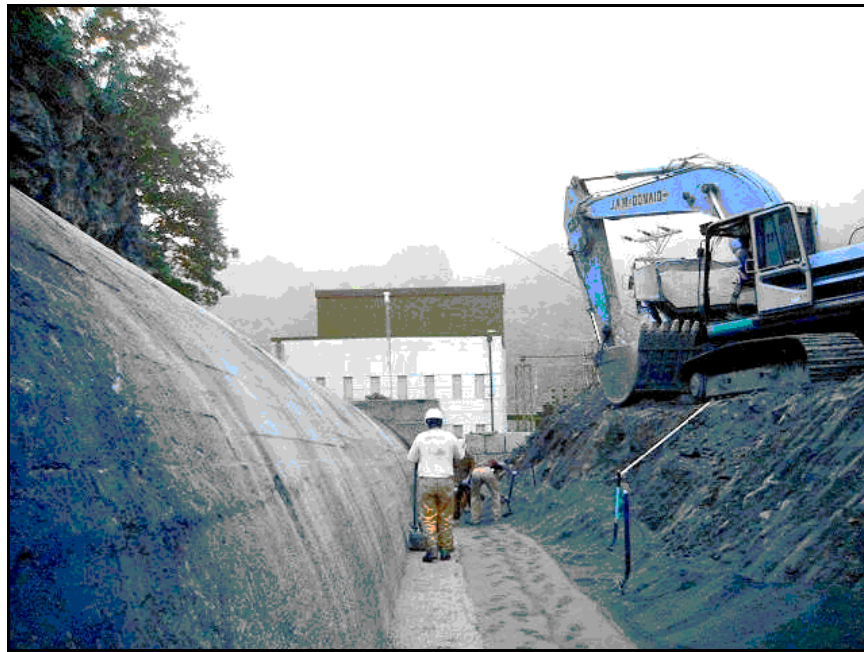
Figure B-79.—Filter material being placed in thin lifts and compacted with hand-operated vibratory compaction equipment.

Because of the confined spaces and irregular bedrock surfaces, the drainage and filter zones were placed in thin lifts and compacted with hand-operated vibratory compaction equipment (figure B-79). Although the work was time consuming, the uniformly graded materials were very easy to place and compact. To accommodate

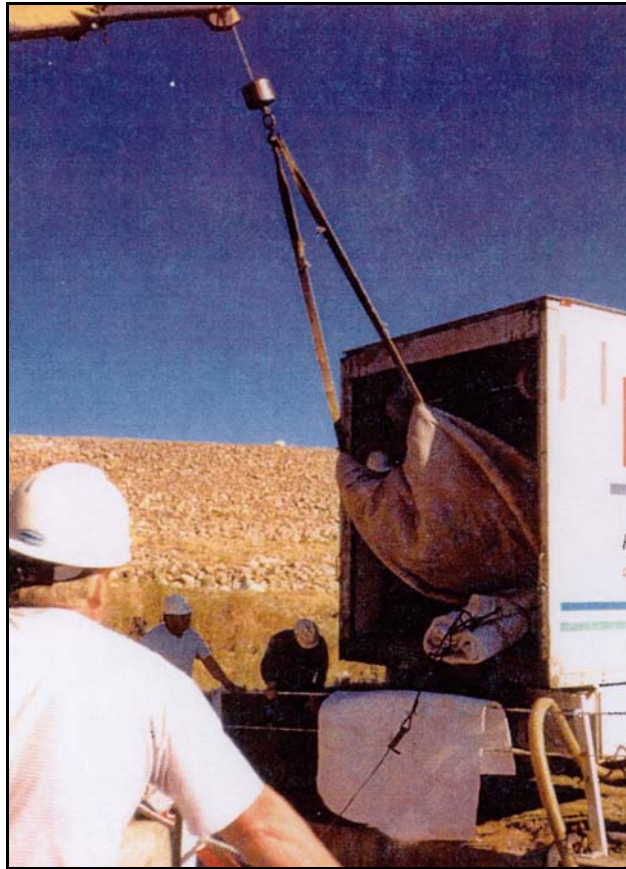
Figure B-80.—Lowering of the CIPP liner into the stilling basin, so it can be winched up the tunnel.

Both ends of the liner were trimmed using chain saws and circular saws, and a 0.5-inch deep groove was provided around the periphery to accommodate installation of end seals. Amex 10/WEKO seals were used, each consisting of a 14.5-inch wide rubber seal with three stainless steel bands spread by a hydraulic expanding device to ensure a tight fit. The work was completed on August 15, one week after site mobilization, for a total cost of about \$145,000. Subsequent laboratory tests on field samples confirmed the design parameters for tensile and flexural properties.

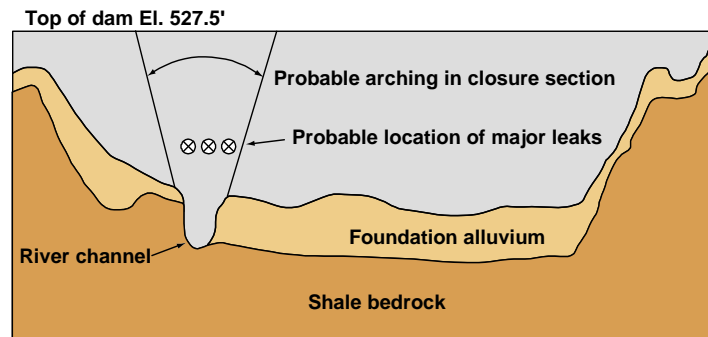
Figure B-83.—Cross section A-A from figure B-82. Profile along centerline of embankment viewed upstream.

problematic soils, such as dispersive clays. This case history also illustrates the increased potential for arching and hydraulic fracture associated with closure sections in embankment dams.
