Report on Fire Boom Tests at Ohmsett in October, 2000

**U.S. Department of the Interior
Minerals Management Service
Herndon, VA**

**SL Ross Environmental Research
Ottawa, ON**

January 31, 2002

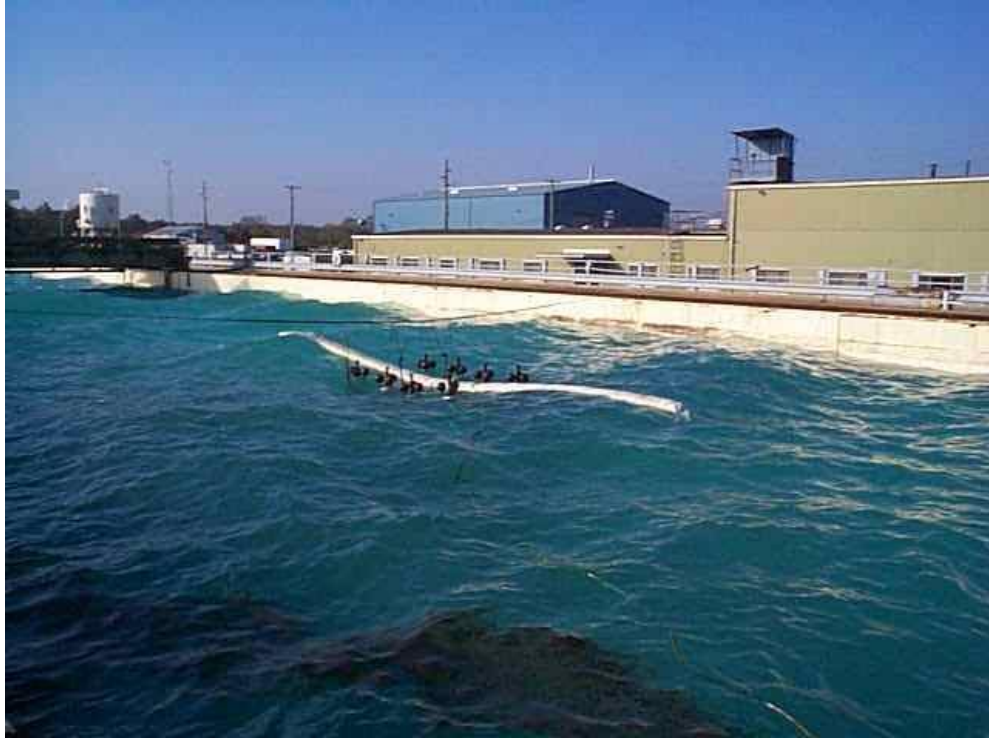
Figures 16 and 17 show the SWEPI fire boom in place over the bubbler frame during the two-hour pre-burn wave stress test on the morning of October 19, 2000. It is clear that the boom was considerably flexed in the harbor chop waves. Figure 17 illustrates how the boom was periodically over-washed by a wave. It should be remembered that this fire boom was designed for use in broken ice conditions, where wave action would be severely damped by the presence of the floes.

Inspection of the boom after the test showed no visible damage to the exterior components.

Figure 16 - SWEPI boom in waves.

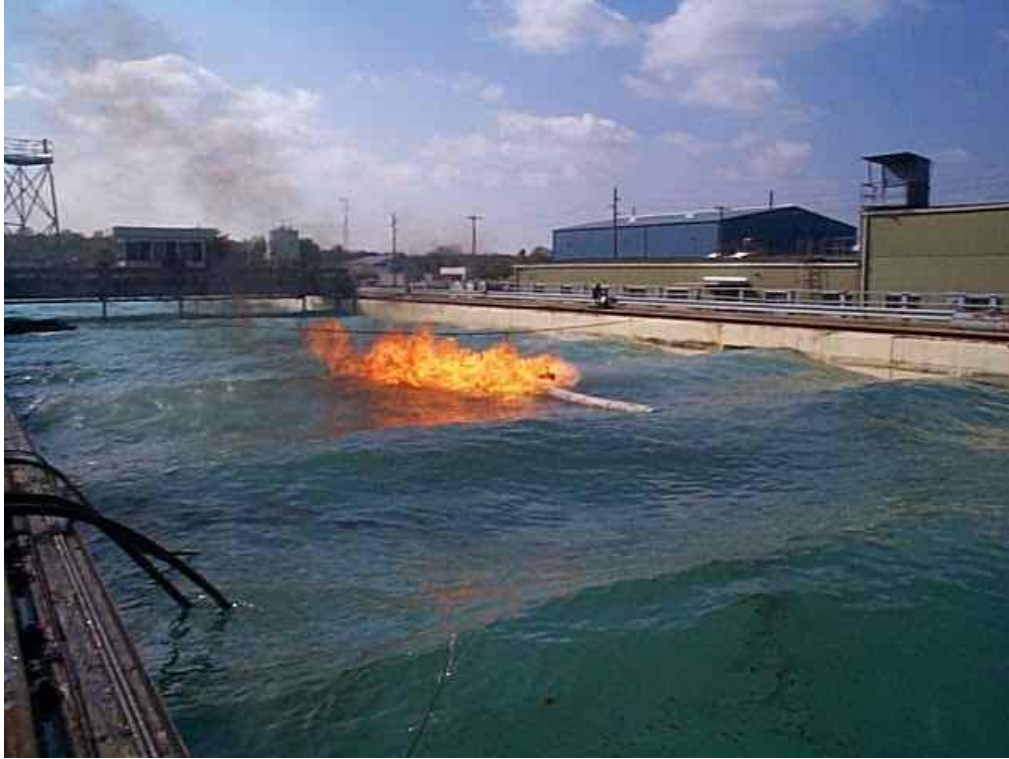
Figures 22 and 23 show the first hour of burn tests with the SWEPI boom. For these tests the wave beaches were raised, to produce regular waves. Figure 24 shows a short section of the wave height record for this test. The wave heights on this graph varied between 0.19 m (7.5 in) and 0.32 m (12.5 in) which appear representative of the heights recorded over a ten-minute period (Appendix D) and were significantly smaller than the waves used for the pre-burn wave stress test. The average wave period on Figure 24 is approximately 2.2 seconds. This equates to wave lengths from 4.2 m (14 ft) to 5.4 m (18 ft). These waves regularly over-washed the entire length of the boom and periodically soaked it with water during the tests. This behavior would not be expected in the boom's intended operating environment (broken ice conditions) and is an artifact of the test protocol that should perhaps be changed for future tests of booms intended for use in ice-covered environments.

Figure 22 - Photo of SWEPI boom during first hour of flame exposure.

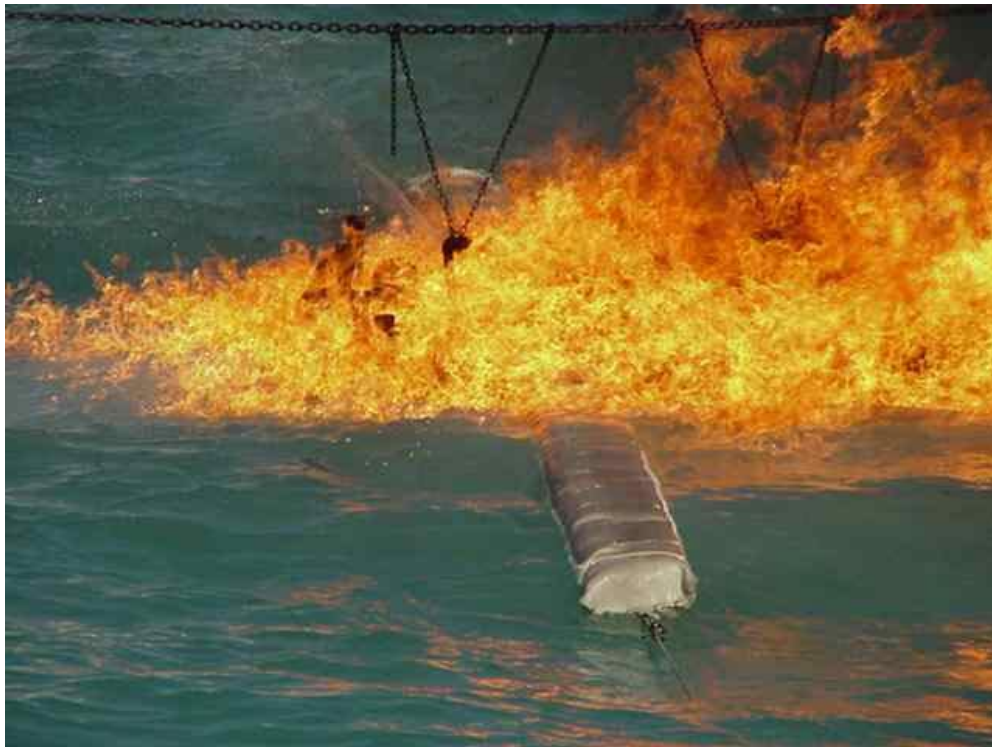
Figure 23 - Close-up of SWEPI boom during first hour of flame exposure.

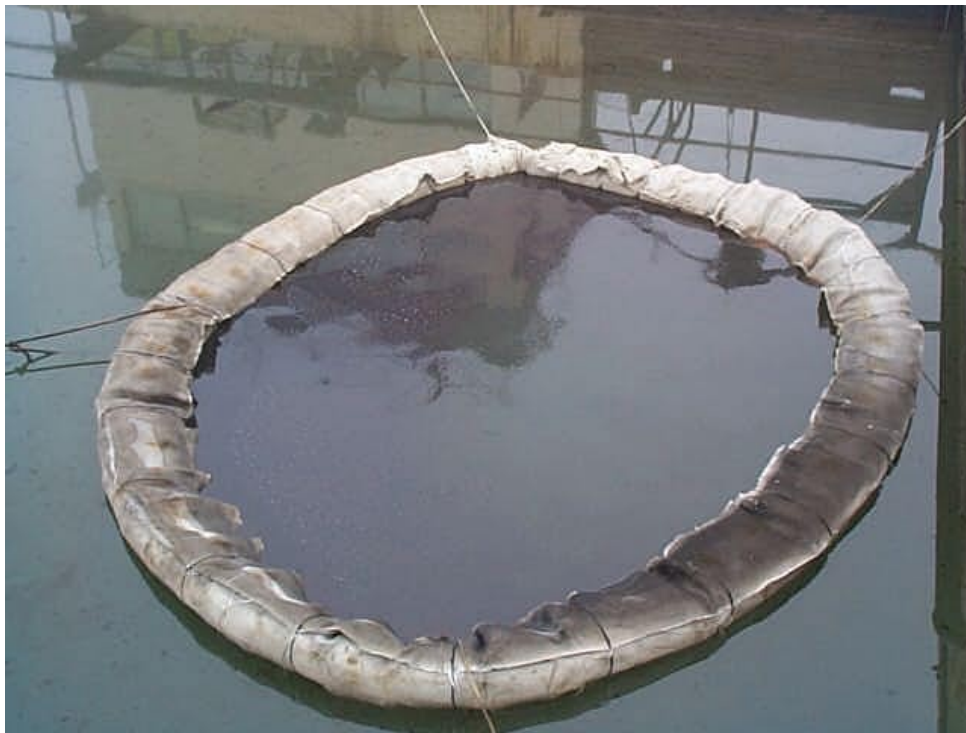
Figure 41 - SWEPI boom static oil containment test.

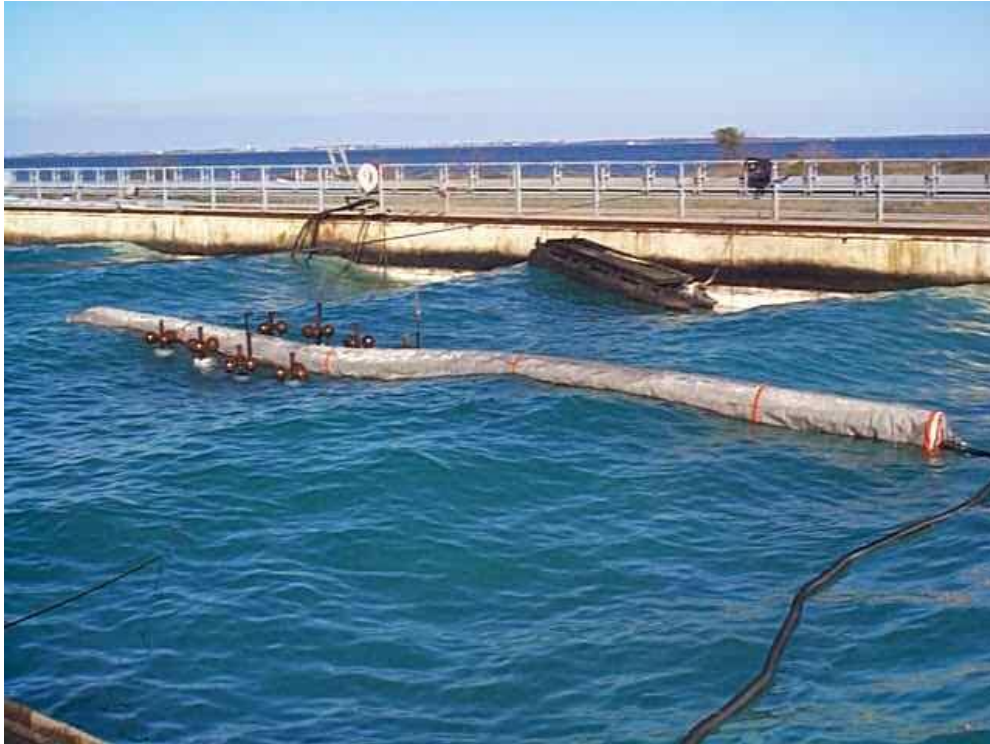
Figure 42 - Oil Stop Auto Boom during Pre-burn Wave Stress test.

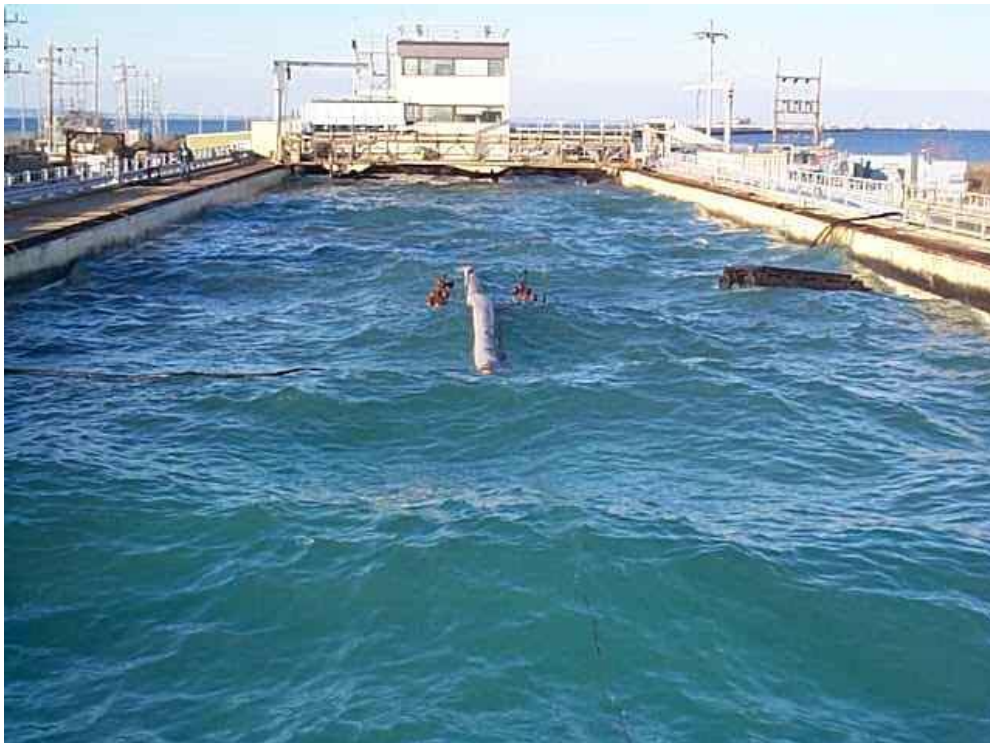
Figure 43 - Oil Stop Auto Boom during Pre-burn Wave Stress test.

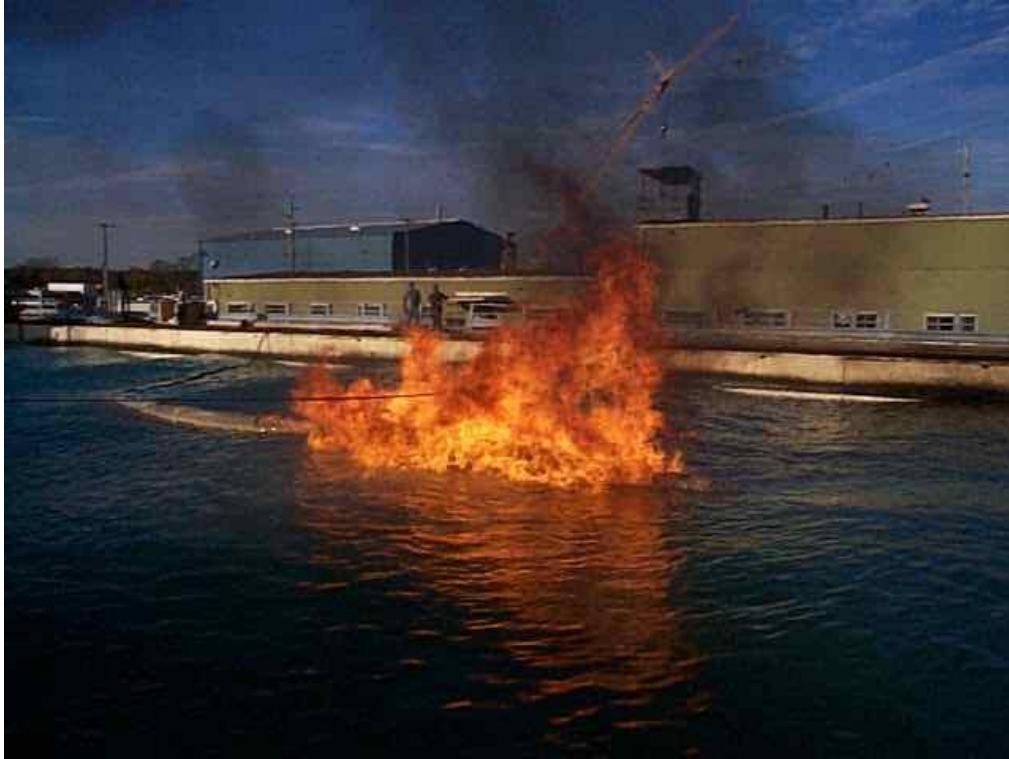
Figures 46 and 47 show the first hour of burn tests with the Oil Stop boom. Note that the boom is not centered in the flame. This was done in an attempt to avoid propane bubbles entering an air chamber valve access slit in the skirt at the center of the test section. For these tests the wave beaches were raised, to produce regular waves. The wave heights varied between 0.15 m (6 in) and 0.29 m (11.5 in). The average wave period was approximately 2.4 seconds. This equates to a wave lengths between 3.75 m (12 ft) and 5.2 m (17 ft). The boom followed the waves well.

Figure 46 - Photo of Oil Stop boom during first hour of flame exposure.

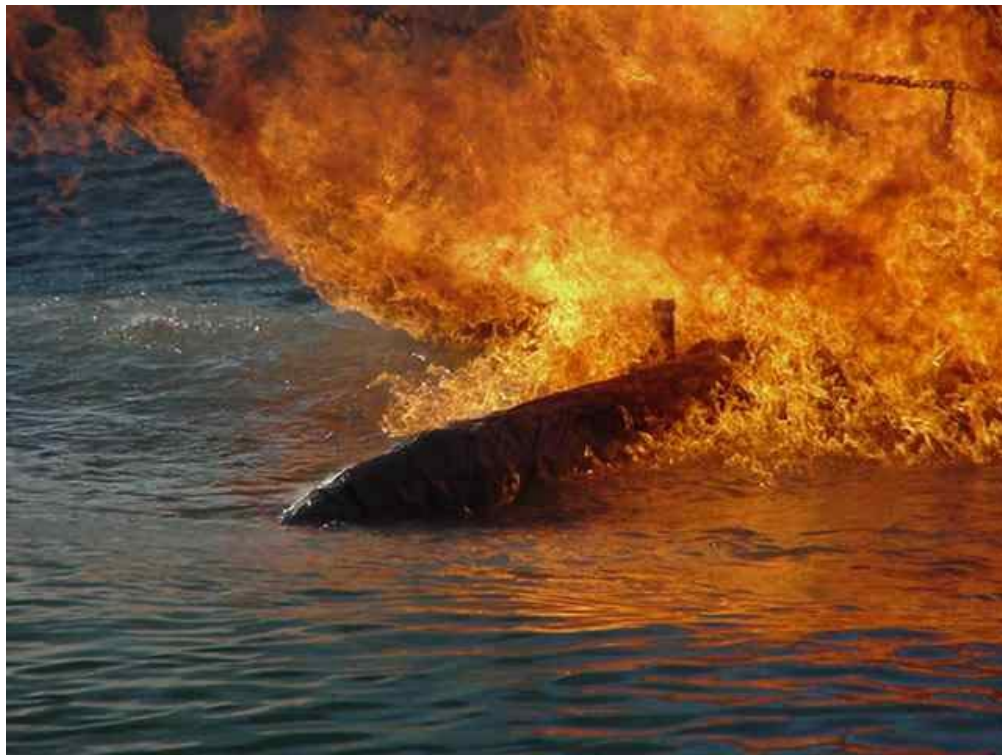
Figure 47 - Close-up of Oil Stop boom during first hour of flame exposure.

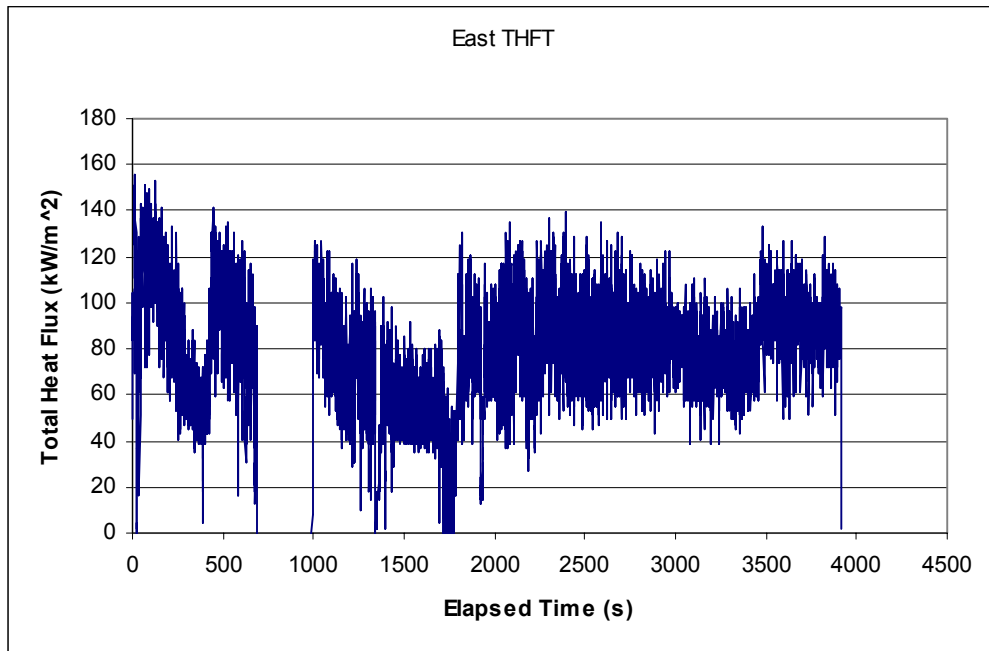
Figure 49 - East THFT

Figures 49 and 50 show the total heat fluxes recorded during the first hour of burning. Several times during this burn tests, the THFTs were lowered below the tops of the waves by the stretching of the suspension chain. This reinforces the need for the THFT support mechanism to be modified to incorporate a constant-tension system. The heat fluxes measured on the west side of the boom were slightly higher than on the east side. The wind was blowing lightly from the south-west at 8 km/hr (5 mph). Figure 51 gives the flame temperatures recorded at the instrument stalk. It is apparent that the lower two thermocouples were influenced by the waves: the lowest (TC 4) was apparently periodically submerged by wave crests. The “cold zone” at the bottom of the fire (where the combustion reaction has not yet proceeded fully) was seemingly also moved up and down by the waves, as evidenced by the dips in the flame temperatures for TC3. The data from TC2 should be treated with suspicion; the excursions to 1400+°C (2500+°F) and below 0° indicate that this thermocouple was beginning to fail. The temperature recorded by the highest thermocouple (TC1) was on the order of 815°C (1500°F), as expected.

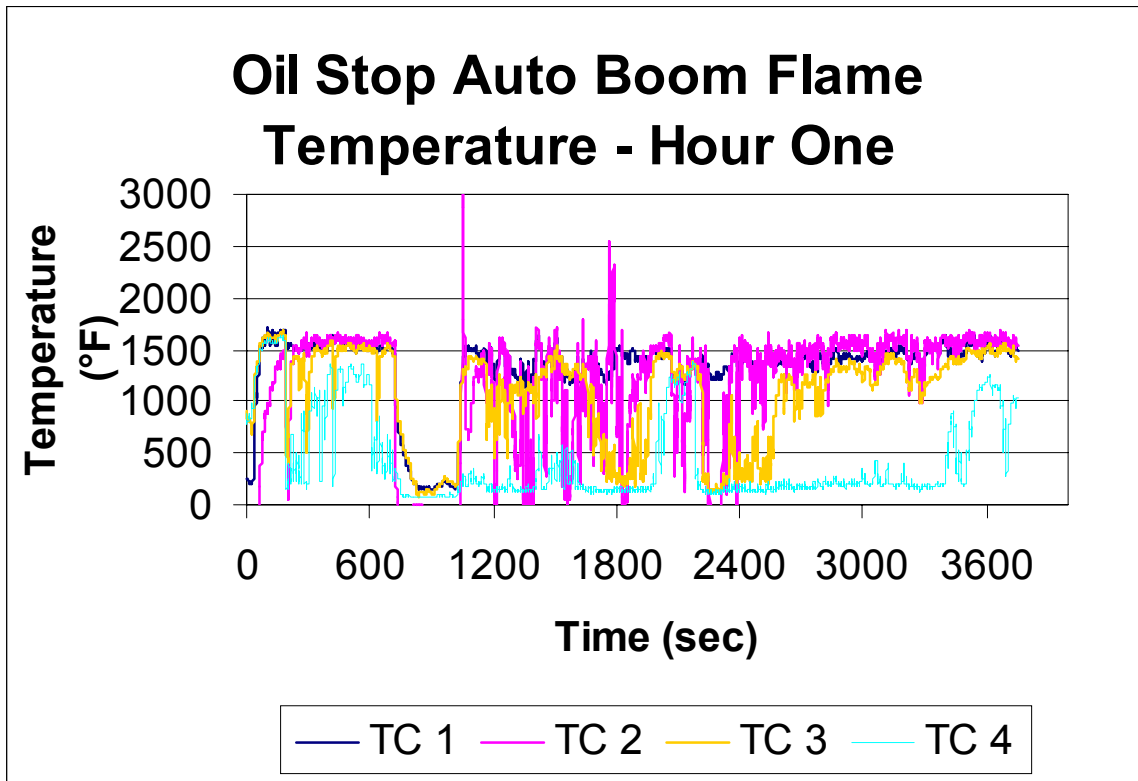
Figure 51 - Flame temperatures.

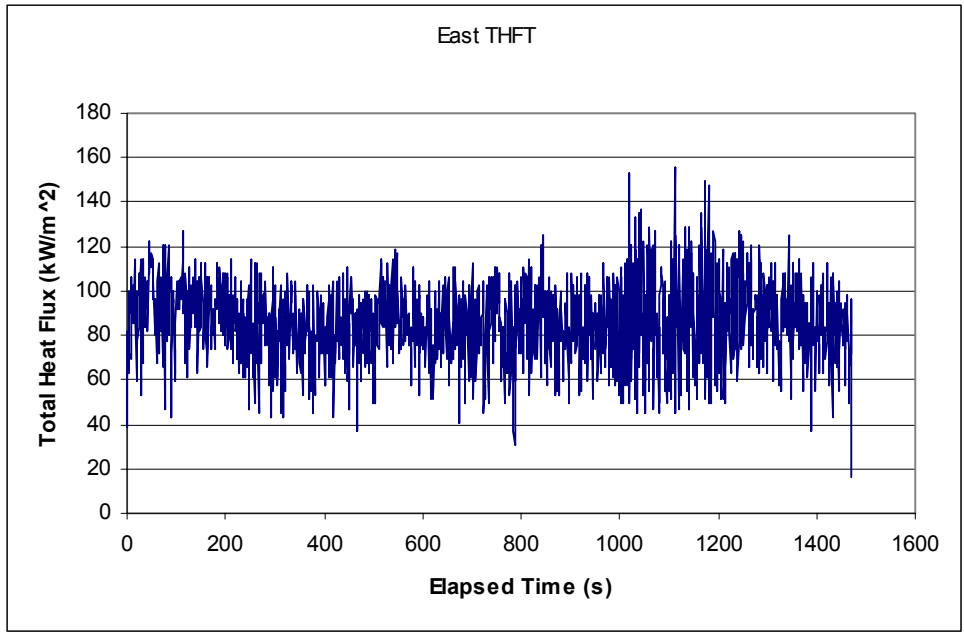
Figure 54 - East THFT

After initial adjustments, the propane flow for the second burn with the Oil Stop boom was recorded at a steady 25 kg/min (56 lb/min). Figures 54 and 55 show the total heat fluxes recorded during the second hour of burning. The heat fluxes measured on the east side of the boom were lower than on the west side because the east THFT had inadvertently rotated and was now looking south towards the 13 km/hr (8 mph) wind from the south-south-west.

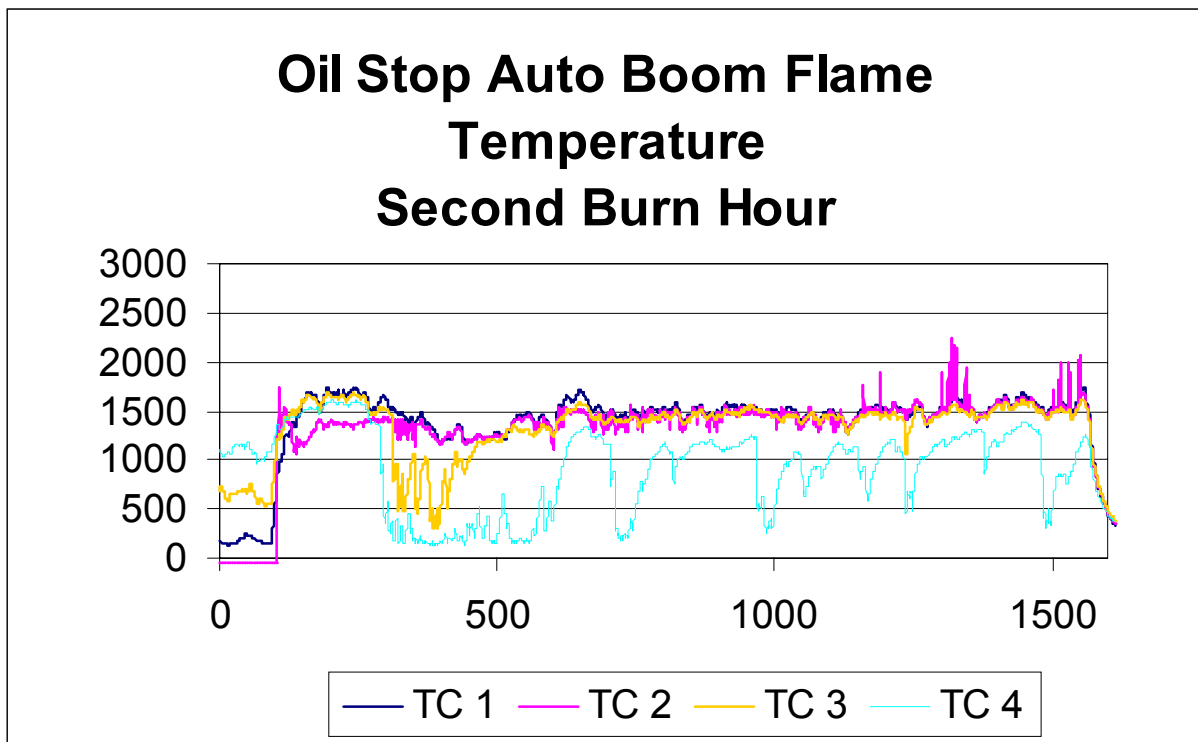
Figure 56 gives the flame temperatures recorded at the instrument stalk. The temperature recorded by the highest thermocouple (TC1) at the steady flow of 25 kg (56 lb) of propane per minute was on the order of 815°C (1500°F), as expected. The readings from TC2 should be discounted.

Figure 56 - Flame temperatures.

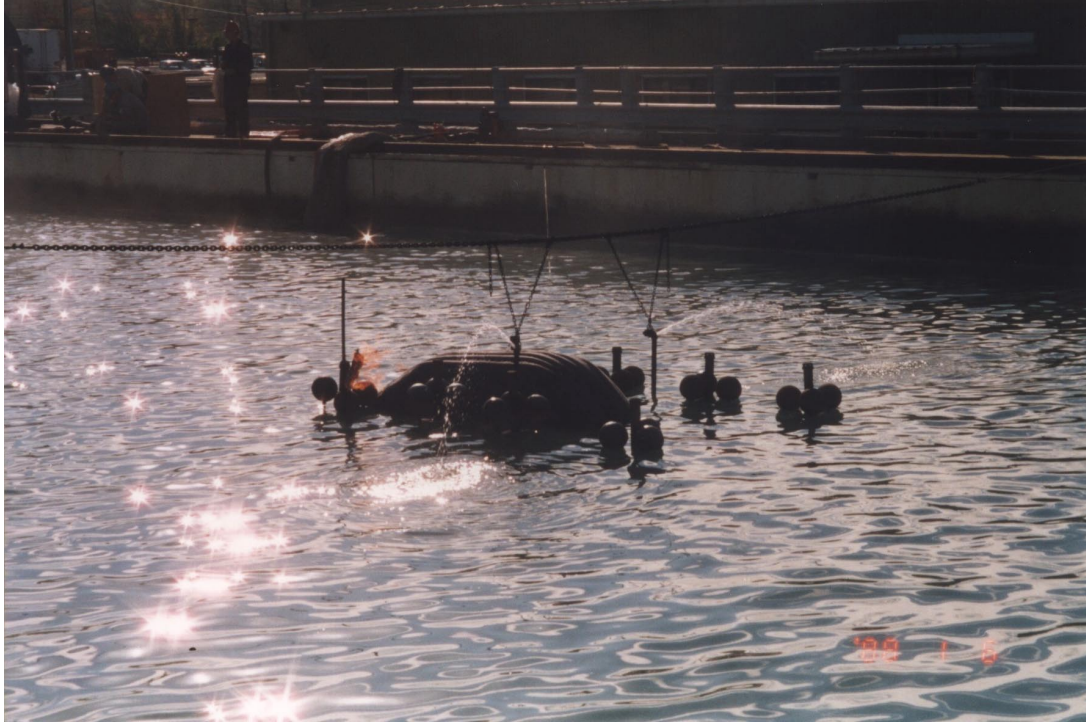
The final test of the project involved exposing a short length of Oil Stop, Inc. water-cooled blanket covering a single flotation section (Figure 64) to the air-enhanced propane fire and slowly reducing the water flow to the blanket, until the floatation unit failed. The tests were run in calm conditions. Figure 65 shows the blanket/floatation unit completely immersed in the flames.

Figure 64 - Oil Stop, Inc. blanket over single flotation section.

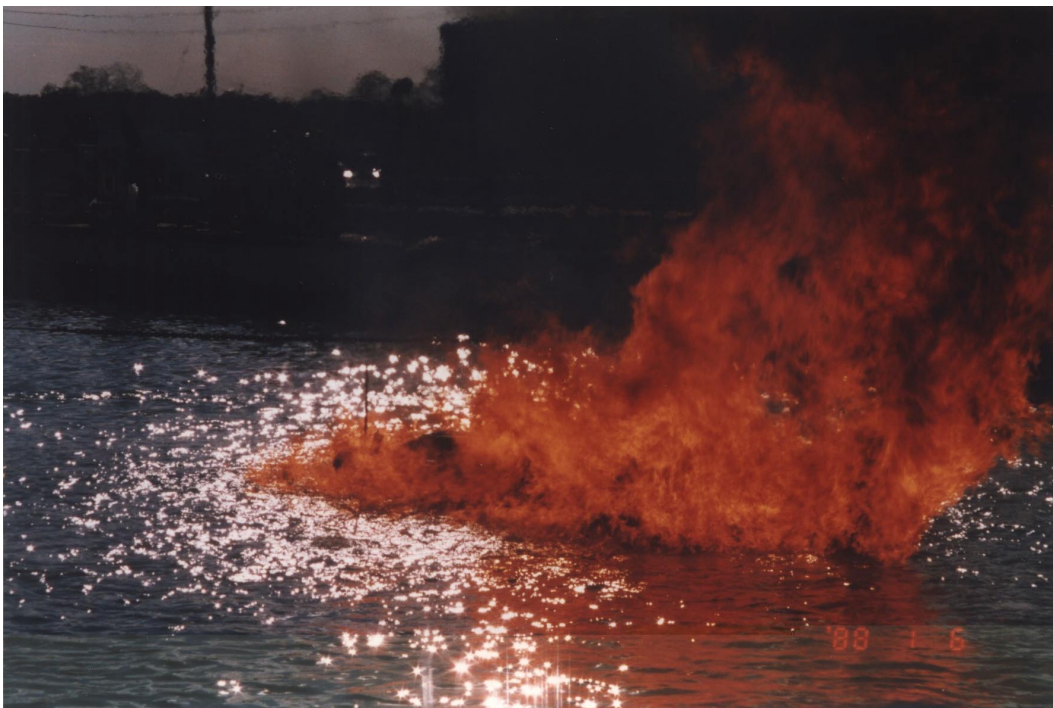
Figure 65 - Oil Stop, Inc. single unit immersed in flames.

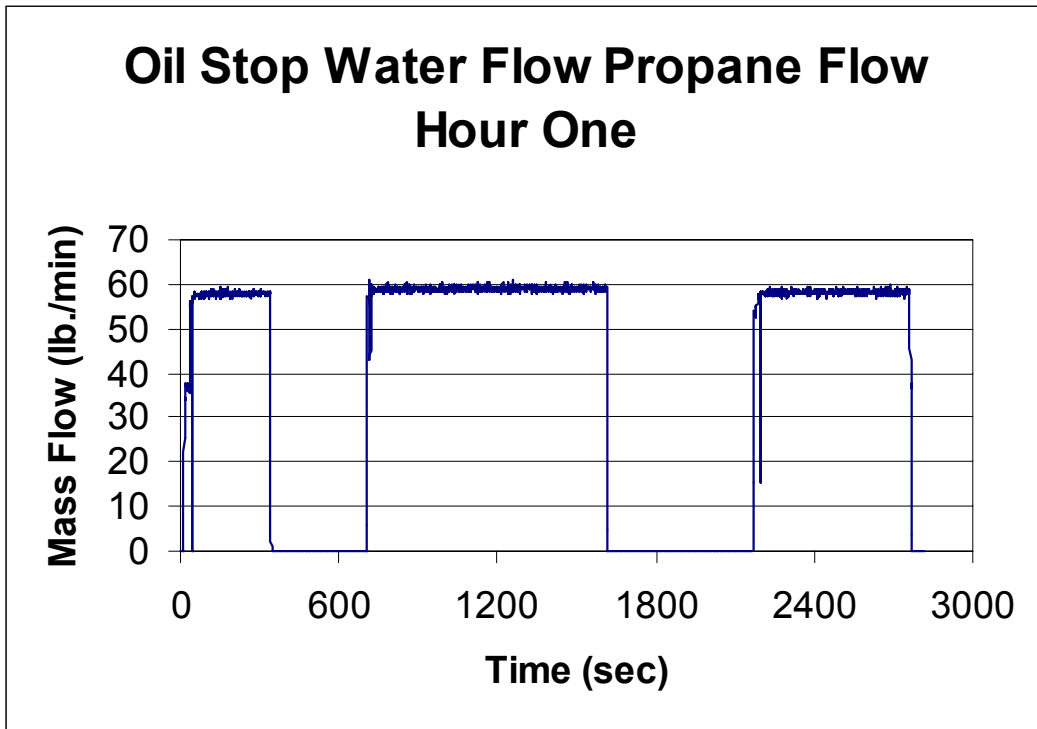
Figure 66 shows the propane flow rate recorded for this test and Figure 67 gives the flame temperatures measured at the instrument stalk (note that the data from TC2 should be discounted). The test involved exposing the test section to three fires of approximately 15 minutes duration, each with a lower flow rate of water being supplied to the blanket covering the flotation section. Figures 68 through 73 give the heat fluxes recorded during the burns. The east THFT had rotated and was pointing almost due south, into the 8 km/hr (5 mph) wind from the south-south west. After each fire stabilized, the east THFT could be seen above the flames. It is also possible that, for the second and third burns, the east THFT was being hit by a spray of water from a leaking cooling hose on the blanket. The heat fluxes recorded with the west THFT show averages in the 100 kW/m² range with peaks in the 100 to 150 kW/m² range for each of the short-duration burns.

Figure 66 - Propane flow for Oil Stop water flow test.

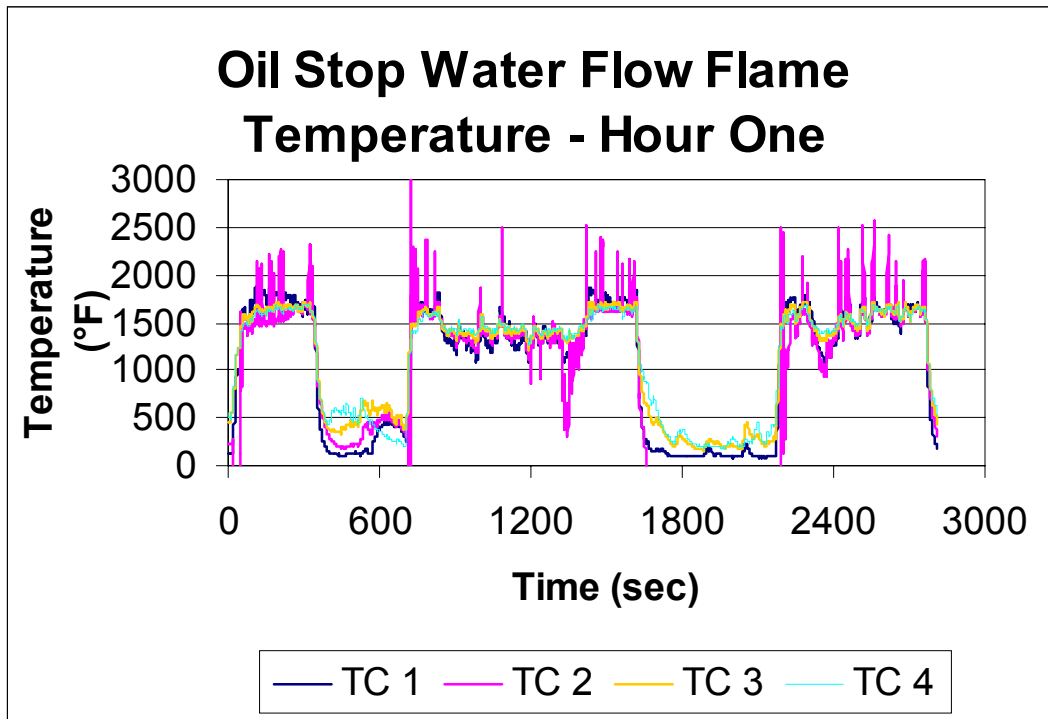
Figure 67 - Flame temperatures for Oil Stop water flow test.

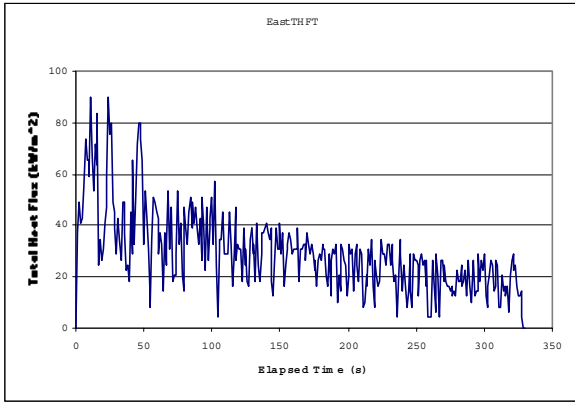
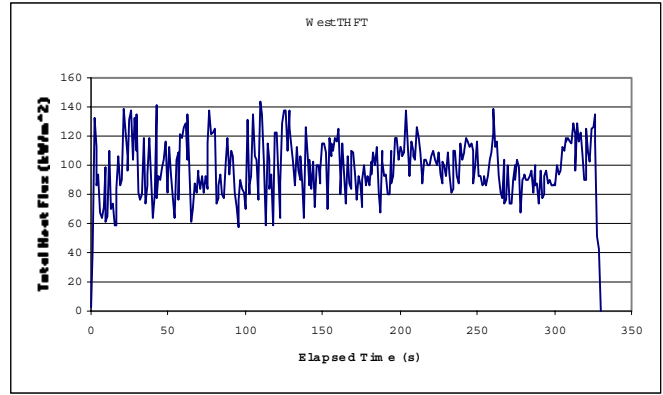
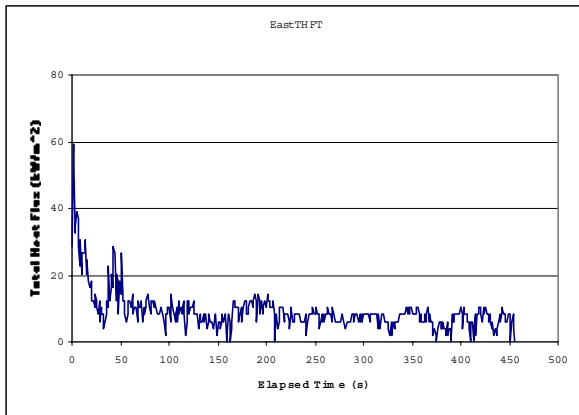
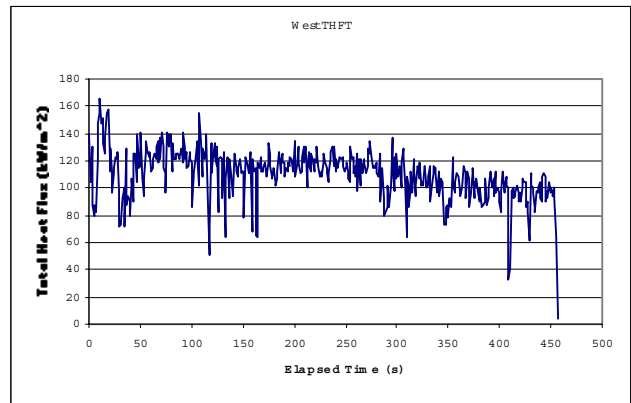
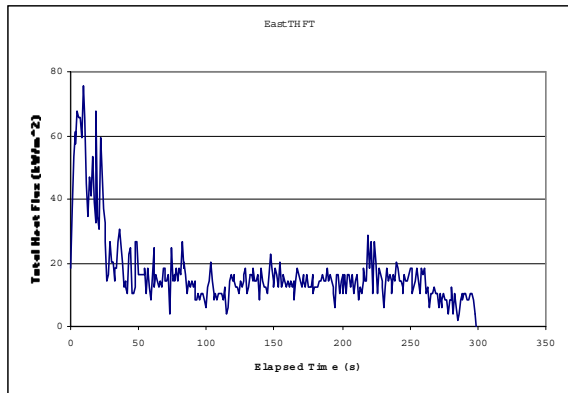
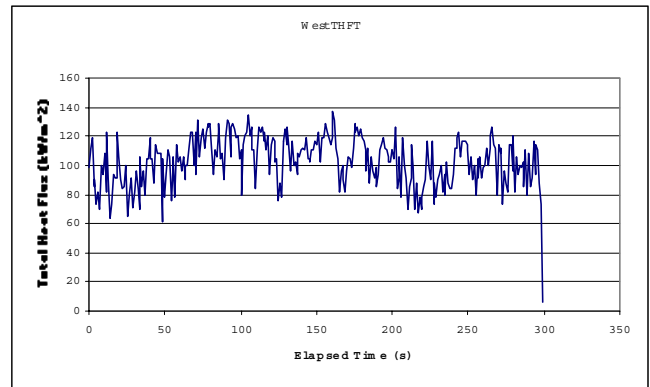
Figure 68 - Heat fluxes for Oil Stop water flow test.

The cooling water flow rate for the first burn was 100 L/min (26.4 gpm). The water flow rate for the second burn was measured in the range of 25 to 31 L/min (6.6 to 8.3 gpm). The water flow for the third, and final burn during which the boom failed, was measured at 16.3 L/min (4.3 gpm).
