## Fire Boom Testing at Ohmsett in 2000

### Abstract

One water-cooled blanket and one conventional fire boom failed the test protocol. Two versions of the reflective/insulating blankets proved effective in significantly reducing the heat insult to the underlying containment boom.

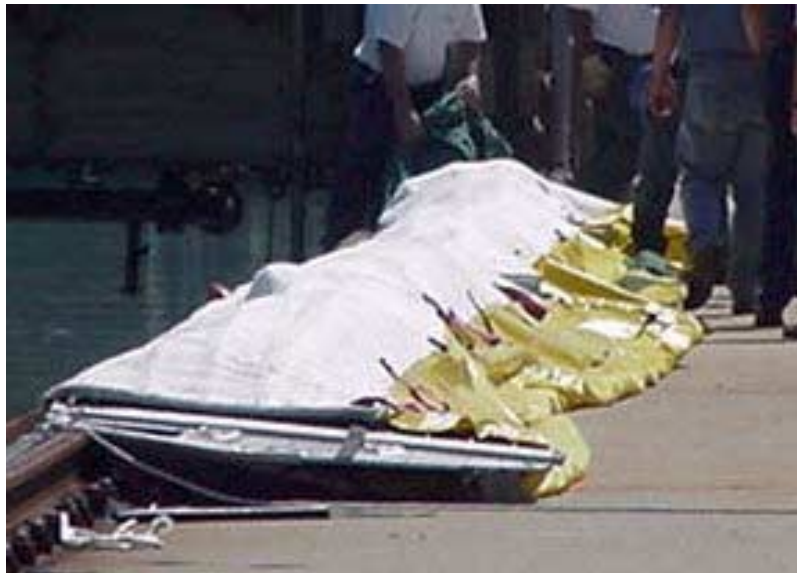
Figure 9 - Elastec/American Marine water-cooled fire blanket installed on the USS-42B boom.

Detailed descriptions of the water-cooled blankets may be found in Stahovec et al. 1999. Figure 9 shows the Elastec/American Marine water-cooled fire blanket

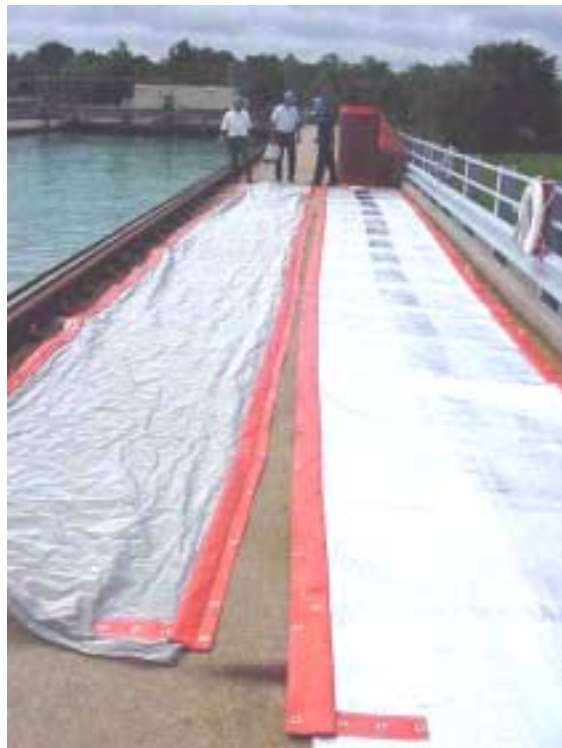
Figure 10 - Oil cooled fire blanket deck prior to its USS-42B boom

Figure 10 shows the Oil Stop, Inc. water-cooled fire blanket laid out on the deck prior to its installation on the USS-42B boom. Note that this blanket was not constructed to seal around the bottom of the boom thus allowing the propane bubbles access to the underside of the blanket. Note also that there is no specially constructed connector section for this blanket; there is a length of overlap between adjacent blankets.

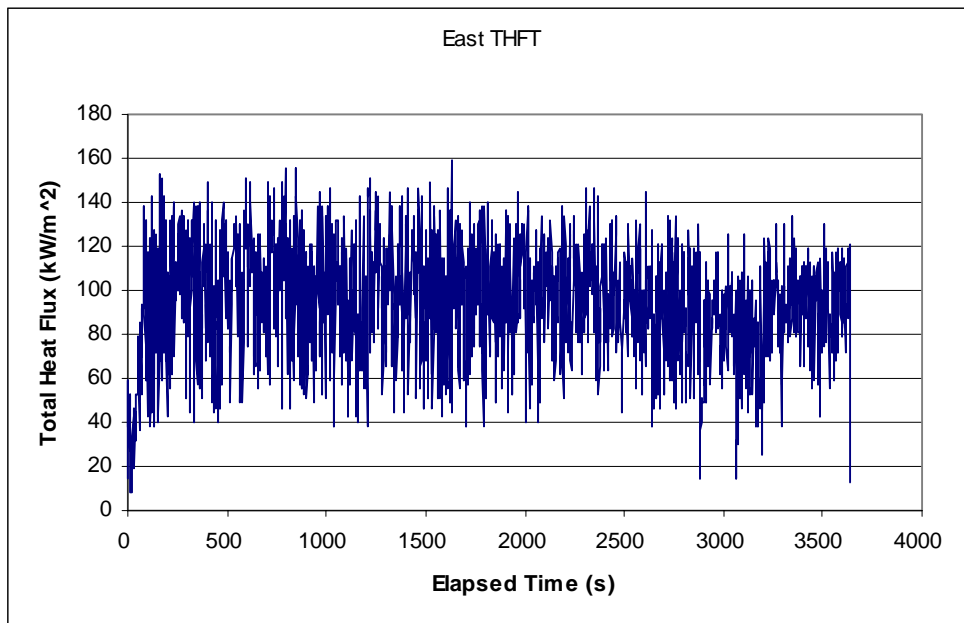
Figure 13 - East THFT data from first hour burn with SWEPI boom.

During the first, hour-long burn a steady 21 kg/min (46 lb./min) propane flow was recorded. The air flow rate, for this and the Oil Stop, Inc. Auto Boom Fire Model tests, was 750 cfm. Figure 13 shows the total heat fluxes recorded during the first hour of burning. These data are typical of those recorded for all the fire tests. As the heat from the fire warmed the chain suspending the two THFTs in the flames it stretched, lowering the THFTs. Periodically the chain was tightened, raising the THFT's back up. Despite these problems, the THFT data showed that the fire was

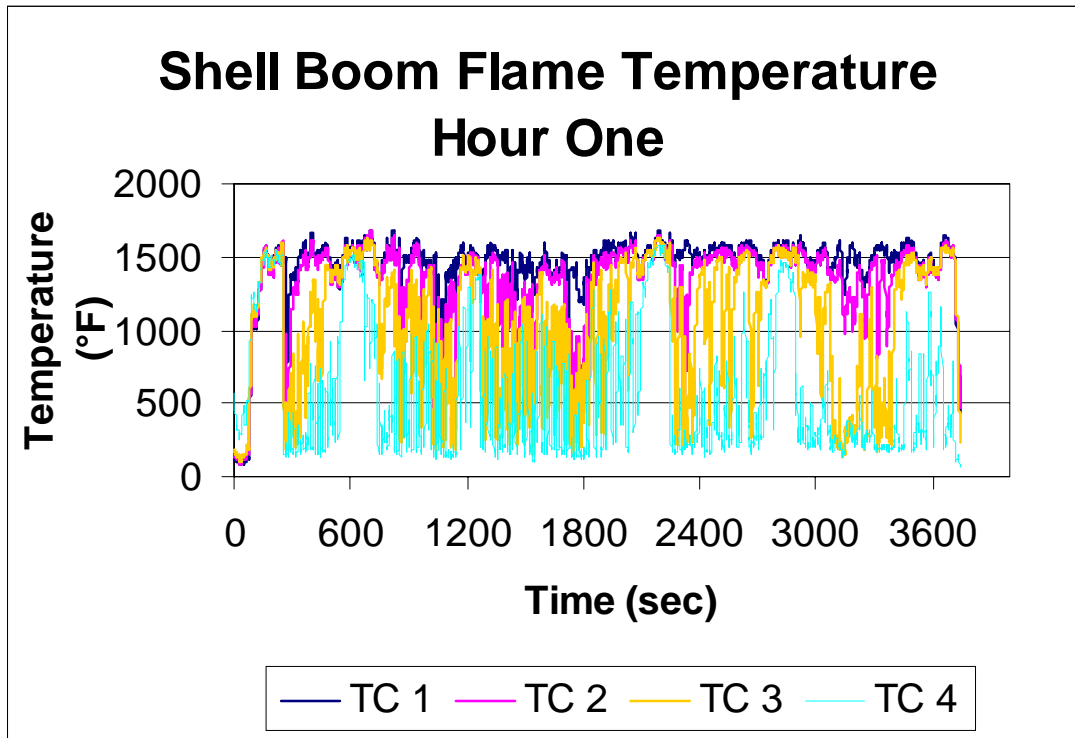
Figure 14 - Flame Temperatures recorded during the first burn hour with the SWEPI boom.

Figure 14 gives the flame temperatures recorded at the instrument stalk. This graph is also typical of all the fire boom and blanket tests. It is apparent that the lower two thermocouples were influenced by the waves: the lowest (TC 4) was apparently periodically submerged by wave crests. The “cold zone” at the bottom of the fire (where the combustion reaction has not yet proceeded fully) was seemingly also moved up and down by the waves, as evidenced by the dips in the flame temperatures for the other, lower thermocouples. The temperature recorded by the highest thermocouple (TC1) was on the order of  $815^\circ\text{C}$  ( $1500^\circ\text{F}$ ), as expected.
