## Coal Mine Fatal Accident 2006-26

Operator:	Lone Mountain Processing Inc.
Mine:	Huff Creek No. 1
Accident Date:	April 21, 2006
Classification:	Machinery
Location:	Dist. 7, Harlan County, Kentucky
Mine Type:	Underground Coal Mine
Employment:	135
Production:	12,000 Tons/Day

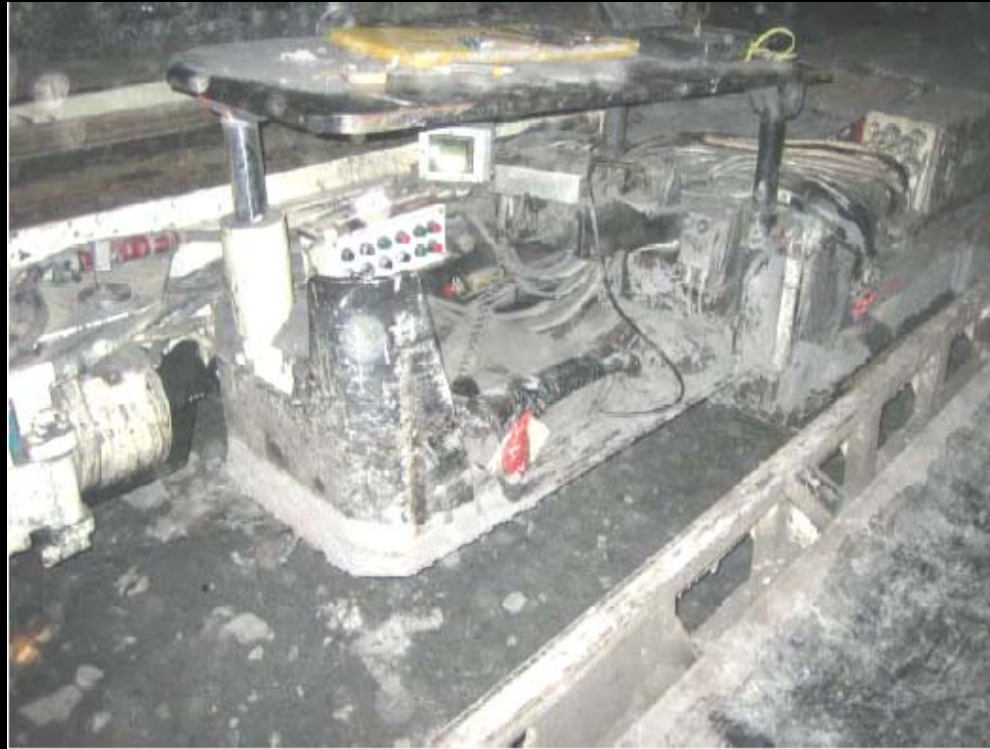
At approximately 4:30 a.m. on Friday, April 21, 2006, a 45 year-old Electrician was found fatally injured at Lone Mountain Processing Inc.'s Huff Creek No. 1 mine. The accident occurred while the victim was checking the hydraulic pressure on the left side tram of the No. 4 Breaker Car Module (BCM) while outside the operator's compartment. During this process, the No. 4 BCM tram control was bumped or struck by the victim, causing the machine to move, pinning him between the operator's compartment and the lo-lo conveyor belt structure.

Causal Factor: The mine operator did not have written procedures or policies in place to require blocking machinery against motion before performing repairs or maintenance. The victim was fatally injured when the BCM moved due the BCM not being blocked from motion. The victim's position, being located in a pinch point area, exposed him to hazardous conditions when the No. 4 BCM was started up and the left tram was engaged in reverse.

Corrective Action: The operator developed and implemented an action plan that was added to the training plan to require safety procedures to be followed when operating or performing maintenance on equipment.
