Historic Preservation Assessment and Recommendation Report for the Gun Site Restoration Project

LA-UR-08-05177

Historic Building Report No. 281

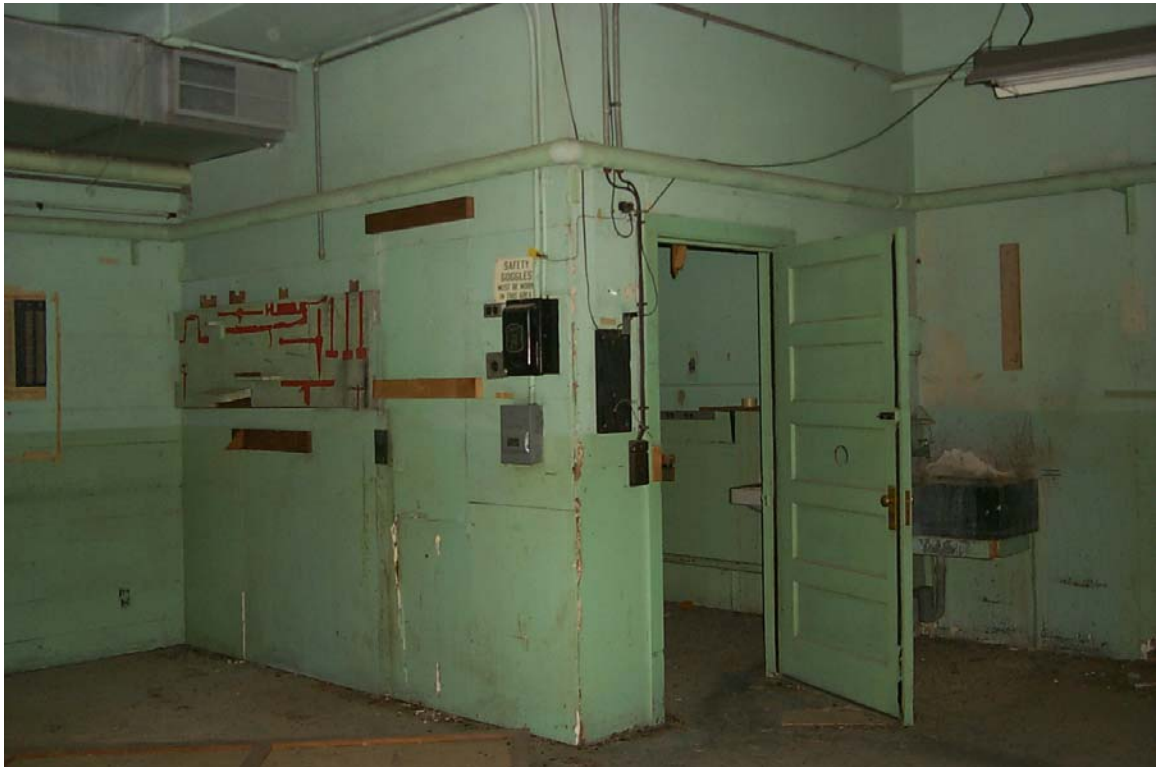
Figure 5b. Interior TA-8-1, current Room 5 looking southwest into current Room 6

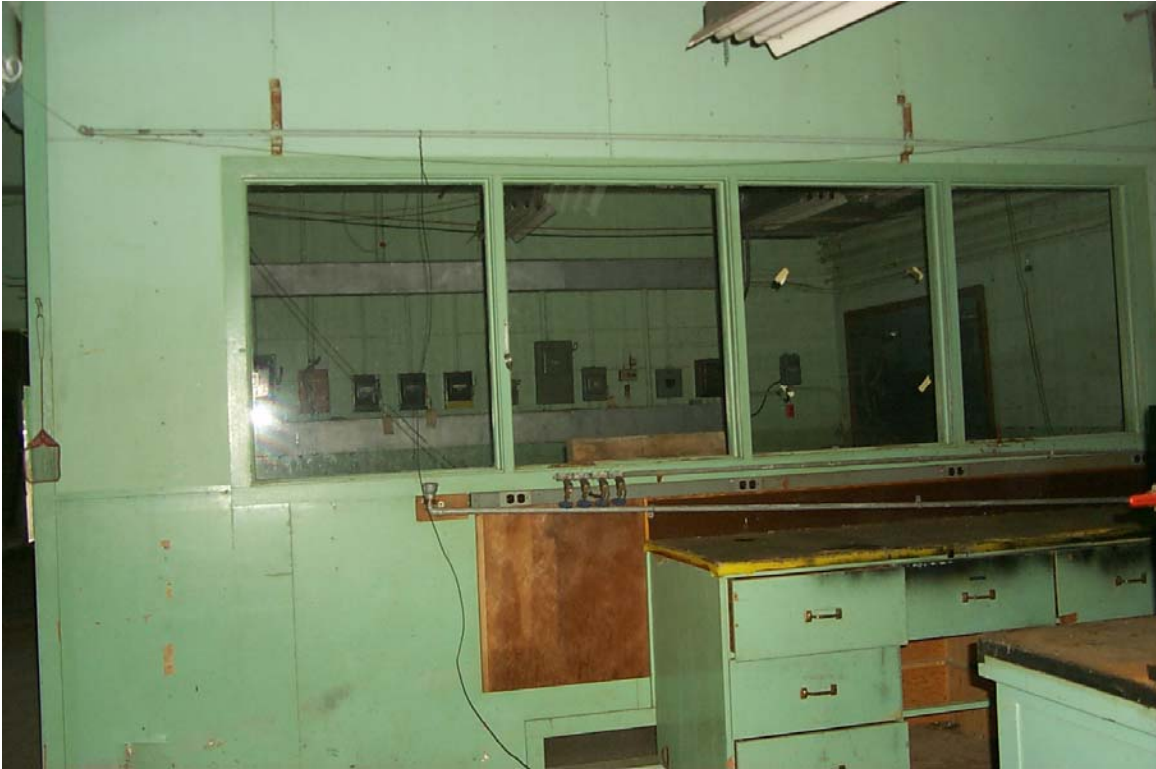
² It appears the “X-Ray Room” in Room 2 and the “Office” in Room 3 were created at the same time. As this subdivision into smaller units indicates the original uses of Rooms 2 and 3 were modified, these two room subdivisions (i.e., X-Ray Room and Office) should be considered non-historic.

Figure 5c. Interior TA-8-1, current Room 3 looking east through windows into current Room 4 (a portion of original Room 3)

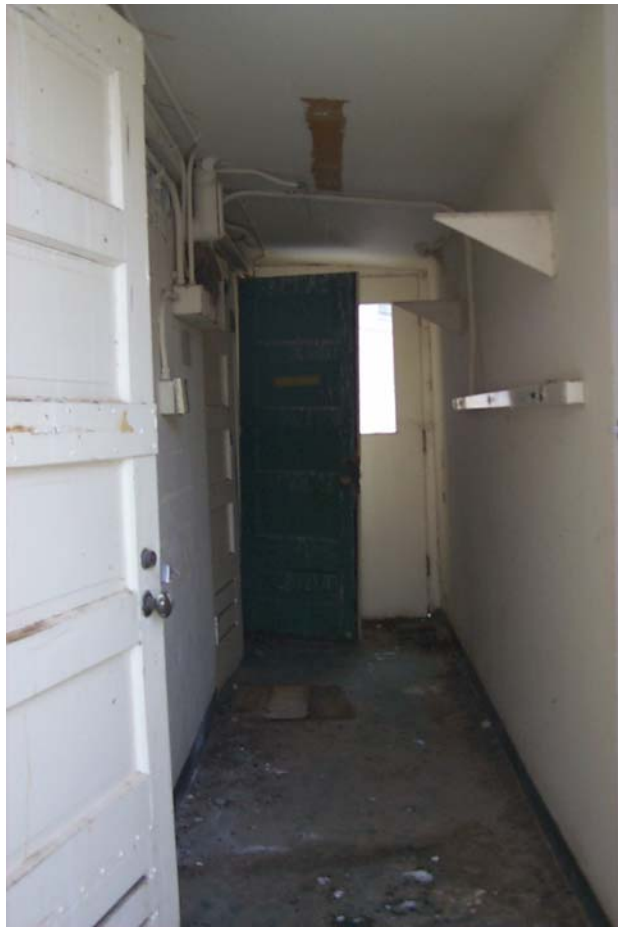
Figure 7a. Interior TA-8-3, enclosed dock

Further alterations to the exterior occurred in 1966 with the addition of a “dock enclosure” that currently exists (ENG-C 34041 April 6, 1966). These additions are considered non-contributing and are recommended for removal.

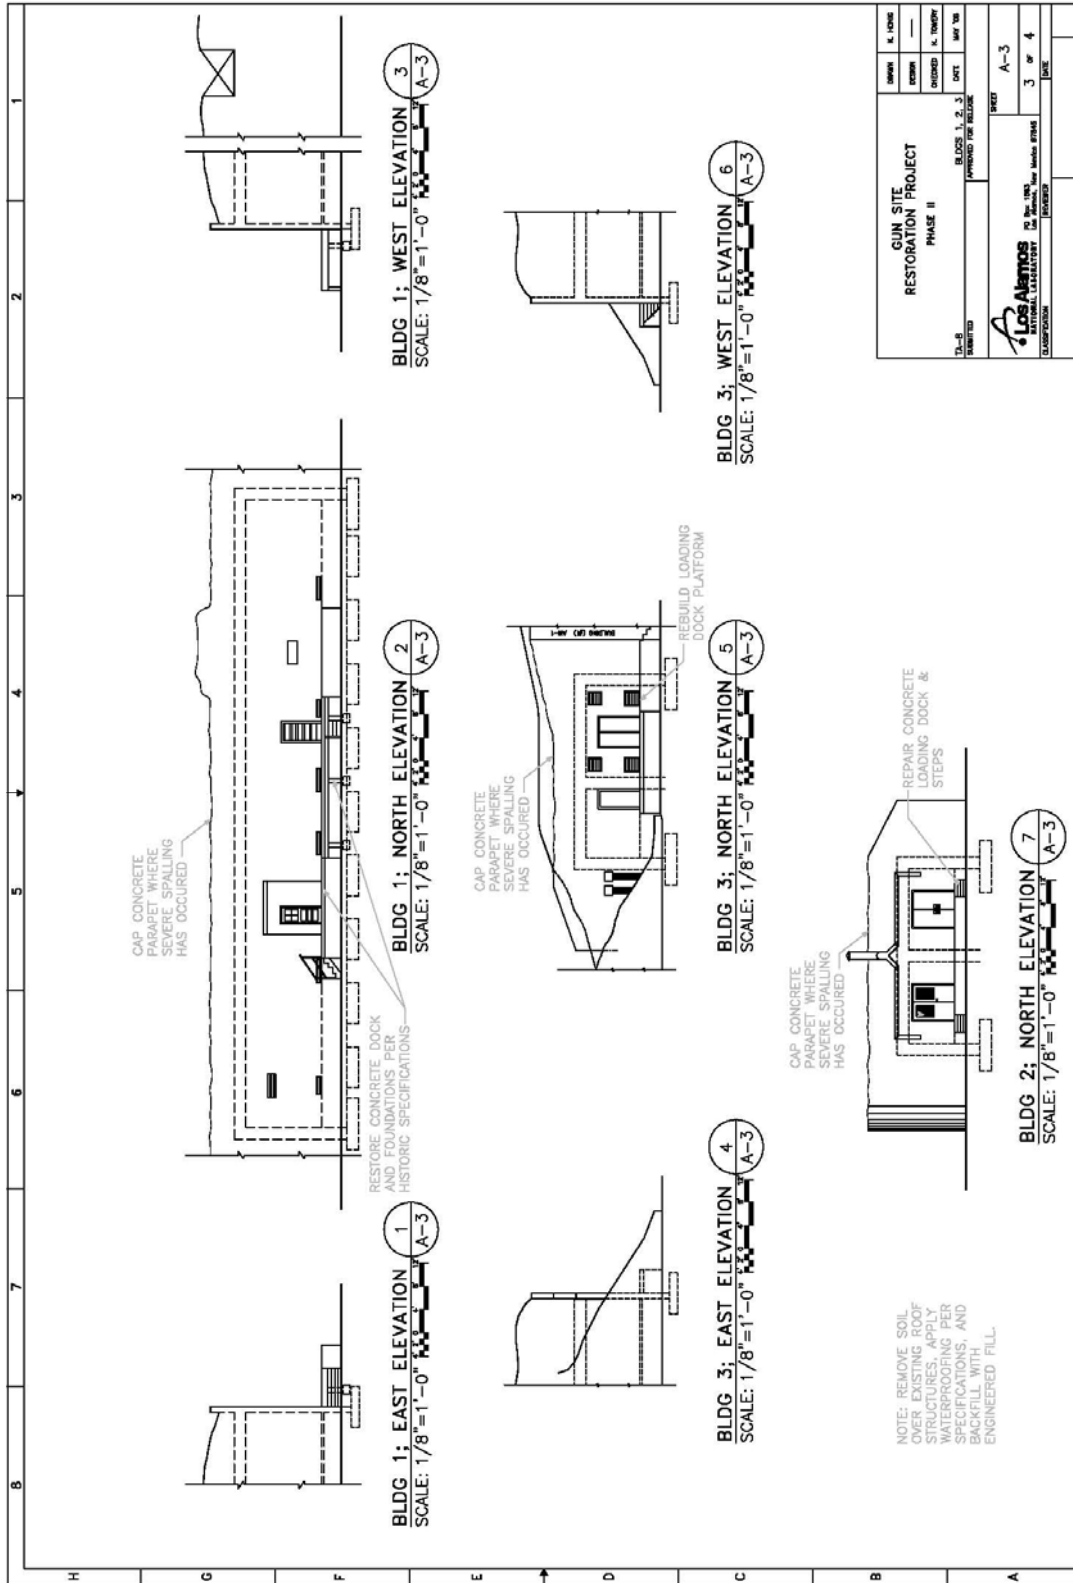
Figure 11. Phase II of restoration project

Phase II is designed to address remediation of major structural issues and/or active pathologies that are causing ongoing deterioration (Figure 11).³

The concrete buildings should be waterproofed. All soil on top of the buildings would be removed and modern waterproofing installed. The specific type and technique to be used will depend on engineered specifications and field conditions. The finished grade should provide for positive drainage away from the back of the concrete retaining wall for at least 12 feet. Original architectural plans indicate that two 2,000-gallon diesel fuel oil tanks are buried in the hillside. One is buried six feet to the east of Building 1 with six feet of cover, and the other is approximately six feet directly behind Building 3 with 10 feet of cover.

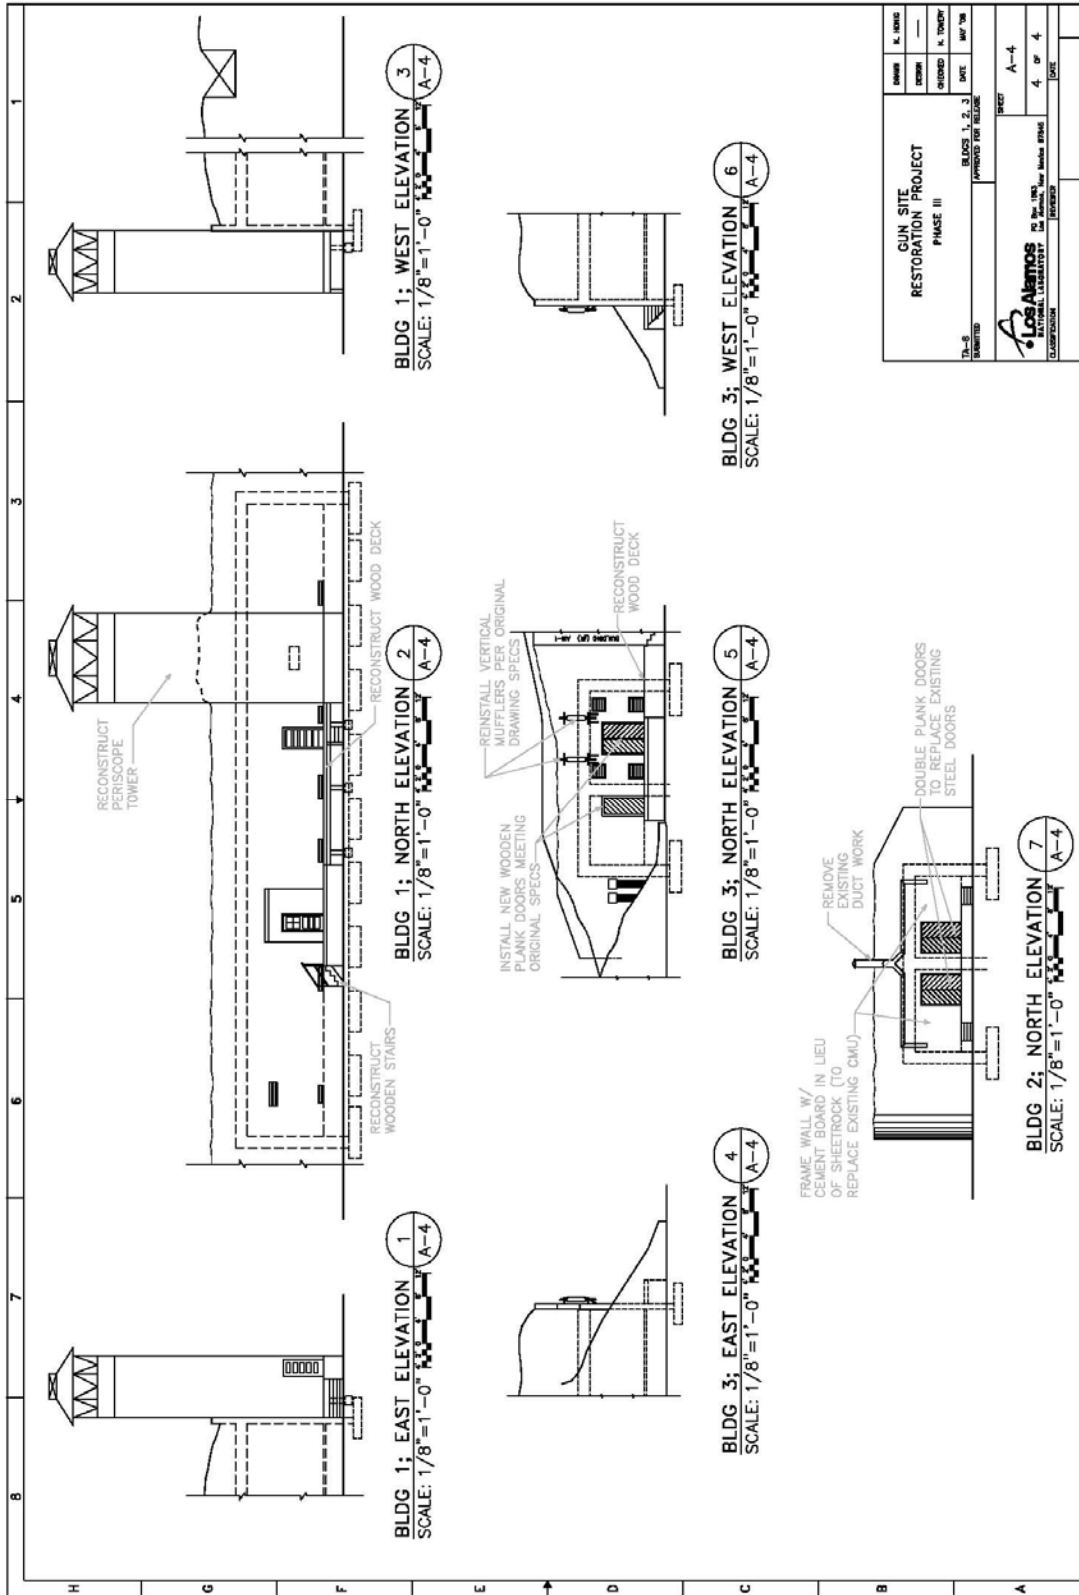
Figure 14. Phase III of restoration project

Phase III is designed to rebuild historically significant portions of the facility that were removed previously and to restore all exterior building components. Current recommendations do not address interior restoration, as ultimate end-use will determine restoration (Figure 14).

Tower Reconstruction: The only remaining physical evidence of the periscope tower are the foundations and the anchor bolts running vertically up the north face of the retaining wall. However, excellent historic architectural documents detail the specifications, dimensions, and materials for the tower. A reliable reconstruction is possible given the reliability of the construction documents and the physical evidence that remains at the facility. The tower had an all-wood frame approximately 18 feet wide, nine feet deep, and 45 feet high. Steps wound around the perimeter of the tower leading to the top of the berm and up to the top of the tower. The periscope ran through the center of the tower. Every effort should be made to comply with the original specifications when reconstructing the tower, but occupancy estimates and current code requirements may dictate re-evaluation of some structural details.

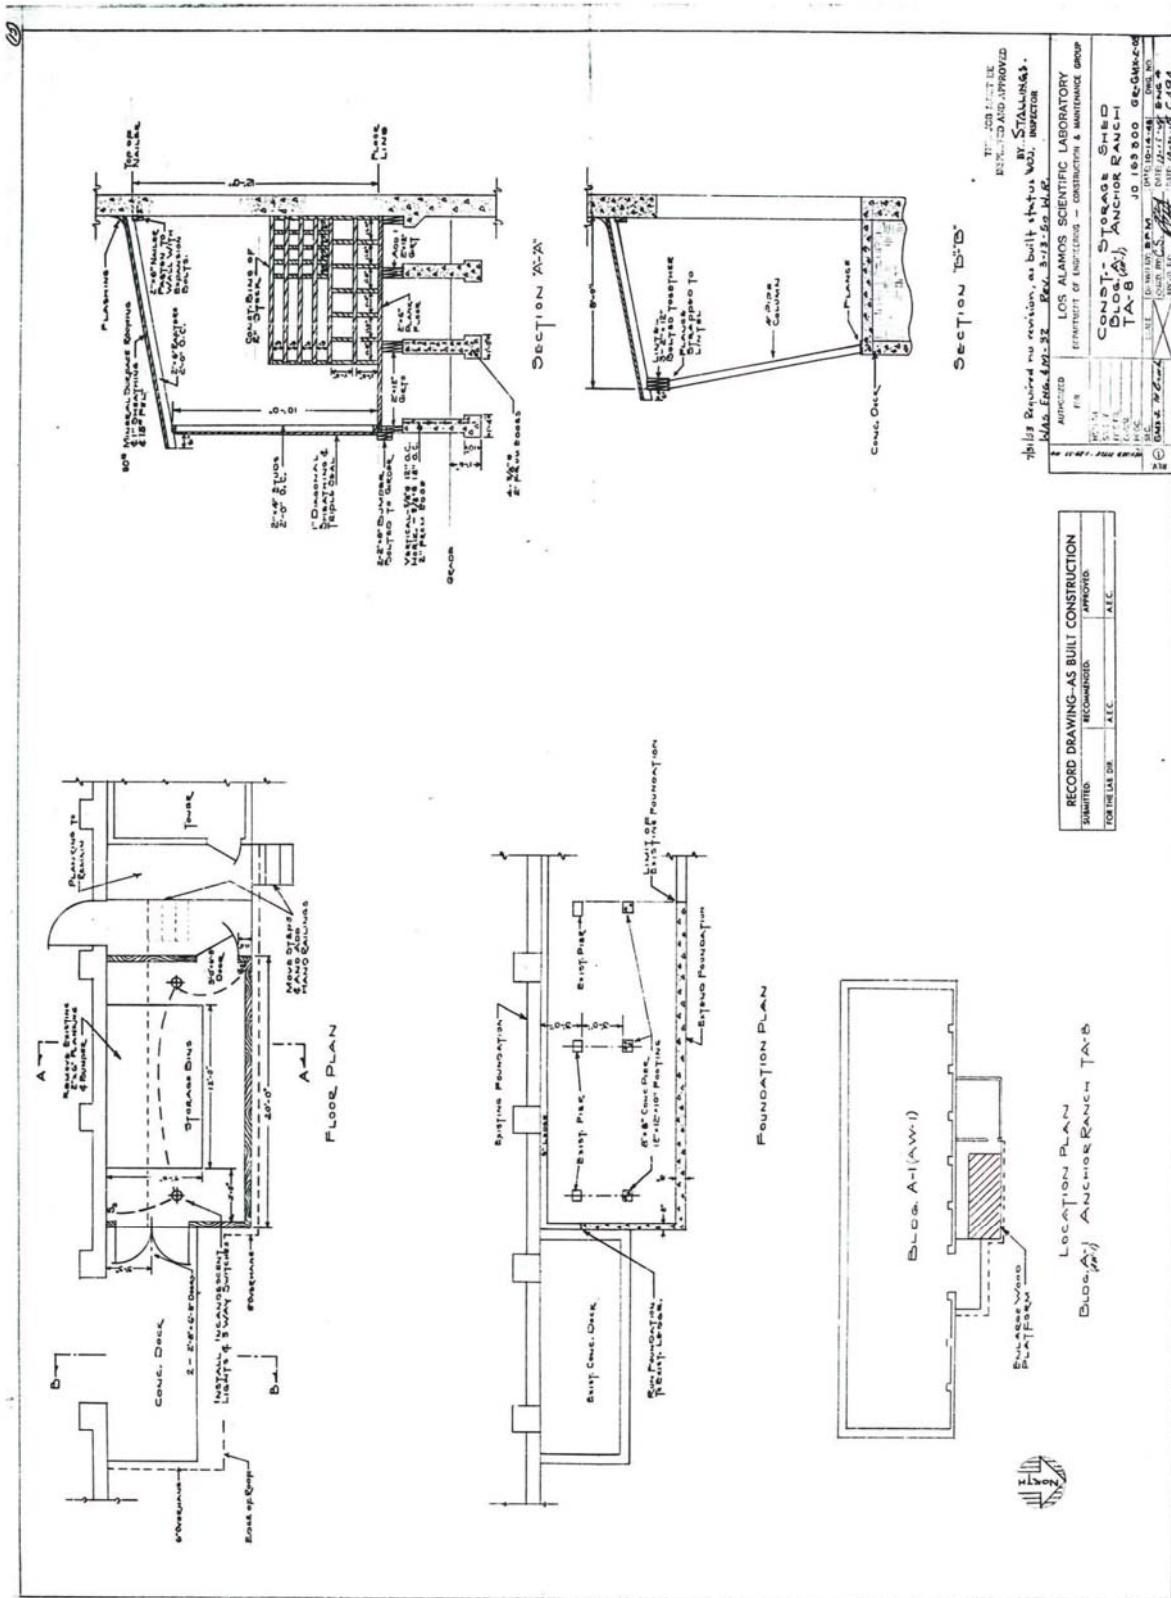
ENG4-C 494 October 14, 1948 Const. - Storage Shed Bldg. A-1 (AW-1)

Loading Dock Addition: The 1948 addition to the exterior face of the loading dock (canopy and dock addition) is not structurally stable and is non-contributing to the historic status of the facility (ENG4-C 494 October 14, 1948) (Figure 9). This addition should be removed. However, because removal of these elements will result in increased exterior exposure of the original historic doors and woodwork now protected by the addition, measures should be taken to protect the original wooden elements until restoration efforts are made. If safety concerns are met, all concrete foundations should remain to document historic foundation sections. Any non-contributing concrete work associated with the loading dock addition should be removed.

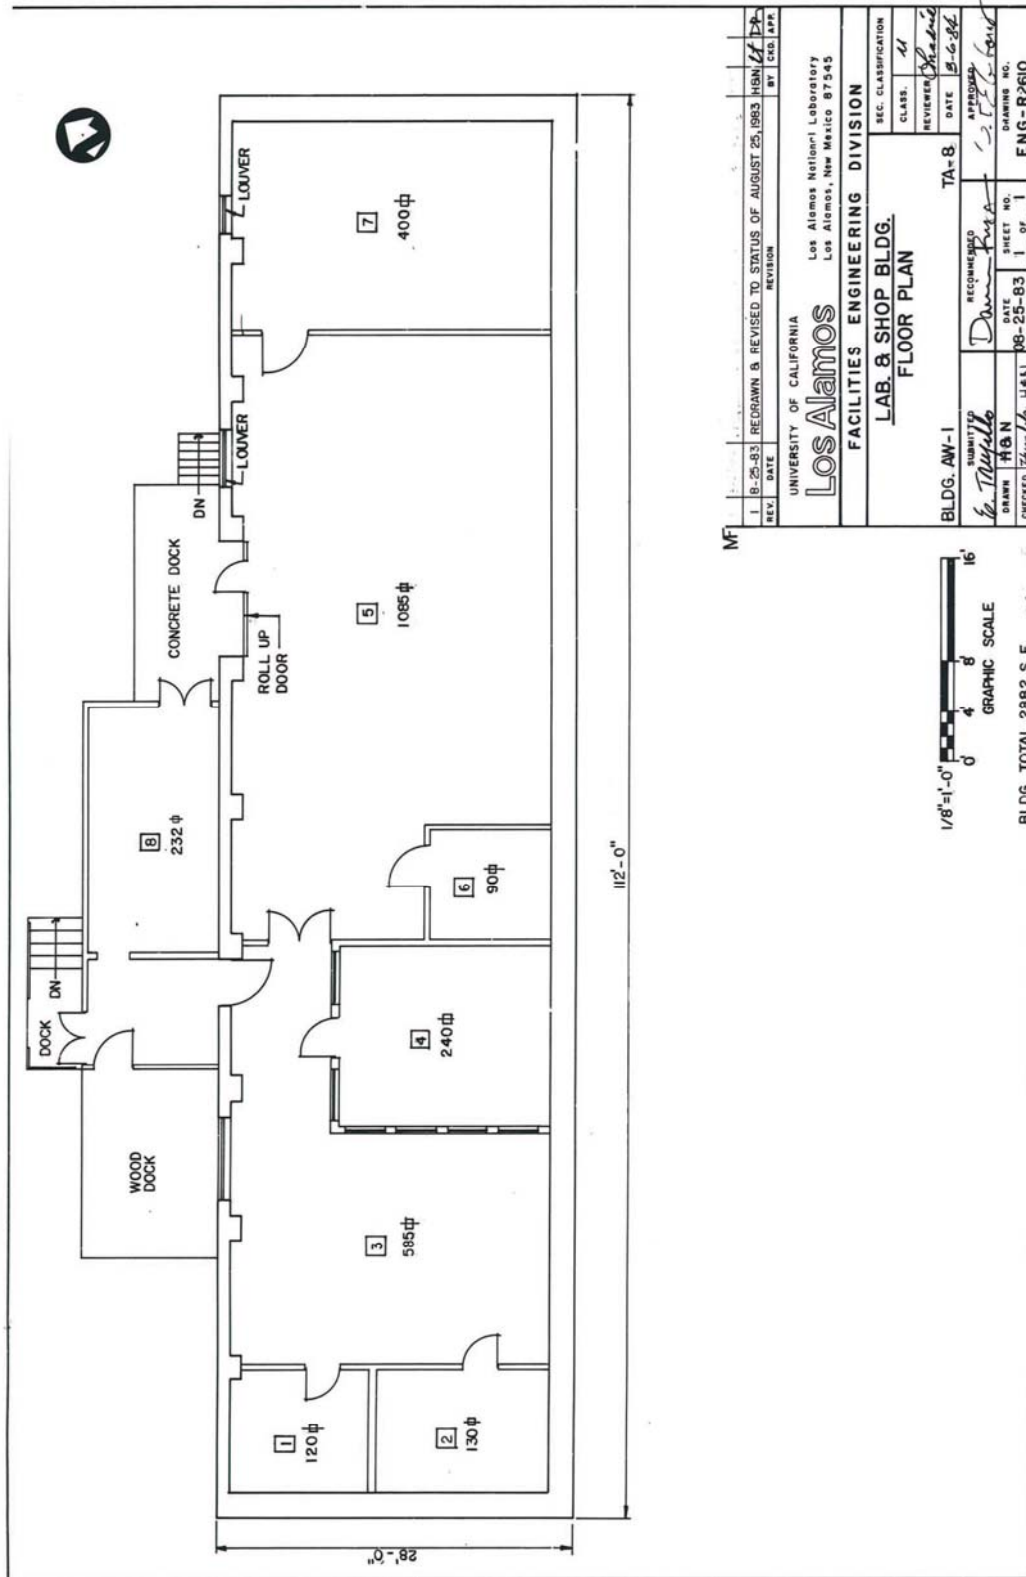
ENG-R2610 August 25, 1983 Lab. & Shop Bldg. Floor Plan, Bldg. AW-1

At approximately 3,200 square feet, Building 1 covers the largest area and is currently configured into eight rooms (ENG-R2610 August 25, 1983) (Figure 5a–d). It extends approximately 28 feet back from the concrete façade. All interior finishes are painted cast concrete unless otherwise noted. All electrical and mechanical systems are surface mounted. Original architectural documents (ENG-C 12307 May 30, 1943) indicate that the building contained five rooms, numbered east to west, and the tower structure, which was referred to as Room 6.¹ Descriptions of original rooms 1-5 are as follows.
