**Composite Repair Methods for Steel Pipes**  
Research Activities Summary Report

**Supplemental Project Report**  
**Prepared for the Minerals Management Service**  
**Under the MMS/OTRC Cooperative Research Agreement**  
**1435-01-04-CA-35515**  
**Task Order 39300**  
**MMS Project Number 558**

**June, 2007**

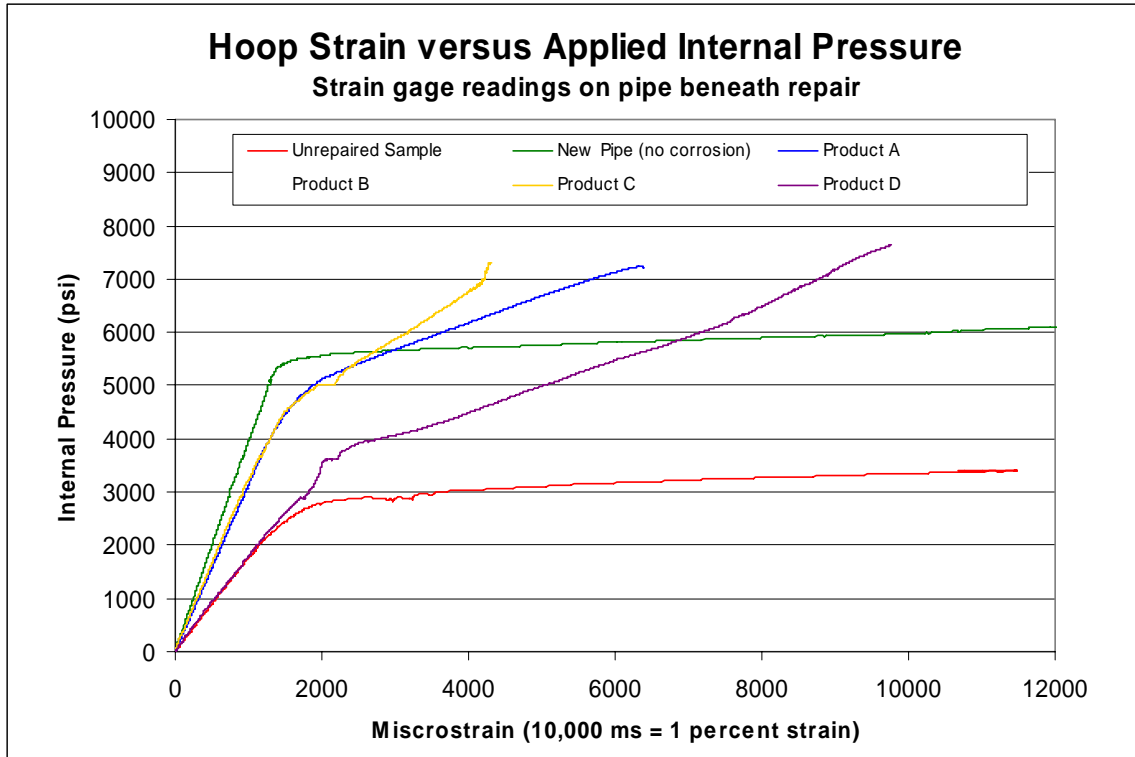
**Figure 6 – Test results from pressure-only testing**

Results for the pressure-only test are provided in **Figure 6**. This phase of testing represents the initial benchmark of the test. To a certain extent, it presents the most basic test as it only addresses the performance of the repair in reinforcing hoop strength.

In reviewing the test data in **Figure 6**, there are several noteworthy points:

- In limit state design, one must address the limit state, or the maximum capacity a structure can withstand. Although fundamentally this involves failure, more practically it involves assessing the load at which unbounded displacements (or strains) occur. In pressure vessel design, this condition is known as the lower bound collapse load. The strain gage results presented in **Figure 6** show the pressure at which unbounded displacements occur, typically near 2000 microstrain (or 0.2 percent strain).

- The post-yield slope in the stress-strain curves observed for each of the repair systems is the result of reinforcement being provided to the corroded region of the steel pipe. This occurs once plasticity initiates in the steel and load is transferred to the reinforcing composite material. This bi-linear stress-strain curve is typical for structures reinforced using composite materials subject to tensile loading.

- The unrepaired sample failed at a pressure of 3,694 psi. The failure pressures for the four repaired samples are listed below. Failures in the test samples involving Products A, C, and D occurred in the steel away from the repaired region. **Figure 7** shows the failure in the unrepaired sample, while **Figure 8** shows the failure in the Product C repaired sample outside of the repaired region in the base pipe.
  - Unrepaired – 3,694 psi
  - Product A – 6,921 psi
  - Product B – data not reported
  - Product C – 7,502 psi
  - Product D – 7,641 psi

- The strain gage results provide measurements of the strains in the pipe during pressurization. The measurements of greatest significance are those that demonstrate behavior once yielding initiates in the steel and the point at which load is transferred from the steel into the composite material. This latter observation is the best indicator for determining how much reinforcement is provided by the composite material. Product C provides the greatest continuous reinforcement, while Product A provides similar results up to 2,500 microstrain. Although Product D did not provide the same level of strain reduction beneath the repair as the other two systems, this system generated the largest burst pressure of all the test samples.

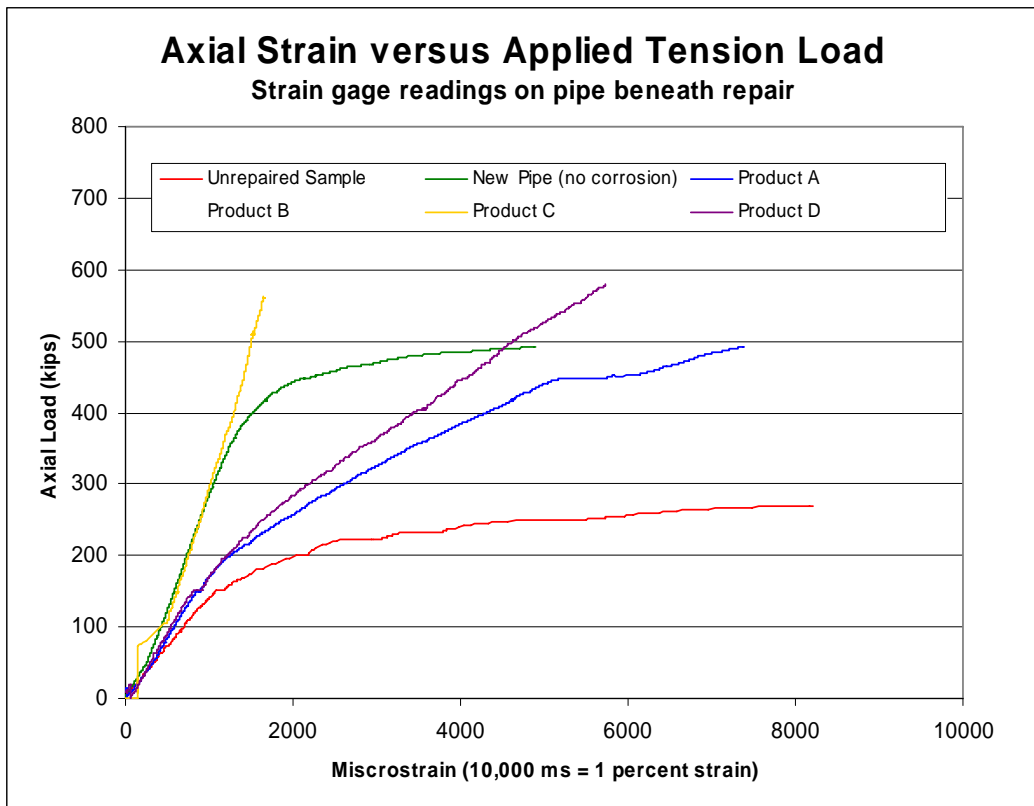
**Figure 9 – Test results from pressure-tension testing**

Results for the pressure-tension test are provided in **Figure 9**. This phase of testing fundamentally assessed the lap shear strength of the adhesive that bonded the composite reinforcement to the steel pipe. This failure condition was anticipated prior to testing and was the basis for the minimum repair length of 60 inches. Several noteworthy observations are made in reviewing the test data presented in **Figure 9**:

- Product C shows the greatest axial rigidity of all the repair systems. The basis for this observation is that Product C was fabricated using carbon fibers, with a large percentage of fibers being oriented axially. Products A and D show similar levels of reinforcement up to 200 kips, while after this point Product D shows greater reinforcement.
- The following tension failure data were recorded.

- Unrepaired sample – 317 kips
- Product A – 492 kips
- Product B – data not reported
- Product C – 562 kips
- Product D – 579 kips

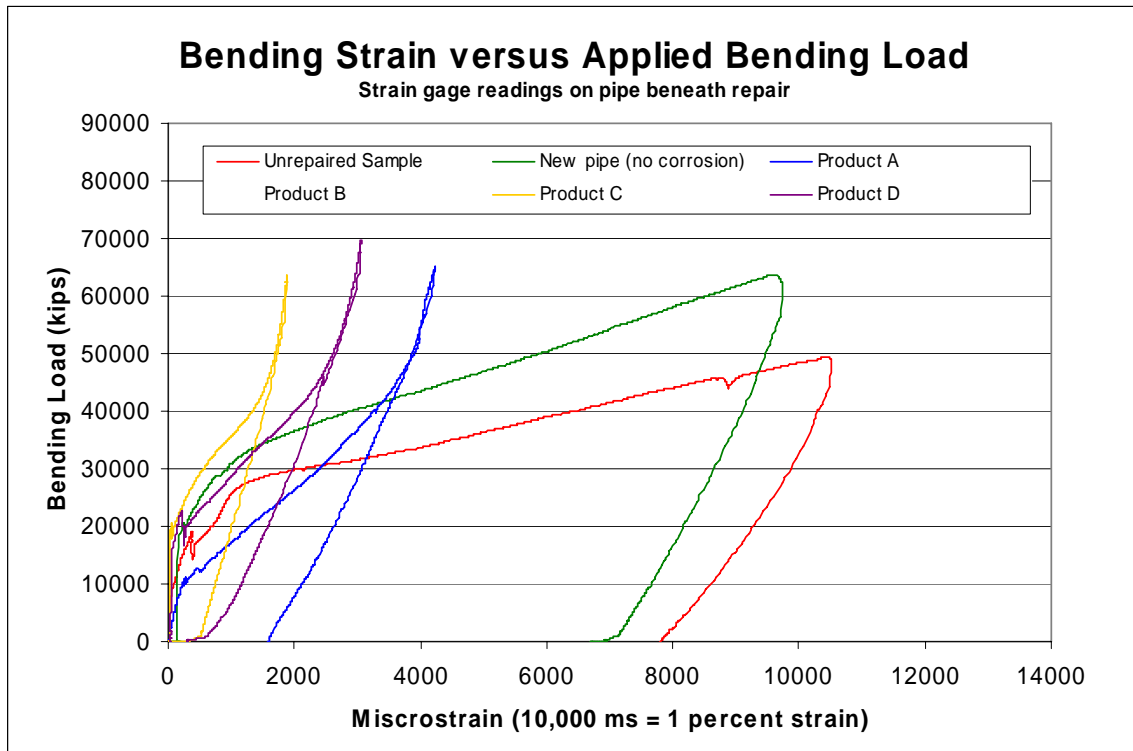
**Figure 11 – Test results from pressure-tension-bending testing**

Results for the pressure-tension-bending test are provided in **Figure 11**. There are several noteworthy observations in reviewing the plotted data:

- Unlike the other tests, there is a unique pattern observed for the level of reinforcement provided by each of the respective repair systems. As expected, the carbon in Product C provides the greatest level of reinforcement. For comparison

purposes, consider the strain in the steel at a bending load of 40 kips (bending moment of 116.7 ft-lbs) for each of the repair systems:

- Product A – 4,130 microstrain
  - Product B – data not reported
  - Product C – 2,150 microstrain
  - Product D – 3,022 microstrain
- 
- In assessing the relative performance of the composite systems, the objective of the repair is to reduce the strain in the corroded steel during bend testing, as well as provide reinforcement in the circumferential and axial directions against internal pressure and axial tension loads, respectively. As noted in **Figure 11**, at some point the strain gage results appear to stop changing with increasing load (plotted lines go vertical). It is at this point that gross plastic deformation occurs outside of the reinforced region and that deflection is occurring primarily in areas outside the composite reinforcement. The sooner this transformation takes place, the more effective the repair is in reinforcing the corroded region.

- Another option for assessing the relative performance of the composite repair systems is to determine the applied bending moment at a specified strain value. If the strain limit is 0.20 percent, the following bending forces and moments are extracted. This method is a better assessment of the relative performance of the repair systems. It should be noted that the unreinforced sample did not include internal pressure as failure would have occurred at a low bending load.
    - Unreinforced sample – 30 kips (87.5 kip-feet)
    - Product A – 26 kips (75.8 kip-feet)
    - Product B – data not reported
    - Product C – 70 kips (204.2 kip-feet)
    - Product D – 40 kips (116.7 kip-feet)
