Oxygen Regulator Flash Severely Burns One Fire Fighter - Florida

SUMMARY

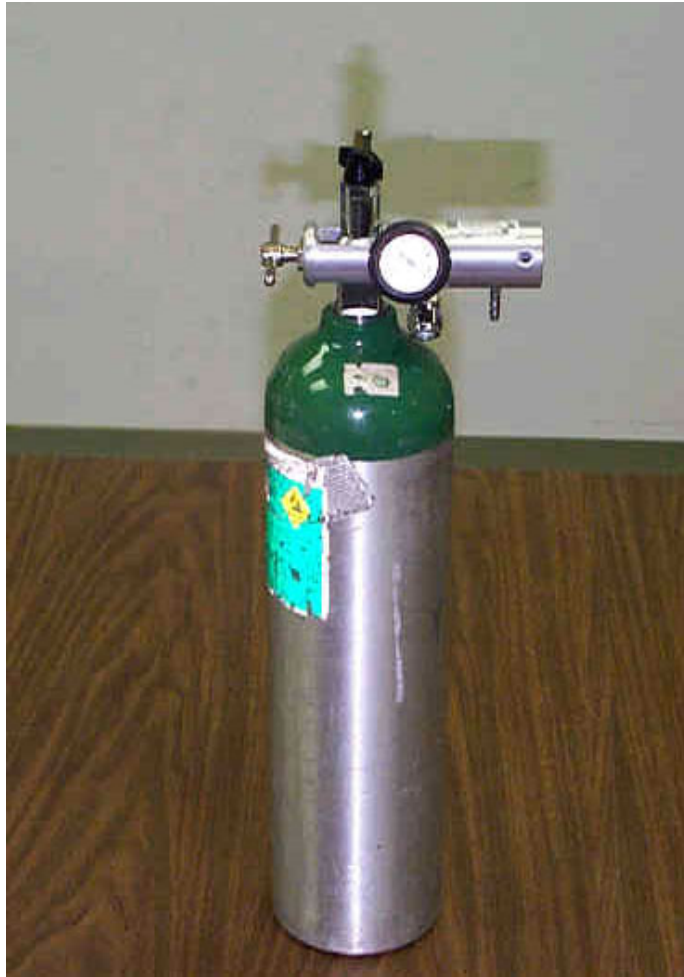
The fire fighters involved in the process of filling cylinders with oxygen are trained in the proper procedures. The oxygen cylinders commonly filled by the fire department and used as medical equipment by the paramedics and EMTs are D- and E-size cylinders (Photo 3). These cylinders are filled from a cascade system of 12 M-size (300-cubic-ft.) cylinders connected in series (Photo 4). The cascade systems used at Station 34 and 28 are capable of refilling 14 D- or E-size oxygen cylinders at a time. Two banks of 7 cylinders each are arranged in a storage rack for filling (Photo 5). As cylinders are refilled, 1 out of every 14 is sampled to ensure the cylinder is filled with 99.7% pure oxygen. If a sample is found to fall below 99.7%, the entire lot of 14 is isolated until the problem is identified and corrected. After filling, each cylinder is capped with a plastic plug over the post valve opening to keep the valve clean and to identify cylinders that are ready for use.

Photo 3: This photo depicts a D-size cylinder similar to the one that was involved in the incident.

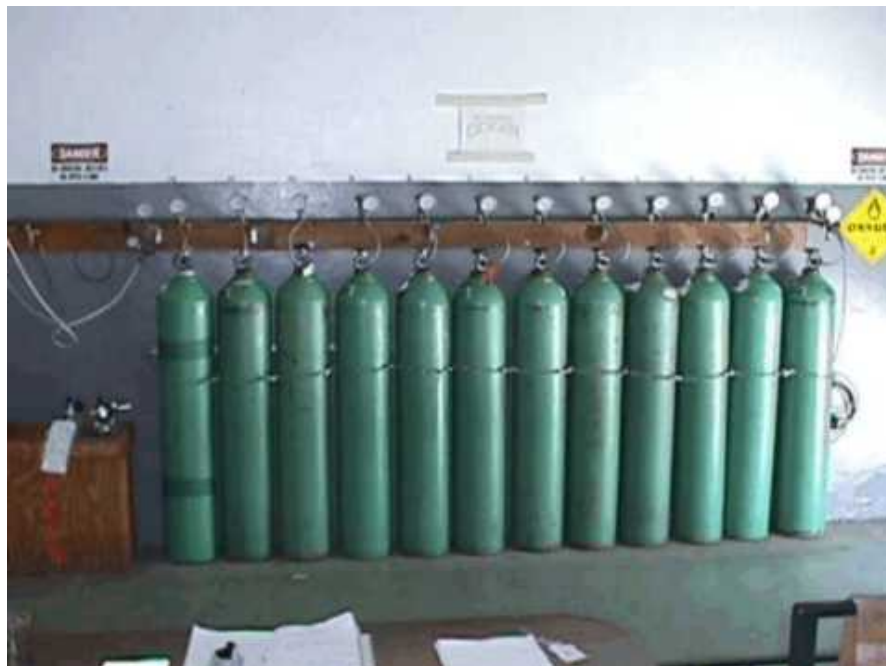
Photo 4: This photo depicts the cascade system used by the fire department to refill the oxygen cylinders. The cascade system is composed of 12 M-size (300 cubic

foot) cylinders connected in series.

Recommendation #6: Fire departments should ensure that oxygen refilling stations and maintenance areas where oxygen equipment is serviced, are in a locked air-conditioned room that is clean, and free of dirt, oils, and grease.^{8, 9}

The refilling process should be completed by an individual who has been properly trained. The individual should have clean hands free of any contaminants, and if using gloves, should use a clean pair that is used only for this process. All tools and materials used in this process should be routinely cleaned and used only for this process. The area of the refilling station should be air conditioned to maintain adequate temperatures.
