A Summary of a NIOSH fire fighter fatality investigation

May 18, 2000

Motor-Vehicle Incident Claims Life of Volunteer Fire Fighter Who Was Responding to Alarm - Ohio

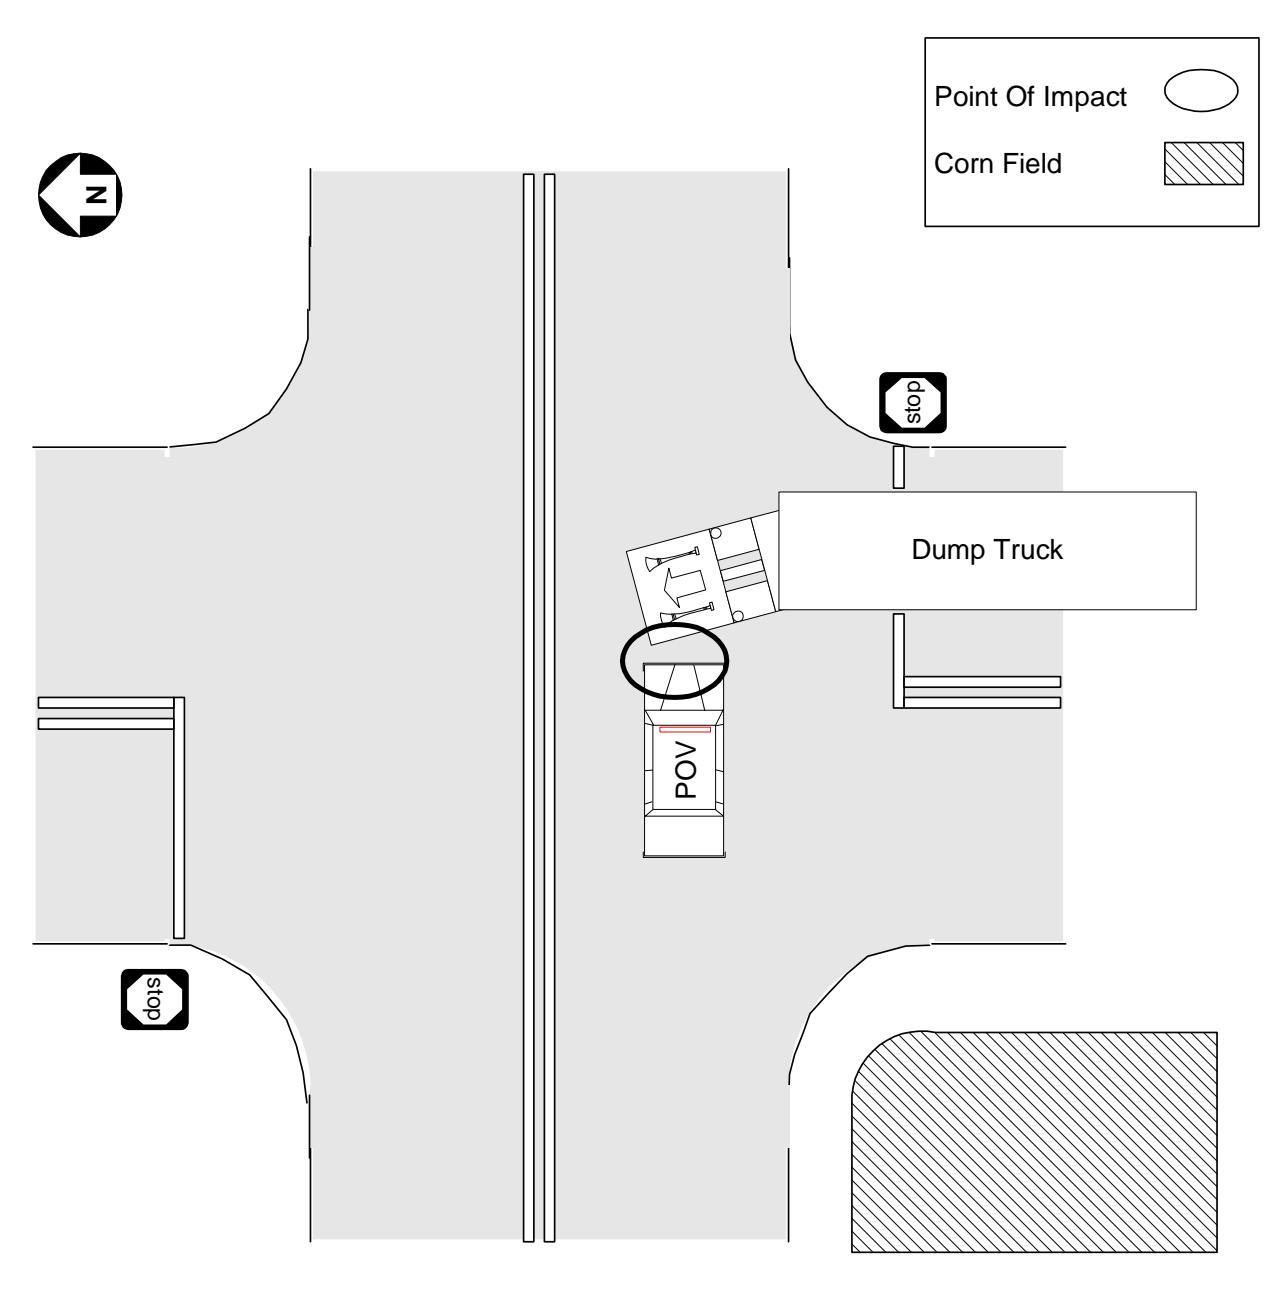
Figure 2. Vehicles Involved

roadway, the victim may not have seen the truck until the collision. The victim's vehicle struck the dump truck's front axle, and the victim was killed instantly. At 0702 hours, the driver of Engine 81 informed Central Dispatch of a motor-vehicle incident at an intersection near the fire station which involved a tandem dump truck and the POV of a fellow fire fighter. After approximately 40 minutes of extrication, the victim was removed from the vehicle and was pronounced dead at the scene by the local coroner.
