**Jim Walter Resources # 5 Coal Mine Disaster**

**September 23, 2001;**

*A United Mine Workers of America Report*

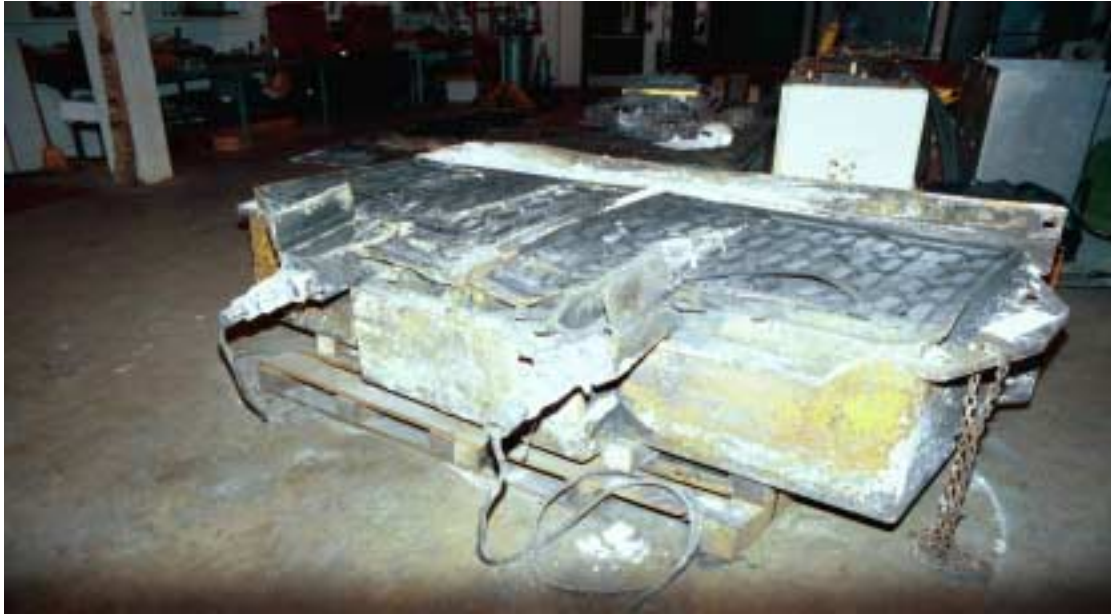
Pictured below is the Douglas Battery recovered from the roof fall on No. 4 section. It is believed to be the ignition source of the first explosion.

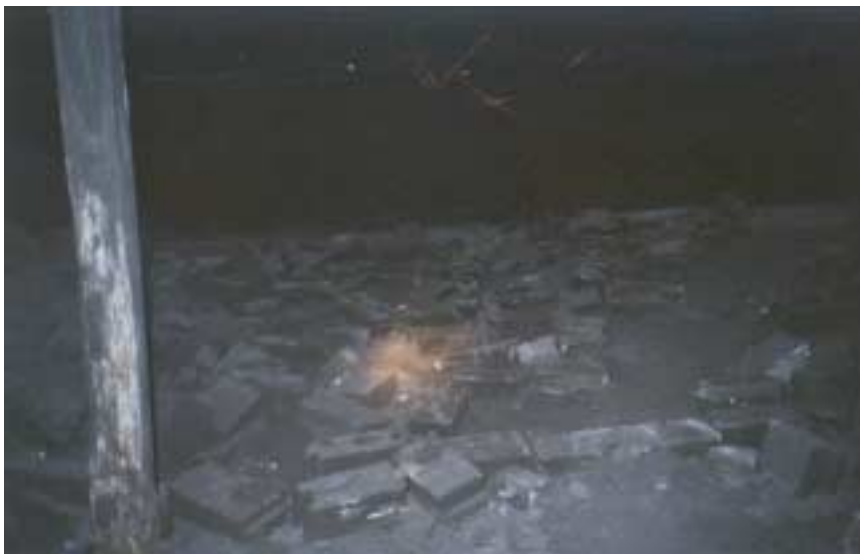
**Figure 1:**  
Concrete block blown from a  
stopping between #1 and #2 entry,  
taken from the #2 entry at spad  
#13295.

**Force Damage – After Second Explosion** - Visual effects of force were detected throughout No. 4 section. The force affected all ventilation controls on No. 4 section inby spads #12833, 12841, 13039, and 13048. This included impact on 28 stoppings or brattices, two regulators, one point feed regulator, run through drops and line curtain. All but two were completely removed and destroyed. (Figure 1).

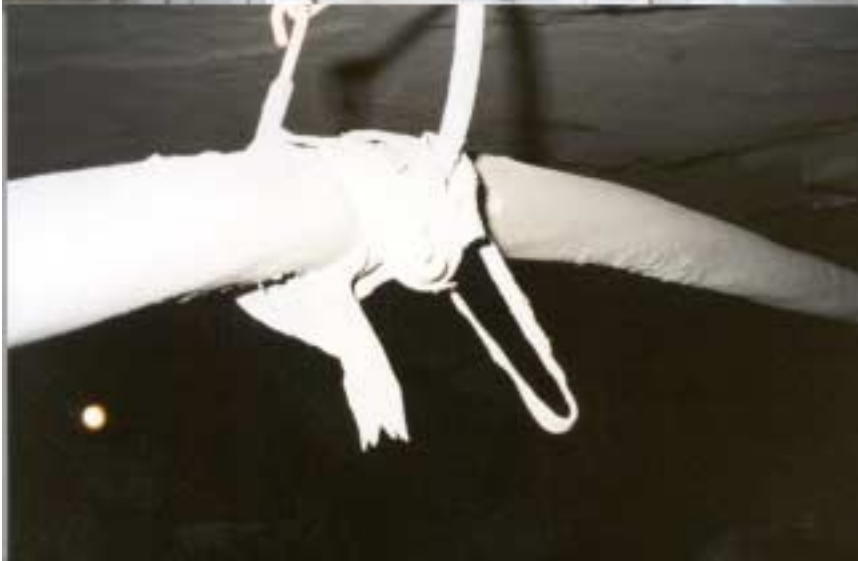
**Figure 26:** Located at the left outby rib corner at spad #13231 in the #2 entry. Picture is of a “J”hook and shielding melted into high voltage cable.

The most visible signs of coking on the roof and ribs of the No. 4 section were found in the last open crosscut between spad #13352 (#2 entry) and spad #13353 (#3 entry), (Figure 32), and inby the last open crosscut in the #3 entry. (Figures 34 and 35). Evidence of heat damage on No. 4 section is depicted in Figures #26 through #38. Damage from the heat of the explosion was identified as far outby in the mine as 3 East turnout at spad #12286
