# **REVELATIONS FROM A SINGLE STRONG-MOTION RECORD RETRIEVED DURING THE 27 JUNE 1998 ADANA (TURKEY) EARTHQUAKE**

**Mehmet Çelebi**  
**Research Civil Engineer, Earthquake Hazards Team**  
U.S. Geological Survey, MS 977,  
345 Middlefield Rd., Menlo Park, CA 94025  
[Tel; 650-329-5623, Fax: 650-329-5163, e-mail: celebi@usgs.gov]

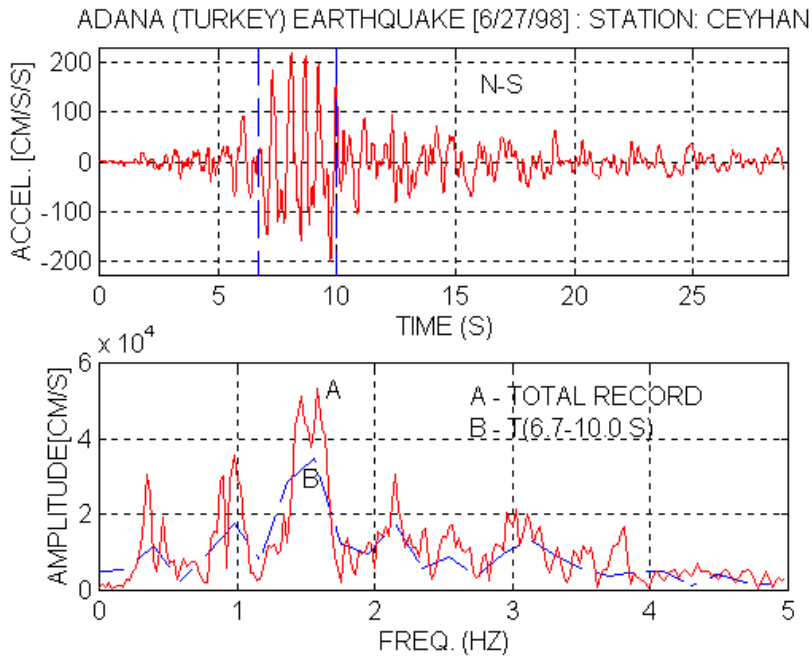
Figure 5. North-South component of the Ceyhan main-shock record and amplitude spectra.

Figure 4 shows the NS and EW acceleration and the normalized cumulative energy variation with time. Particularly for the NS component, it is seen that between 6.7 – 10.0 time frame, approximately 65 % of the shaking energy takes place within about four, relatively harmonic excursions. The rate of increase in energy is decreasing after about 10 seconds. However, the strong shaking within this time frame must have been quite damaging to those structures with 0.5-0.7 second fundamental periods. Figure 5 shows the NS component and its Fourier amplitude spectra calculated using the total record and the band between 6.7-10 seconds. The signal within that time-band exhibits the same peaks and significant percent of the amplitude (>50%) as that from the total time band.
