Surface Haulage Accidents...

...Ways to Prevent Them

MSHA's investigations of surface haulage accidents reveals two key points:

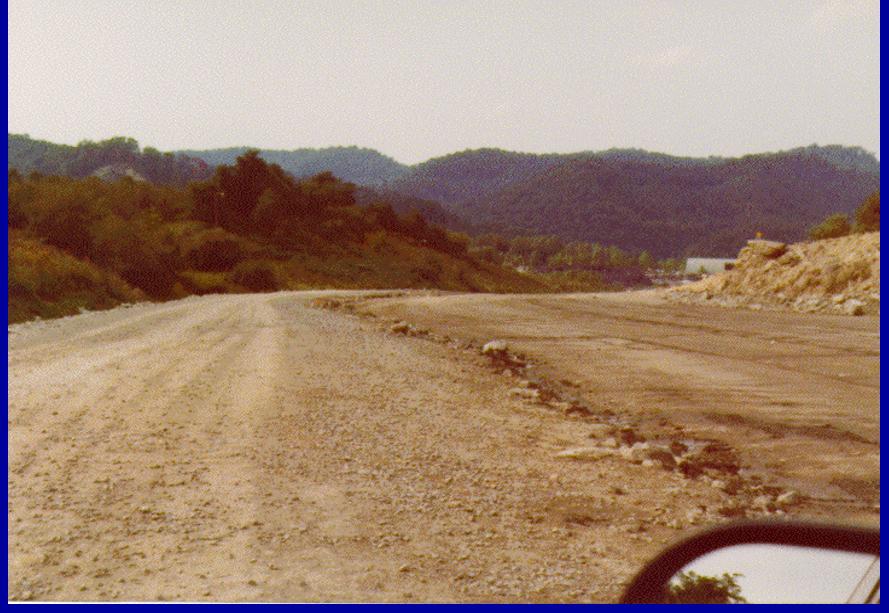
Example of a fatal haul-truck accident: The operator of this 170-ton capacity haul truck was killed when his truck went out of control as he descended an 8-percent grade.

The contract truck driver had 22 years of experience. At the end of a 4-mile long haul, he was descending this grade to the dump point just around the curve. It was his fifth haul of the shift.

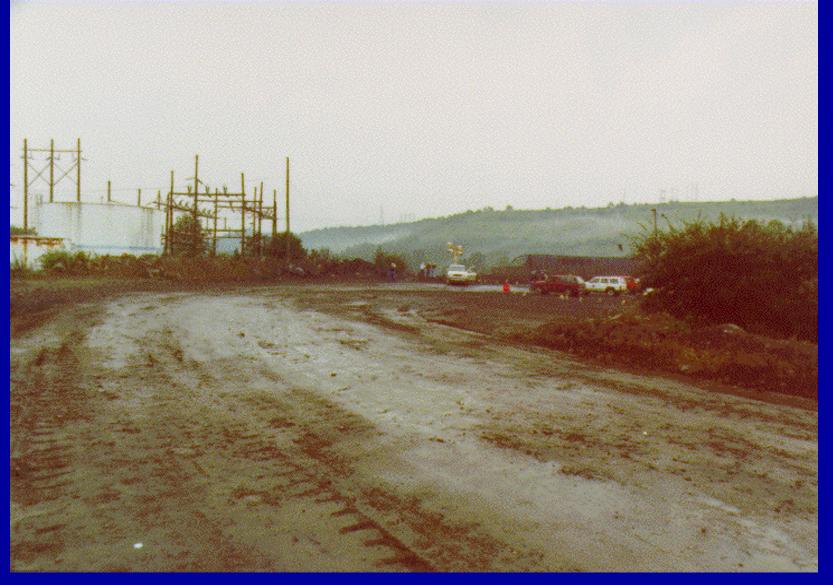
A witness reported that as the truck was descending the grade it appeared to be going at an excessive rate of speed and flames were coming out of the rear wheels. The truck failed to make the curve to the right and left the road at the point where the white truck is parked facing the camera.

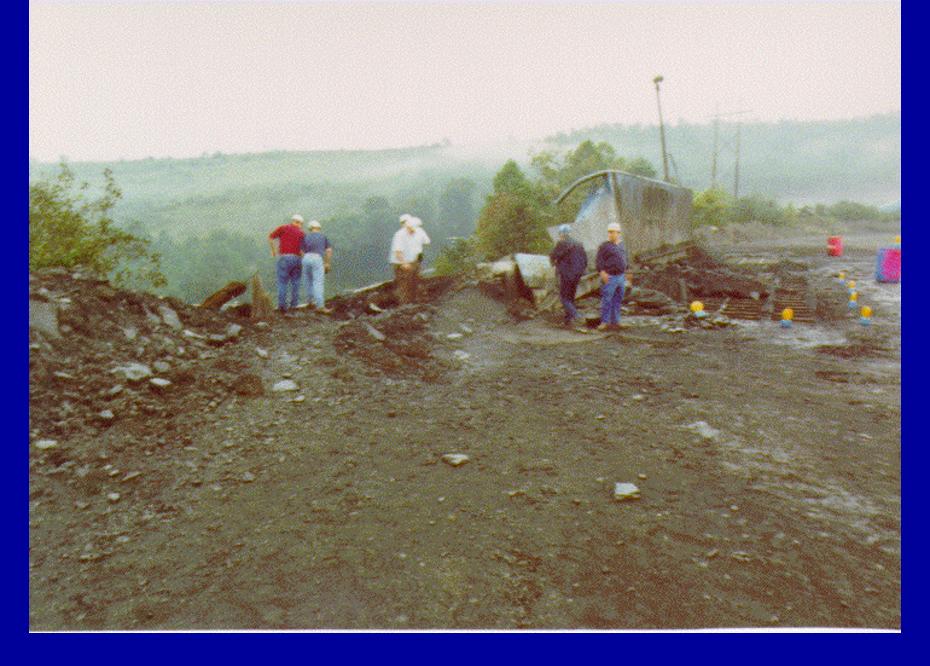
This is a close-up view of the area where the truck left the haul road...

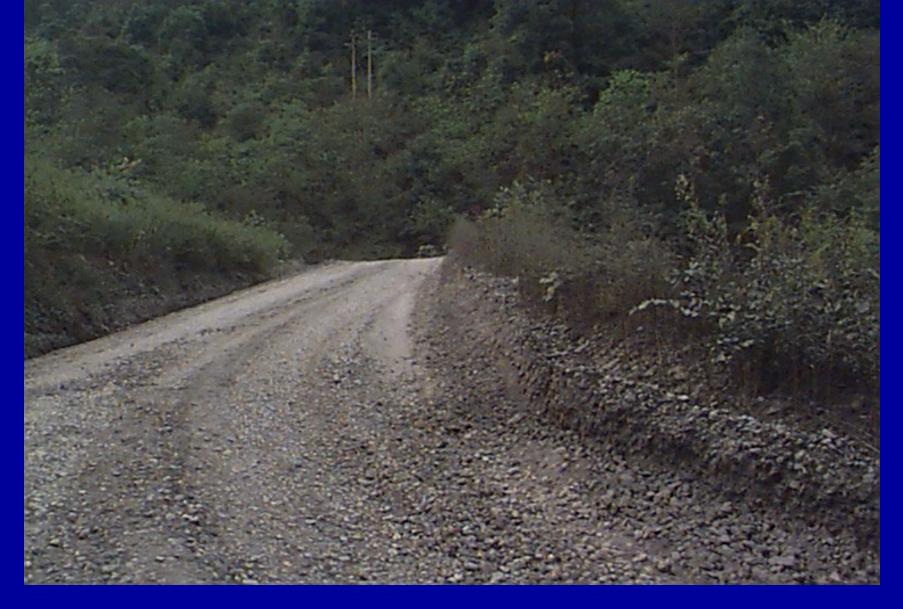
This is the site of another fatal truck accident. The truck was hauling mine waste on a haul road with six switchbacks. The grade of the road varied from 9 to 19 percent.

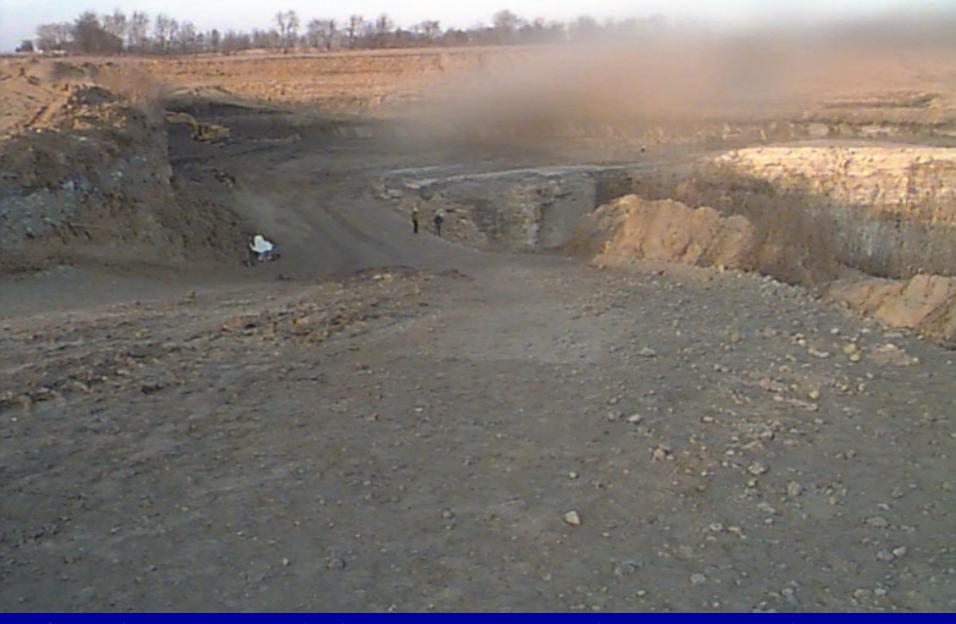
A fatal accident occurred at this mine when a scraper was hauling overburden up this ramp. The ramp was 320 feet long at a grade of 17%. The ramp runs along the top of a highwall.

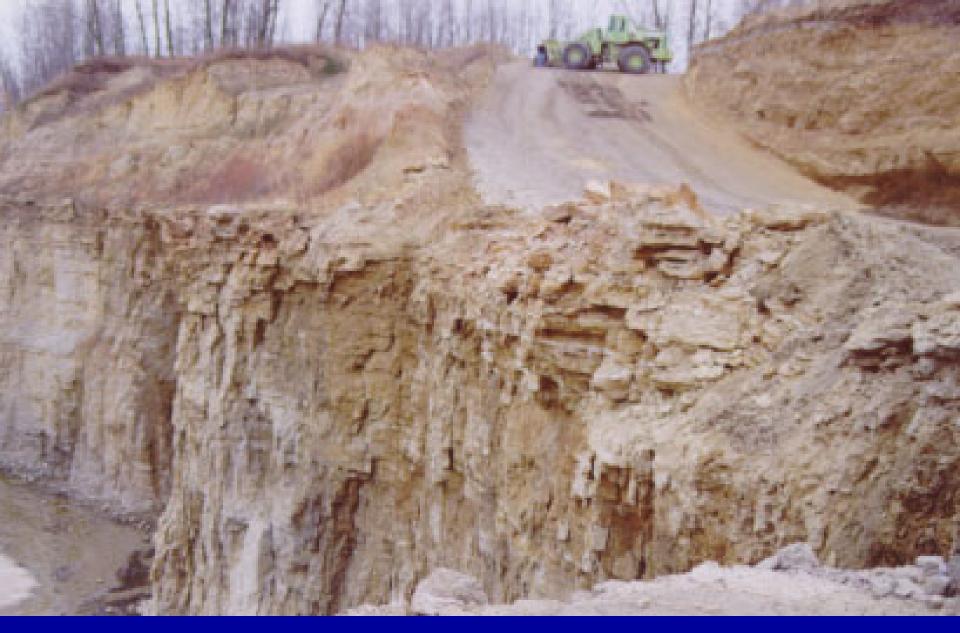
The mine uses a left-hand traffic pattern in this area.

As the scraper neared the top of the ramp it stalled and rolled backwards.

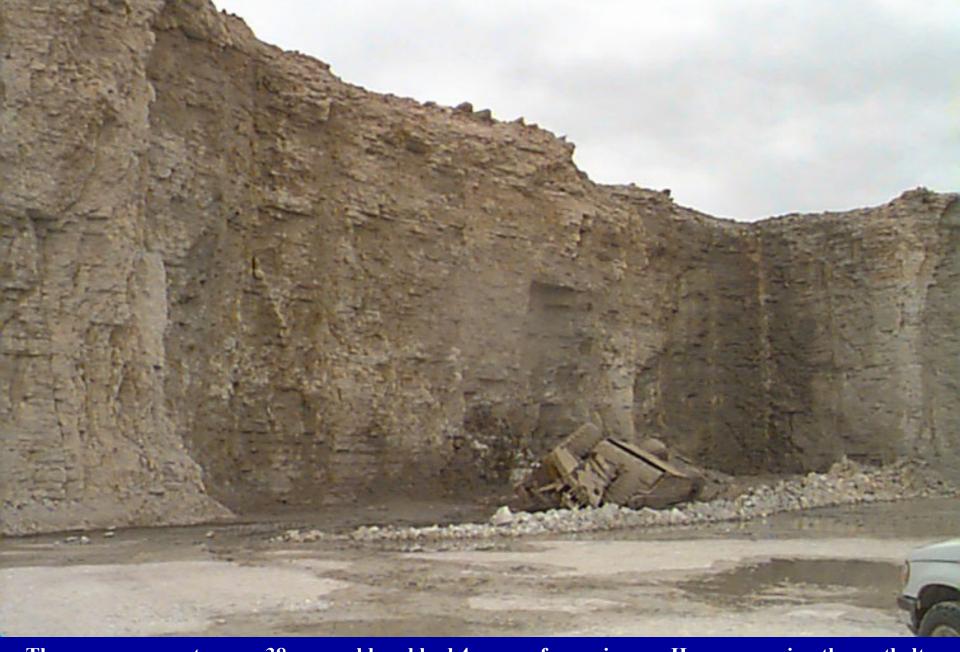
The scraper operator was 38 years old and had 4 years of experience. He was wearing the seatbelt.

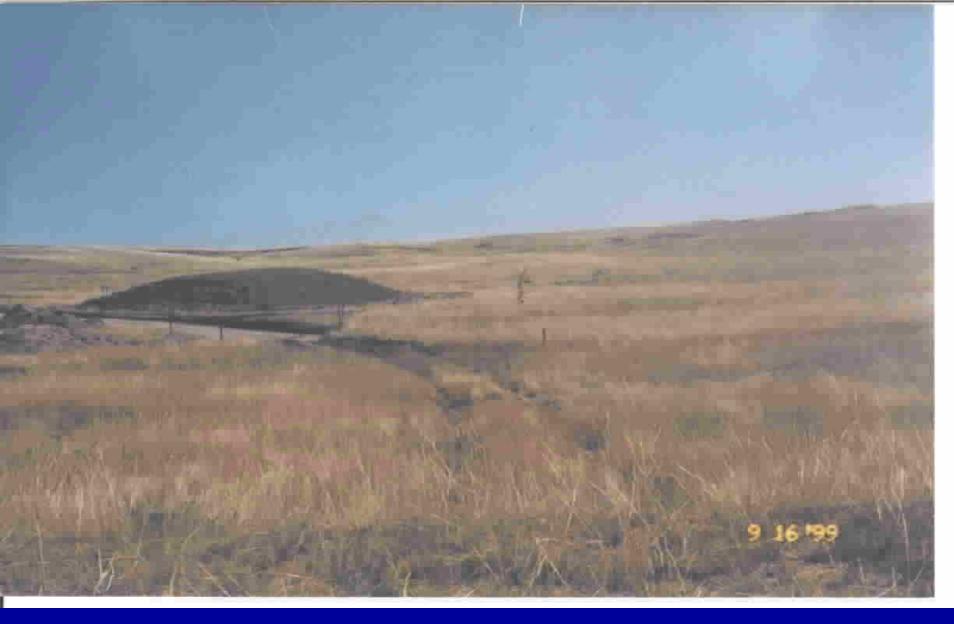
In this case a water truck went out of control while descending a 1000-foot long section of haul road on a 10% grade. The truck missed a curve at the bottom of the grade and ran across this field. This could have been a fortunate circumstance, but unfortunately...

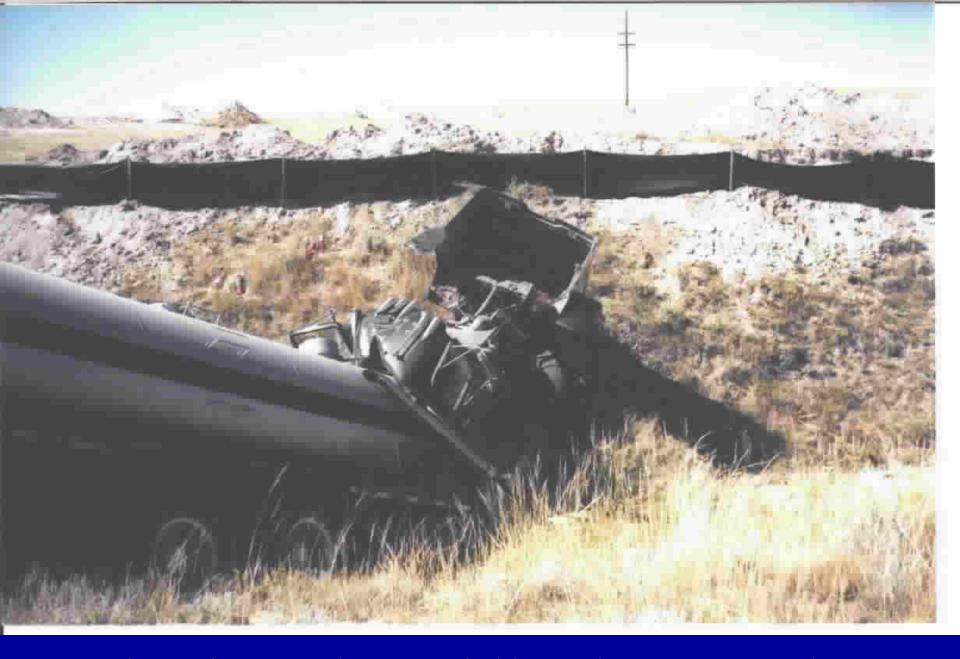
The truck driver was 37 years old with one year of driving experience. He was not wearing a seatbelt.

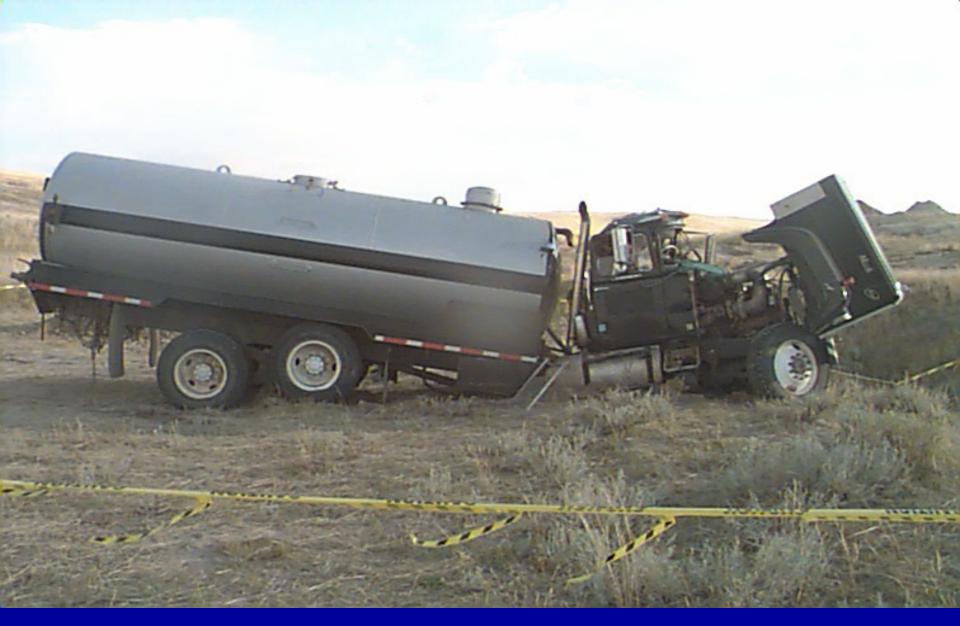
The point here is that if the truck hadn't run into the ravine - if the truck had lost its momentum rolling through the field or otherwise been brought to a controlled stop - the operator may have survived this accident unharmed.

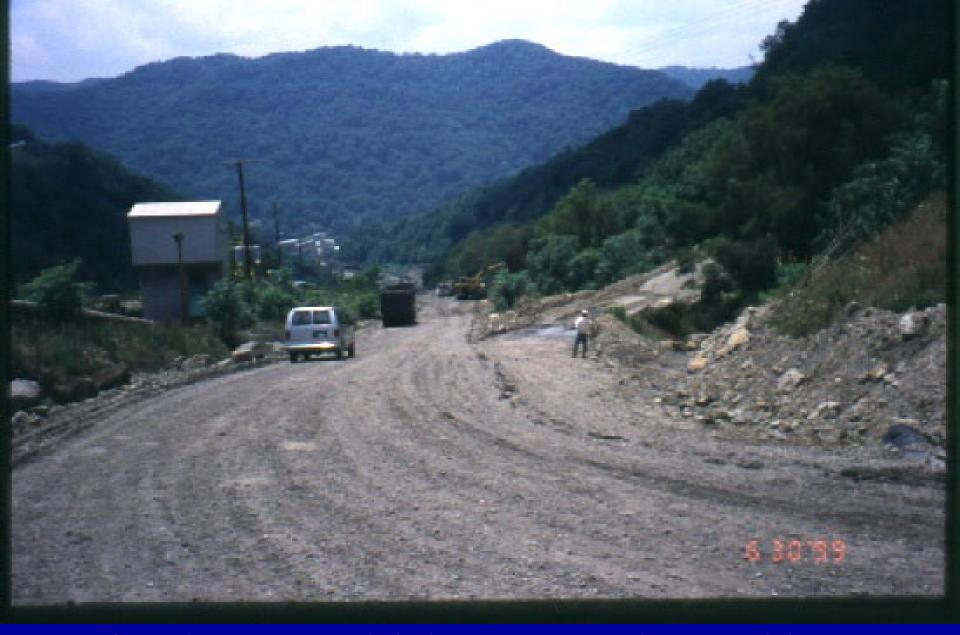
When a fatal accident occurred at this site, it was only the second time that the victim had driven down this haul road and the first time in the particular model truck. The road had an 18 % grade.

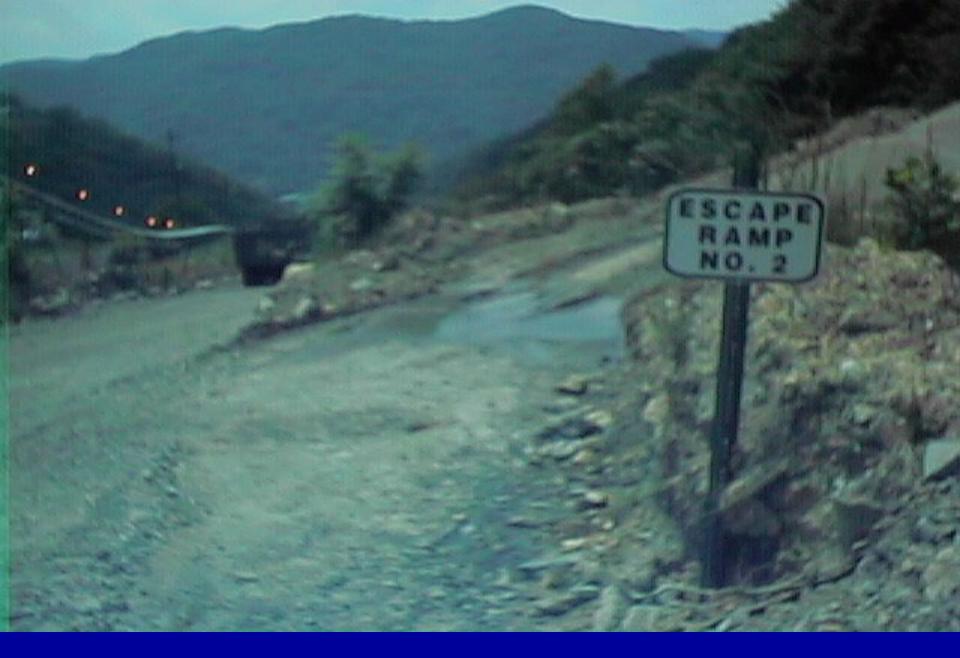
Three runaway-truck escape ramps had been constructed on the steep grade as a safety measure.

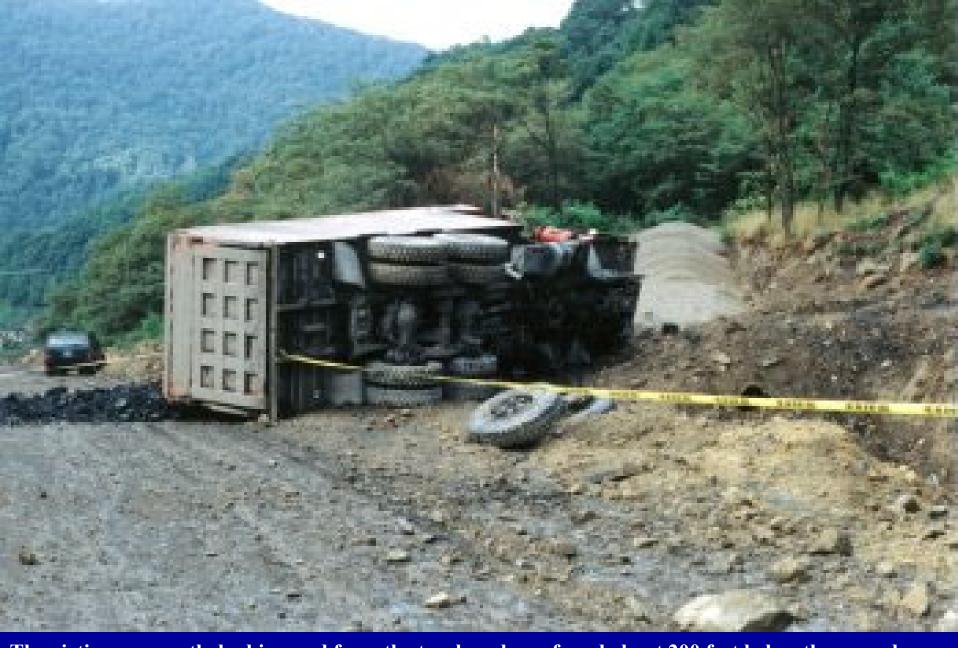
The victim apparently had jumped from the truck and was found about 200 feet below the second escape ramp. The truck went into a ditch and ended up on its side near the third escape ramp, which can be seen to the right of the truck. This ramp was 350 feet below the second ramp.

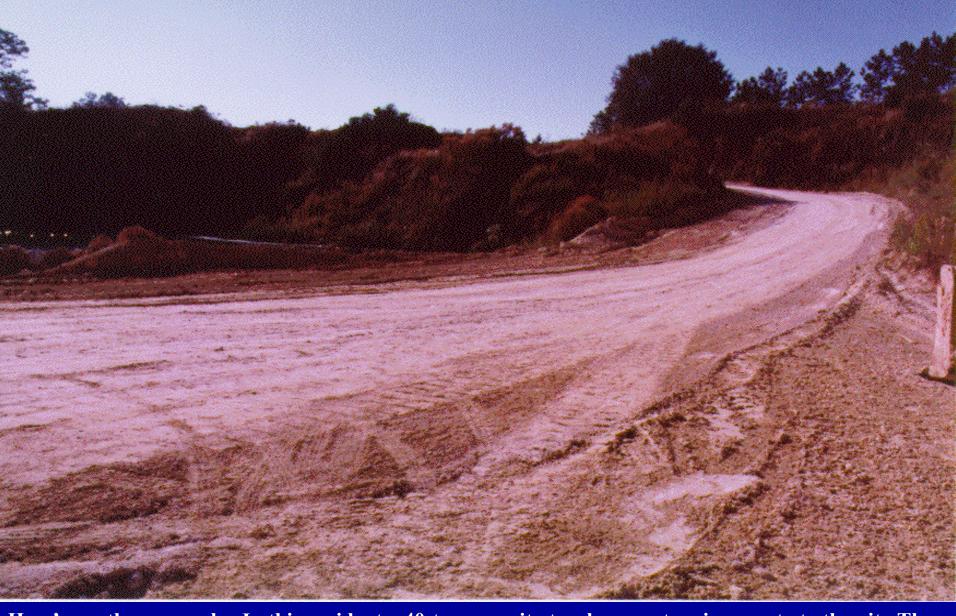
Here's another example. In this accident a 40-ton capacity truck was returning empty to the pit. The truck was descending this 10 percent grade and negotiating the curve when a mechanical problem with the truck caused it to continue turning to the right where it plunged into a pond.

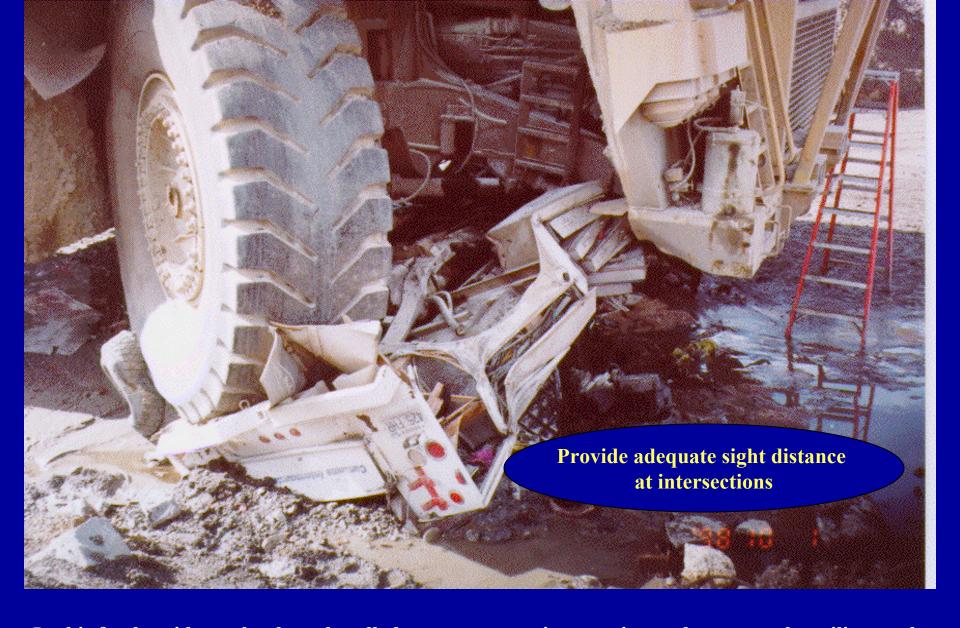
In this fatal accident a haul truck pulled out to cross an intersection and ran over the utility truck.

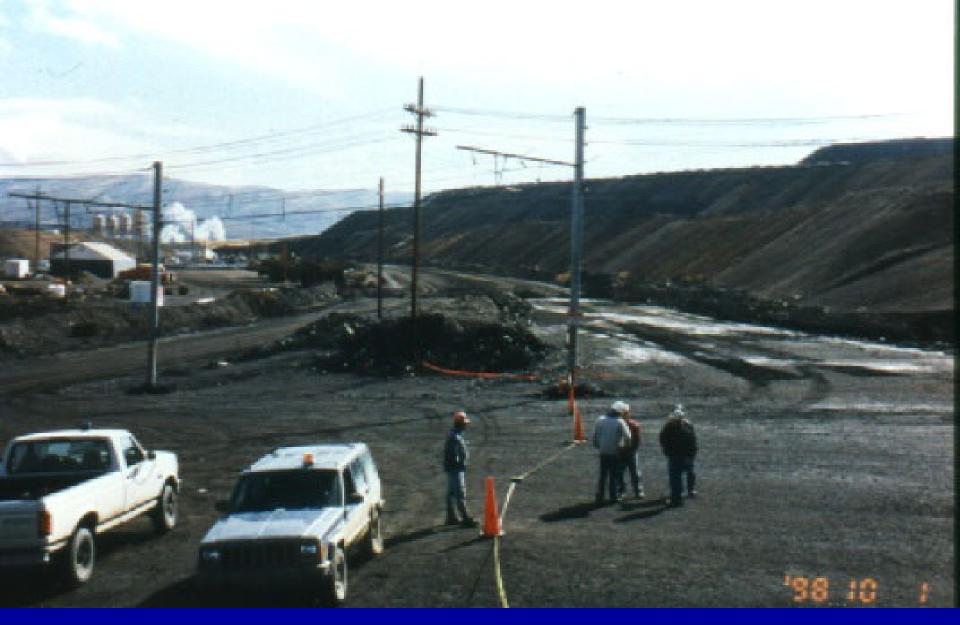
Here's the actual intersection. The main road runs from left to right across the front of the picture. The haul truck would have approached and stopped near the right side of the picture.

Intersections should be laid out keeping this right side blind spot in mind. Avoid intersections at angles of less than 90 degrees to the truck's right side. Layout intersections to provide the drivers with as much sight distance as possible.

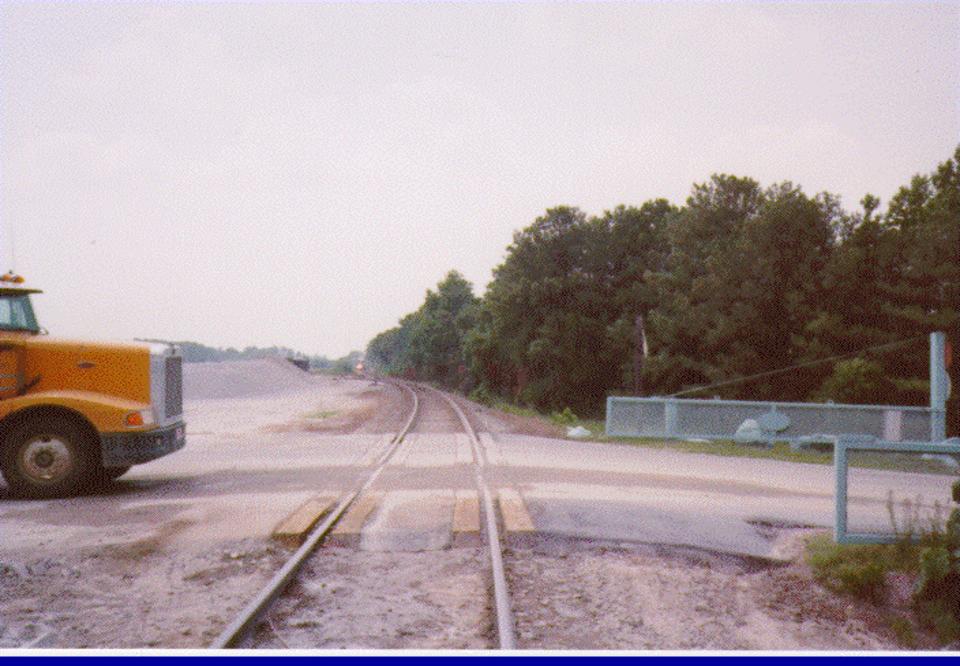
At this crossing, a 44 year old driver was killed when her truck was struck by a train. She had 15 weeks of experience.

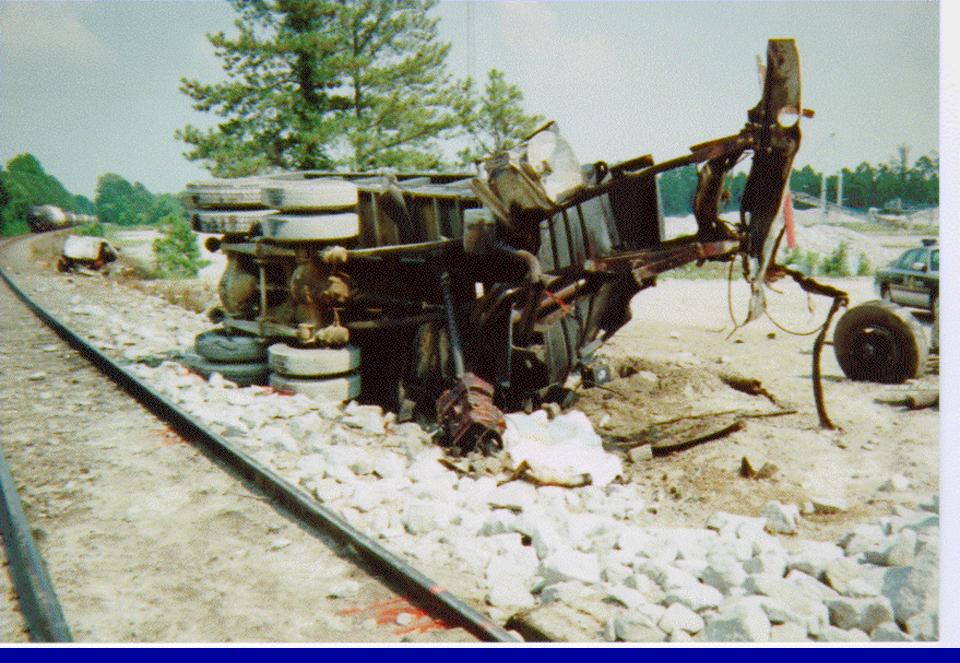
The accident occurred at 1:40 p.m. Other workers heard the train whistle, but the victim did not stop her truck at the crossing.

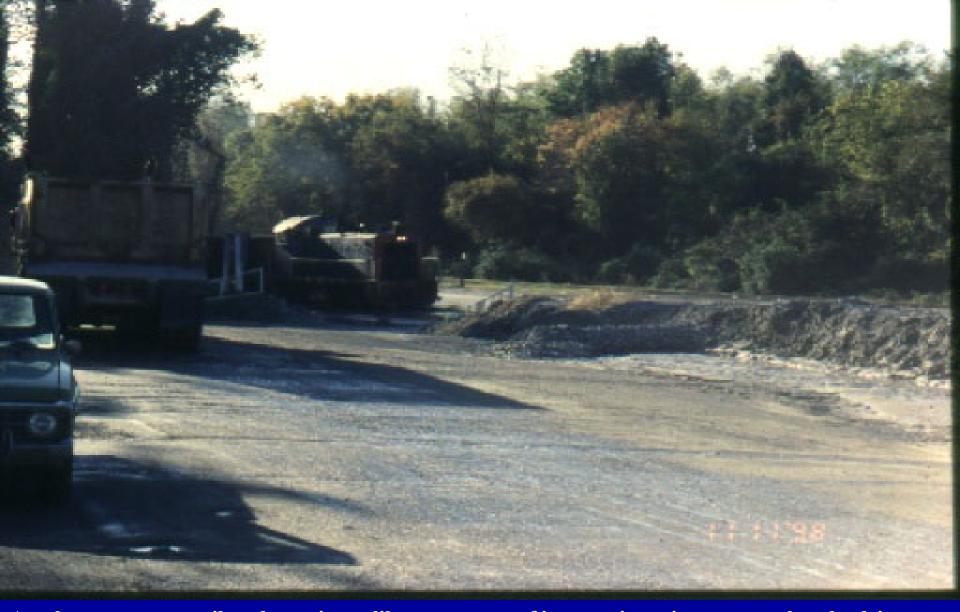
Another concern at railroad crossings - like at any type of intersection - is to ensure that the drivers have adequate sight distance down the tracks. Also avoid situations where trucks leaving mine property and waiting to enter a highway may become backed up and be sitting on the tracks. If this situation can't be avoided, train the drivers about the dangers and provide warning signs.

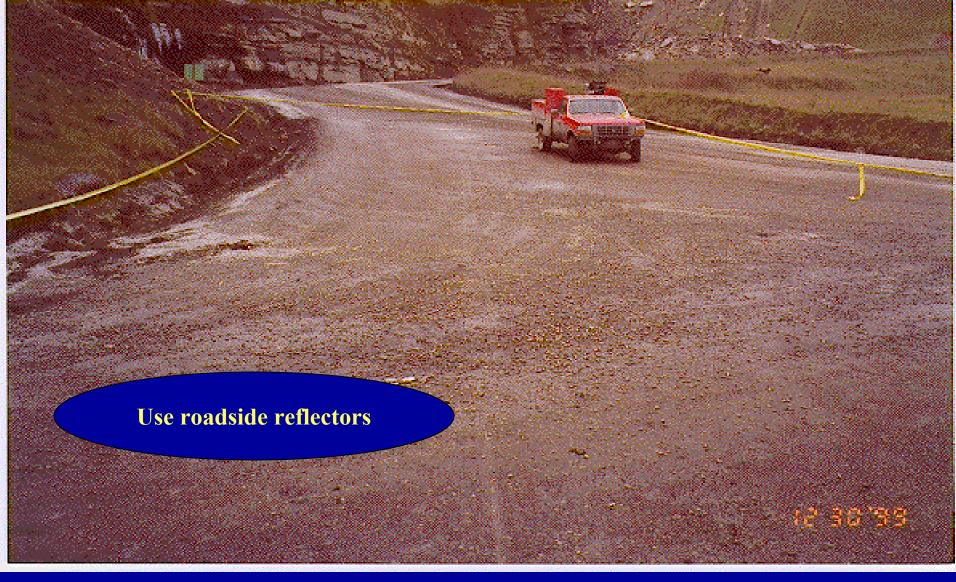
A fatal accident occurred in at this site involving a 10-ton welding truck. The welding contractor was leaving mine property around midnight. He came down this 10 percent grade to a "T" intersection. Note the skid marks coming across the intersection.

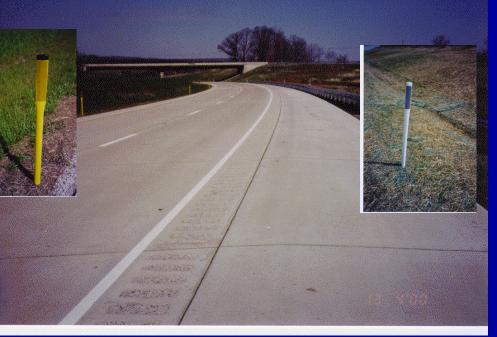
As shown to the left, road side reflectors are a common safety feature on public highways.

- Road side reflectors can provide similar safety benefits on mine roads. They would be helpful for new employees and visitors on the property. And they would benefit older drivers since our ability to see at night diminishes as we age.
- Different colored reflectors could also be used on each side of the road to act as a reminder on "drive-left" properties.

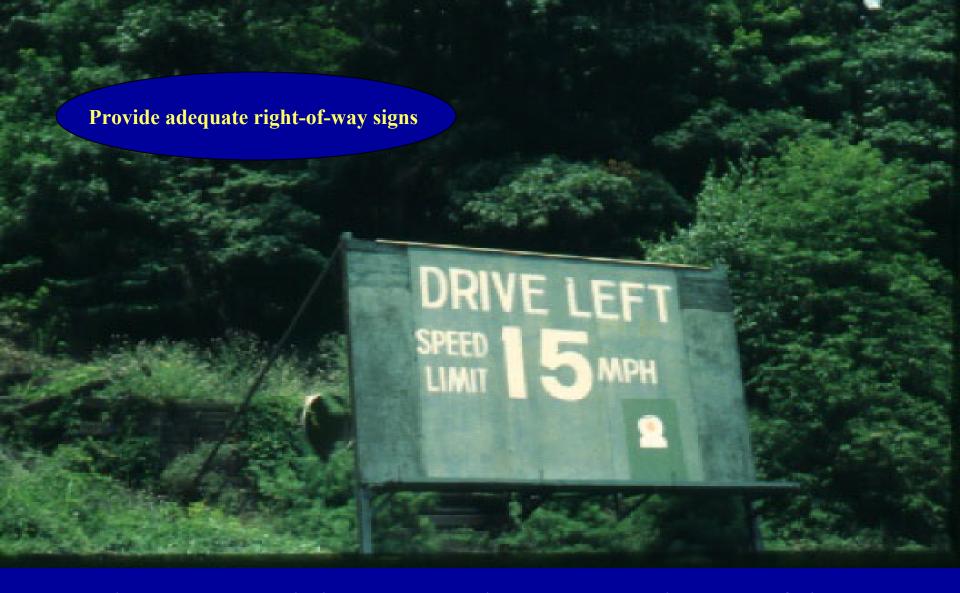
Suppose a tire salesman sees this sign as he enters mine property and drives on the left side as he makes his way to the maintenance shop. As he gets back in his truck after spending a couple of hours at the shop will that salesman remember to drive left as he leaves the property? Make sure there are sufficient signs for this type of circumstance - especially when unusual right-of-way rules are used on the property.

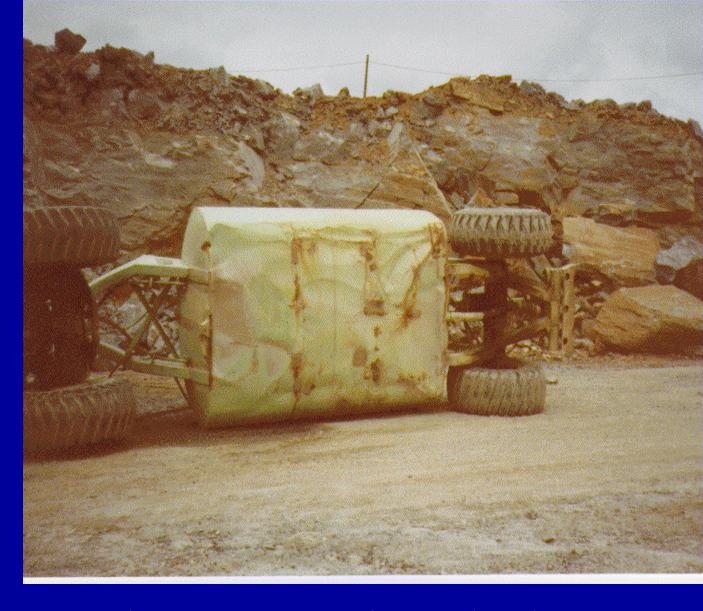
A witness reported that the truck appeared to be "going too fast" as it rounded the curve.

The victim was not wearing the seatbelt and the rear brakes were found to be defective.

Avoid water-truck accidents by ensuring that: water trucks receive preventive maintenance just like production equipment; water tanks are baffled to control the effects of the water movement in the tank; and water-truck drivers are properly trained on operating the truck.
