Fort Point National Historic Site
Golden Gate National Recreation Area

Abbreviated Fort Point Historic Structure Report

September 2006

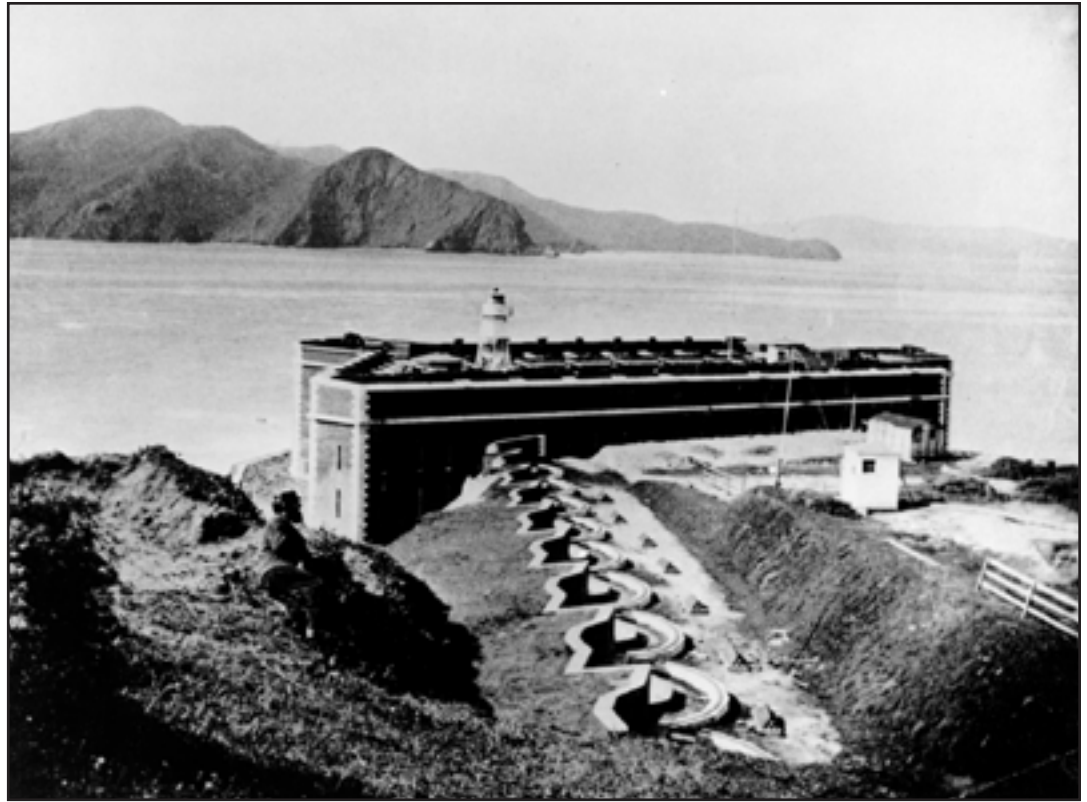
Figure 5. Photograph: Southwest view of Fort and 10-Gun Battery, circa 1869. The 10-Gun Battery is disarmed. Credit: Fort Point NHS Collection, Golden Gate National Recreation Area.

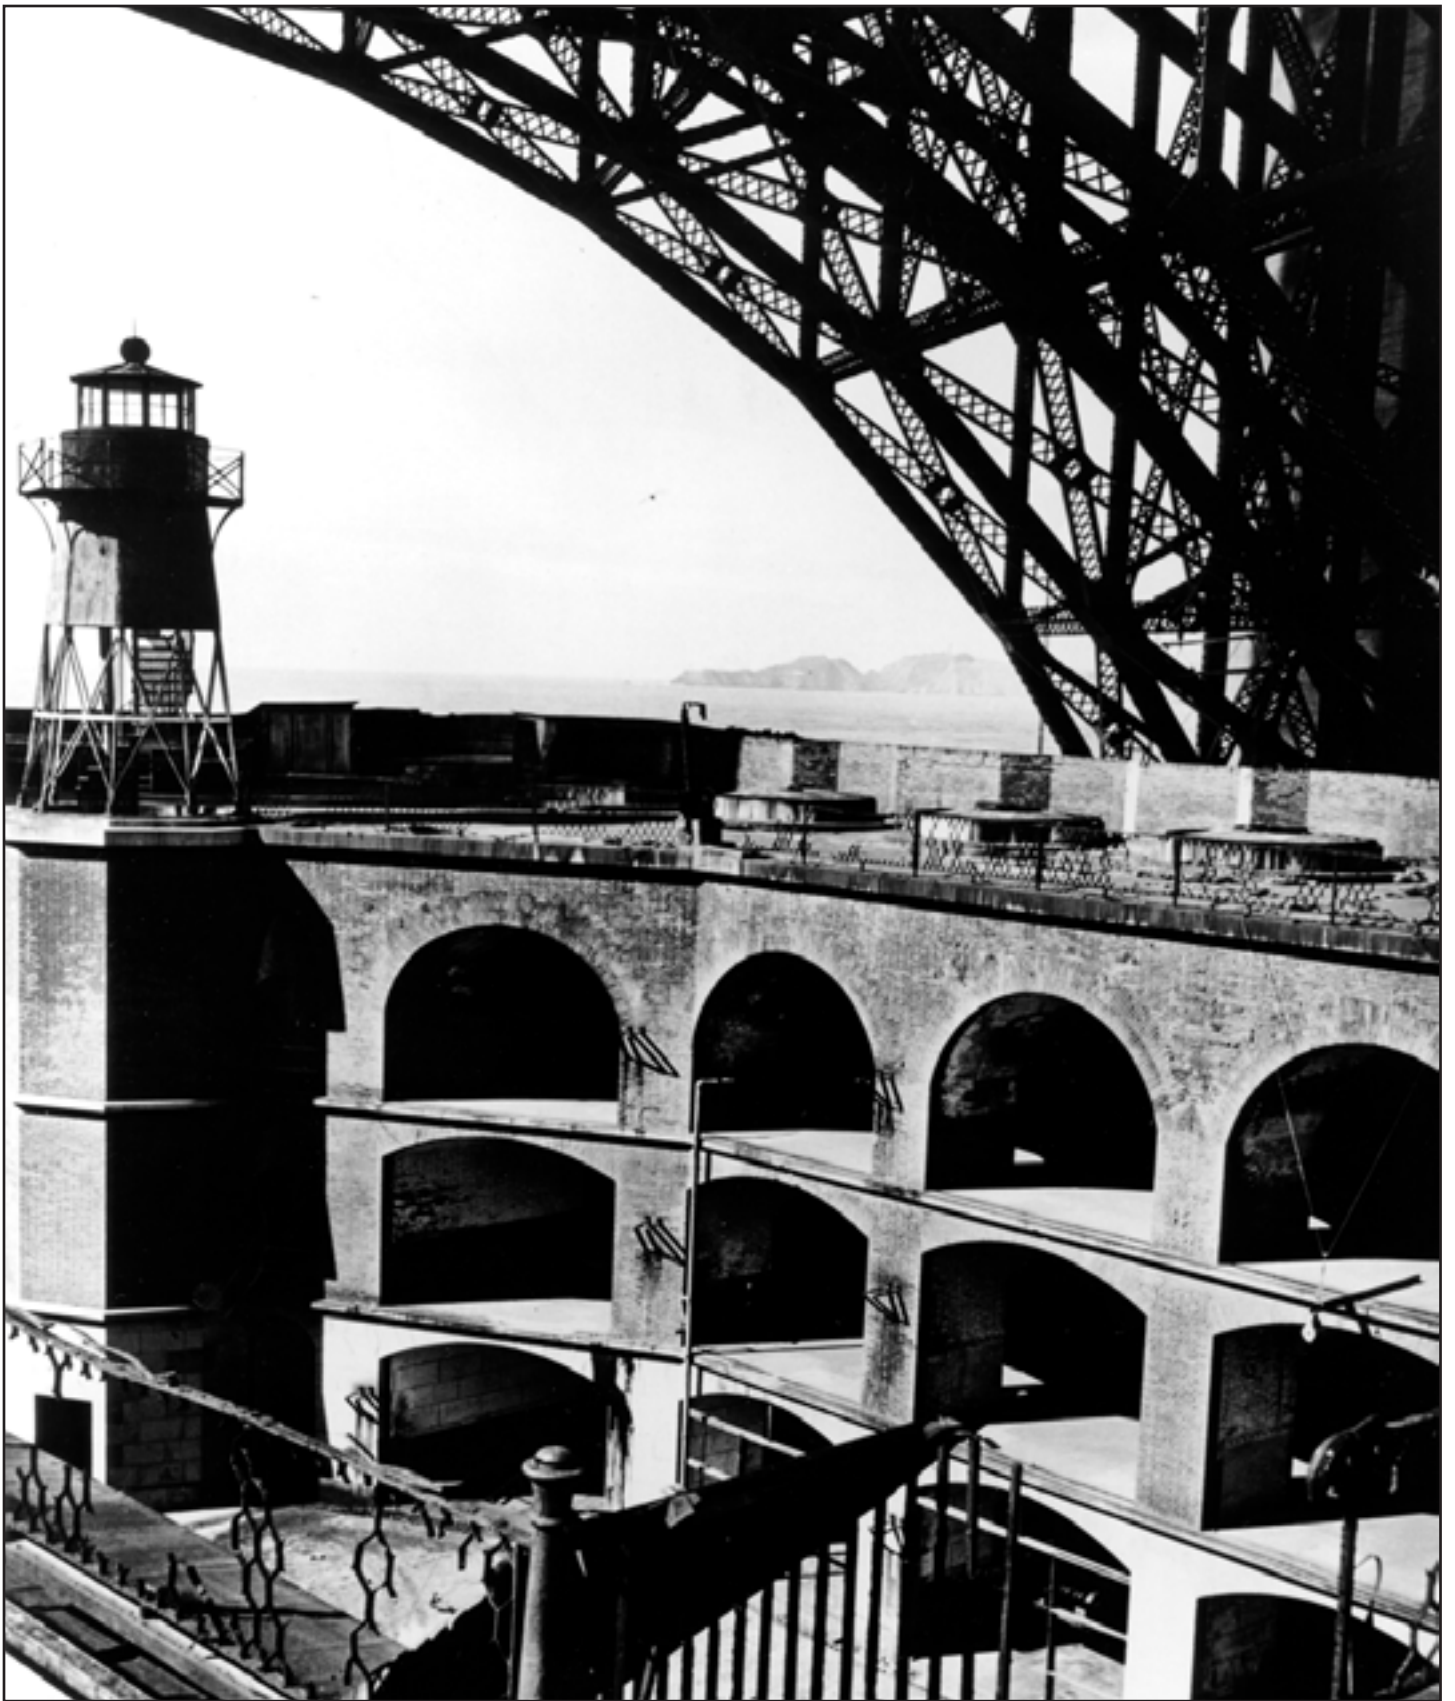
One of San Francisco's best potential tourist attractions is badly in need of a friend... [Rust lay] in great scales on the barrette pintles on the parapet. Rust had eaten the ironwork railings. The seaward side and outer walls...are pocked and pitted by nearly a century of attack from the sea (figure 19).¹

Figure 19. Photograph: Fort, viewed from Southeast corner of barrette, circa 1947. Credit: Fort Point NHS Collection, Golden Gate National Recreation Area.

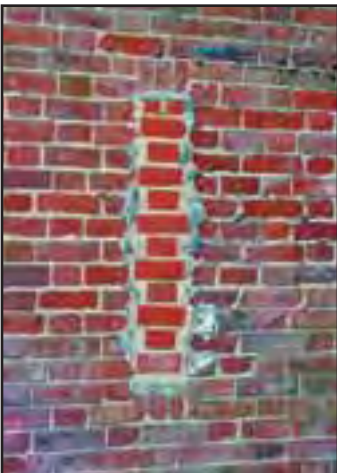
This 13 ft wide elevation has two rifle slit openings in it. There is a parapet with a granite coping. On the 1st tier there is the outline of a small rifle slit that was infilled with brick at some point in the past. The parapet on top shows evidence of a lateral displacement that was never corrected, but instead the opening was patched with brick. The quoins in this area are eroding and the lower quoins have parallel grooves from quarrying.

Former rifle slit on south flank filled in with brick. (Jane Lehman, 2005)

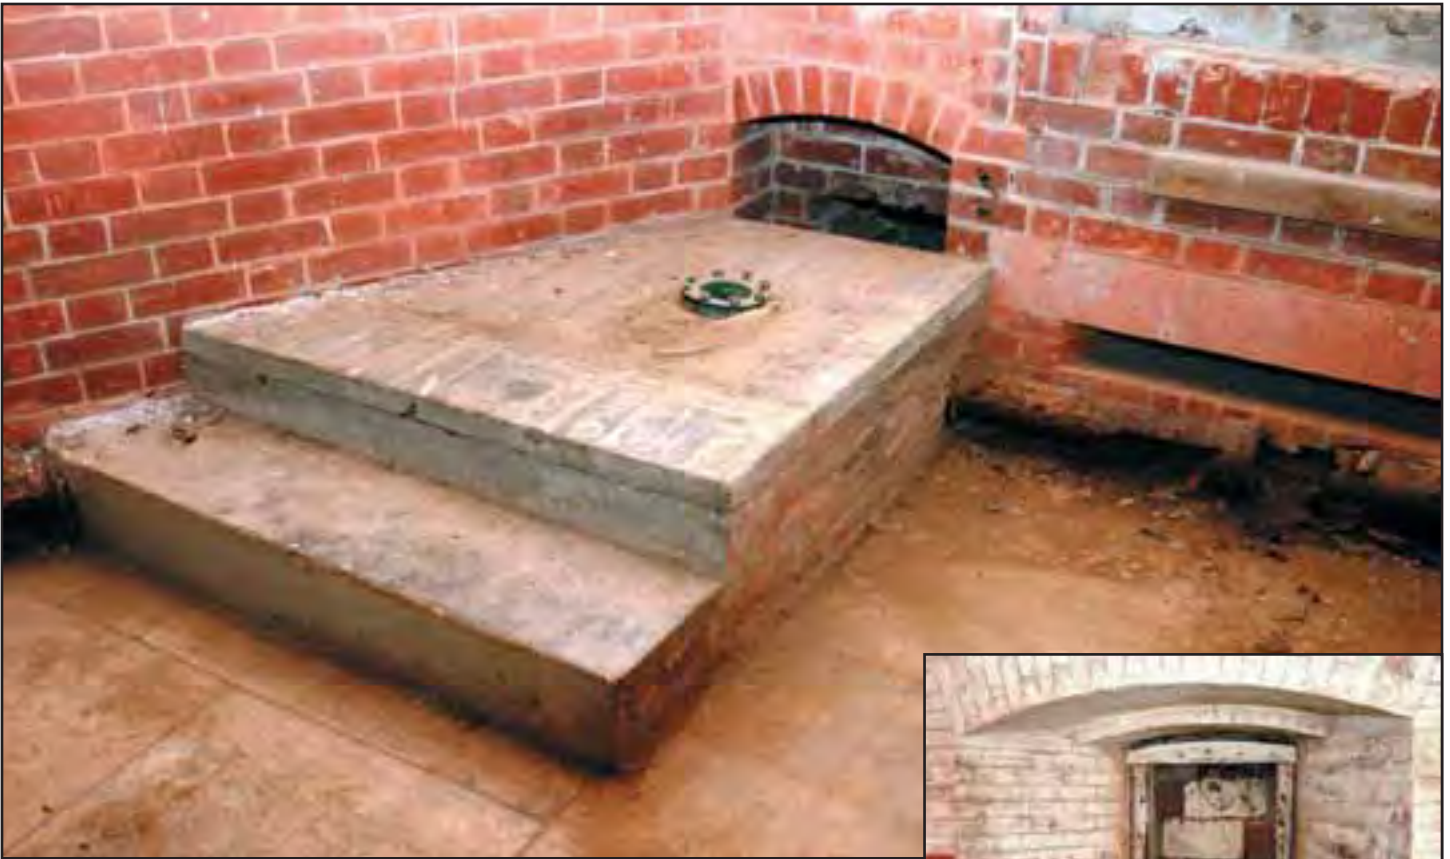
These concrete platforms for plumbing fixtures remain from the 1914 attempted remodel of the fort into a disciplinary barracks. (John Martini, 2005)

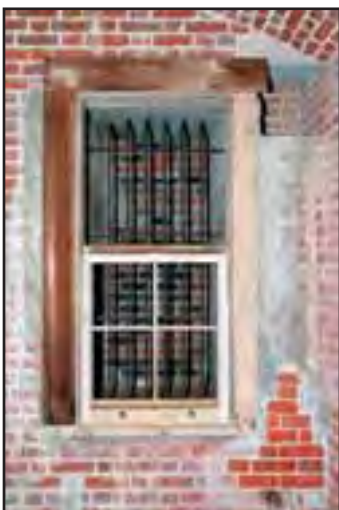
Rifle slit openings were enlarged and then bricked up leaving various building components. (John Martini, 2005)

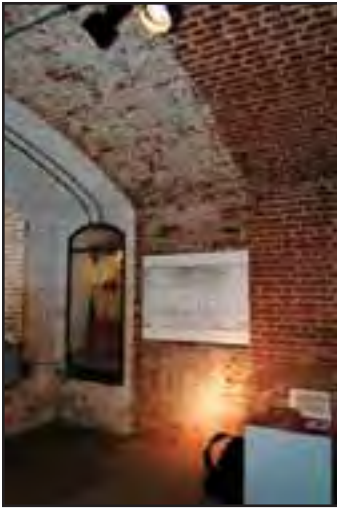
The original 4½ ft. thick wall between magazine 1 and the corridor was also removed in 1914. In this area the floor is patched with concrete and the cut bricks are visible on the walls and ceiling. Only part of the wall between magazine 1B and

Walls were removed in the magazines during the conversion of the fort to a disciplinary barracks in 1914. Half of the 4-foot thick brick and rubble wall remains at right, while only the outline of a wall remains above. (John Martini, 2005)

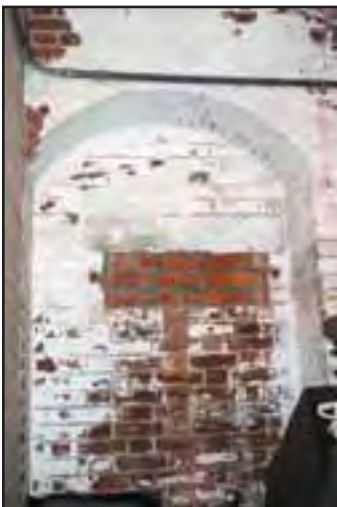
The rifle slit in the corridor of the jail area has been infilled with brick. (John Martini, 2005)

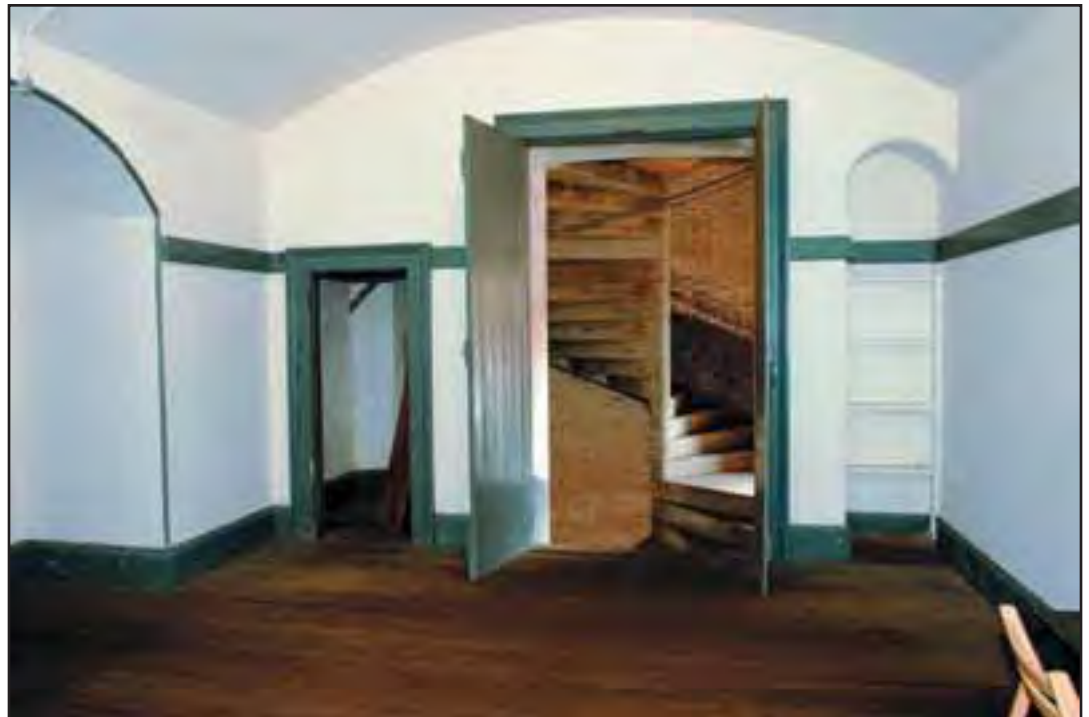
The outline of the former rifle slit is visible in all the window sills along the southwest gorge elevation. (Jane Lehman, 2005)

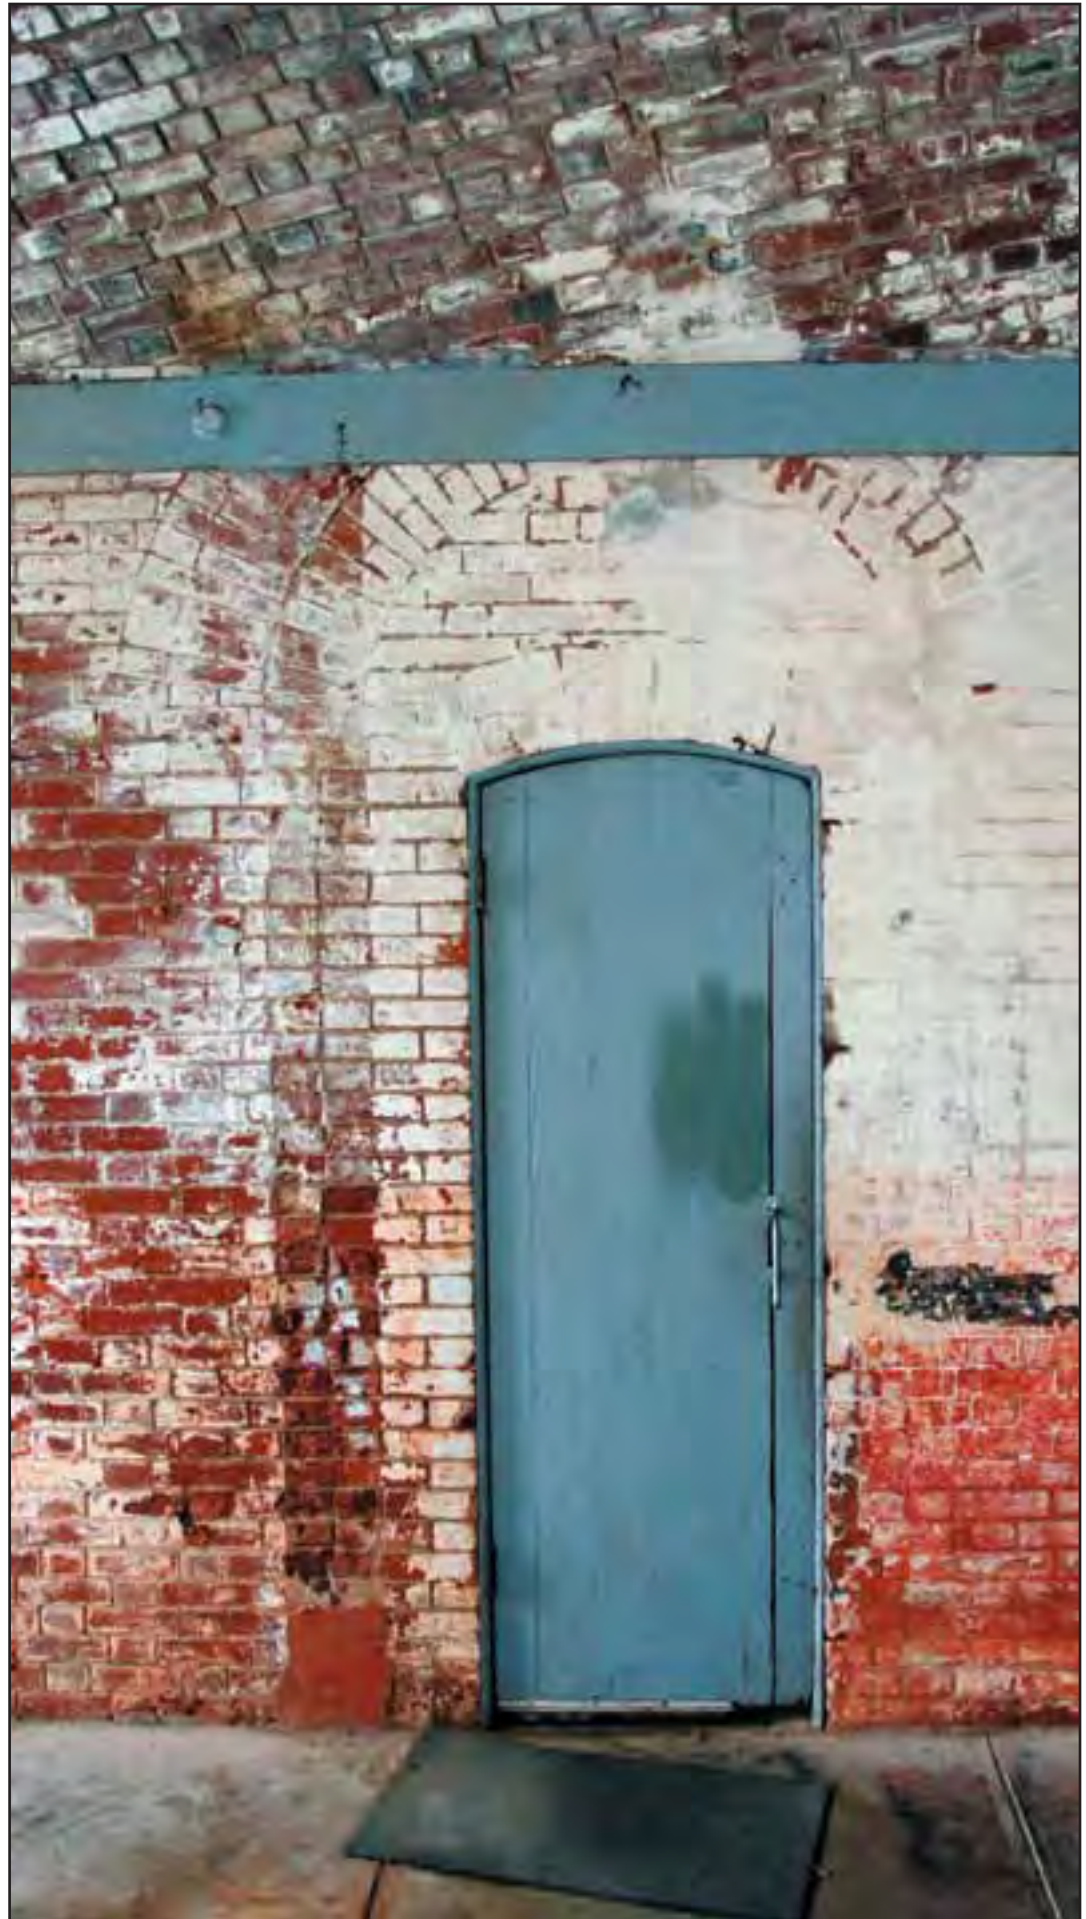
Above the door from the stores to the kitchen is a double arch in the brick. To the left of the door is the outline of one of the fort's original brick walls. The metal brack running along the wall above the door is part of the seismic reinforcing project. (John Martini, 2005)

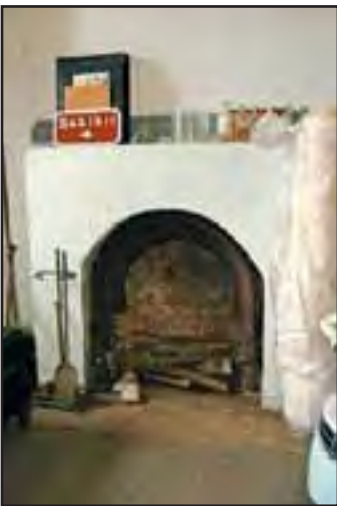
arched opening over the firebox. The bricks in the firebox are rough and appear to be carved out of the masonry wall as well. There is a remaining flue and no evidence of another flue hole in the wall above the fireplace. There is also a decorative iron insert remaining, although this is heavily rusted and broken in places.

One of the older style fireplaces in non-commissioned officer's quarters 3. (John Martini, 2005)

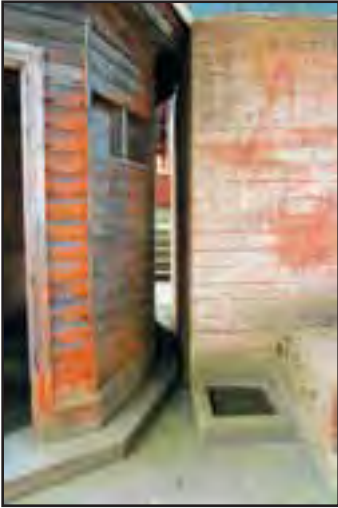
The remnants of the WWII searchlight housing are adjacent to the penthouse for stair #1. (John Martini, 2005)

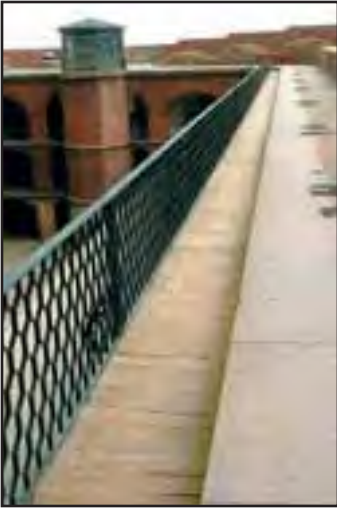
This 3-foot wide walkway and railing above the gallery on the southwest gorge elevation was replaced in a 1973 project. Beyond is the penthouse over stair #3. (John Martini, 2005)

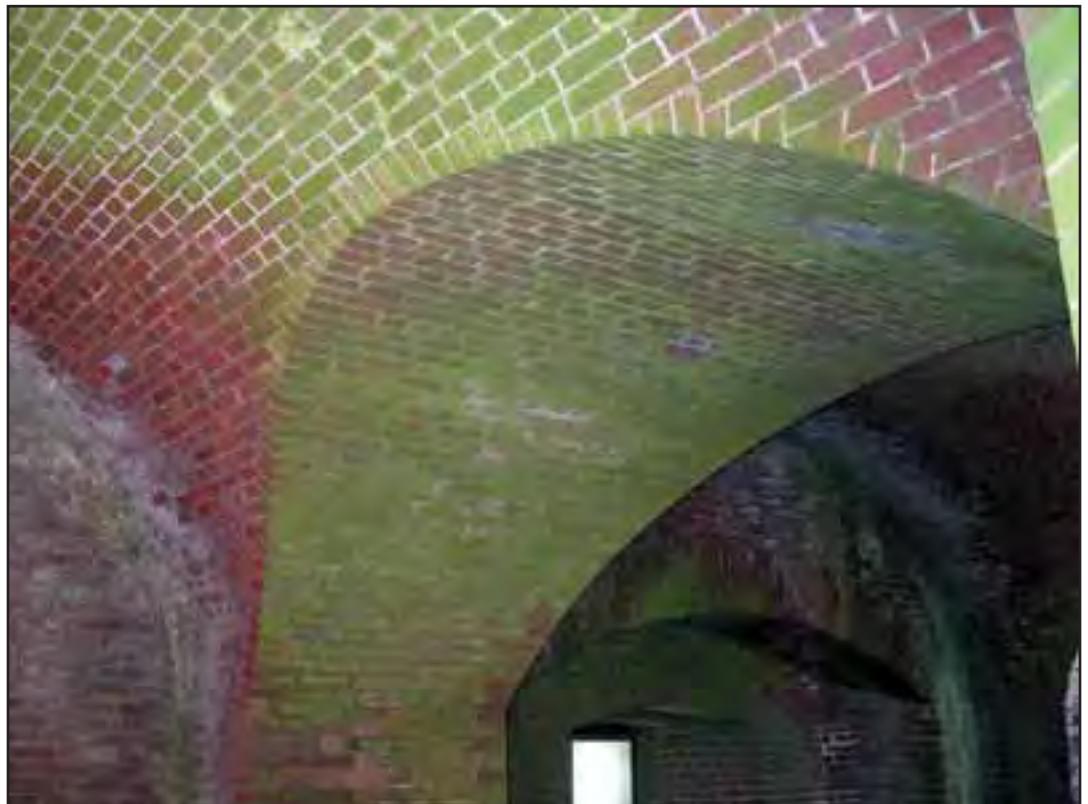
Condition Photo 3:
Casemate 101; Calcium deposits
are draining from open joints
and coating is no longer extant.
(Courtesy of ARG, 2003)

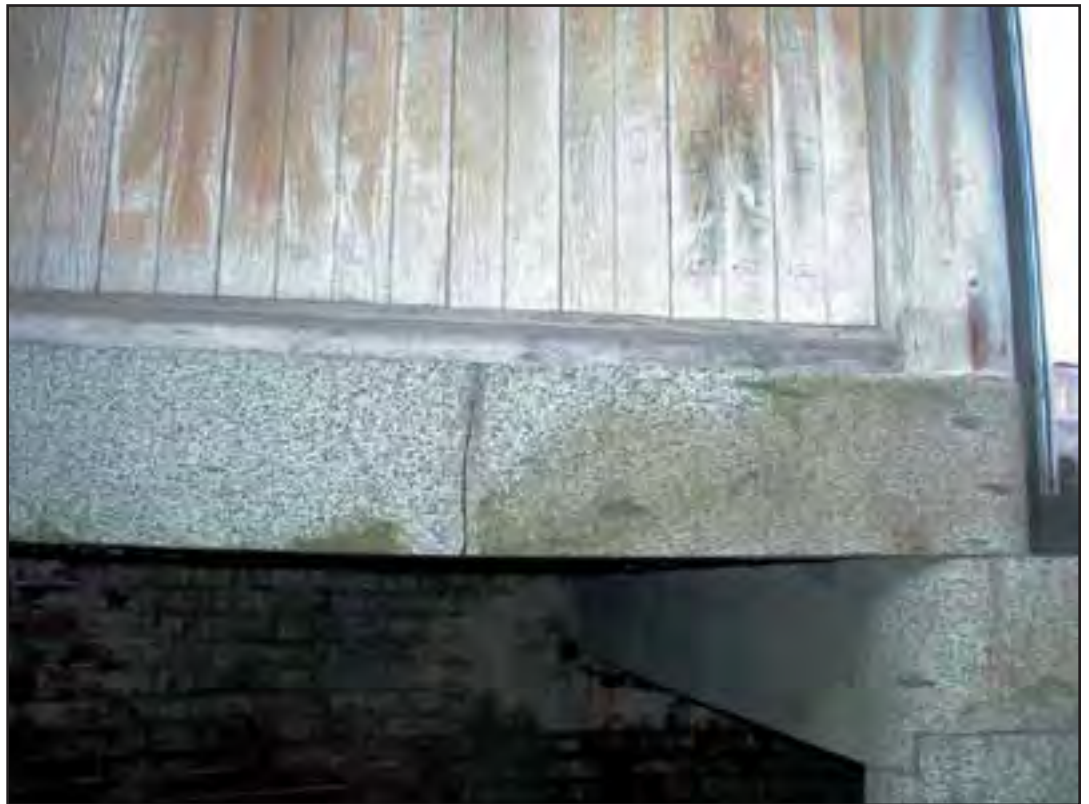
There is one location of a substantial loss at the upper southwest quoin. The severity and location of this opening allows water to sit and enter the walls. There is impact damage on the granite at the East Bastion on the southeast face elevation, which appears to have been caused by vehicles. The damage is unsightly, but does not currently contribute to water intrusion (see Condition Photos 6–7).

Condition Photo 7:
East Bastion—East Flank; Impact
damage at granite quoins and base.
(Courtesy of ARG, 2003)

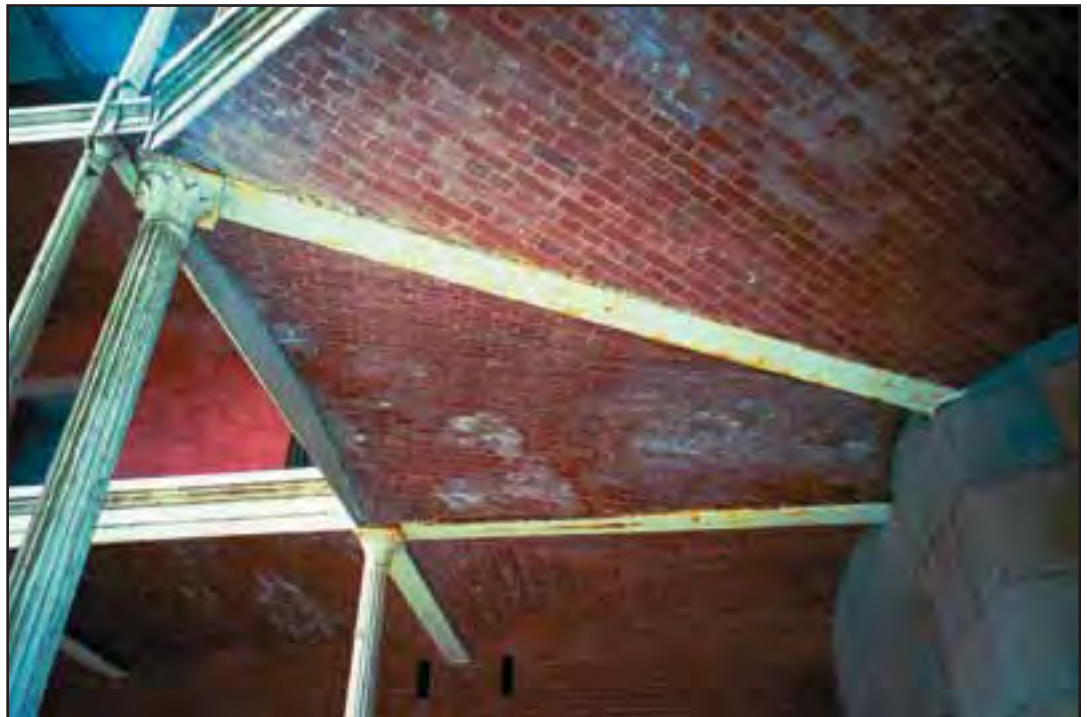
The lighthouse is constructed almost entirely of metal. Most of these elements show signs of corrosion and corrosion staining. Some of the material, like the flooring and stair treads, are displaced and the section of the metal is thin. The lighthouse structure is off limits to the public due to the poor condition of the materials (see Condition Photos 9–11).

Condition Photo 10:
Southeast Face Courtyard; Corroding
metal columns and walkway
supports. Missing metal railings in
this photo have been reinstalled.
(Courtesy of ARG, 2003)

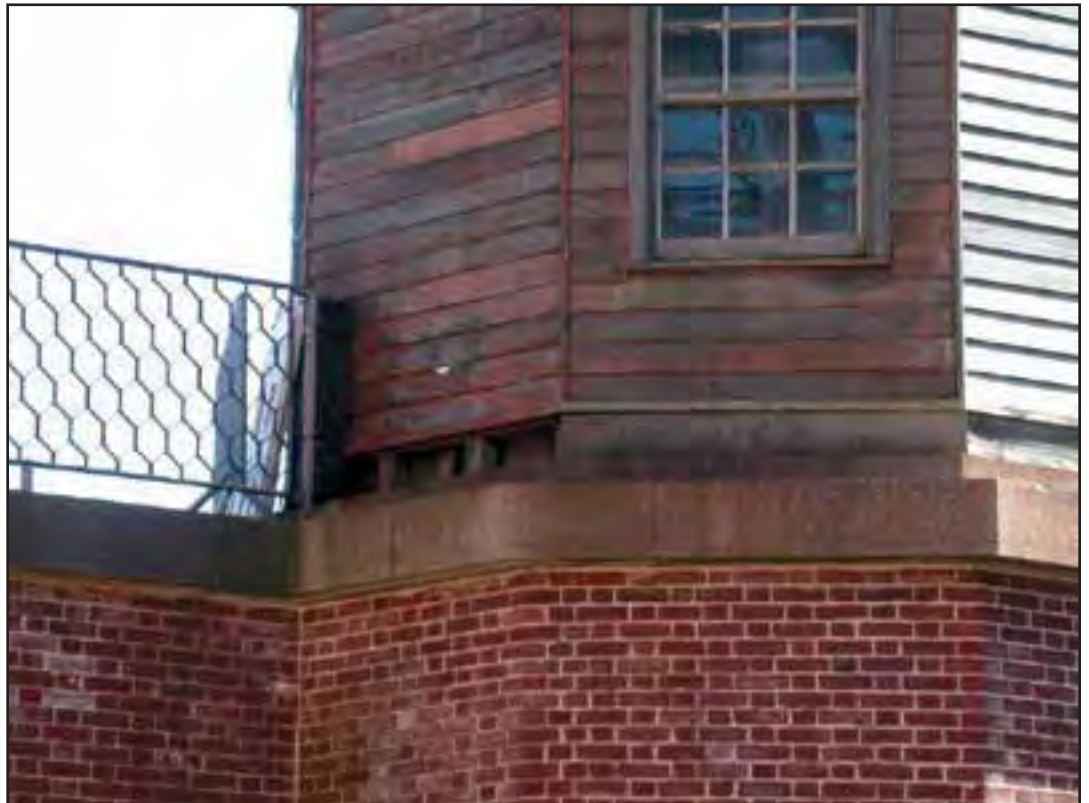
Condition Photo 14:
Wood Walkway – Barquette Tier
by Stair 1; Components are not
properly fastened at wood walkway.
(Courtesy of ARG, 2003)
