Second Five-Year Review Report

Tibbetts Road Superfund Site

Town of Barrington

August 2008

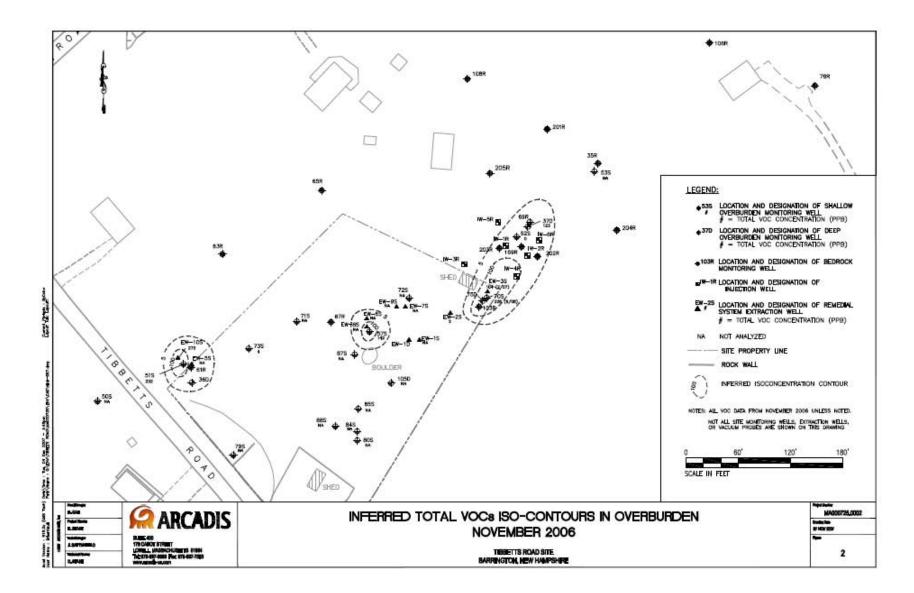
As seen in the preceding figure, any contamination is limited to essentially the footprint of the former drum storage areas. Table 1 presents the maximum concentrations found in the shallow, overburden aquifer at the site at critical junctures in the site's history. Overall, as seen in Table 1, below, concentrations are at or near their cleanup levels for nearly all the compounds with the exception of arsenic. All compounds have downward trends that indicate progress towards attaining cleanup levels. These concentrations reflect all contaminants from the drum storage areas A, B, and C as well as their associated plumes.
