EPA/OSHA JOINT CHEMICAL ACCIDENT INVESTIGATION REPORT

Napp Technologies, Inc.
Lodi, New Jersey

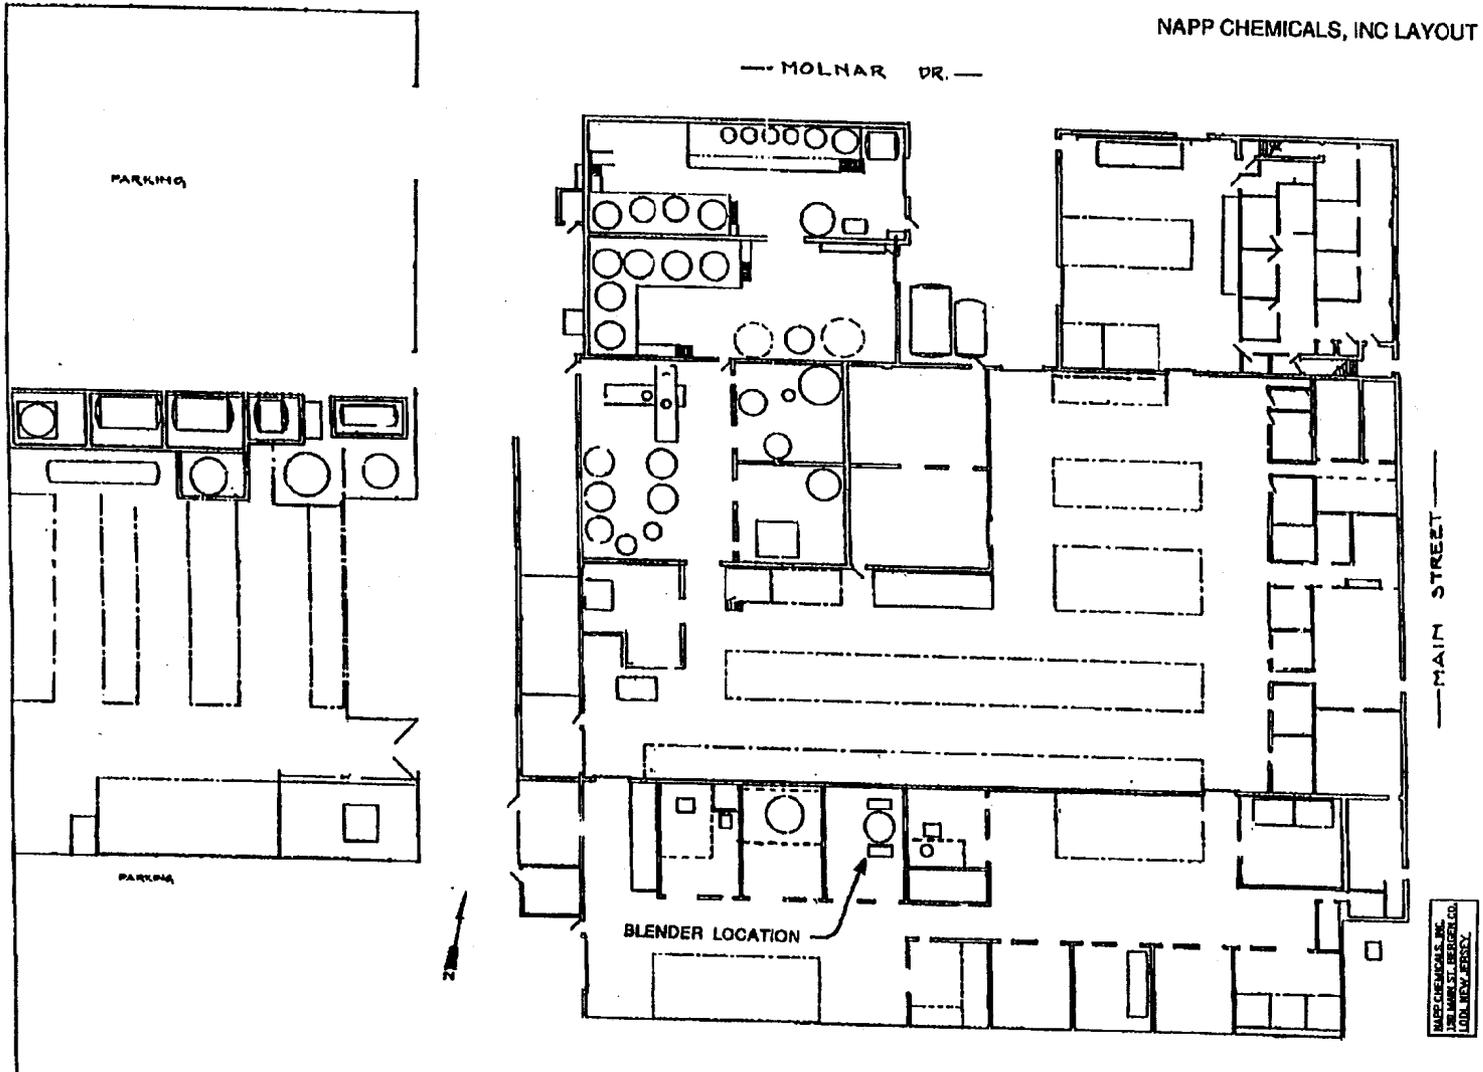
FIGURE 1

The Patterson-Kelley (PK) 125 blender used in the GPA blending operation was located in the PK-125 Blending Room, located in the Pulverizing and Blending Department on the South side of the facility, near the main warehouse area (see Figure 1).

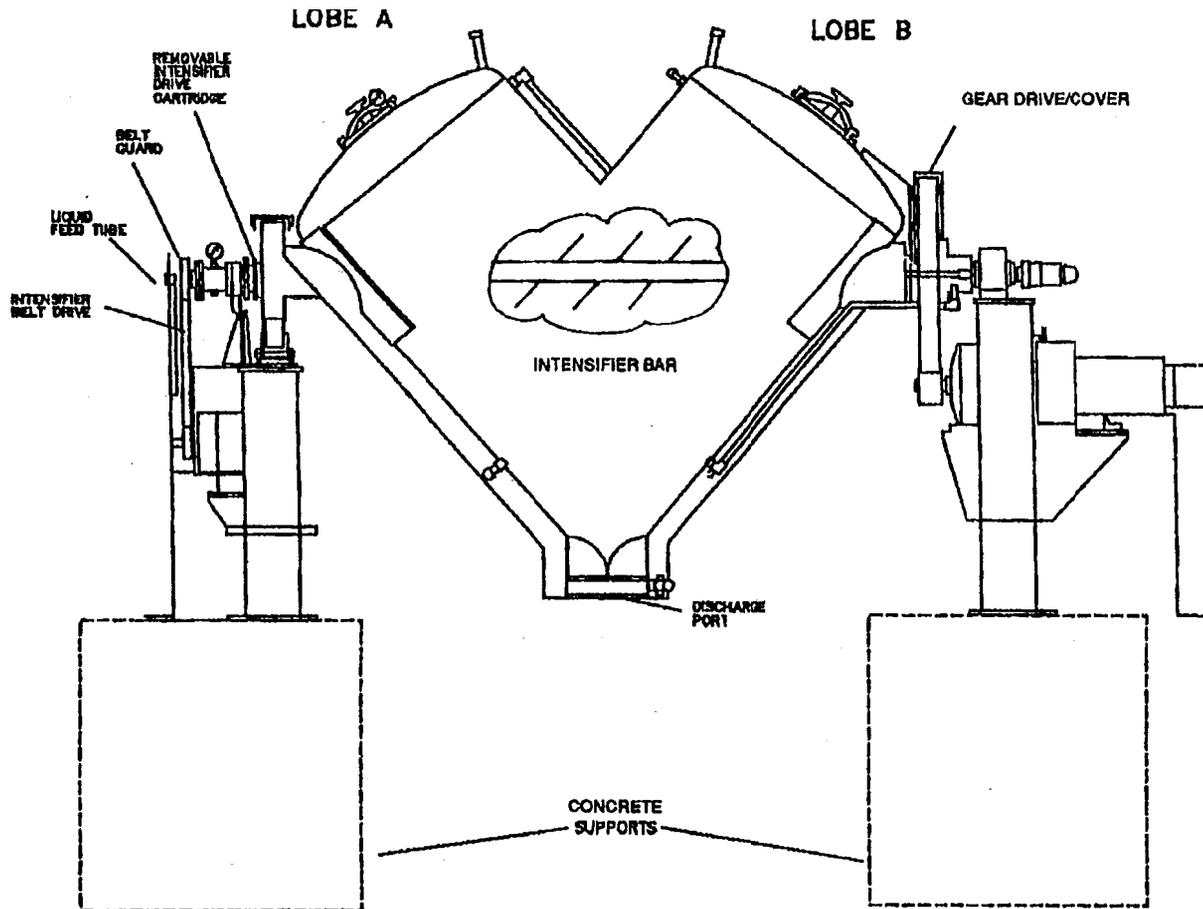
FIGURE 2

Figure 2 shows a typical Patterson-Kelley V-shaped blender. Patterson-Kelley builds each blender with options and features as specified by the purchaser. The blender at Napp had a working capacity of 6 cubic meters (125 cubic feet). It was approximately 6 meters wide (19 feet), including supports, and 3 meters (10 feet) high. The blender is a double-lobed stainless steel shell shaped like a heart. It is supported on its widest dimension by a horizontal trunnion attached to support tubes set in cement footings. It is insulated with a rigid foam material and encased in a steel jacket containing a water/glycol mixture for cooling and heating. The two access covers on top of the blender are used for loading raw materials, and one port is located at the bottom for off-loading product. A gear to one side of the blender (right side of Figure 2) rotates the shell of the blender through a 360-degree arc. Several water lines enter the jacket on this side. On the other side (left side of Figure 2) of the blender, a vacuum tube housing enters the blender. A graphite seal located inside the vacuum tube separates the seal's cooling water from the internal area of the vacuum tube and the blender. The purpose of the vacuum tube housing is to: (1) act as a conduit for establishing vacuum conditions when the blender is used for drying and other operations; and (2) contain other concentric lines, shafts, etc., including a liquid feed line (added by Napp) and the shaft used to rotate an intensifier bar (I-bar). The purpose of the I-bar is to enhance the mixing of materials being blended. The purpose of the feed line is to allow the controlled introduction of liquids to the materials being blended. The PK-125 blender can be used with or without the I-bar in service. The I-bar, Figure 3, transverses the inner walls of the blender connecting the inner sides of the blender on the same plane as the trunnion. See Figures 4-8 showing a larger but similar blender and associated equipment.

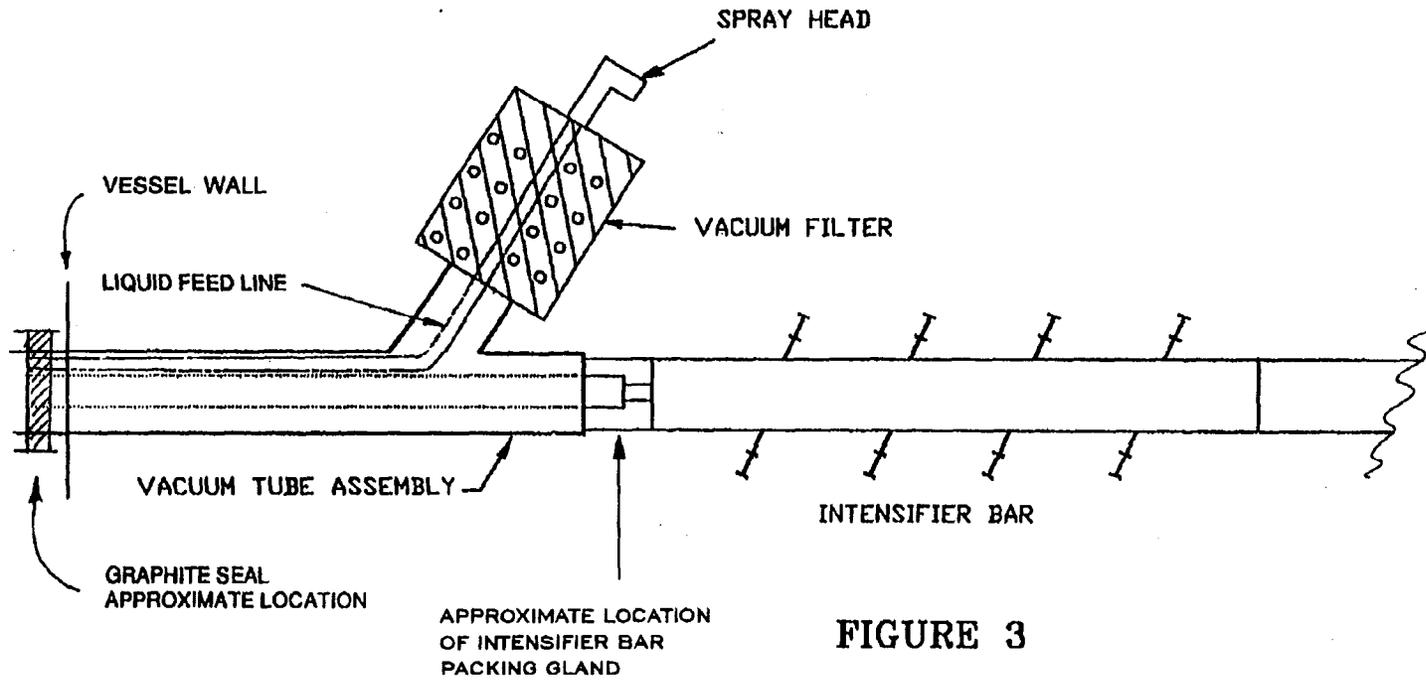
FIGURE 3

The maintenance foreman instructed a maintenance employee to remove and change the packing gland associated with the intensifier bar on the PK-125 blender. This activity was standard procedure whenever there was a scheduled product change for one of the Napp P-K blenders. After removing the old packing gland and its housing, the maintenance employee observed water next to a bearing. Based on this observation, the maintenance foreman instructed the maintenance employee

to drain the water out of the area, replace the packing, and seal the blender. As part of the procedure to check the integrity of the seal and packing gland, the maintenance employee ran the blender and its intensifier bar for 15 minutes and visually inspected the interior of the blender to assure that the water-cooled seal and packing gland were not leaking. The mechanic found no evidence of leakage.

At 3:30 am. on April 20, as part of the precharging verification, operators made a final check to assure the blender was ready (i.e., clean and dry) to be loaded. The two operators and a foreman discovered that the vacuum head area, inside the blender, was wet. They also observed water on the internal walls of the blender. Another employee saw a wet spot also described as “droplets of water on the stainless steel” at the intensifier bar shaft seal (connection). They believed this moisture was

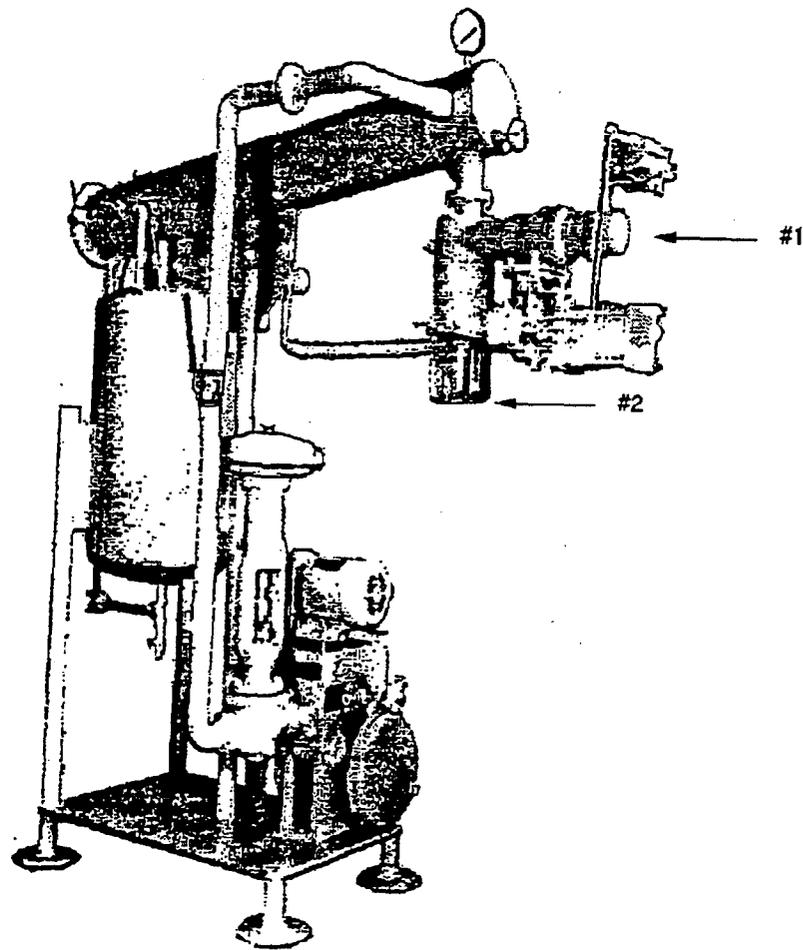
FIGURE 3A: TYPICAL VACUUM COLLECTION SYSTEM As SUPPLIED BY PATTERSON-KELLEY. # 1 SHOWS APPROXIMATE LOCATION OF INLET FROM BLENDER VACUUM LINE; # 2 SHOWS VACUUM SEPARATOR BOWL.

Between midnight and 4:30 a.m. on April 21, 1995, the third shift attempted to inject benzaldehyde into the batch on two occasions; each attempt failed. Operators observed the benzaldehyde running back into the vacuum separator. During each attempt to add the liquid, the blender was rotated for about two minutes with the intensifier bar running. Suspecting that product was blocking the spray tip of the nozzle and preventing the injection of the liquid, operators opened the blender twice and removed and washed the spray nozzle. Operators reportedly observed a slight dusty powder wafting within the head space of the blender. This was reported to the shift supervisor, who then checked the inside of the blender and directed the operators to remove and clean the nozzle. After the final attempt to charge benzaldehyde into the vessel it was determined that no fresh benzaldehyde remained. It was by then approximately 5:00 a.m. and coming to the end of the third shift. The shift supervisor told the operators to perform a lock and tagout of the blender.

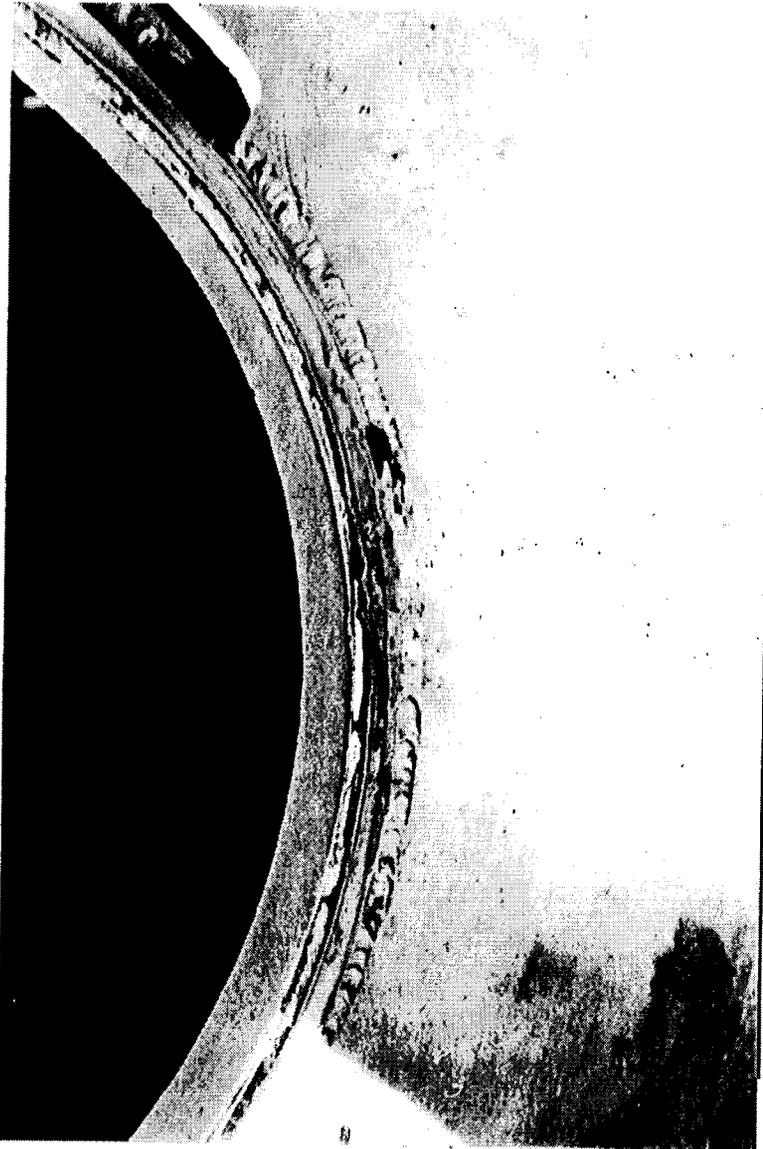
Figure 4: One of the top loading ports on the 150 cubic foot blender showing how the insulation jacket is attached (weld) and access door tabs.

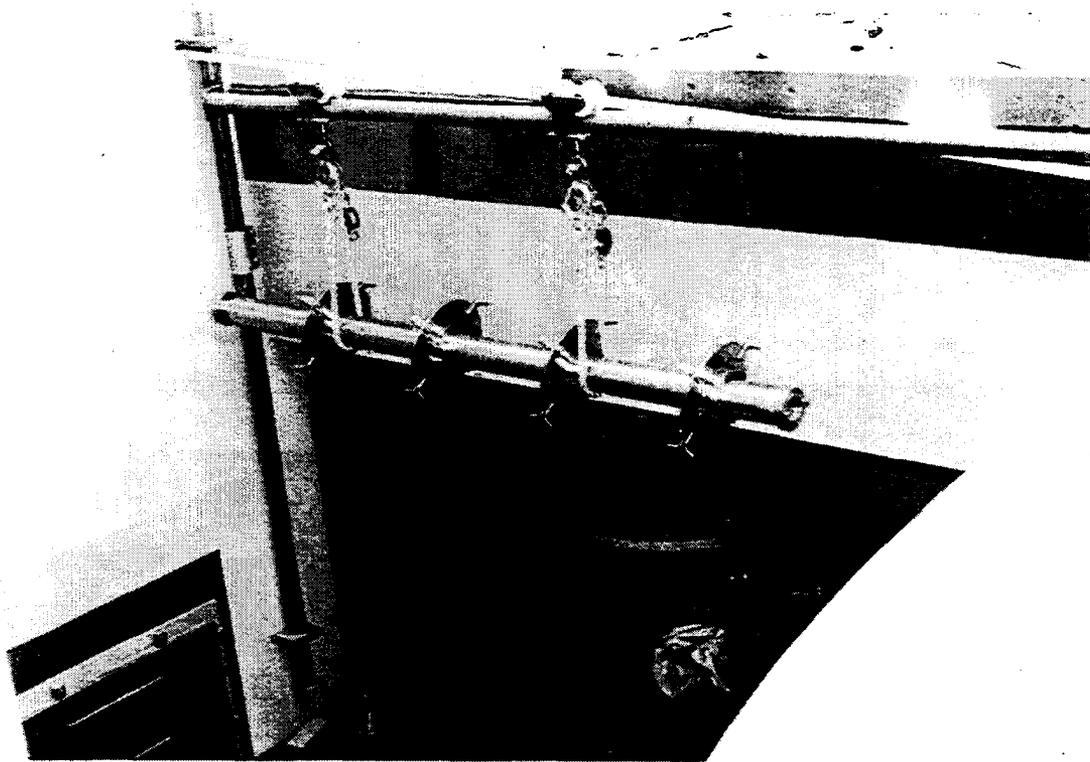
Figure 6: The intensifier bar for a PK-150 cubic foot blender shown in its storage position.

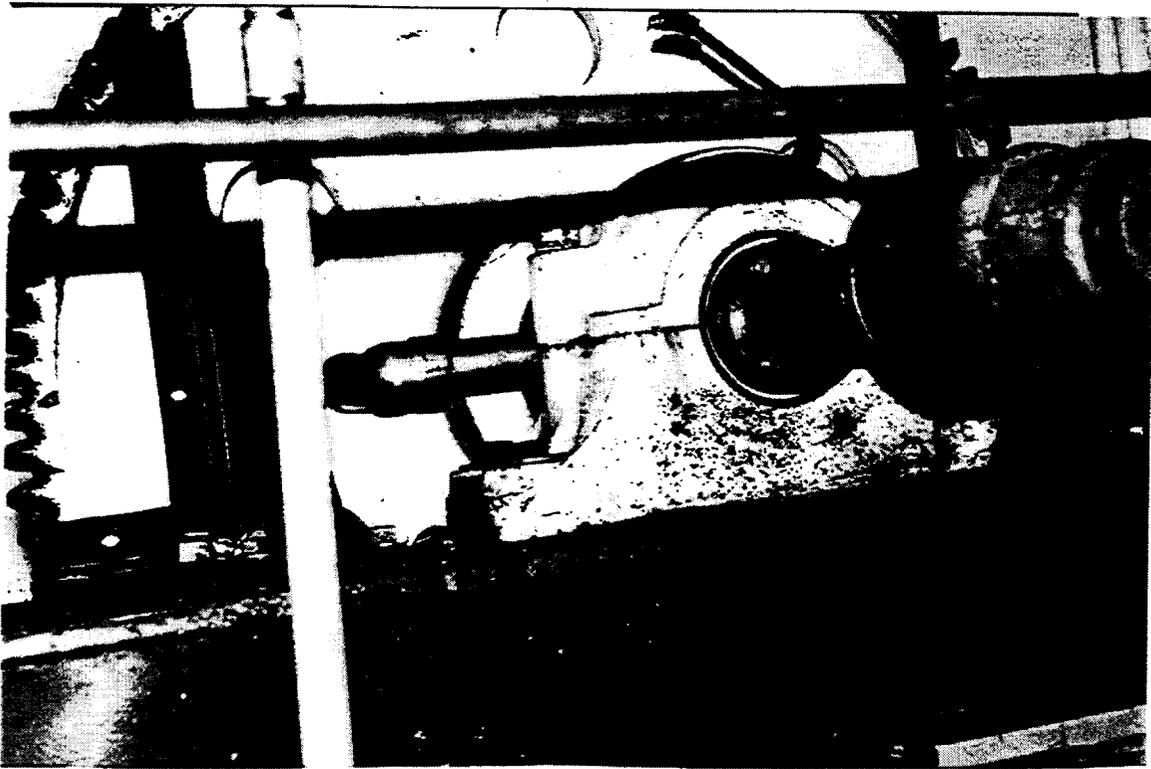
Figure 7: The gear drive and bearing that supports one side of a 150 cubic foot blender.

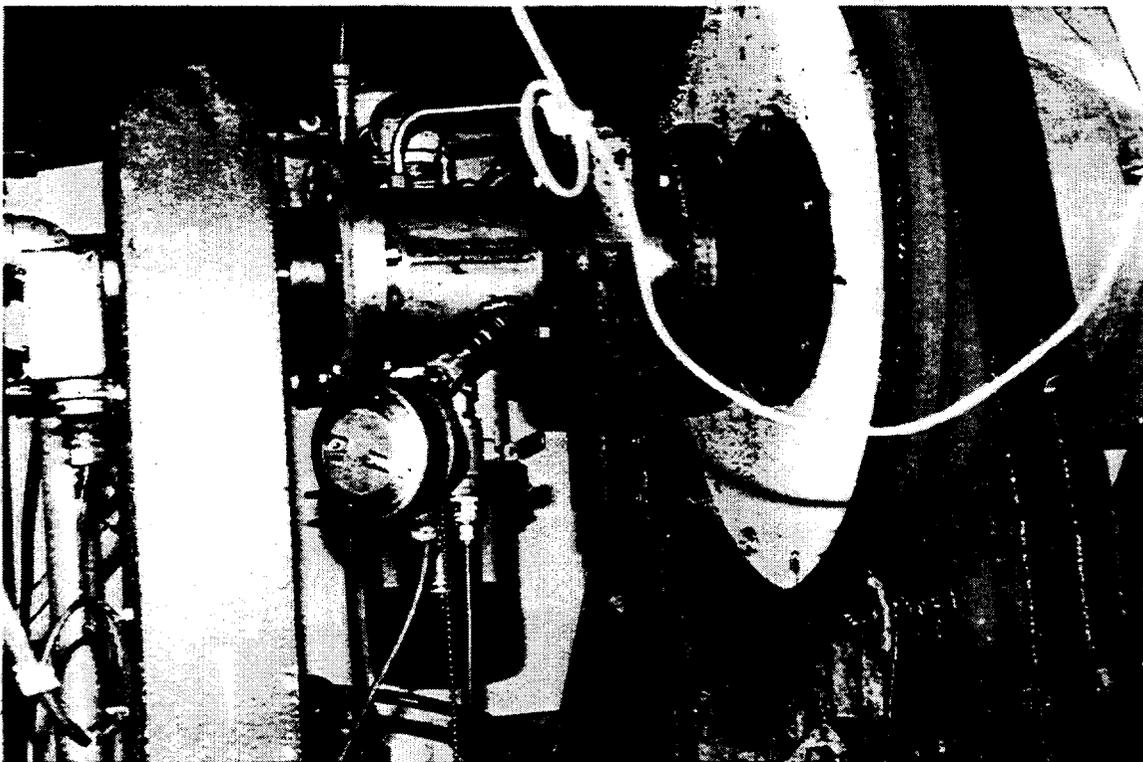
Figure 8: The other side support (intensifier bar drive side) of a 150 cubic foot blender.

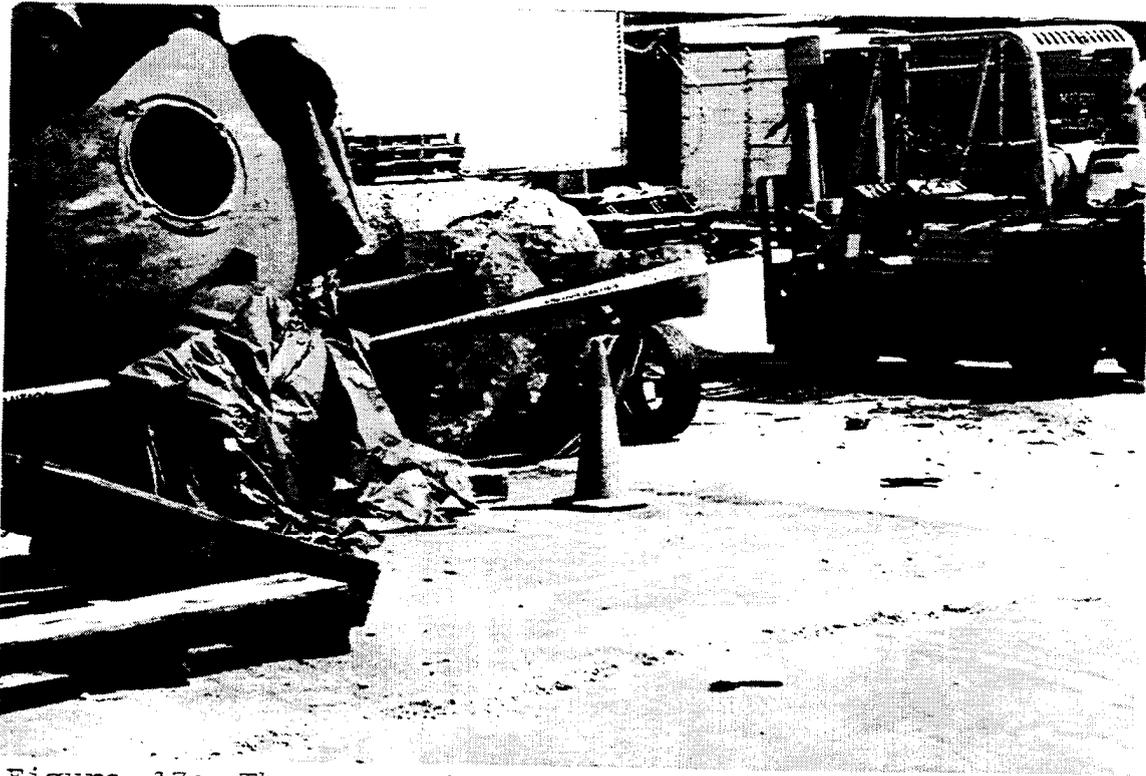
Figure 17: The concrete support and bracket that secured the bearing on the gear drive side of the blender.

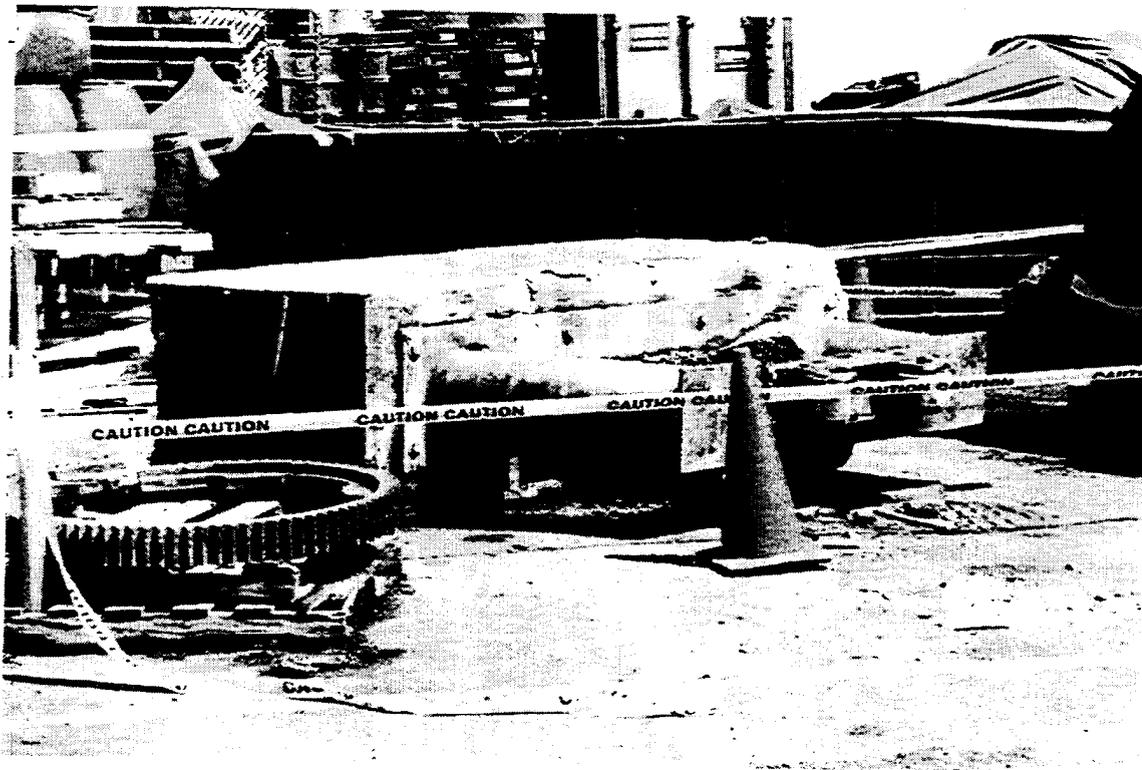
Figure 18: The concrete support and rollers that supported the belt drive side of the blender.
