EPA/OSHA JOINT CHEMICAL ACCIDENT INVESTIGATION REPORT

**BPS, Inc.
West Helena, Arkansas**

Executive Summary

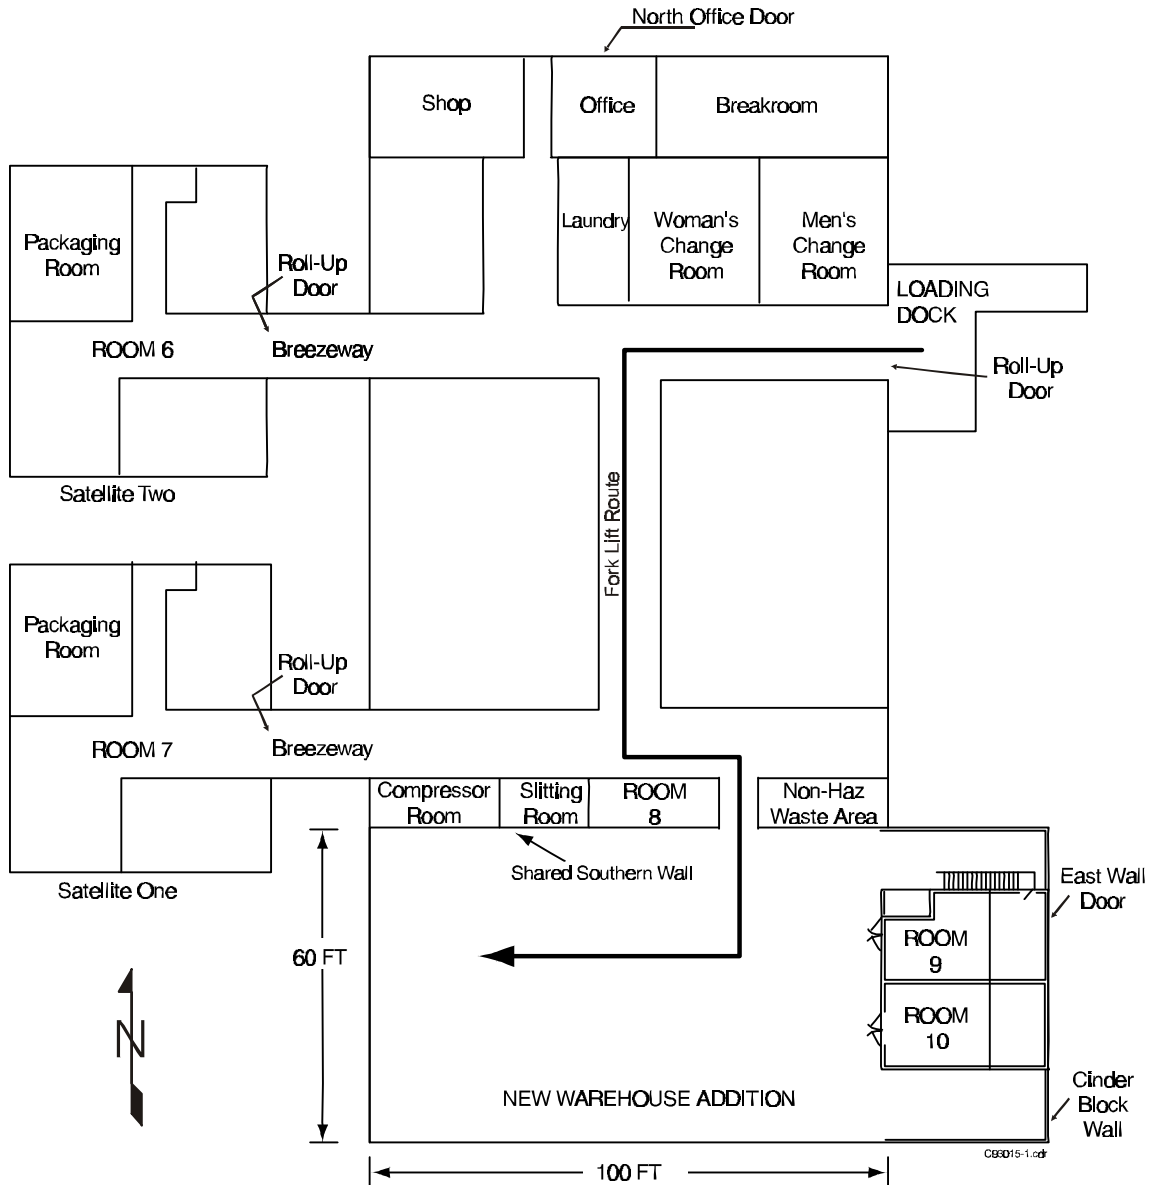
FIGURE 1: FLOOR PLAN - BPS, INC. UNIT #2

The West Helena facility employs approximately 130 workers. At the time of the incident 65 employees were on duty. The facility consists of two production buildings (referred as units One and Two), two satellite buildings, and a Agel@building. The production buildings are constructed of corrugated metal with steel reinforcement. The Unit Two building (Figure 1),

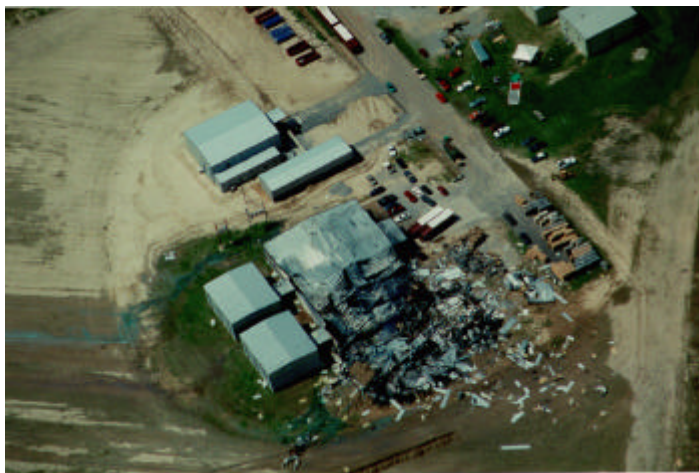
Figure 6. Aerial Photo BPS Unit Two

Several of the chemicals stored in the new warehouse addition at the time of the incident had the potential to decompose thermally while in contact with the hot compressor pipe. The JCAIT collected bulk samples of the combusted residue where the explosion occurred, attempting to determine the exact location of each chemical pallet. The analysis of these samples was of limited use due to the total destruction of the area and combustion of the sampled material (Figure 6). The collection and analysis of samples was supplemented with the analysis of other physical evidence and witnesses' statements.
