Effectiveness of Road Restoration in Reducing Sediment Loads

Agreement No. FG7354IF

Final Report

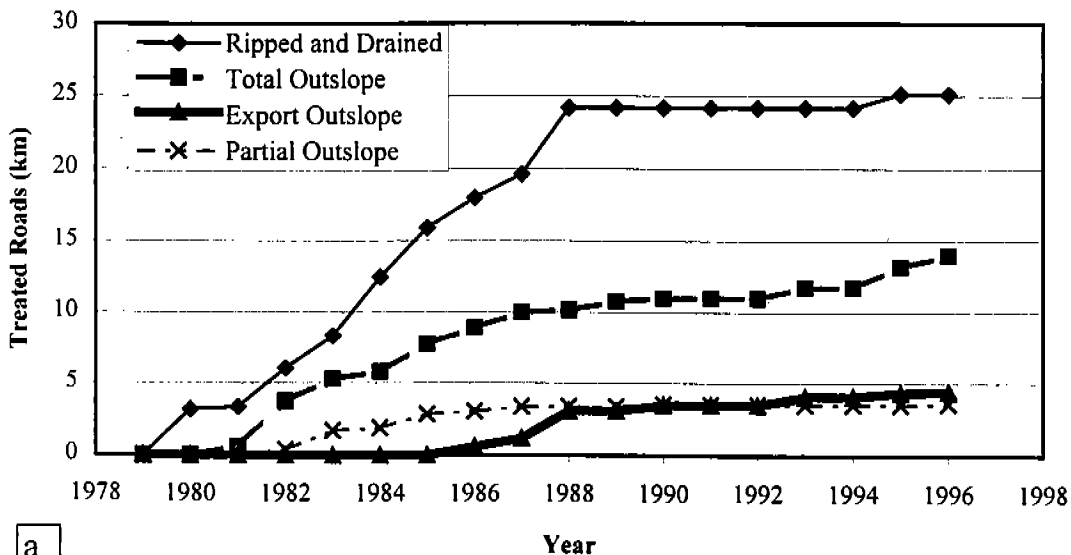
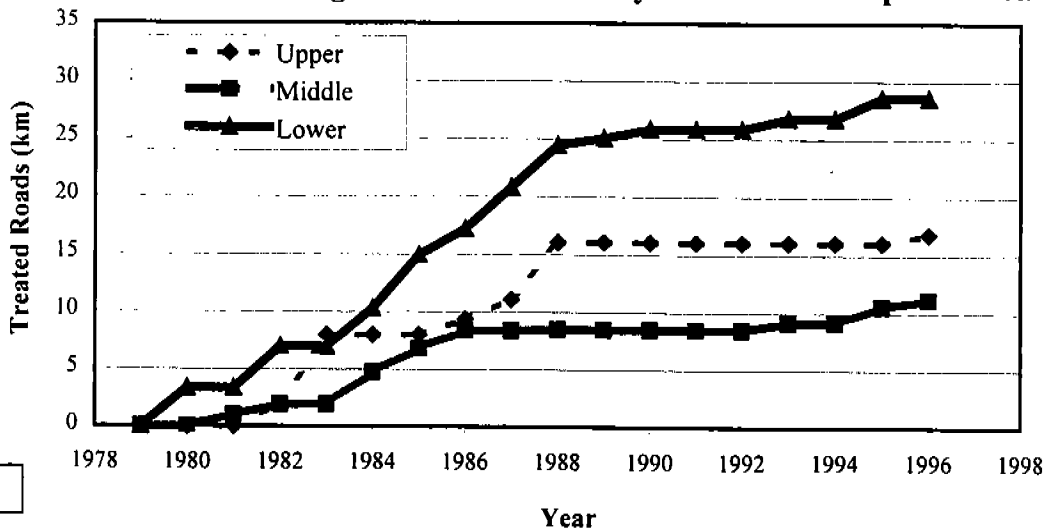
The cumulative length of road treated by the different methods is shown in Figure 9a. Most roads that were ripped and drained were treated prior to 1988, and most export outsliping occurred after 1988. This means that most minimally treated roads were subject to more storms than roads which had more intense levels of treatment. A greater length of road was treated in early years, when treatments were still being refined. Due to budget constraints and more intensive treatments in later years, fewer road segments were treated in more recent years. Figure 9b shows the cumulative length of road treated by hillslope position. More lower hillslope roads were treated in the first few years of the restoration program than roads in upper and middle hillslope positions, and overall more lower hillslope roads were treated. The implications of these interactions among date of treatment, treatment method and hillslope position are discussed more fully later.

Figure 9a) Cumulative length of sampled roads by date and method of treatment

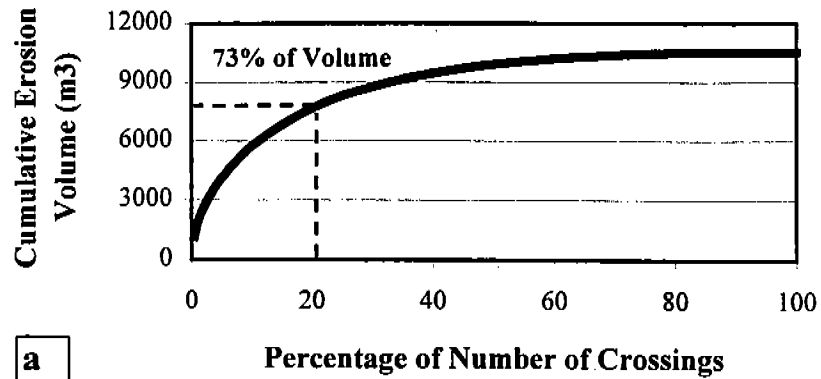
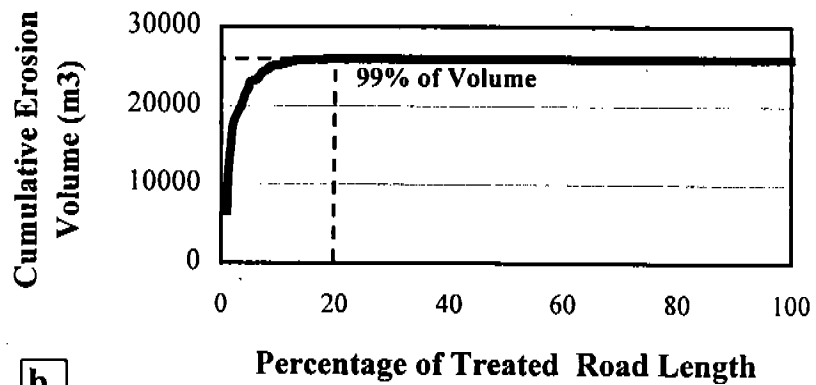
The total amount of material eroded from treated road reaches was 25,900 m³. Most (77%) of this erosion was attributed to mass movement processes, primarily road fill failures. Of the total erosion from road reaches, 74% of the eroded material was delivered to a stream channel. Most treated road reaches performed well and produced very little sediment. The cumulative distribution of erosion from road reaches is even more highly skewed than that for road crossings (Figure 10b). Twenty percent of the

Figure 10a) Cumulative plot of total erosion from excavated crossings

treated road reach length produced 99% of the total erosion from treated road reaches. Total post-treatment erosion from 61 km of road, including both fill failures and stream crossing erosion, was 37,000 m³ (600 m³/km of road); total sediment delivery was 29,500 m³ (480 m³/km of road).
