**EPA REGION 6 ANNOUNCES THE COMPLETION OF THE DRAFT FINAL
REMEDY SYSTEM EVALUATION (RSE) REPORT**

**HOMESTAKE MINING COMPANY SUPERFUND SITE
CIBOLA COUNTY, NEW MEXICO**

REMEDIATION SYSTEM EVALUATION (RSE)

**Homestake Superfund Site
Milan, New Mexico**

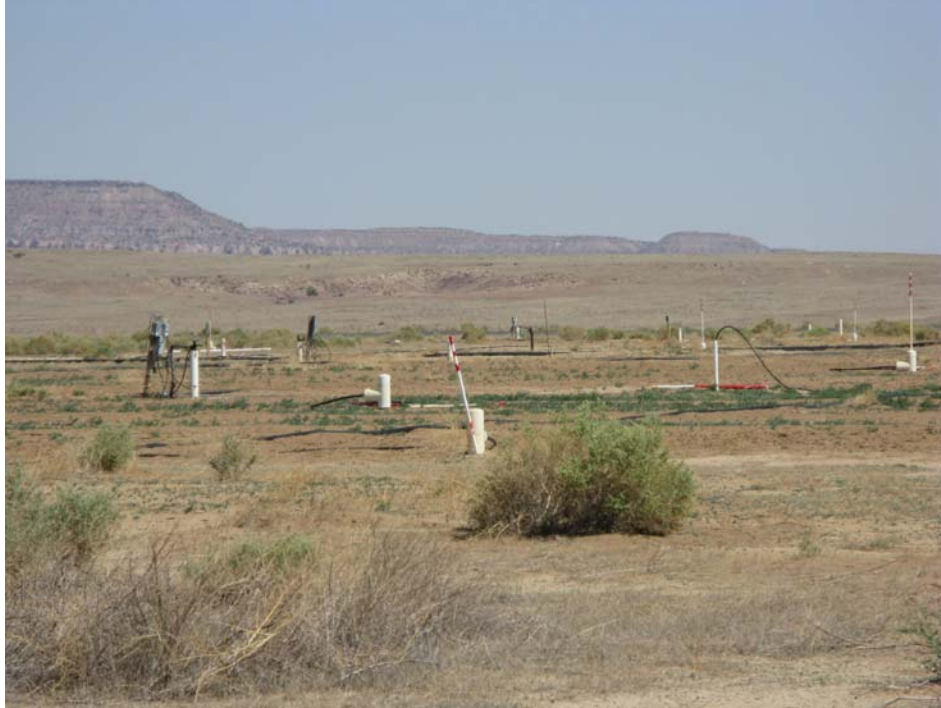
Extraction and injection (red striped) wells (looking northwest)

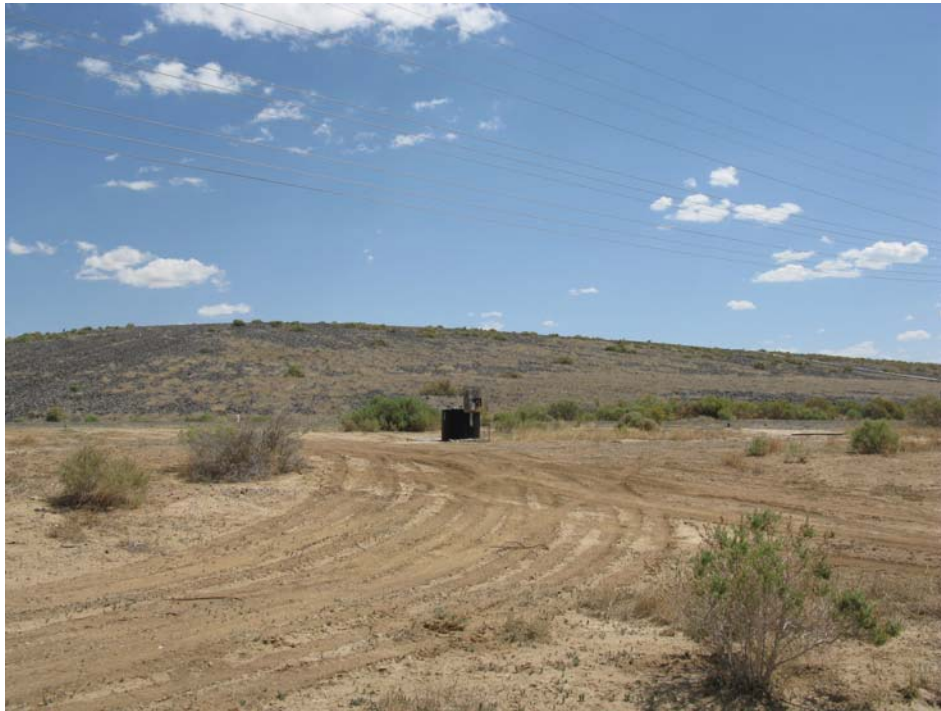
Toe drain collection sump with tailings pile behind (looking northeast)

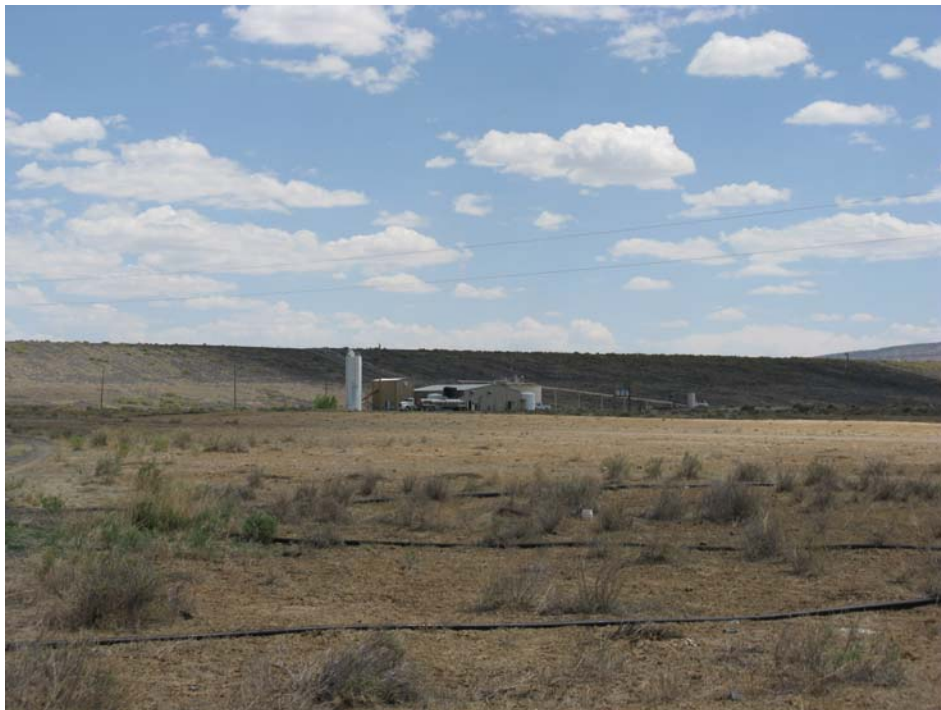
Large Tailings Pile in distance behind RO plant with aboveground piping in the foreground (looking northeast)

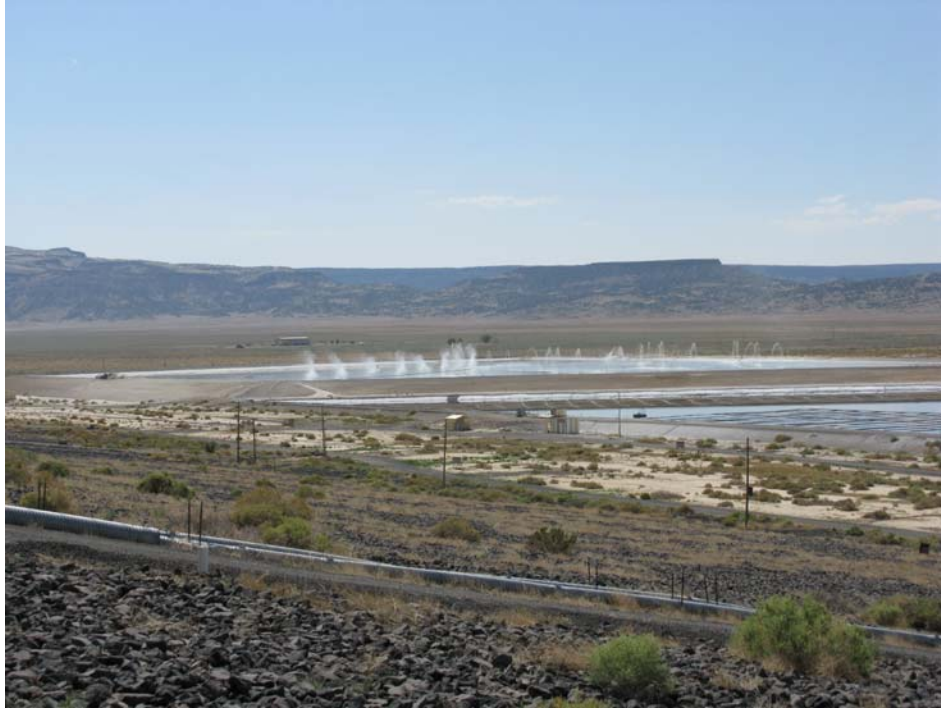
Evaporation Pond # 1 with sprayers on from Large Tailings Pile (looking southeast)

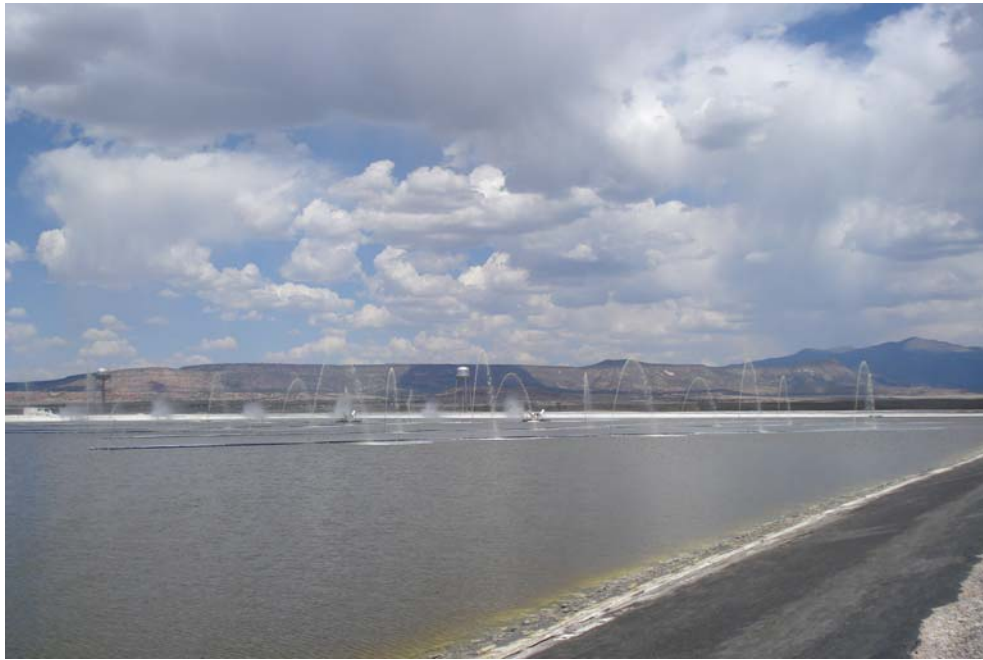
Evaporation Pond #1 with sprayers (looking northeast)

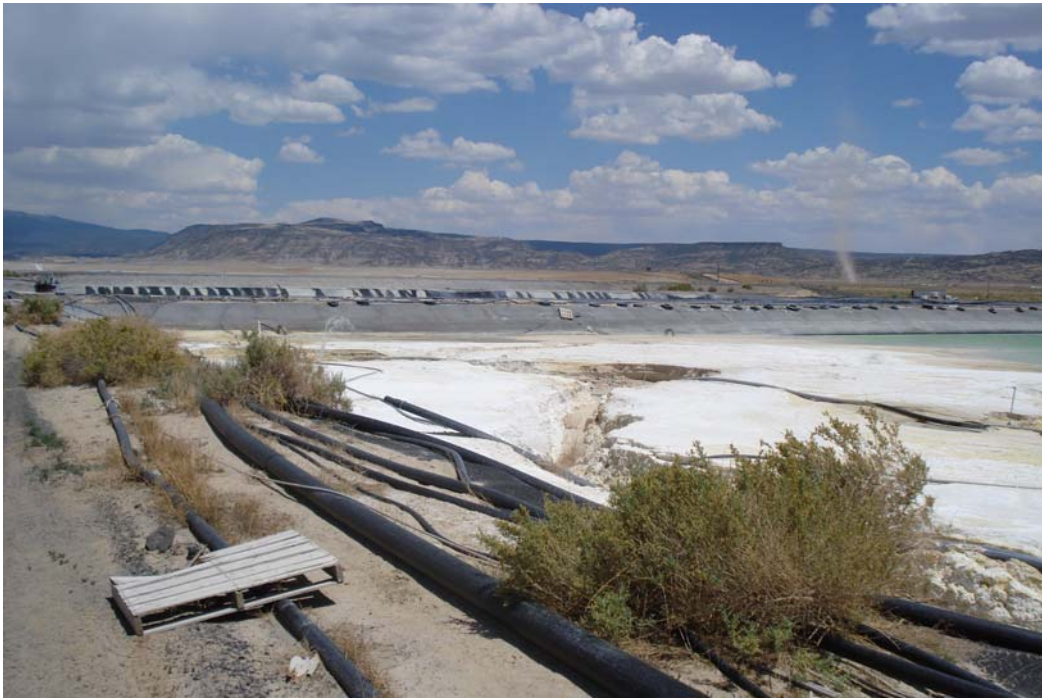
Collection Pond #1 (looking east)

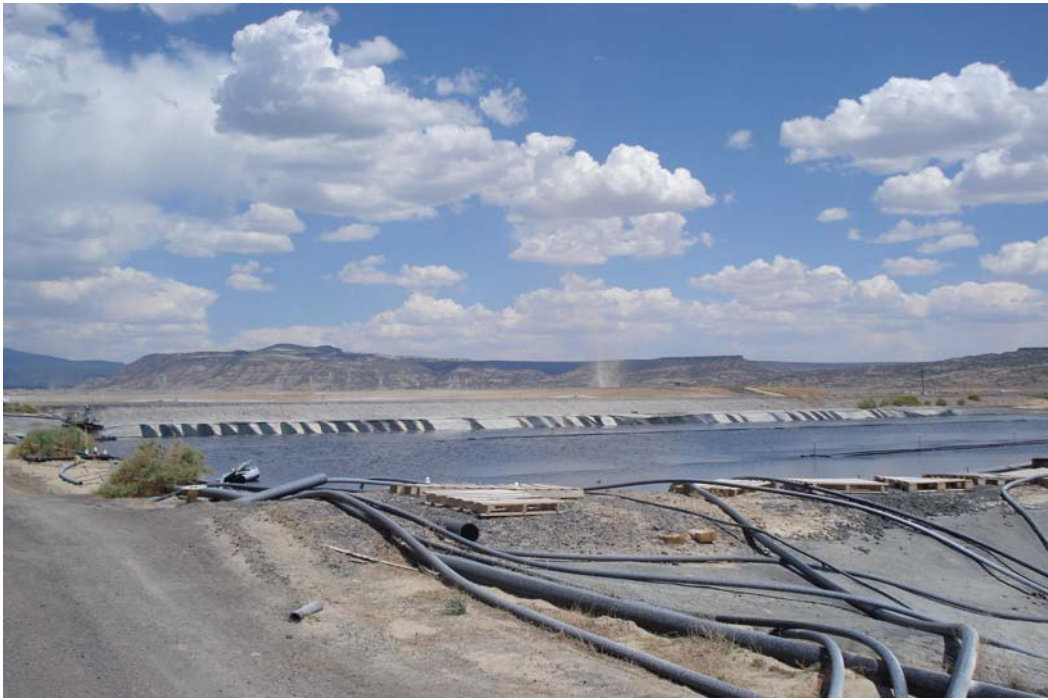
Collection Pond #2 (looking east)

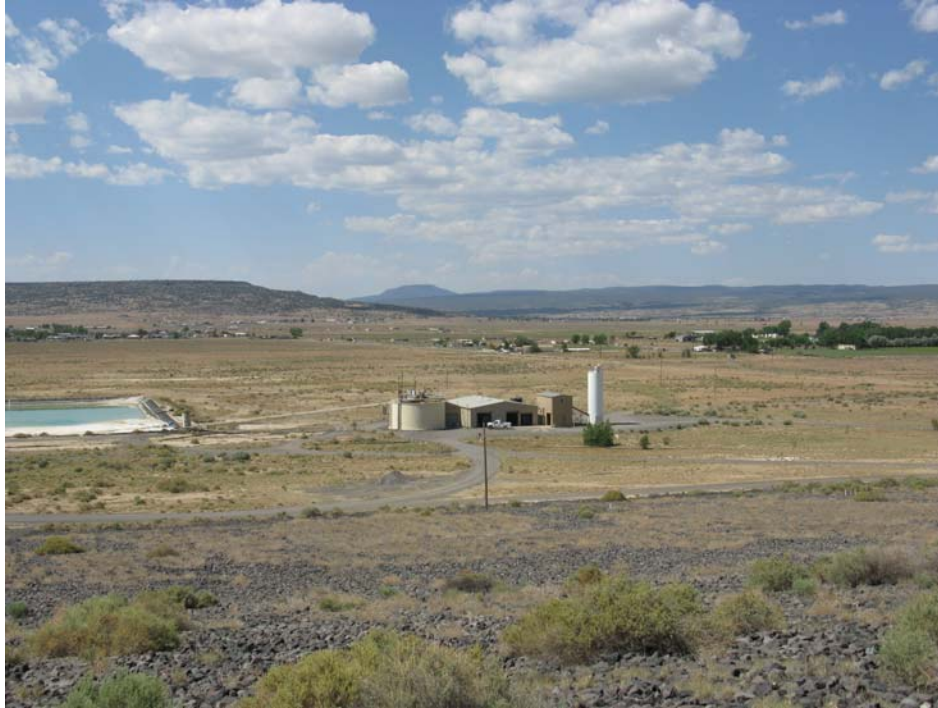
RO Plant from Large Tailings Pile (looking southwest)
(Clarifier to the left and lime slaker unit to the right)

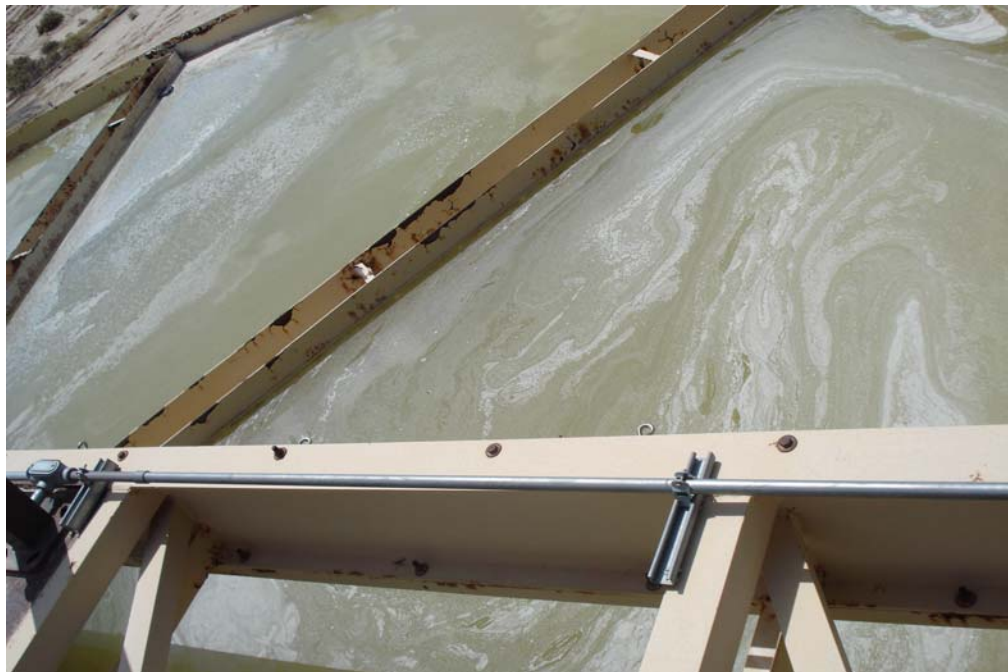
Reactor Clarifier (from top)
