Five-Year Review Report

Second Five-Year Review Report for the Vertac Incorporated Superfund Site Jacksonville, Pulaski County, Arkansas

November 2003

**CH2M HILL
Contract Number 68-W6-0036
Work Assignment Number 119-FRFE-0604**

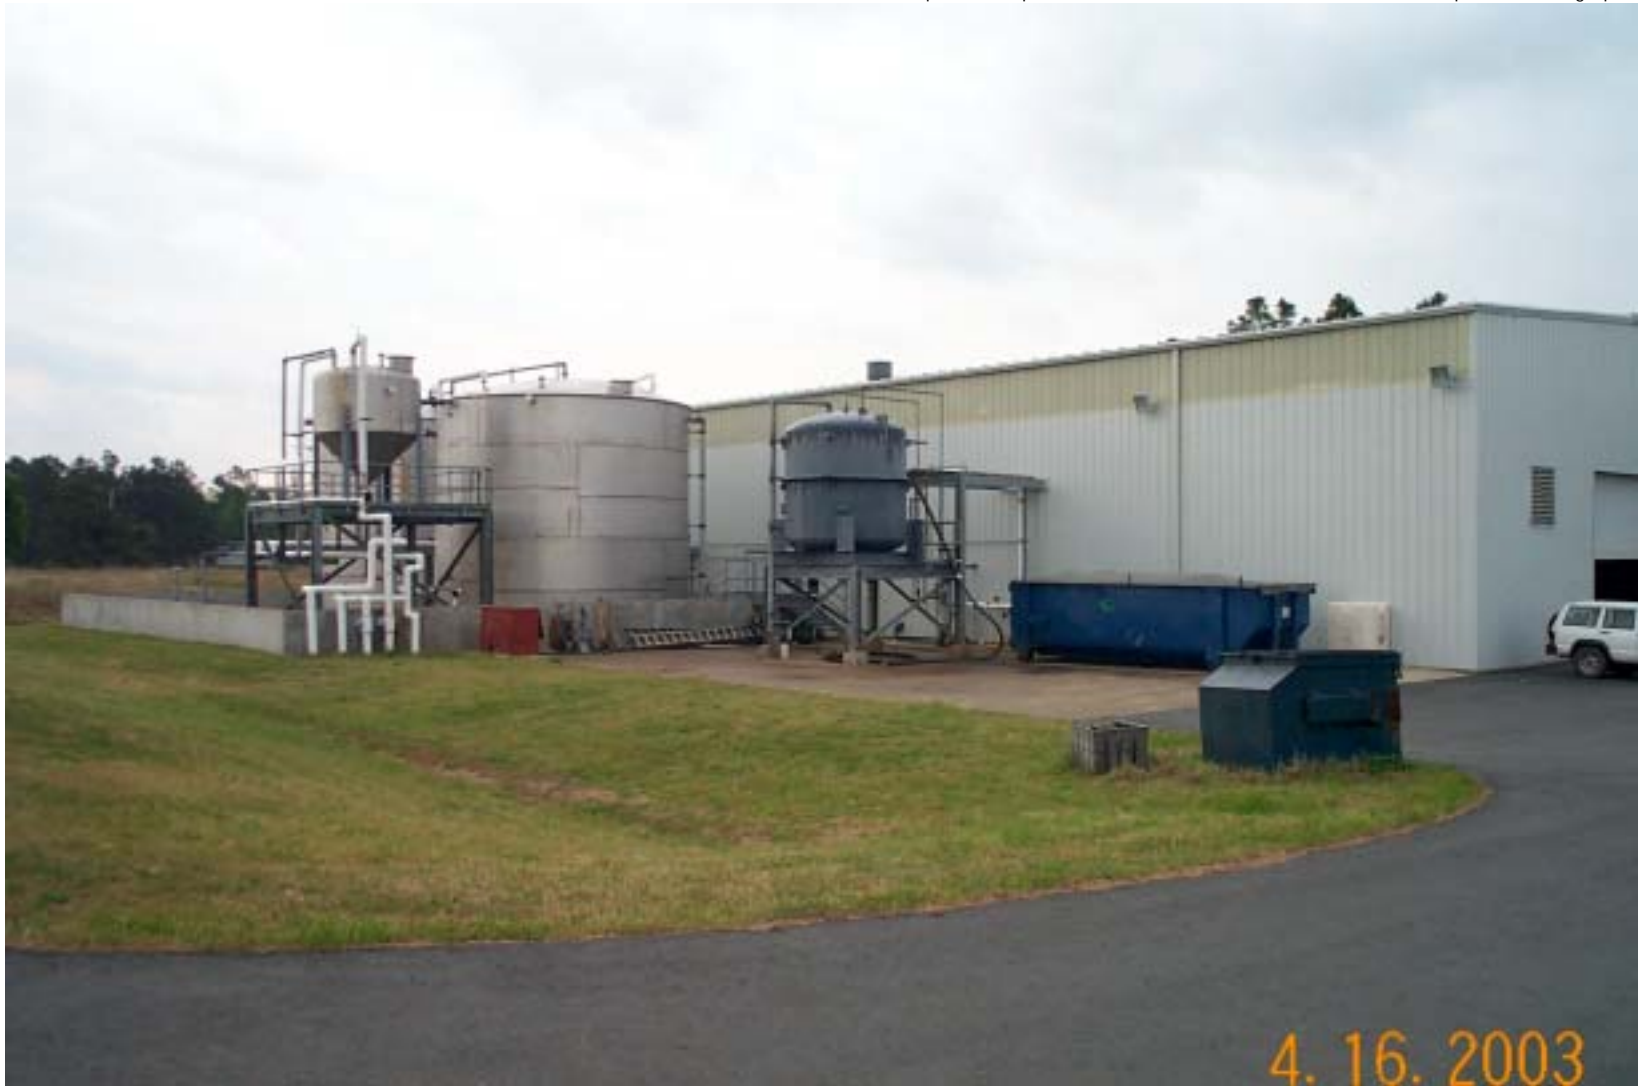
Photo 1: View of Wastewater Treatment Plant, facing southeast. Two large tanks contain untreated water from the french drain and ground water extraction systems.

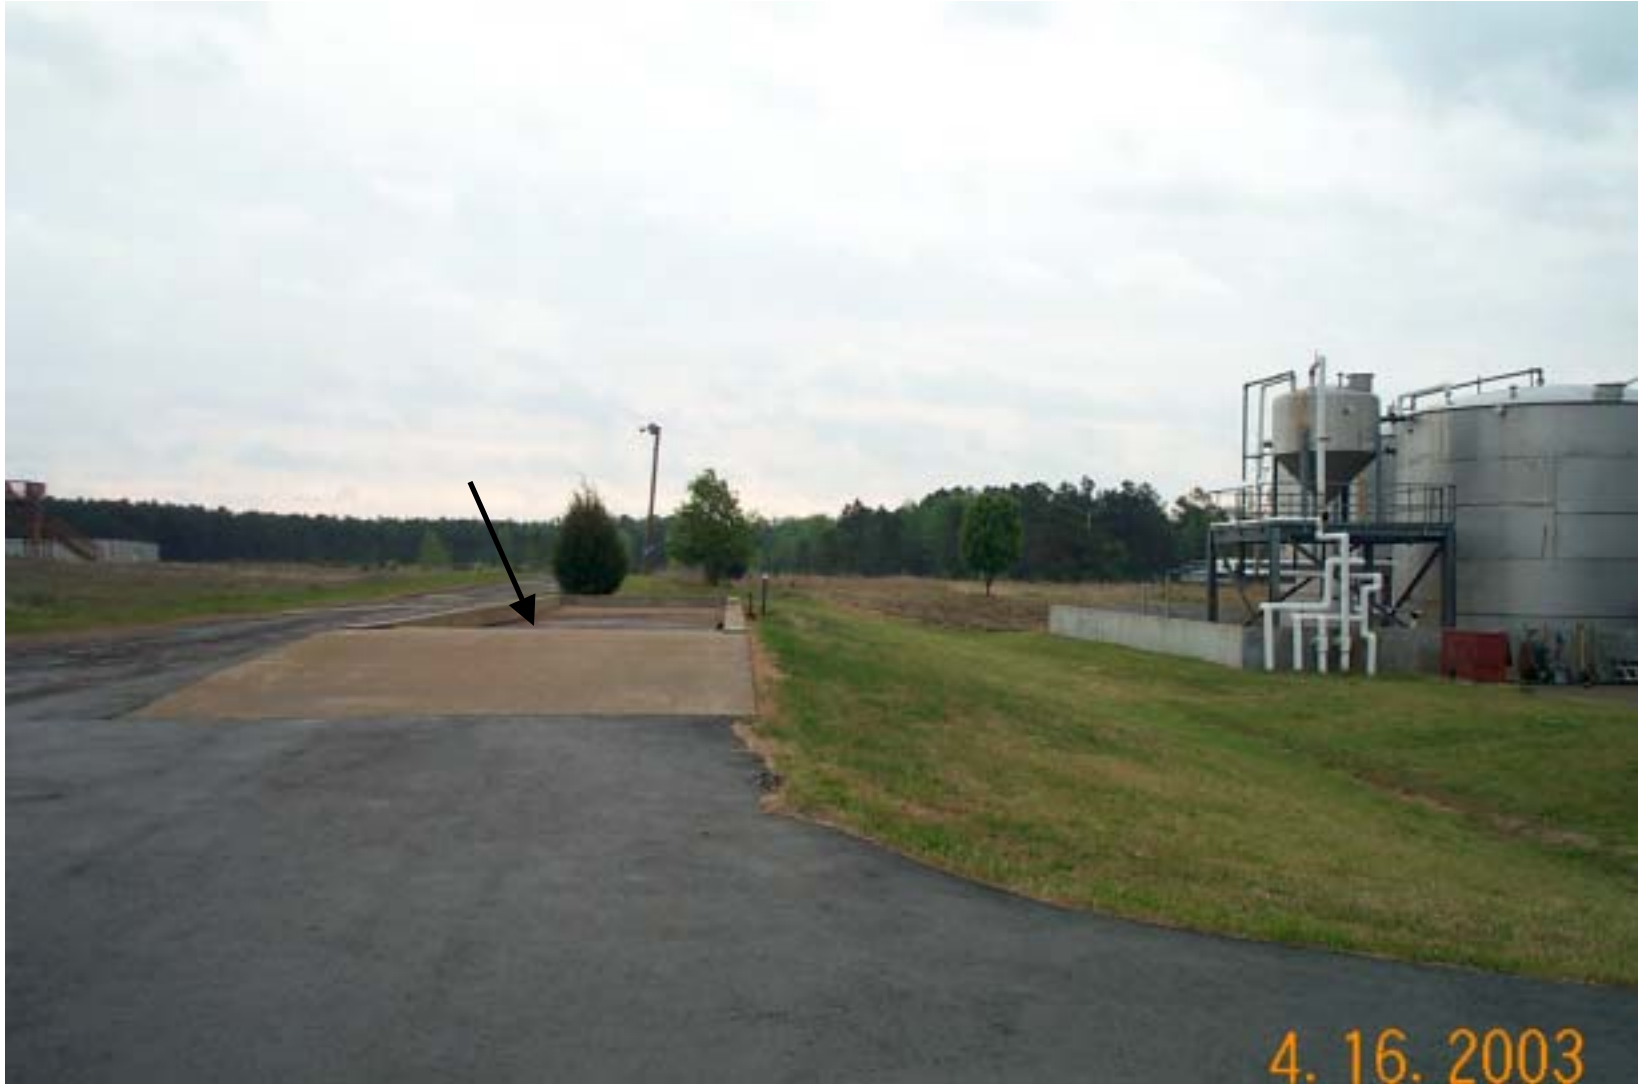
Photo 2: View looking east at the site. The Wastewater Treatment Plant is to the left (just out of view). Object in center left of photograph is a decontamination pad for large equipment (arrow).

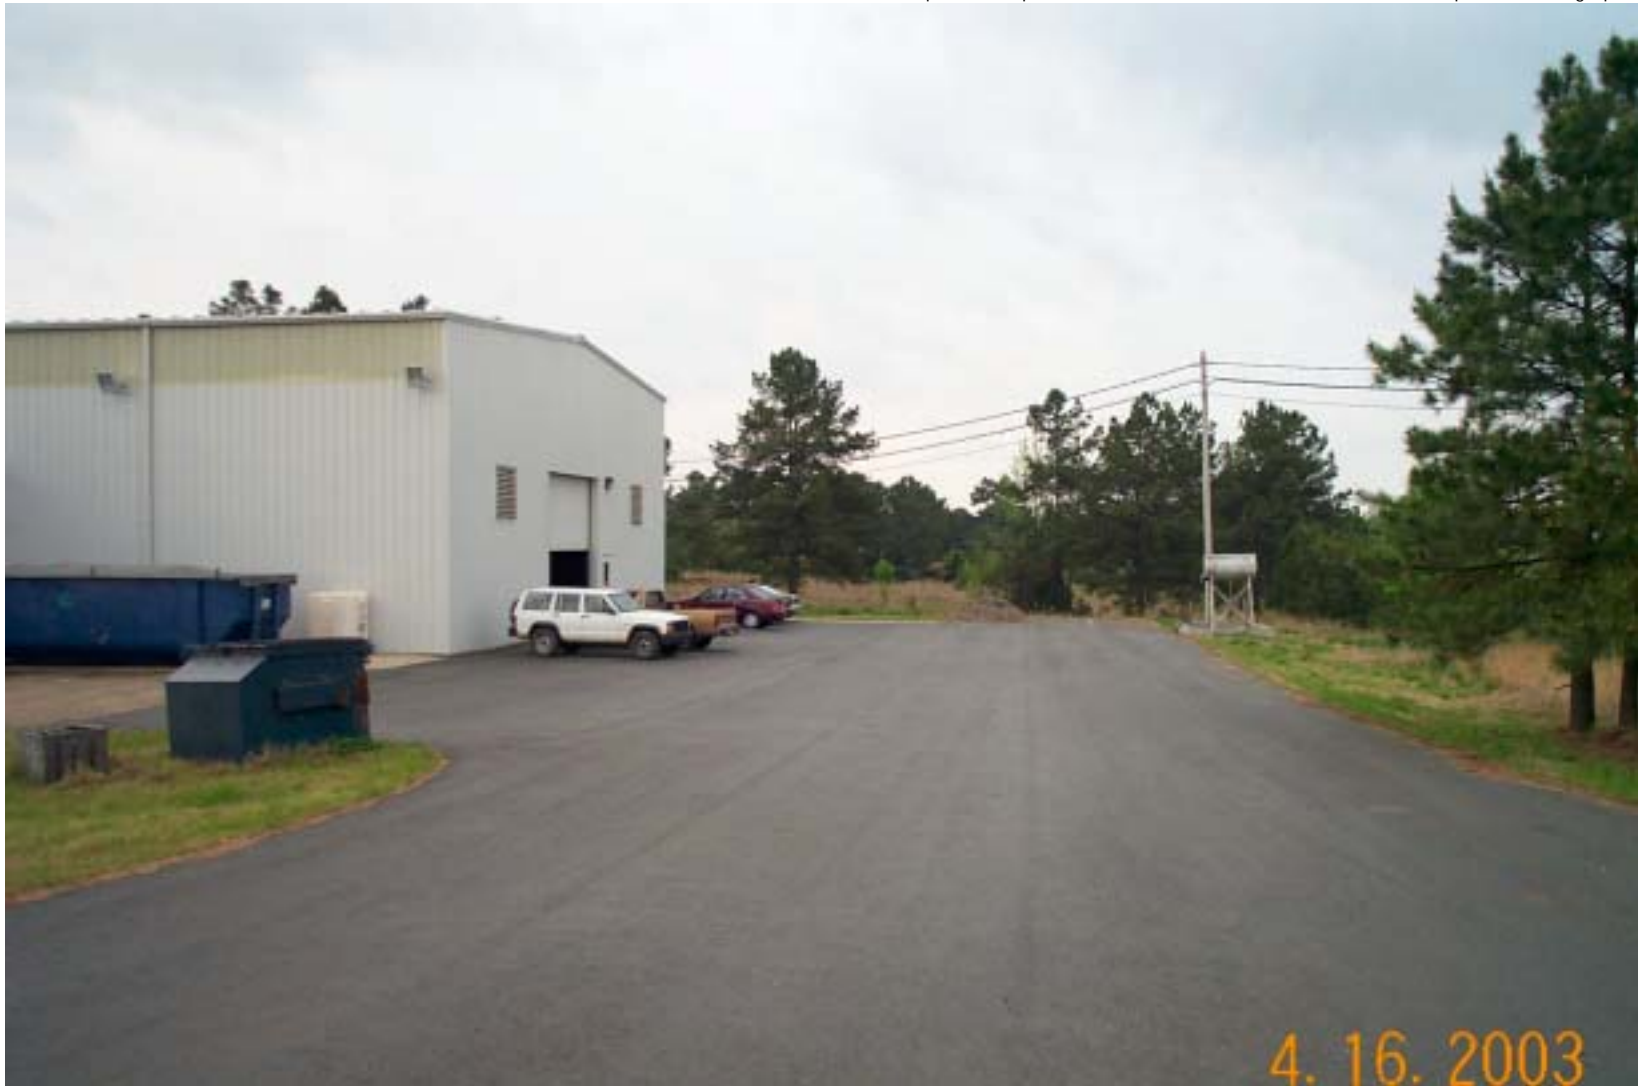
Photo 3: View to the south along the west side of the Wastewater Treatment Plant.

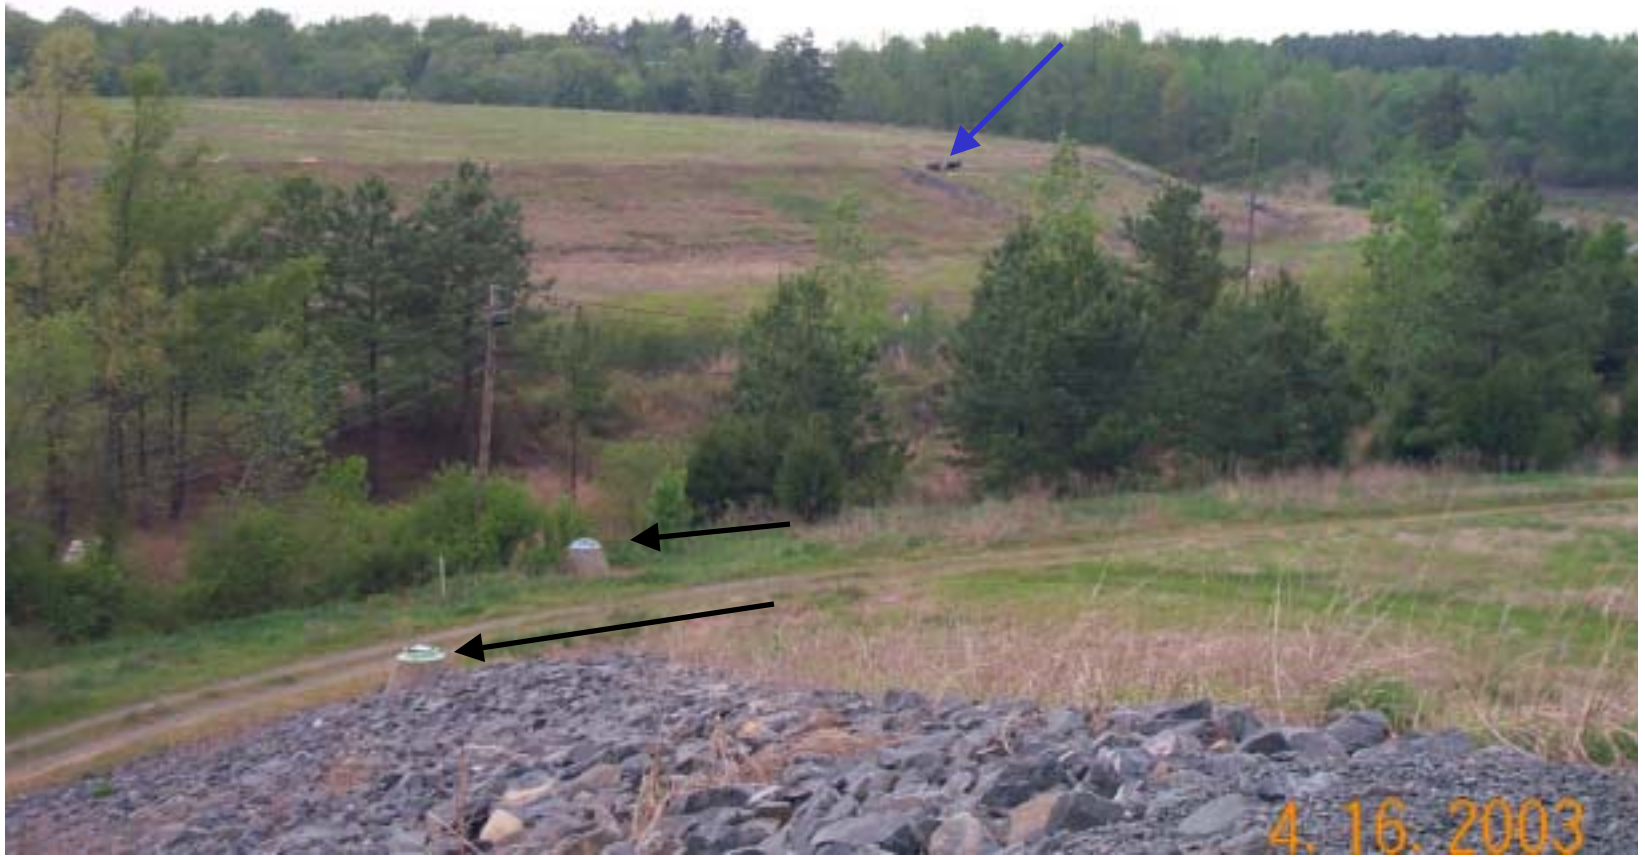
Photo 9: View of the OU1 landfill from Mt. Vertac. View is to the northwest. Two sumps for the french drain are visible in the foreground (black arrows). The leachate collection and detection system sumps are visible on the landfill (blue arrow).

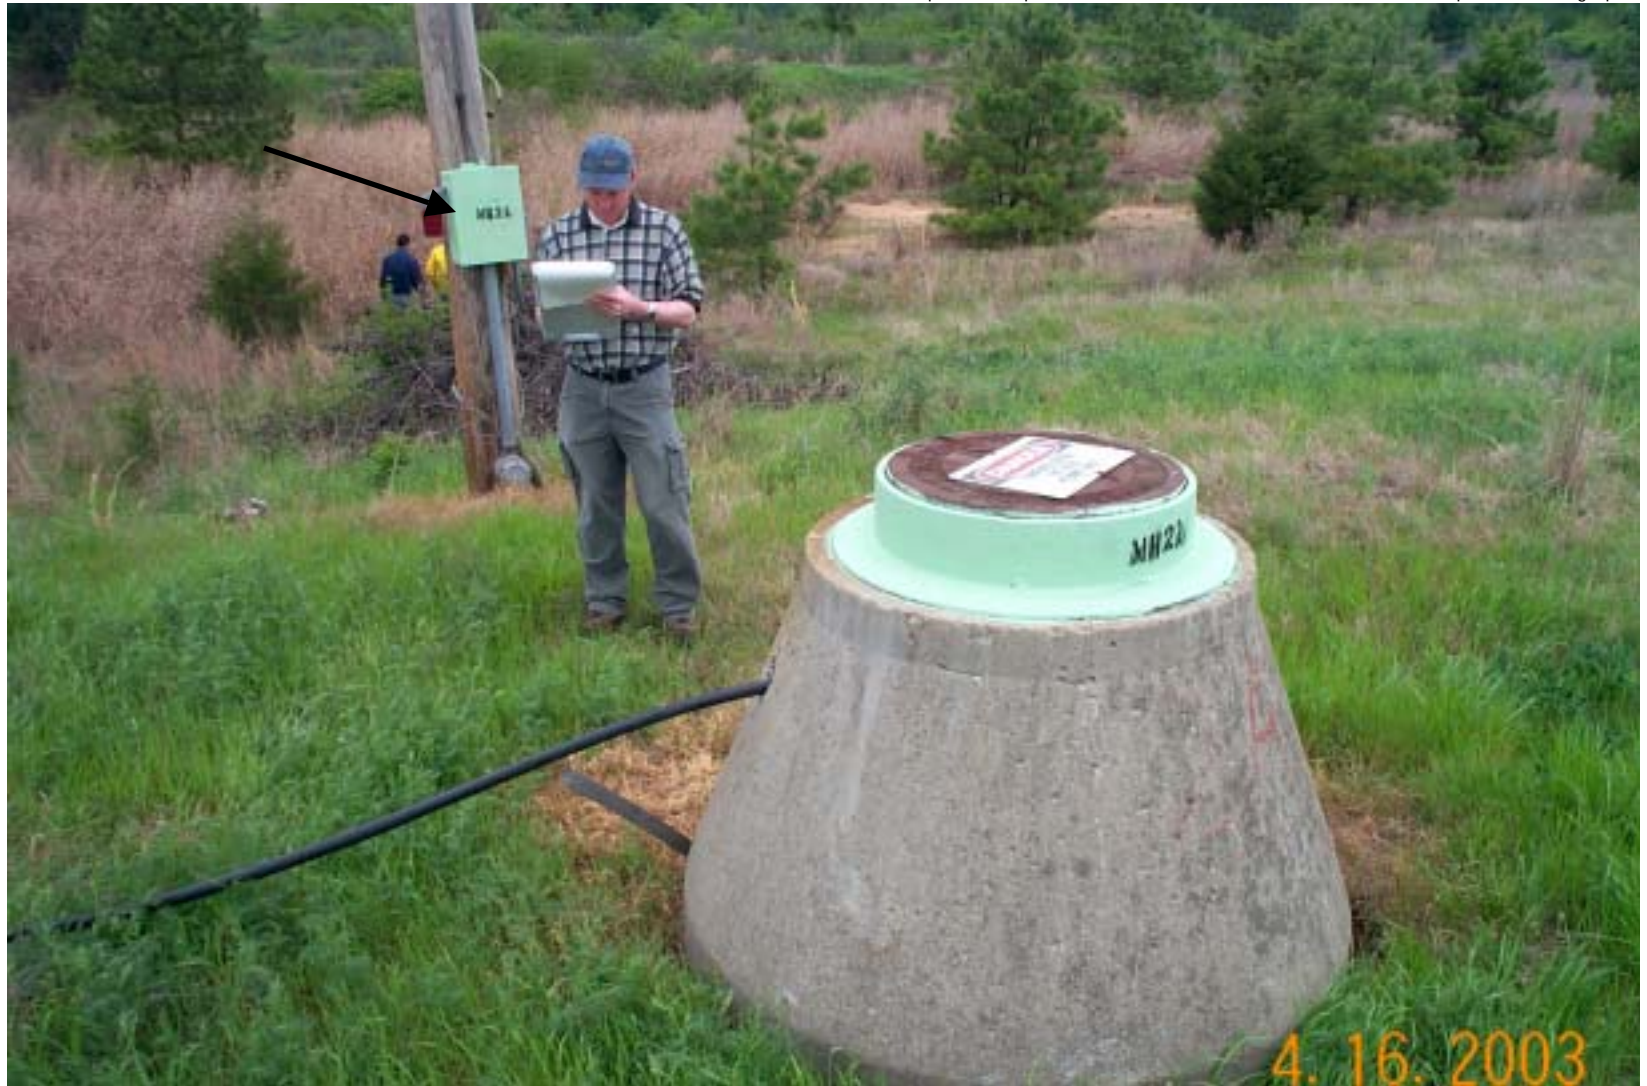
Photo 12: View of Manhole 2A of the french drain. The manhole contains a sump and pump to collect and remove leachate. The controller box for the pump and leachate level detector system is mounted on the pole in the background (at arrow).

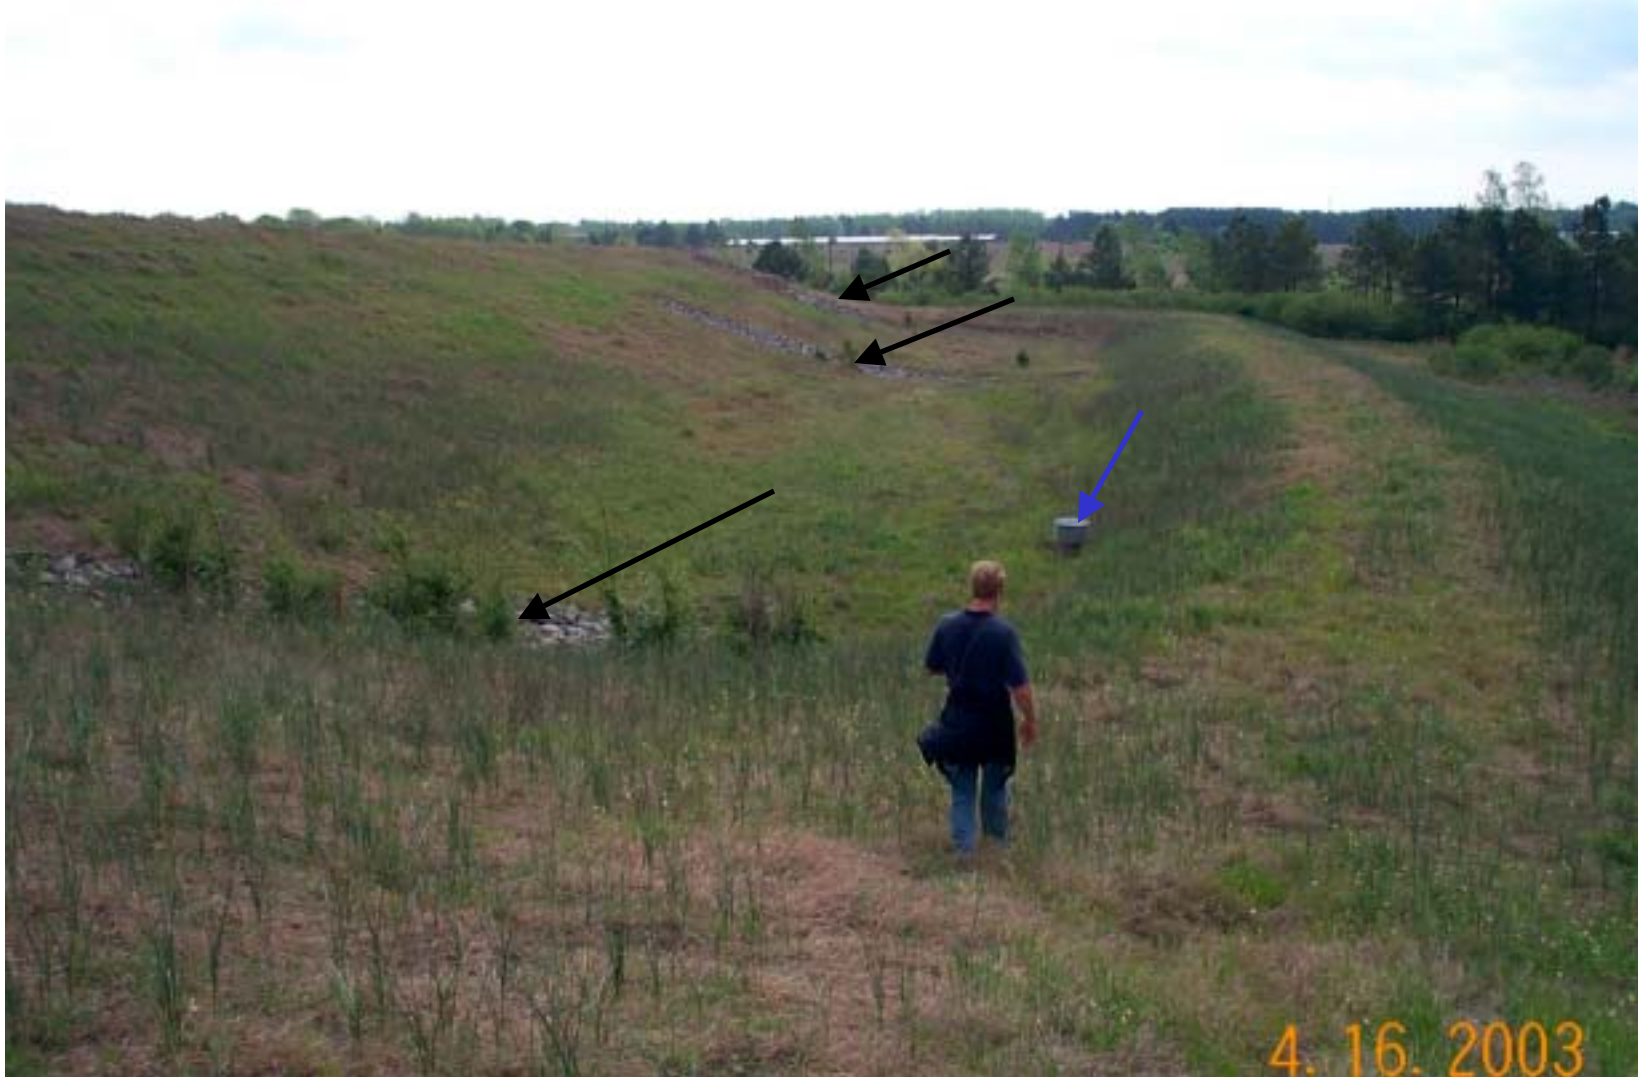
The second five-year review site inspection also included an inspection of the OU1 landfill. The vegetative cover was observed to be thin in places on the cap (**Photograph Nos. 22, 23, 28, 29, and 30**). A few small pine trees were observed growing on the cap (**Photograph Nos. 21, 25, 26, 27, and 30**), and again these trees were properly removed by GEC following the request of the EPA RPM. Some minor erosion was noted at the base of the cap along the northern edge. No signs of slumping, bulging, cracking, or settlement were noted on the cap. The leachate collection and leachate detection sumps were secured and in good condition (**Photograph Nos. 23 and 24**). A few small animal burrows were present on the cap. The letdown channels are covered with large rocks. These channels drain runoff from the top of the cap. The letdown channels were in good condition, and only minor erosion was noted (**Photograph Nos. 20, 21, 22, and 25**). Sedimentation ponds to address runoff from the landfill cap are present along the north, east, and south sides of the landfill. The containment structures surrounding these ponds appeared to be in good condition. The overflow structures were also in good condition, and no signs of excessive siltation were noted in the sedimentation ponds (**Photograph 20**).

Photo 20: View of sedimentation basin at the south end of the OU1 landfill. View is to the east. Rock lined structures (black arrows) are letdown channels. Metal structure (blue arrow) is drainage pipe for the sedimentation basin.

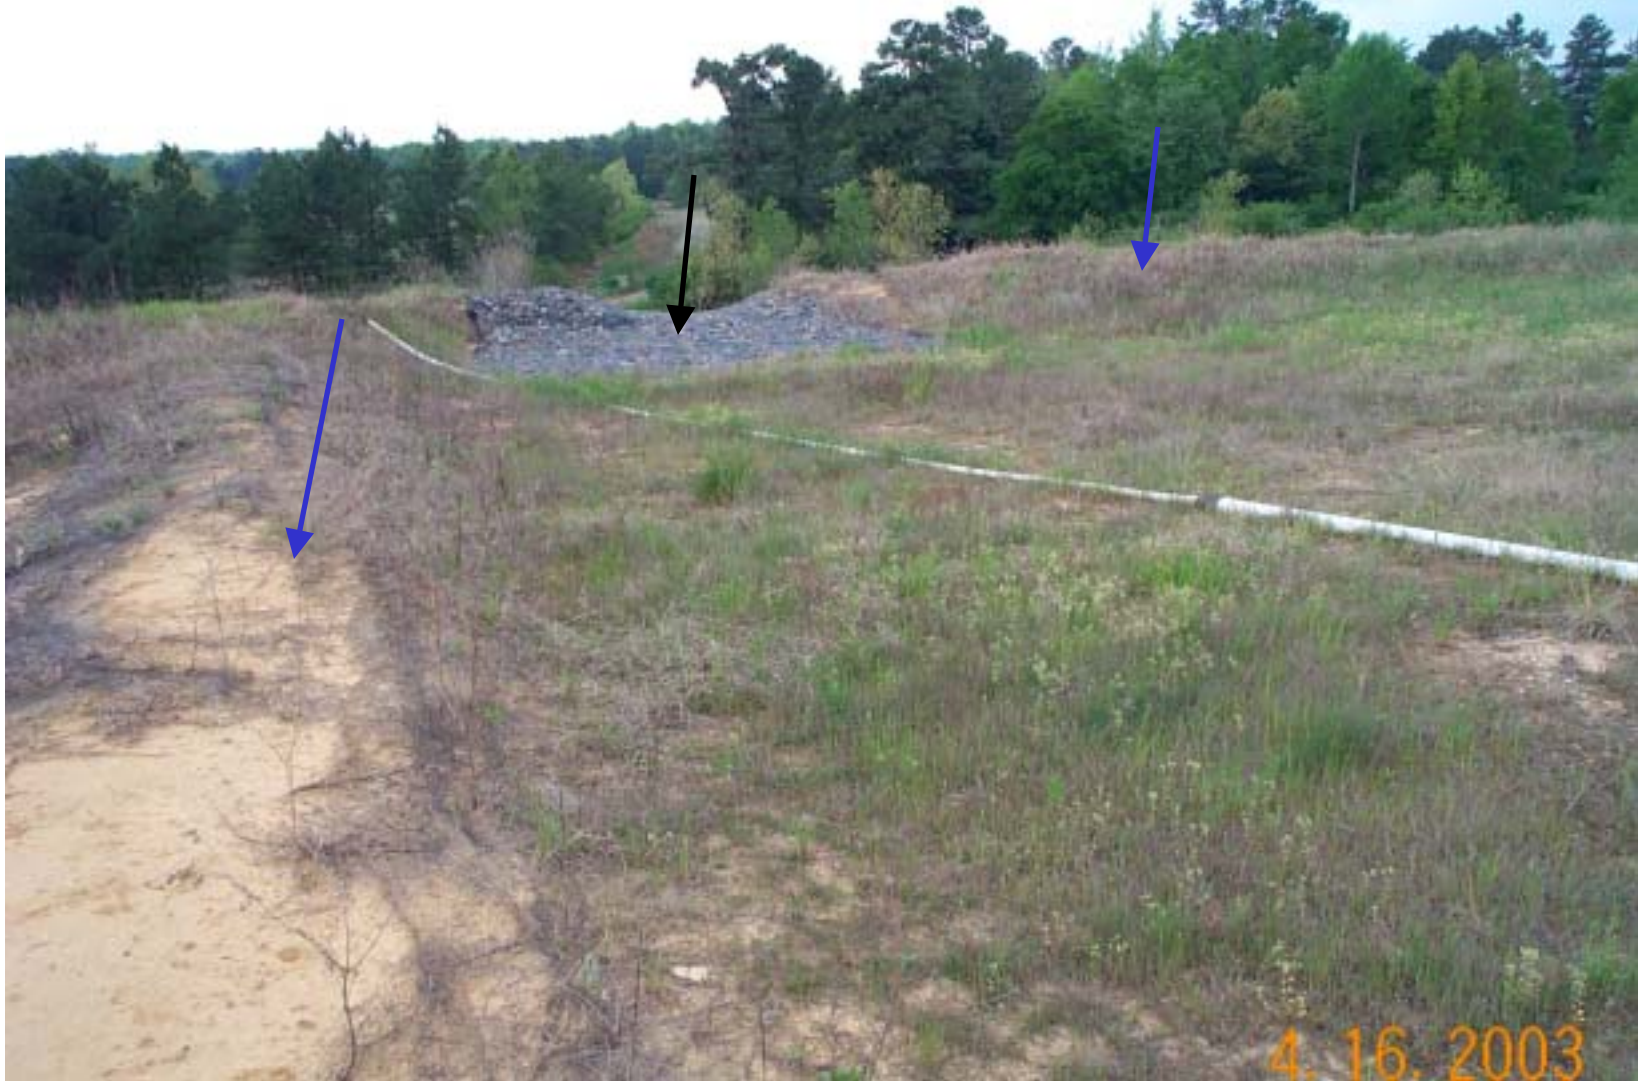
Photo 22: View of letdown channel (black arrow) from the top of the cap at the OU1 landfill. Berms (blue arrows) around outside edge of cap direct runoff to the letdown channels.

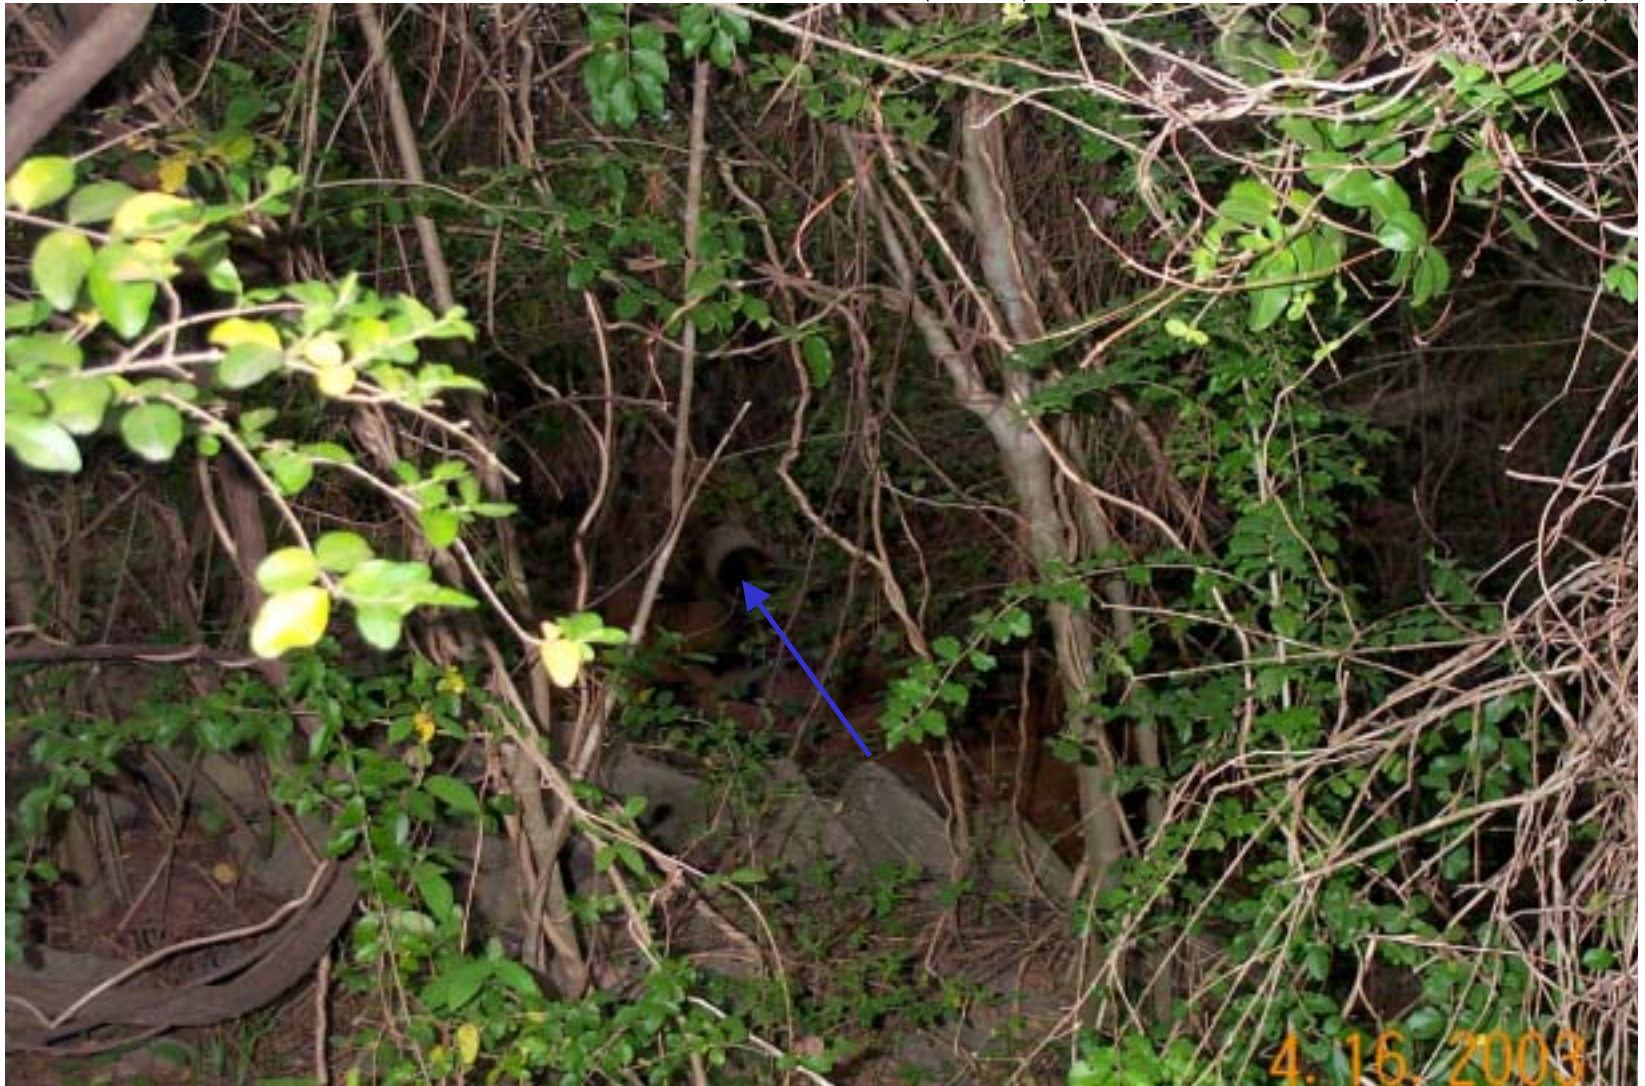
The wastewater treatment plant was also inspected (**Photographs 1, 2, and 3**). Two large equalization tanks are located outside the building (**Photograph 46**). These tanks store the water extracted from the french drain and the ground water extraction system. In addition, leachate recovered from the leachate collection sumps at the OU1 landfill is also pumped into these tanks. The tanks appeared to be in good condition. No leaking was noted around the tanks, and proper secondary containment is present around the tanks. Inside the wastewater treatment plant building, the components of the system include two pumps (**Photograph 47**), two sand filters (**Photograph 48**), a backwash hold tank for the sand filters (**Photograph 48**), three carbon treatment units (**Photograph 49**), a pH neutralization tank (**Photograph 50**), and the treated water tank (**Photograph 50**). Sampling ports are located inside the building before each carbon treatment unit, after the final carbon treatment unit, and after the treated water tank (**Photograph 51**). All components inside the building appeared in good condition. The wastewater treatment plant only operates when enough water has been recovered to treat. The plant was not operating at the time of the site inspection. The facility can be operated manually, but the system is primarily operated by computer. The outfall for the wastewater treatment facility was also inspected (**Photograph 35**). No discharges were observed, and the discharge pipe appeared to be in good condition.

Photo 35: View of discharge pipe from the Wastewater Treatment Plant (blue arrow).

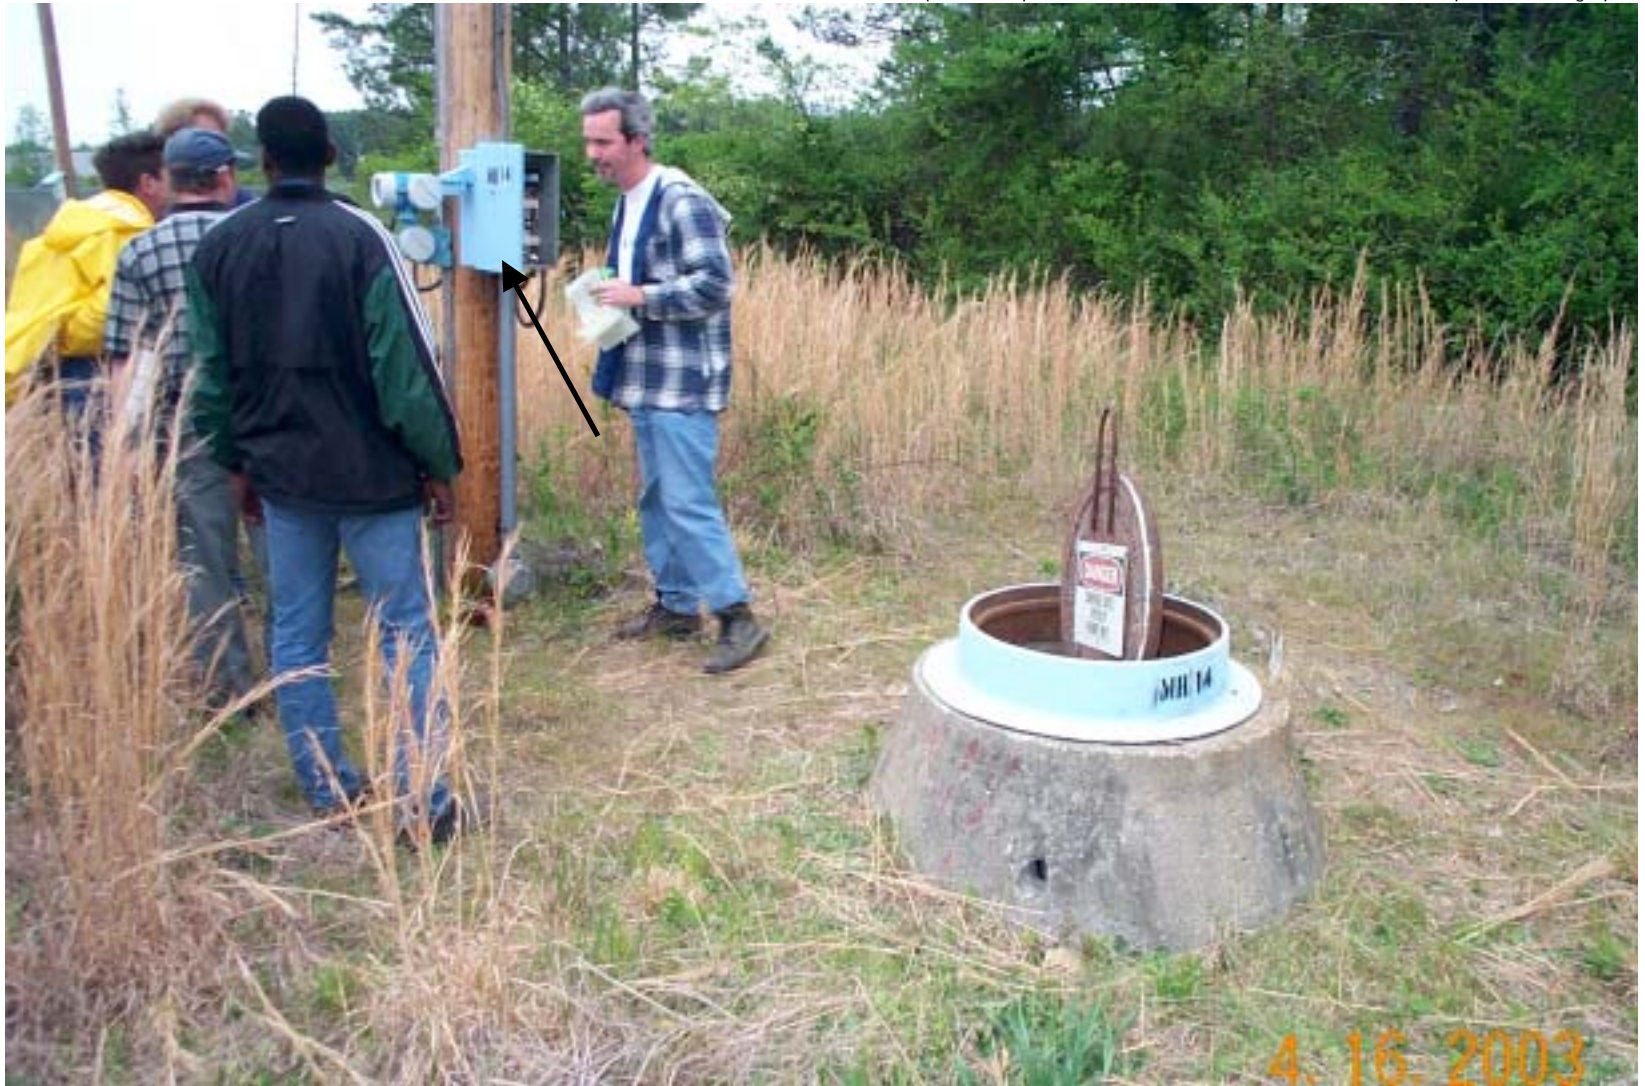
Photo 38: View of Manhole 14 of the french drain system. Manhole cover has been removed for inspection. The controller box for the pump and leachate level indicator are mounted on the pole at left (arrow).

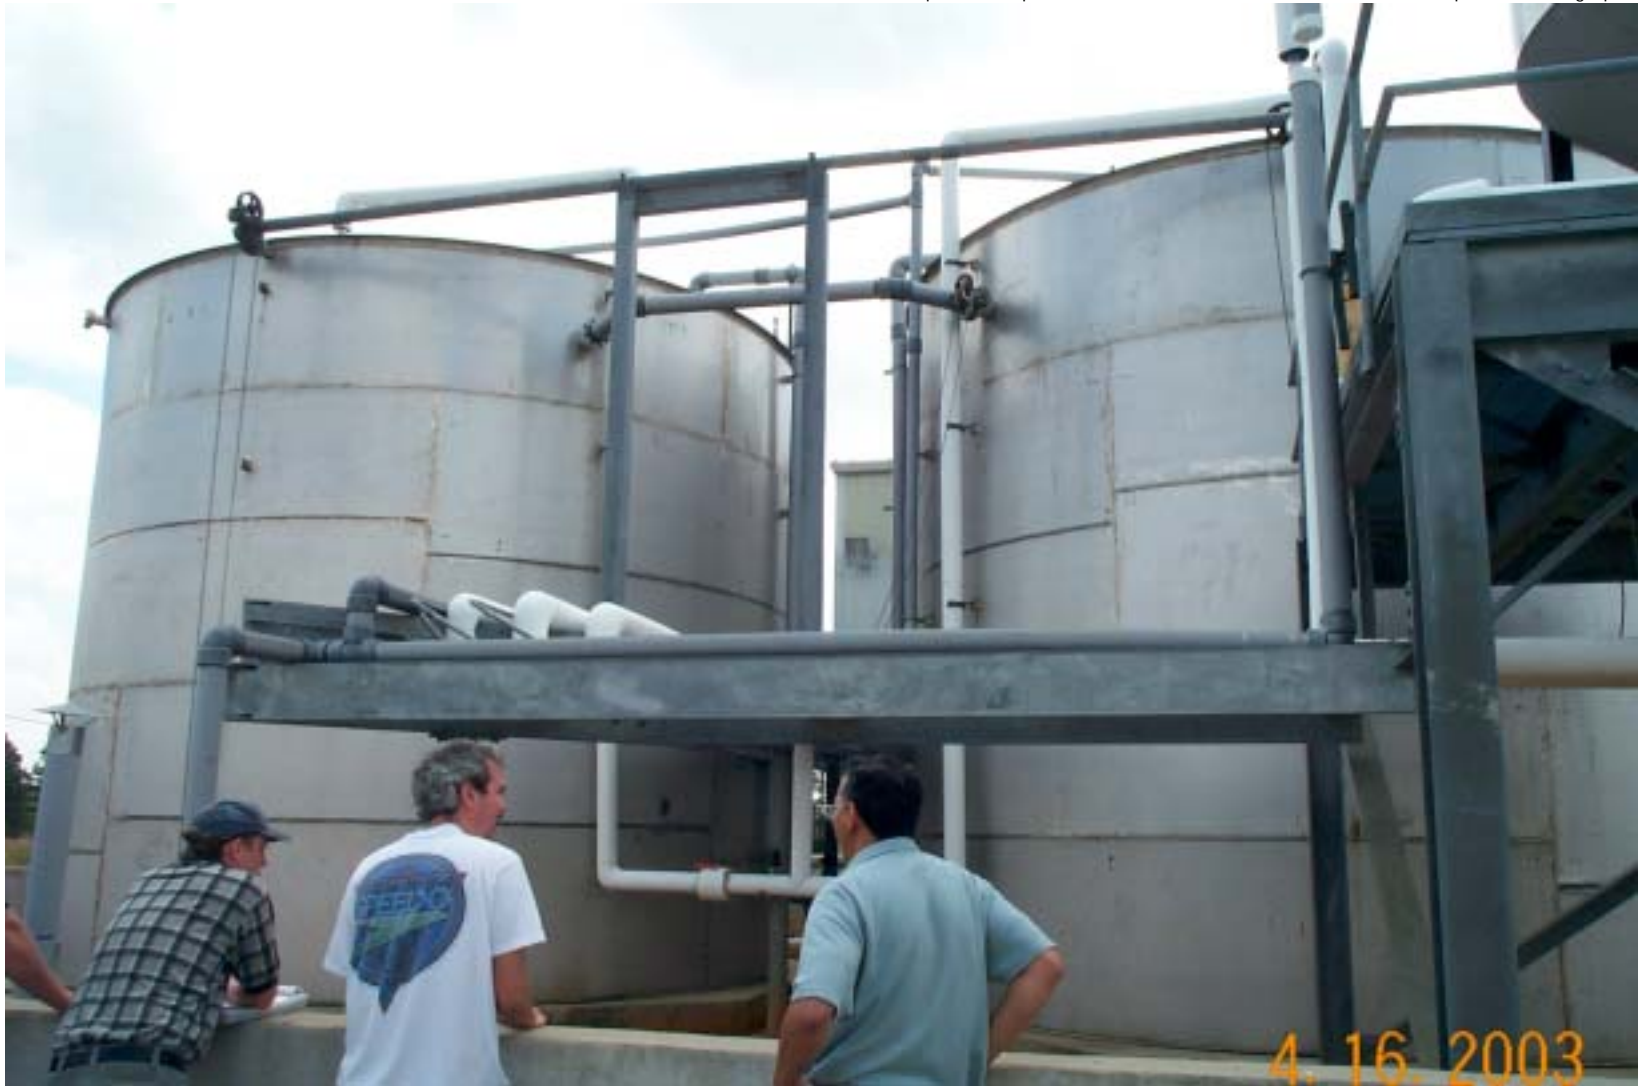
Photo 46: View of equalization tanks outside the Wastewater Treatment Plant. Tanks store contaminated water and leachate prior to treatment.

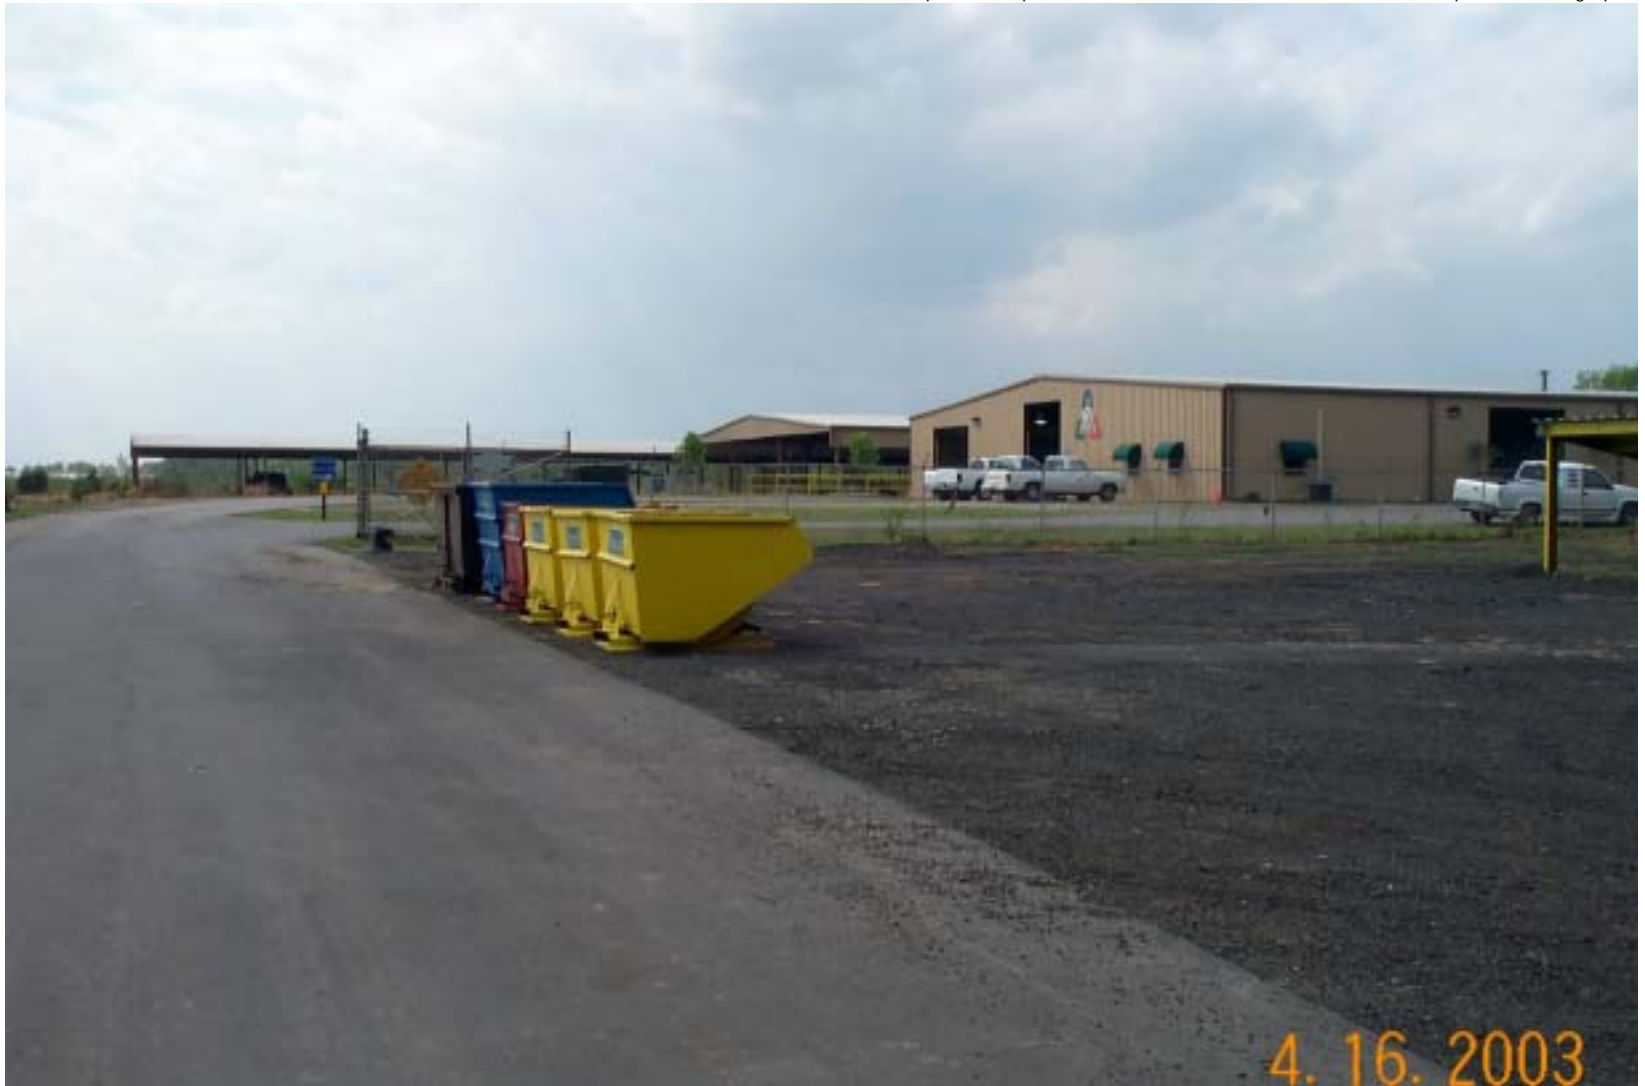
During the remedial action, approximately 10,000 cubic yards of highly contaminated wastes were incinerated. Approximately 25,000 cubic yards of contaminated debris (from the demolition of buildings and equipment) and 20,000 cubic yards of contaminated soil were disposed in the onsite RCRA Subtitle C landfill. All remedial actions were completed for the site in 1998; EPA and the State of Arkansas conducted the final inspection on June 24, 1998 (EPA, 1998c). Much of the northern portion of the site (the area of approximately 100 acres adjacent to the former 93 acre plant site) has been released for reuse, and long-term O&M is ongoing for the southern portions of the site, which includes the landfills and ground water extraction and treatment system (EPA, 2000). In the period since completion of the first five-year review, the City of Jacksonville municipal government has assumed possession of the northern part of the site, and now operates a drive-through recycling facility and houses its Sanitation Department in some of the former drum storage sheds EPA constructed during the incineration process (refer to [Photographs 53](#) and [54](#) of [Attachment 4](#) of this five-year review).

Photo 53: View of the City of Jacksonville's Sanitation Department and drive-through recycling center. These facilities are located in a shed on the northern portion of the site. View is to the west.

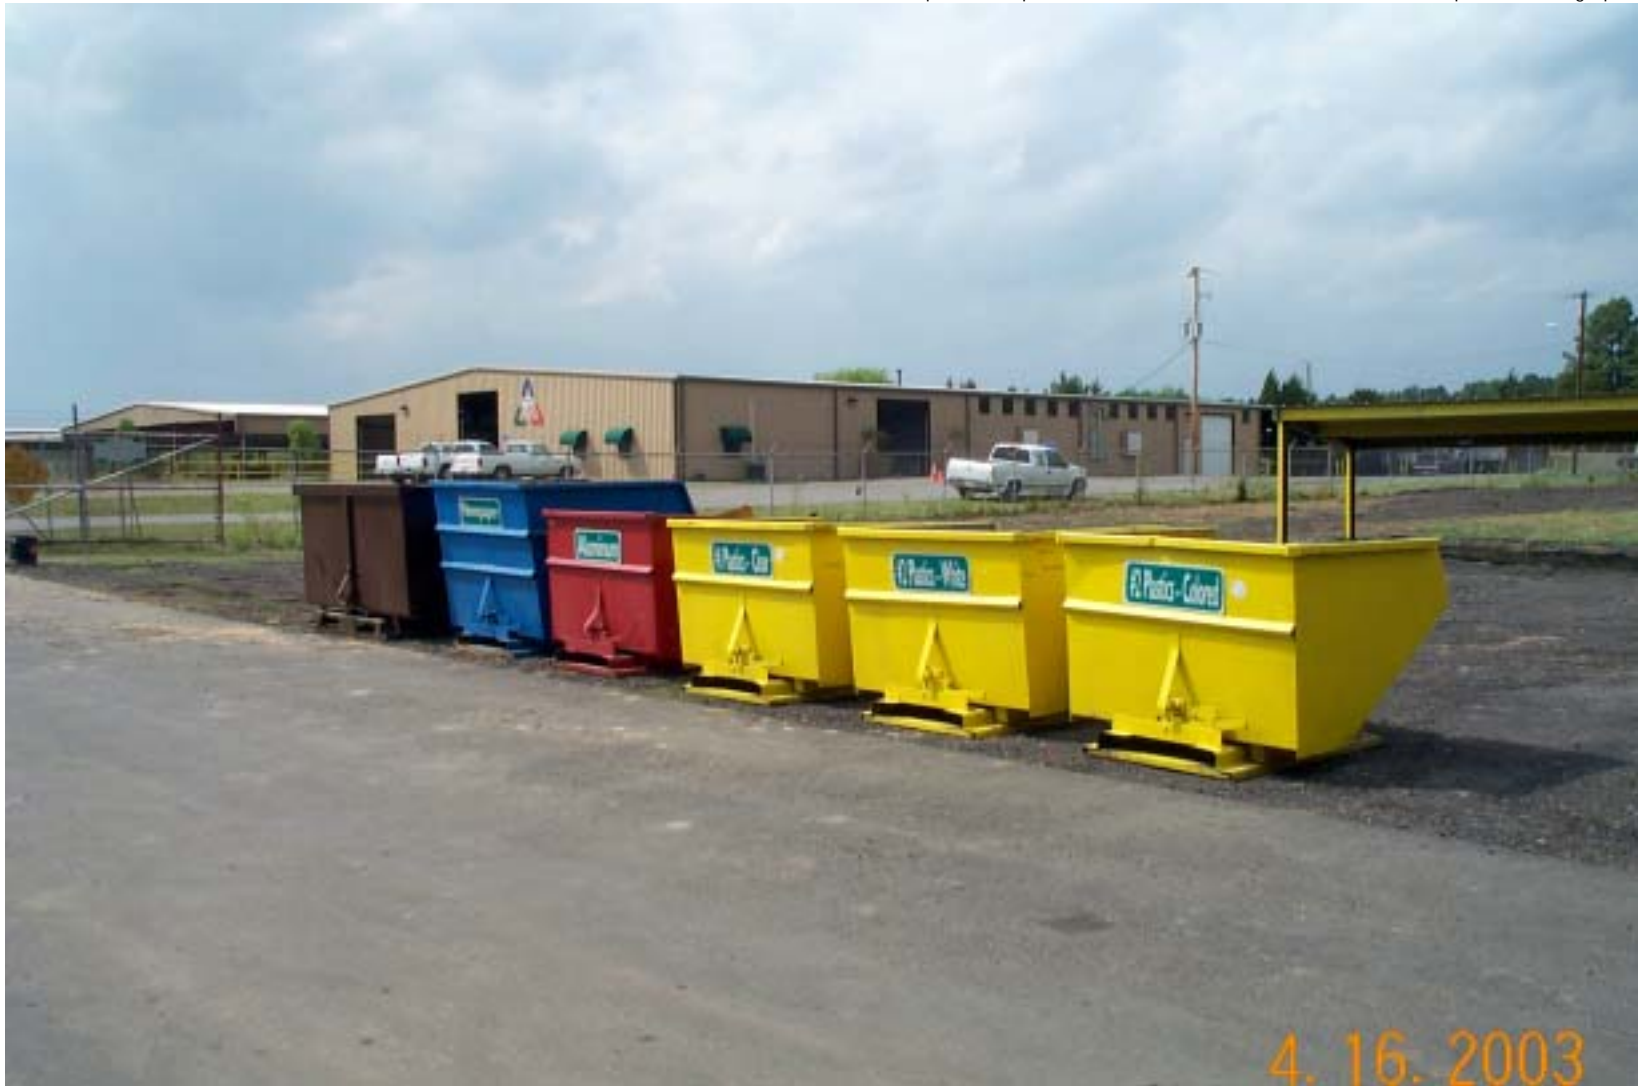
Photo 54: View of drop-off bins for recyclable materials at the City of Jacksonville's drive-through recycling center.
