Rail Passenger Equipment Accidents and the Evaluation of Crashworthiness Strategies

David C. Tyrell
Volpe National Transportation Systems Center
U.S. Department of Transportation

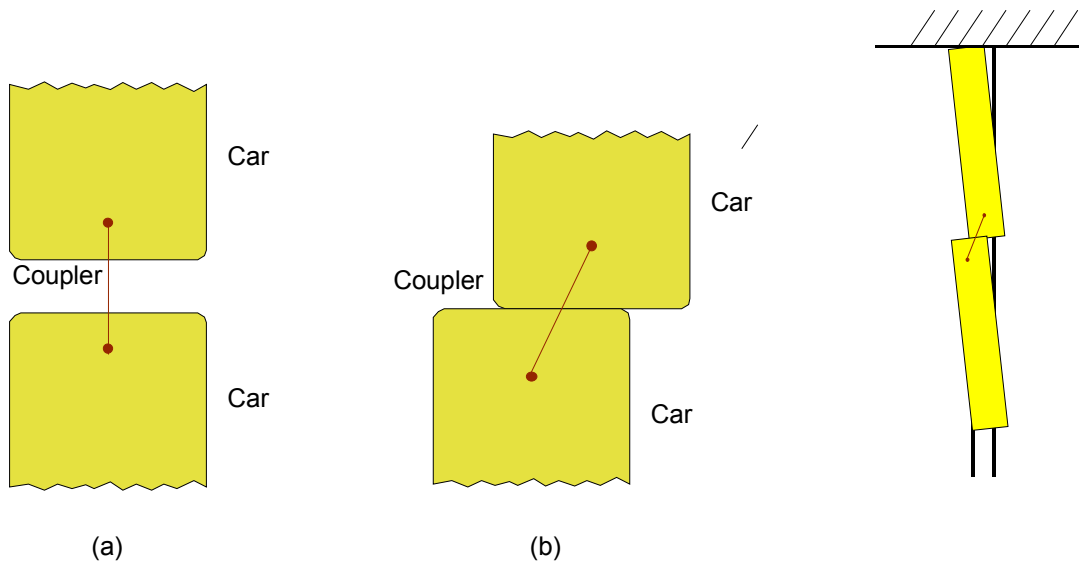
Figure 3. Schematic illustration, sawtooth lateral buckling.

During a train-to-train collision, passenger trains will typically buckle out laterally in either a relatively small amplitude sawtooth pattern or in a relatively large amplitude zig-zag pattern. This is due to the linkage behavior of the couplers used on North American passenger equipment. These couplers essentially form a rigid link between cars. When there is a high longitudinal load present, with only a small perturbation, the link formed by the couplers laterally pushes on the ends of the cars. As a result, when the ends of the cars contact, they are laterally offset from each other. The behavior is illustrated schematically in Figure 3.

Once the cars are misaligned, the high longitudinal force acting on one car exerts a significant lateral component on an adjacent car. Consequently, the train will continue to buckle out into the relatively large amplitude zig-zag pattern if there is sufficient energy from the collision. Depending on the severity, this mode may progress until the cars have side-to-side impacts. The results of this behavior have been observed in accidents (22, 23, 24). The progression of the cars being in-line, to the sawtooth lateral buckling pattern to the zigzag pattern has been simulated (5) with computational models. The progression from in-line to sawtooth buckling has been observed and measured in detail during testing (8, 9).

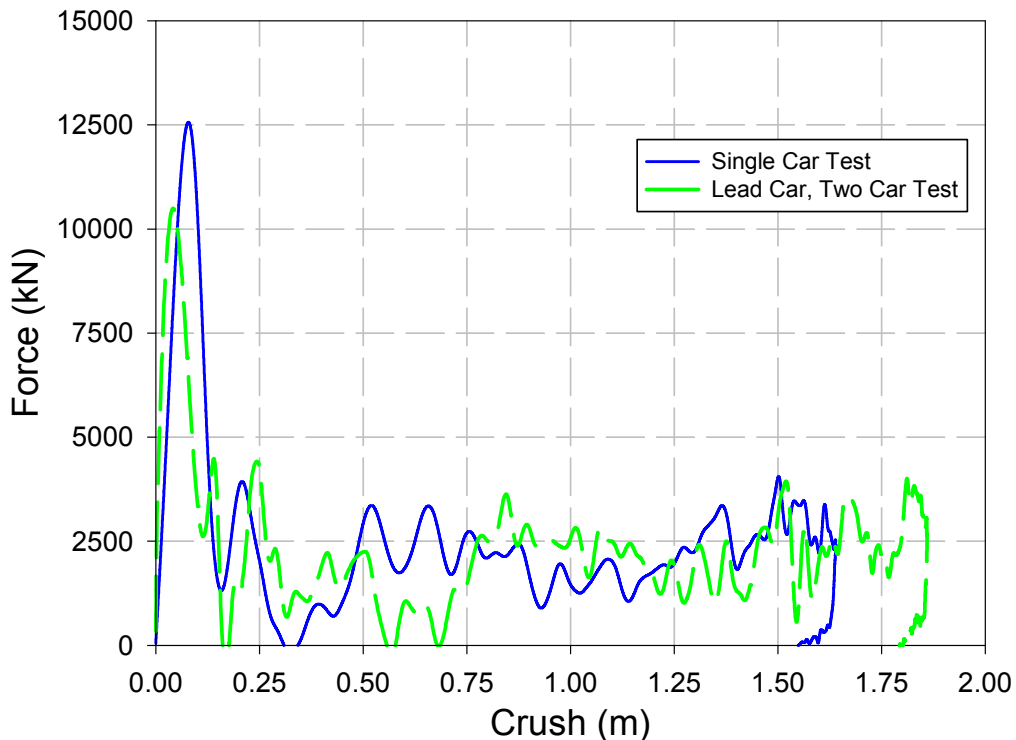
Figure 4. Force/crush curves, typical U.S. passenger equipment.

The force/crush characteristics of the cars and locomotives significantly influence which cars are crushed during a collision, as well as the overall behavior of the train. High strength is required to preserve the occupant volume. However, this high strength, with small vertical or lateral misalignments of the cars, can result in significant lateral and vertical forces. The lateral and vertical forces can amplify any tendency toward lateral buckling of the train or toward override. Figure 4 shows the force/crush characteristics developed from measurements made during impact tests of a single passenger car into a fixed barrier and of two coupled passenger cars into a fixed barrier (7, 8, 9). Both of these curves have high initial peak loads followed by significantly lower loads, which are approximately constant, for continued crush. Similar crush curves have been developed for locomotives (25, 26), and these crush curves are also characterized by high initial loads followed by significantly lower loads.

One implication of the force/crush characteristic shown in Figure 4 is that the crush will be focused on the colliding cars. If two trains, which are made up of cars with the crush characteristics shown in Figure 4, collide, at best only the two colliding cars will crush. Indeed, only one of the colliding cars may crush if the other colliding car has a marginally greater peak crush load. This is principally owing to the inability of a colliding car to push back with sufficient force to crush the car behind it. In the test of two coupled cars impacting with a fixed barrier (8, 9), the lead car sustained significant structural damage – its length was reduced by nearly two meters – while the front end of the trailing car sustained only minor scarring due to the direct contact with the trailing end of the lead car. The most force the car ahead can exert is the lower crush load, while the car behind can apply up to the peak load. There is often little damage to the trailing cars in train collisions of typical U.S. passenger rail equipment.

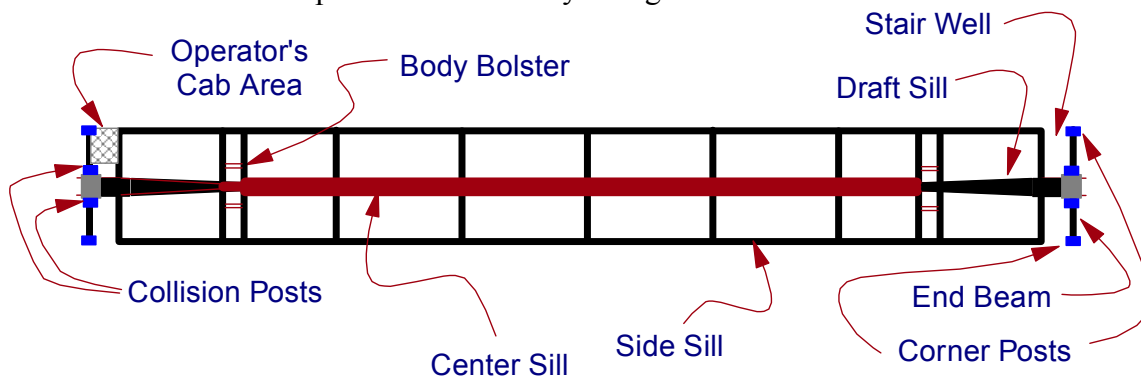
Figure 14. Schematic of typical cab car structural members, plan view.

The typical North American passenger cab car structure consists of an underframe, an end structure and a body shell. The underframe consists of four longitudinal members: the center sill, draft sill and two side sills, and two body bolsters, which laterally connect the center sill, draft sill, and two side sills. The end structure consists of an end beam (or buffer wing), two vertical collision posts and two vertical corner posts. The structural members with the largest cross-sectional areas are the center sill, the draft sill, and the body bolster. The main cab car structural members are depicted schematically in Figure 14.

The main structural elements (i.e., body bolster, center sill, draft sill) of the cab car in the Secaucus collision remained essentially intact. The structural damage consisted principally of crushing of one side of the vehicle, from the end beam to the body bolster longitudinally, and from side sill to the roof plate vertically. There was significant damage to the impacted corner post, end beam and side sill. The end beam failed near the base of the collision post. Figure 15 schematically illustrates the structural damage to the frame of the cab car.

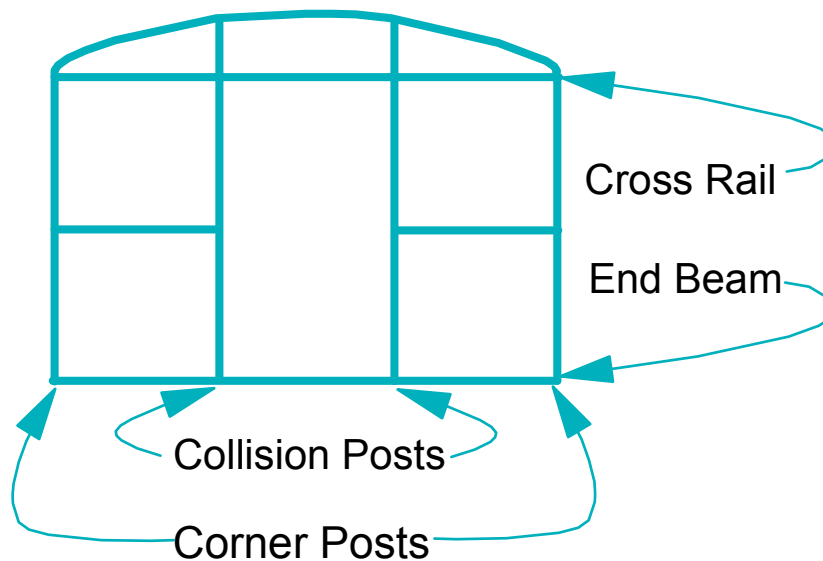
Figure 21. Schematic illustration of cab car end frame structure.

The end frame of the cab car is schematically shown in Figure 21. In cross-section, the collision posts have an I-beam shape. These posts were fabricated from sheet steel, and the widths of the two flanges are different. The collision post webs also included doublers, which extended from the base up to a point approximately 762 mm (30 inches) above the floor.

The coil struck one of the cab cars collision posts and it fractured. The fracture occurred near the impact point, which corresponds to the location where the doublers on the flanges ended. The fracture of the collision post is shown in Figure 22.

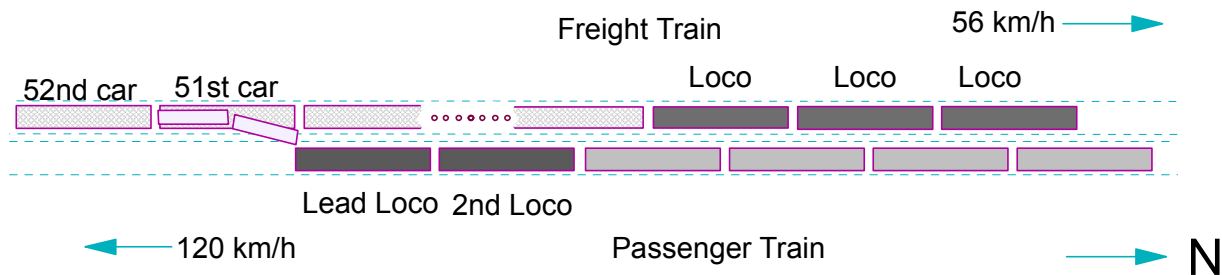
Figure 23. Schematic drawing, initial conditions of Selma, North Carolina oblique collision.

An overhanging intermodal trailer on the northbound freight train was obstructing the right of way of the southbound intercity passenger train. The northbound freight train was traveling approximately 56 km/h (35 mph) and the southbound passenger train was travelling about 120 km/h (75 mph). The forward trailer on the 51st car was overhanging the southbound track and engaged the lead locomotive of the passenger train. At the onset of contact, the trailer was above the deck and offset outside of the collision posts of the passenger train lead locomotive. The assistant engineer was killed during the accident and the engineer was severely injured. Figure 23 schematically depicts the conditions that initiated the oblique impact.

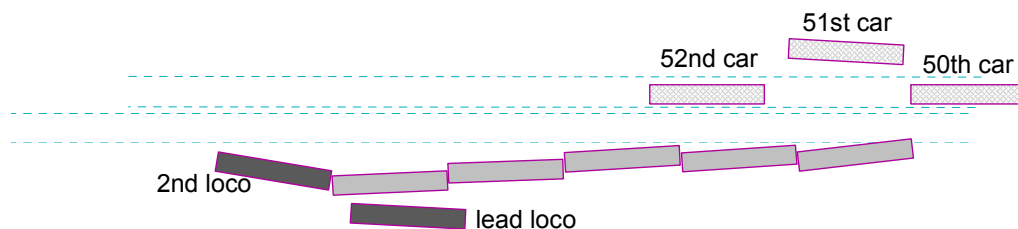
Figure 24. Schematic drawing, final conditions of Selma North Carolina oblique collision.

Damage to the short hood began at the right front corner and extended along the right side to the control compartment. The lead locomotive in the passenger train derailed and rolled over, coming to rest on its left side. All but one of the trailing cars, as well as the second locomotive, left the track, but remained upright. Only the last two cars in the freight train derailed and were damaged. The trailer, which was full of cat litter, burst open, spilling its contents along the track. The flatcar carrying the intruding trailer came to rest about 12 m (40 ft) off the track in an upright position with the deck and end bent. Figure 24 schematically depicts the conditions immediately after the accident.
