**RAIL-CAR IMPACT TESTS WITH STEEL COIL:  
CAR CRUSH**

**Eloy Martinez  
David Tyrell  
John Zolock**

Volpe National Transportation Systems Center  
US Department of Transportation  
Cambridge, MA 02142 USA

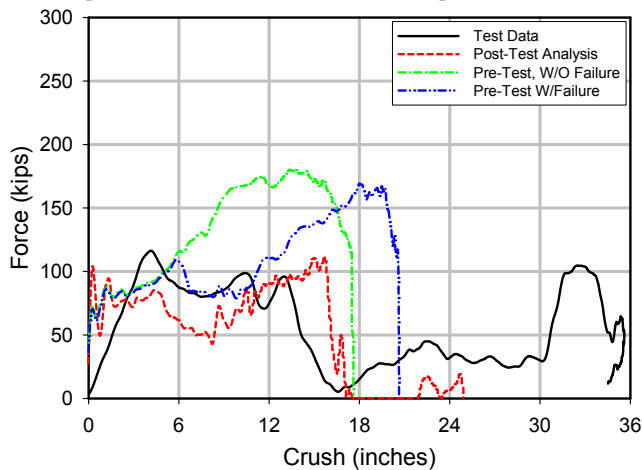
Figure 7. Measured and Predicted Fore/Crush Characteristic, 1990's Design

Figure 7 shows the force/crush characteristic developed for the 1990's design as predicted with the model and as measured during the test. Both pre-test and post-test predictions are shown on the plot. The pre-test predictions from the analysis including material failure and the test measurements are in close agreement up to approximately 12 inches of crush. After 12 inches of crush, the pre-test predictions show the force increasing, while the test measurements show the force decreasing. A source of the discrepancy could have resulted from late changes in the attachment of the anti-telescoping plate to the cant rail that were not incorporated in the model prior to the test and from limitations of the current approach to modeling material failure in finite-element solvers. As a result, failure of the upper attachment of the corner post occurred sooner in the test than predicted.

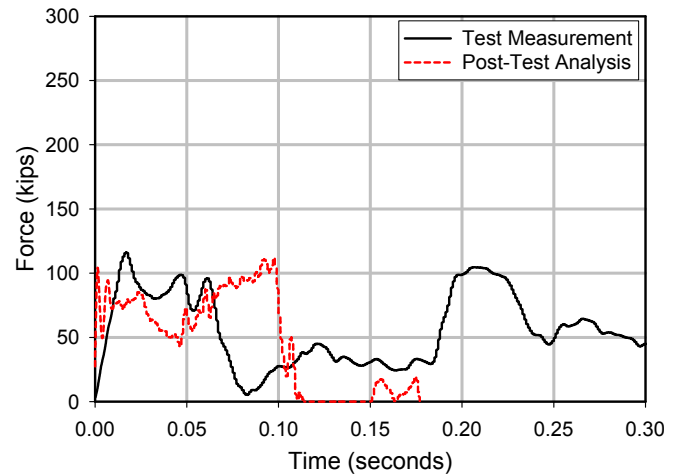
Figure 8. Measured and Predicted Force-Time History, 1990's Design

Figure 8 shows the force time post-test finite element results as well as the derived force time curve taken from test measurements. A nine-accelerometer array was used on the steel coil for the test and the force presented is the resolved acceleration times the mass of the steel coil. The results from the simulation and those derived from the test are very close for the first 0.03 seconds. Between 0.03 seconds and 0.05 seconds the measurements are showing somewhat elevated force levels compared to the analysis (~25%.) Again the results overlay one another between 0.05 seconds and 0.06 seconds. The key difference occurs after 0.06 seconds where the measurements indicate softening behavior due to the failure of the lateral member/shelf and pull-out of the corner post from the anti-telescoping plate over ~0.015 seconds.

The model is predicting a peeling/tearing failure of the lateral member/shelf from the corner post thereby losing a source of load transfer. This resulted in a decreased load in the finite element results between 0.02 seconds and 0.05 seconds. The pull-out failure of the corner post from the anti-telescoping plate occurs in the finite element model around 0.1 seconds. The softening behavior occurs over a much shorter time frame ~ 0.004 seconds. The differences in predicted failure response in time is not surprising given the current state-of-the-art in ductile fracture modeling.

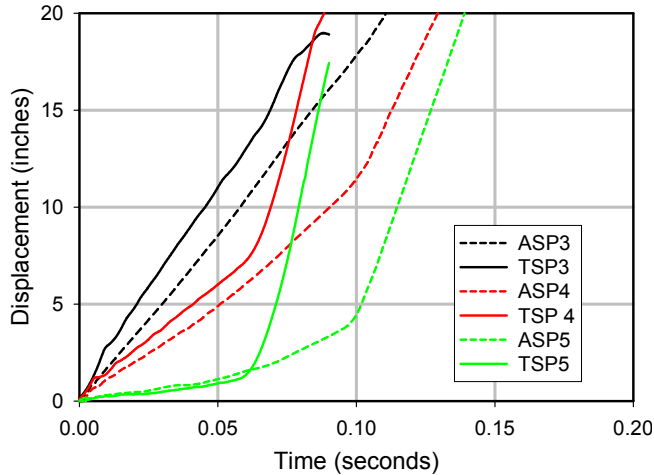
Figure 9. Measured and Predicted Longitudinal Displacement-Time Histories on Circa 1990 Corner Post

Figure 9 shows a comparison of the post-test finite element results taken from corresponding positions on the corner post as the measured longitudinal displacements taken from selected string potentiometers. String potentiometer position varies from bottom to top starting at position 1 and ending at position 5 with the lead letter differentiating the test measurement (T) from the analysis result (A). The string potentiometers are symmetrically placed to equally divide the corner post between the end beam and the anti-telescoping plate.

A detailed discussion of the information presented by TSP3 is given which is representative of the mechanisms occurring for all the string potentiometers. The first slope occurs between initial impact and 0.01 seconds which corresponds to ~ 2.75 inches of displacement. The second slope range occurs between 0.01 seconds and 0.09 seconds

and corresponds to failure of the lateral member/shelf as well as pull down of the anti-telescoping plate. Finally, between 0.07 seconds and 0.09 seconds the last slope corresponds to pull-out of the corner post from the anti-telescoping plate. It is interesting to note that lag time in response from the position of TSP3, TSP4, and TSP5. The nearest string potentiometer to the anti-telescoping plate, TSP5, notices disturbances from the anti-telescoping plate before the further removed string potentiometer, TSP3. The test data has only been plotted to just after failure of the anti-telescoping plate attachment; data past that time is unreliable due to failure of the gauges.

The maximum measured displacement of the corner post near the point of impact, prior to separation of the anti-telescoping plate attachment, taken from this figure is approximately 19 inches. Upon pull-out, there is some elastic recovery and post-test measurement showed that the corner post was permanently deformed by 18.5 inches.

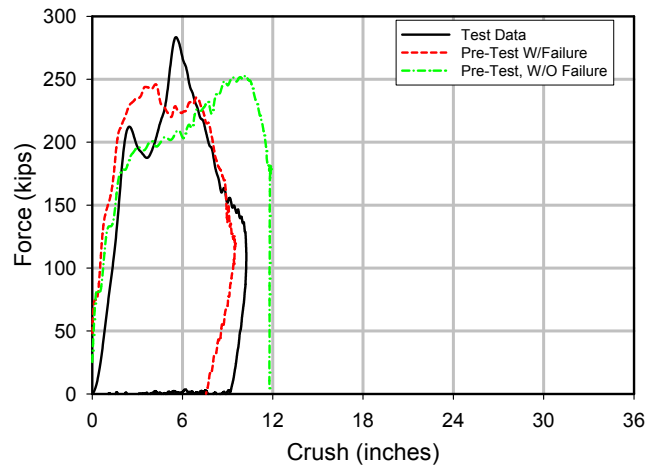
Figure 12. Measured and Predicted Fore/Crush Characteristic, SOA Design

Figure 12 shows the pre-test predictions for the force/crush characteristic for the State-of-the-Art Design. The model was exercised with and without material failure. The model predictions with material failure nearly overlay the test results. Similar to the results discussed with the circa 1990 design, there is a small phase shift in the timing of events. The peak load caused by the initial contact occurs almost instantaneously for the finite element model and is higher than what occurs in the test measurements. As seen from the test measurements, there is a finite rise time for the initial load and the peak load is smaller. In both the test measurements and the crush model results the initial peak is associated with the formation of the central plastic hinge on the corner post. The second and third peaks with their associated load plateaus correspond to the formation of the plastic hinges at the corner post/end beam connection and the corner post/anti-telescoping plate connection respectively. The difference between the crush models with and without failure is apparent after 4 inches of crush. The model without failure considerably over predicts the load after 6 inches of crush, but has a similar unloading slope as observed in the test. The model with failure predicts slightly higher loads after 7 inches of crush but the same maximum crush distance as observed in the test. However, the rate of unloading predicted with the no failure model is slower than observed in the test.

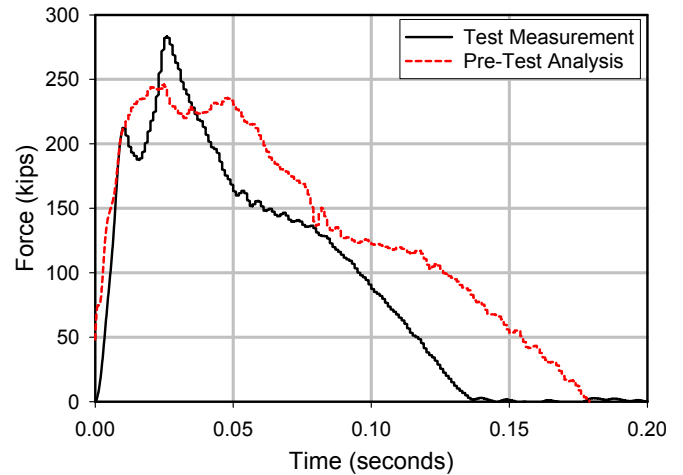
Figure 13. Measured and Predicted Force-Time Histories, SOA Design

Figure 13 shows the force time comparison of the test measurements and the crush model with failure. The force time trace from the test was derived using the resultant deceleration taken from the nine-accelerometer array on the coil multiplied by the coil mass. The results presented are unfiltered. Despite the minor inconsistencies between the test measurements and the crush model results, there is very good agreement. The phase shift experienced in the model is not surprising given the simplicity of the failure criterion used. As elements fail and are removed and depending on the size of the mesh too much material is removed making the response predicted softer than what occurred in the test.

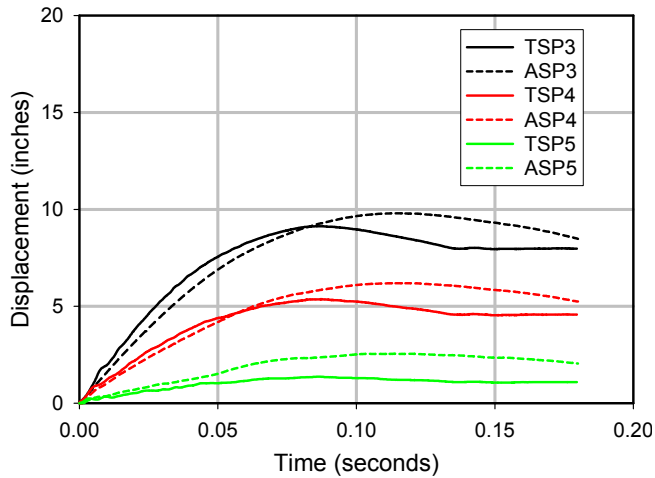
Figure 14 Measured and Predicted Longitudinal Displacement-Time Histories on SOA Corner Post

Figure 14 shows a comparison of the measured string potentiometer longitudinal displacement (solid line) with that predicted prior to the test (dashed line.) The crush model results reflect the average displacement taken at the centroid of the center element at the appropriate height on the corner post. The results presented are for the same string potentiometers as discussed in the 1990's design discussion above. Initially the displacements predicted in the crush model are less than those measured in the test at a given point in time which means the response predicted is stiffer. However when failure is predicted to start in the model, the structural stiffness

decreases due to too much material being removed during element removal. While the peak predicted displacements are larger in the model than predicted by the tests the unloaded final displacements are close. The flat lines at the end of each test result plotted show the final position of the post after rebound of the coil has occurred. The test measurement taken at the point closest to the point of initial contact is 8 inches while that predicted by the model is 8.5 inches.
