## JRCICE2007-40051

### CRASH ENERGY MANAGEMENT CRUSH ZONE DESIGNS: FEATURES, FUNCTIONS, AND FORMS

#### ABSTRACT

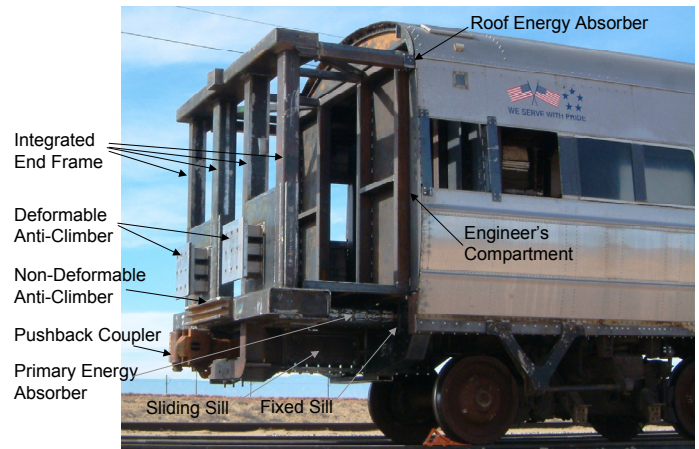
Figure 1. Cab Car Crush Zone

In the test, two types of crush zones existed: cab end and non-cab end. Three types of interfaces existed: impacting cab car, coupled non-cab car, and a coupled cab car. Figure 1 shows the FRA prototype cab end crush zone design that was developed as part of the research. The crush zone does not have exterior skin in this picture. The cab car crush zone includes several elements:

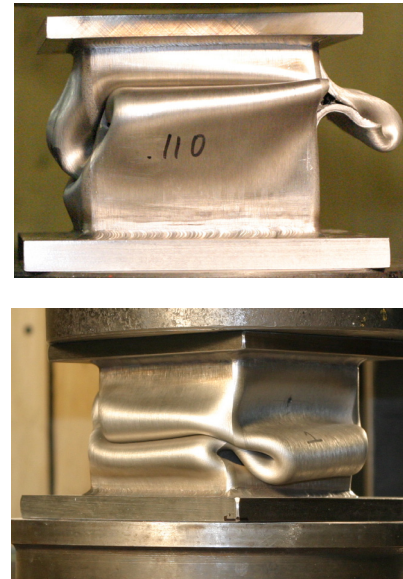
**Figure 7. Component Testing for the Deformable Anti-Climber: Material Failure (Top) and No Material Failure (Bottom)**

**Deformable Anti-Climbers** The deformable anti-climbers resolve non-longitudinal loads into planar loads through the integrated end frame while minimizing the potential for override. The design requirements do not allow material failure, since the component is required to resist longitudinal, lateral, and vertical loads. Figure 7 shows results from component tests in which the material did and did not fail. The stainless steel tubes were annealed to prevent material failure.

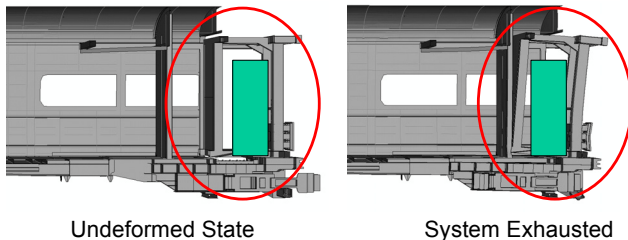
**Figure 10. Model Showing the Engineer's Compartment in the Undeformed State and Once the System Has Been Exhausted**

The engineer's compartment must be preserved so that the engineer can ride out the event. Figure 10 shows results from a model of the engineer's compartment in the undeformed state and once the system has been exhausted. In this design, the engineer's compartment is placed on top of the crush elements. Controlled crush occurs in the service closet, directly behind the engineer.

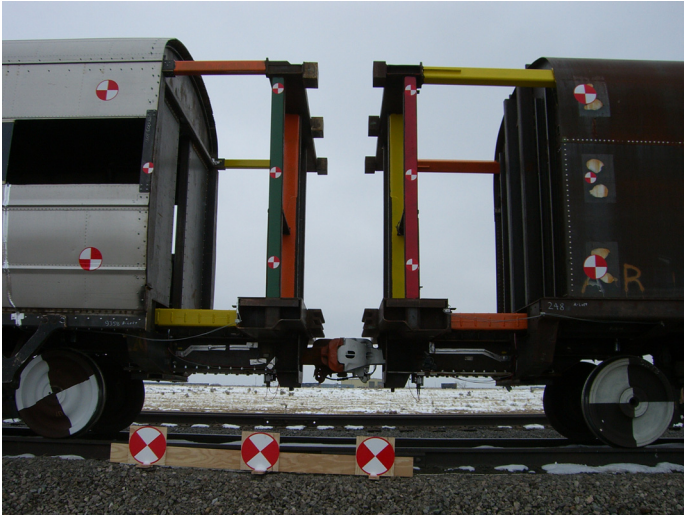
**Figure 12. Coupled Interface Pre-Test**

Figure 12 and Figure 13 show a typical coupled interface pre- and post-test. The post-test photo is a closeup view of the coupler, primary energy absorbers, and interlocking conventional anti-climbers. The crush zones remained inline laterally and vertically during the collision at all coupled interfaces.
