# RTDF2008-74020

# A DYNAMIC TEST OF A COLLISION POST OF A STATE-OF-THE-ART END FRAME DESIGN

Michelle Priante Patricia Llana Karina Jacobsen David Tyrell Benjamin Perlman US Department of Transportation Volpe Center Cambridge, MA

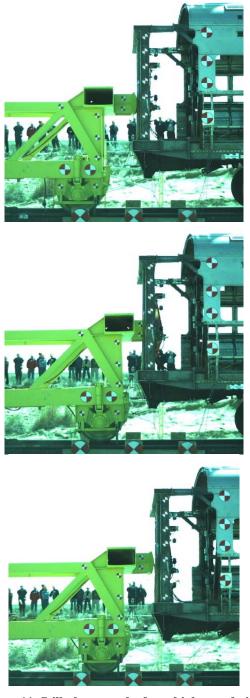
Figure 11. Still photographs from high-speed video

The actual test speed was 18.7 mph. The collision post indented approximately 7.375 inches, meeting the requirement that there be less than 10 inches of crush. The end frame exceeded the energy absorption requirement by absorbing 138,000 ft-lb of energy. Figure 11 shows still frames of the test taken from the high speed video. The top photo shows the cart at the first impact. The second photo shows the cart and collision post at the maximum amount of collision post deflection. The third photo shows the cart and end frame at the end of the test, after some elastic energy has been recovered form the collision post. The cab car moved back approximately 6 feet after the test and stopped. The cart lifted vertically and moved laterally on recoil. When the cart came down after impact, the wheels missed the track and the cart derailed. Since the cart came down off the tracks, it stopped and did not move backwards.

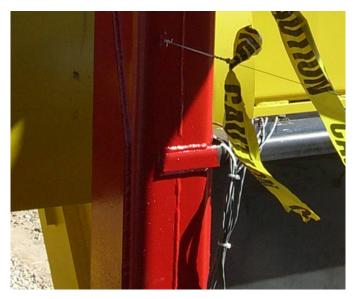
Figure 13. The back of the collision post, at the connection to the shelf, pre-test

Figure 13 shows the back of the collision post and the connection to the shelf before the test. The tab extends from the shelf and is welded to the back of the collision post. There is a gap between the side of the post and the shelf. The post is a box cross section formed by two U-sections welded together at the front and back of the post. There are several internal gussets in the horizontal plane.

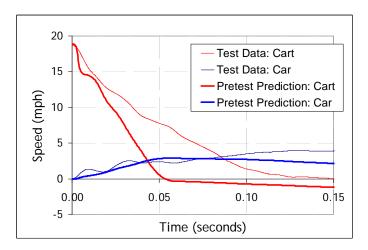
Figure 18. Accelerometer data, velocity vs. time for the cart and cab car

**Gross Motions** Figure 18 shows the velocity time history for the cab car and the cart. The test data time histories are calculated from accelerometers mounted on both the cab car and the cart. The pretest predictions come from the collision dynamics model. The cab car is initially standing and travels at approximately 3 mph after the impact. This matches the pretest collision dynamics prediction. The cart impacts the car at 18.7 mph, rebounds off of the passenger car, derails, and stops. The pretest prediction estimated that is would take 0.05 second for the cart to nearly stop. The test data shows that the cart takes 0.12 second to stop. The energy absorbed by the end frame during the test was 138,000 ft-lb.
