**JRC2009-63035**

## **DYNAMIC AND QUASI-STATIC GRADE CROSSING COLLISION TESTS**

**Michelle Mühlanger  
Patricia Llana  
David Tyrell**

Volpe National Transportation Systems Center  
U.S. Department of Transportation  
Cambridge, Massachusetts, USA  
[www.volpe.dot.gov](http://www.volpe.dot.gov)

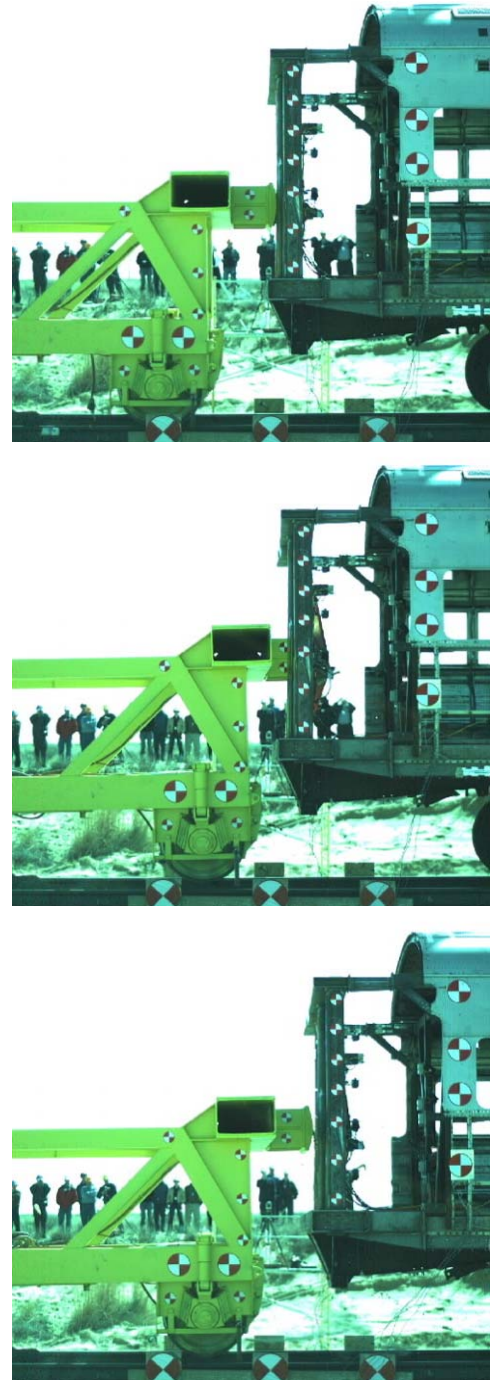
**Figure 5. Still photographs from high-speed video.**

Figure 5 shows still frames of the test taken from the high-speed video. The top photo shows the cart at the initial contact. The middle photo shows the cart and collision post at the maximum amount of collision post deflection. The photo on the bottom shows the cart and end frame at the end of the test, after some elastic energy has been recovered from the collision post. The cab car moved back approximately 6 feet after the test and stopped. The cart lifted vertically and moved laterally on recoil. When the cart came down after impact, the wheels missed the track and the cart derailed. Since the cart came down off the tracks, it stopped and did not move backwards.

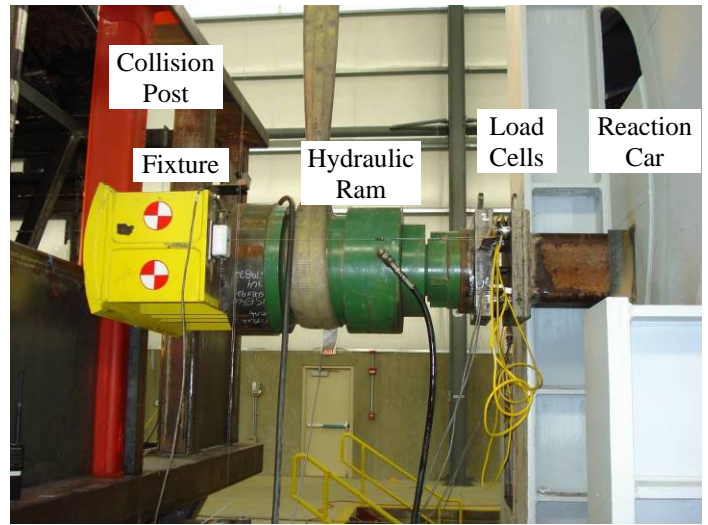
**Figure 9. Hydraulic ram configuration for the collision post test.**

For the quasi-static test, the test car is coupled to a reaction car. Figure 9 shows the configuration for the test. The collision post, on the left, is painted red. The rigid fixture, in yellow with targets, was taken from the dynamic test cart. The hydraulic ram is suspended from a crane. Four load cells, connected in parallel, connect the hydraulic ram to the solid block, which acts as a spacer between the ram and the reaction car. The solid block is removable, and when the stroke of the ram is reached, the solid block was replaced with a longer solid block to continue the test. Figure 10 shows a schematic of the test with the cars coupled together. As the load from the hydraulic ram is introduced to the car through the collision post, it reacted through the couplers. During the test, the force reading from the load cells and the displacement readings from the string potentiometers is displayed real time for test observers.

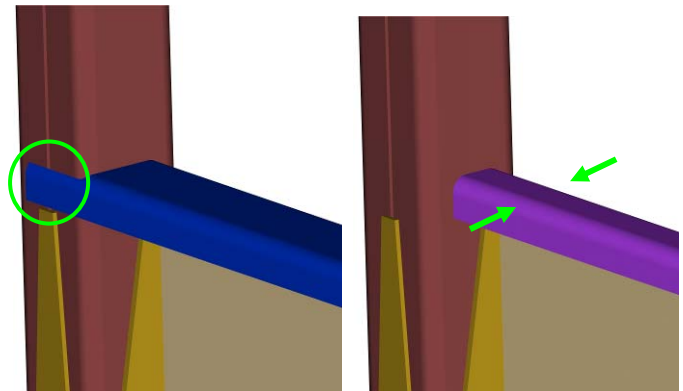
Figure 14. Schematic showing shelf modifications.

The premature fracture at the back of the collision post is of concern. The fracture kept the collision post from absorbing enough energy during the test. Three potential contributing factors were explored: material properties, fabrication quality, and design details. As part of the post-test autopsy, material samples were taken from various locations on the collision and corner posts from the dynamic and quasi-static test of a collision post. Three-point bending tests of the specimens demonstrated that the ductility of the material was within specification. Material properties were ruled out as a contributing factor to the fracture. A visual inspection of the specimens confirmed that the welds were within specification, so fabrication quality was also ruled out as a cause of fracture.

The design details warranted a closer look. The specimens taken at the location of the fracture revealed that an internal gusset on the post coincided with an exterior shelf tab. Figure 13 shows specimens taken from the collision posts in the dynamic and quasi-static tests. The gusset locations were within specification for these posts. However, there is some flexibility with the location of the gusset relative to the location to the shelf tab. In both the dynamic and quasi-static tests, the fracture occurred at the location of both the gusset and the shelf welds. The rigid gusset did not allow the post to oval as it deformed, causing the fracture at the back of the post.

In response to the results of the quasi-static test of the collision post, the shelf was redesigned so the tab was removed and the depth of the shelf was decreased. The circle in Figure 14 shows the tab before modification and the arrows show the decreased shelf size after modification. This reduced the amounts of welds at the corner and back of the post. The corner post was not designed with internal gussets, so the design detail did not need to be addressed.
