Five-Year Review Report

Second Five-Year Review Report for North Cavalcade Street Houston, Harris County, Texas

September 2003

FIVE-YEAR REVIEW
North Cavalcade Street Superfund Site
EPA ID# TXD980873343
Houston, Harris County, Texas

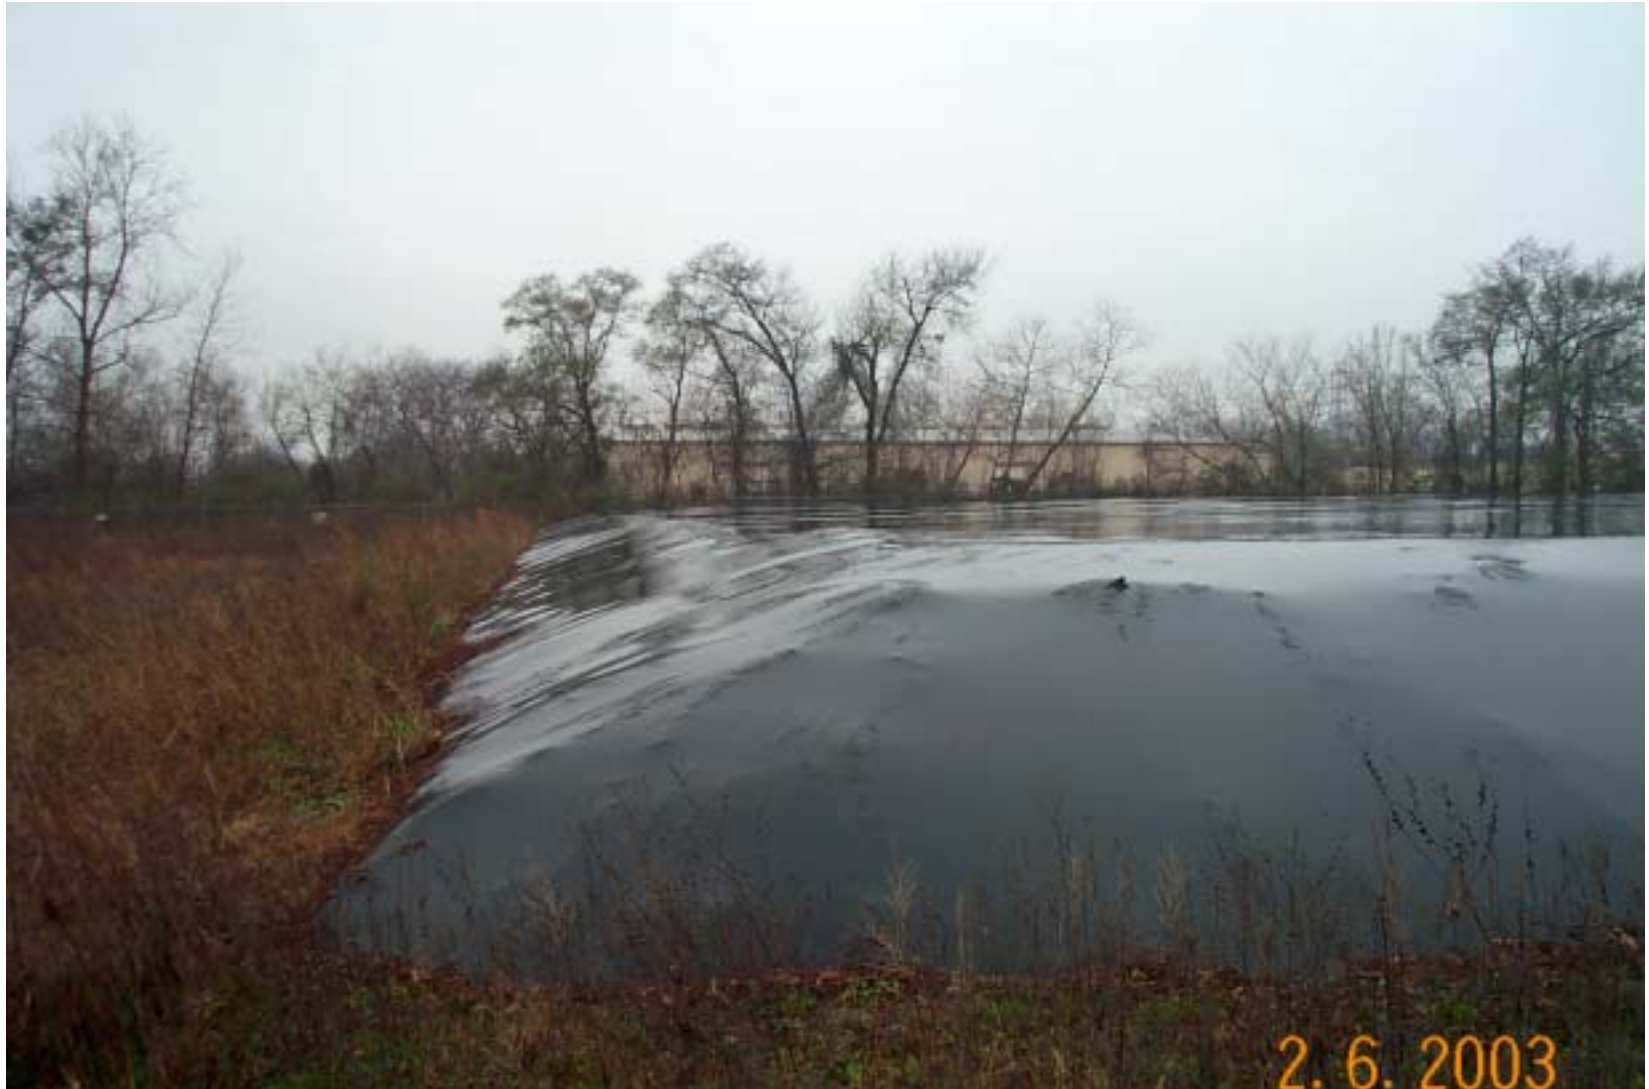
Photograph 2 of 53

Looking west from the southeast corner of the covered biopile. The fence along the west site boundary, with information signs, can be seen in the left background.

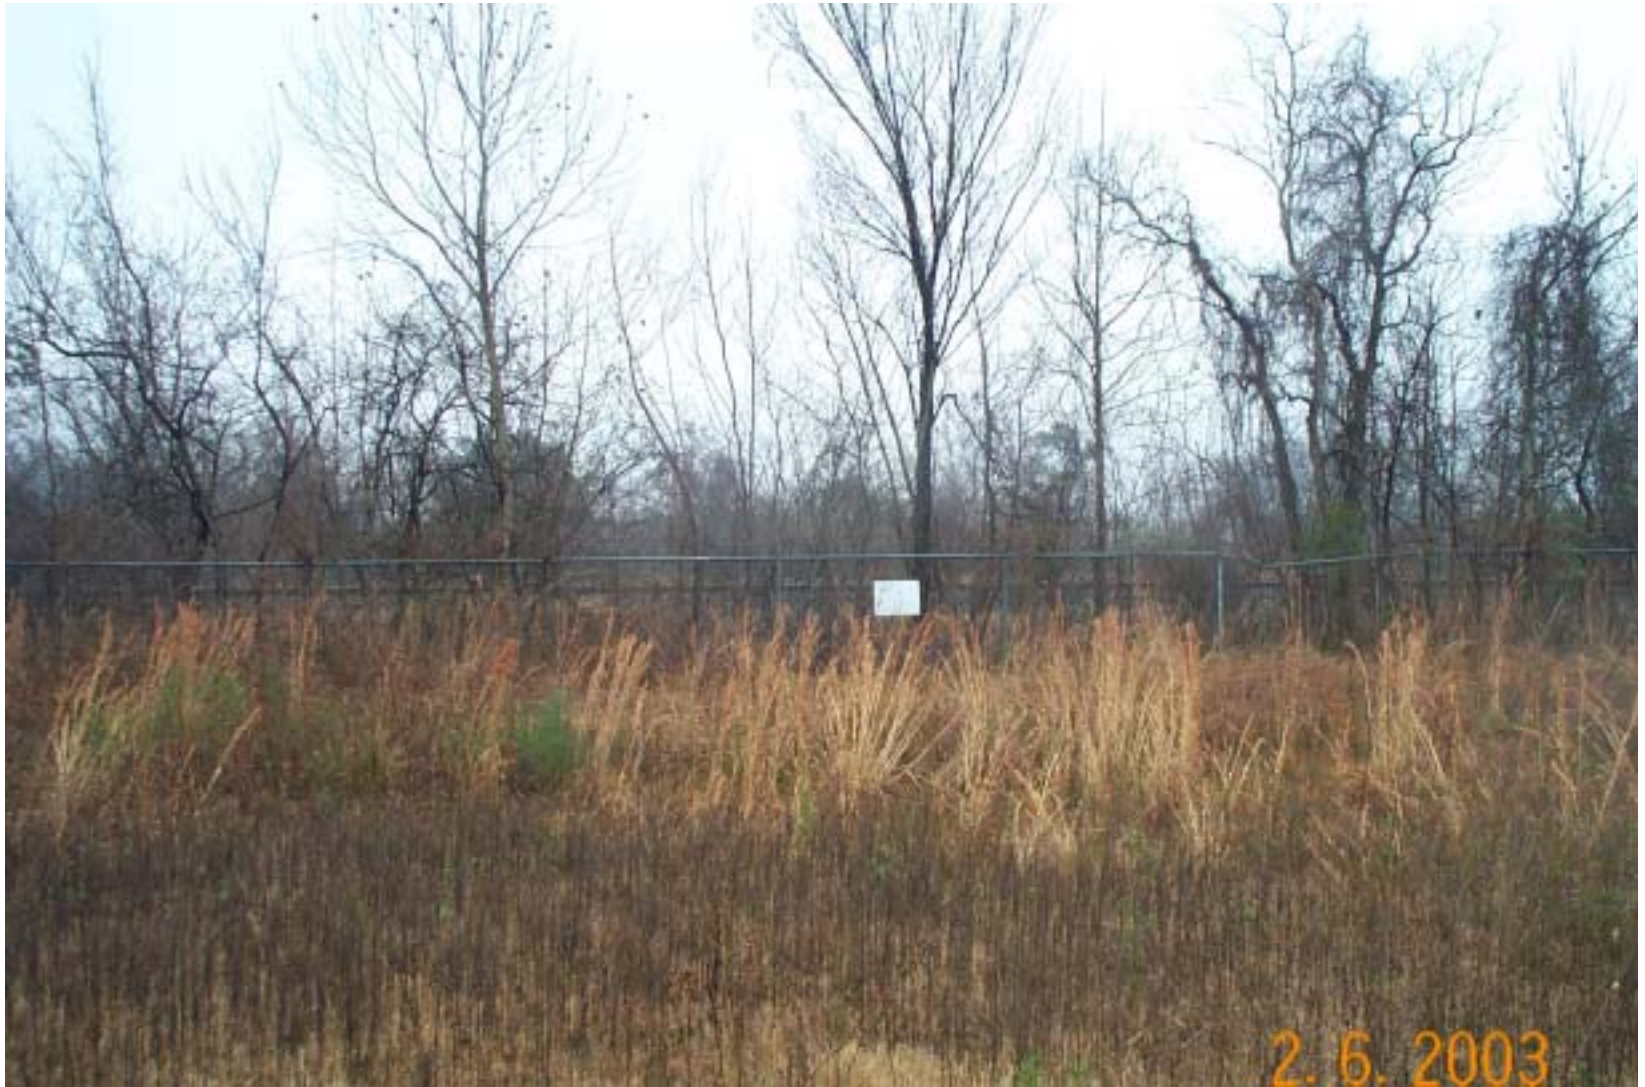
Photograph 8 of 53

Looking east toward the perimeter security fence. The fence encircles the property containing the biopile. A warning sign, in the center of the photograph, facing outward, is attached to the fence.

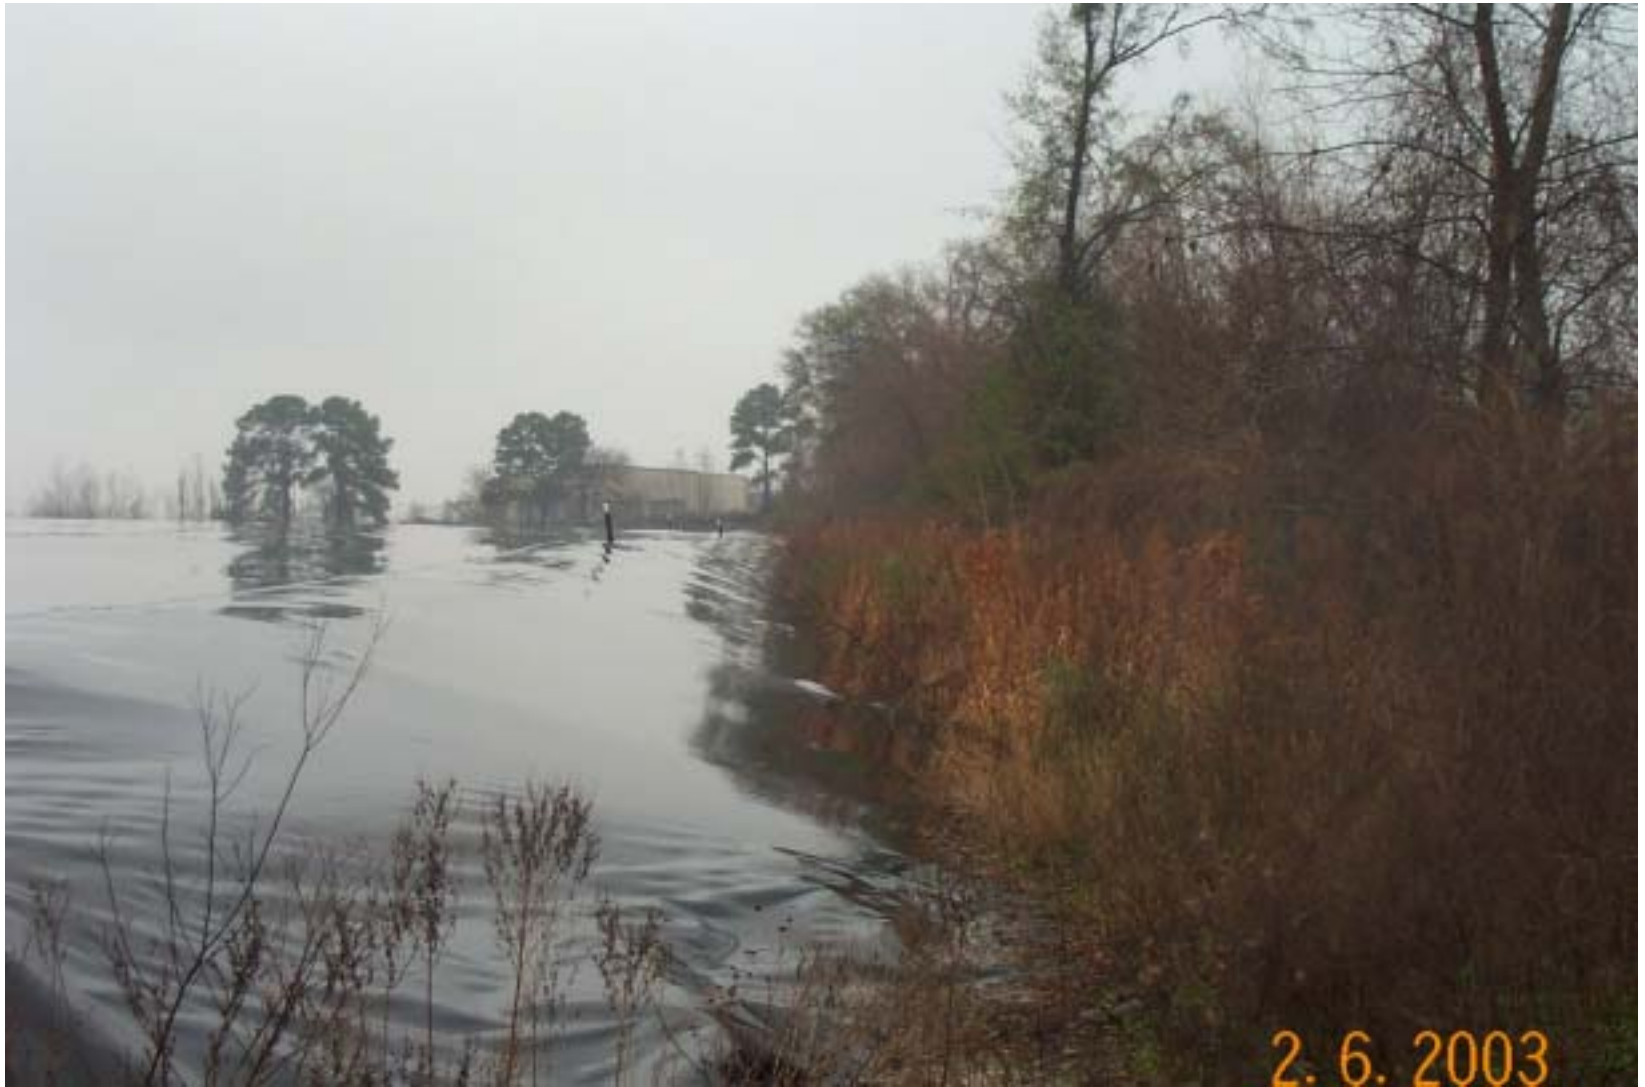
Looking south, along the west side of the covered biopile, from the north west corner of the covered biopile. Leachate detection wells can be seen along the west edge of the biopile. The west boundary fence, on the right, is obscured by vegetation.

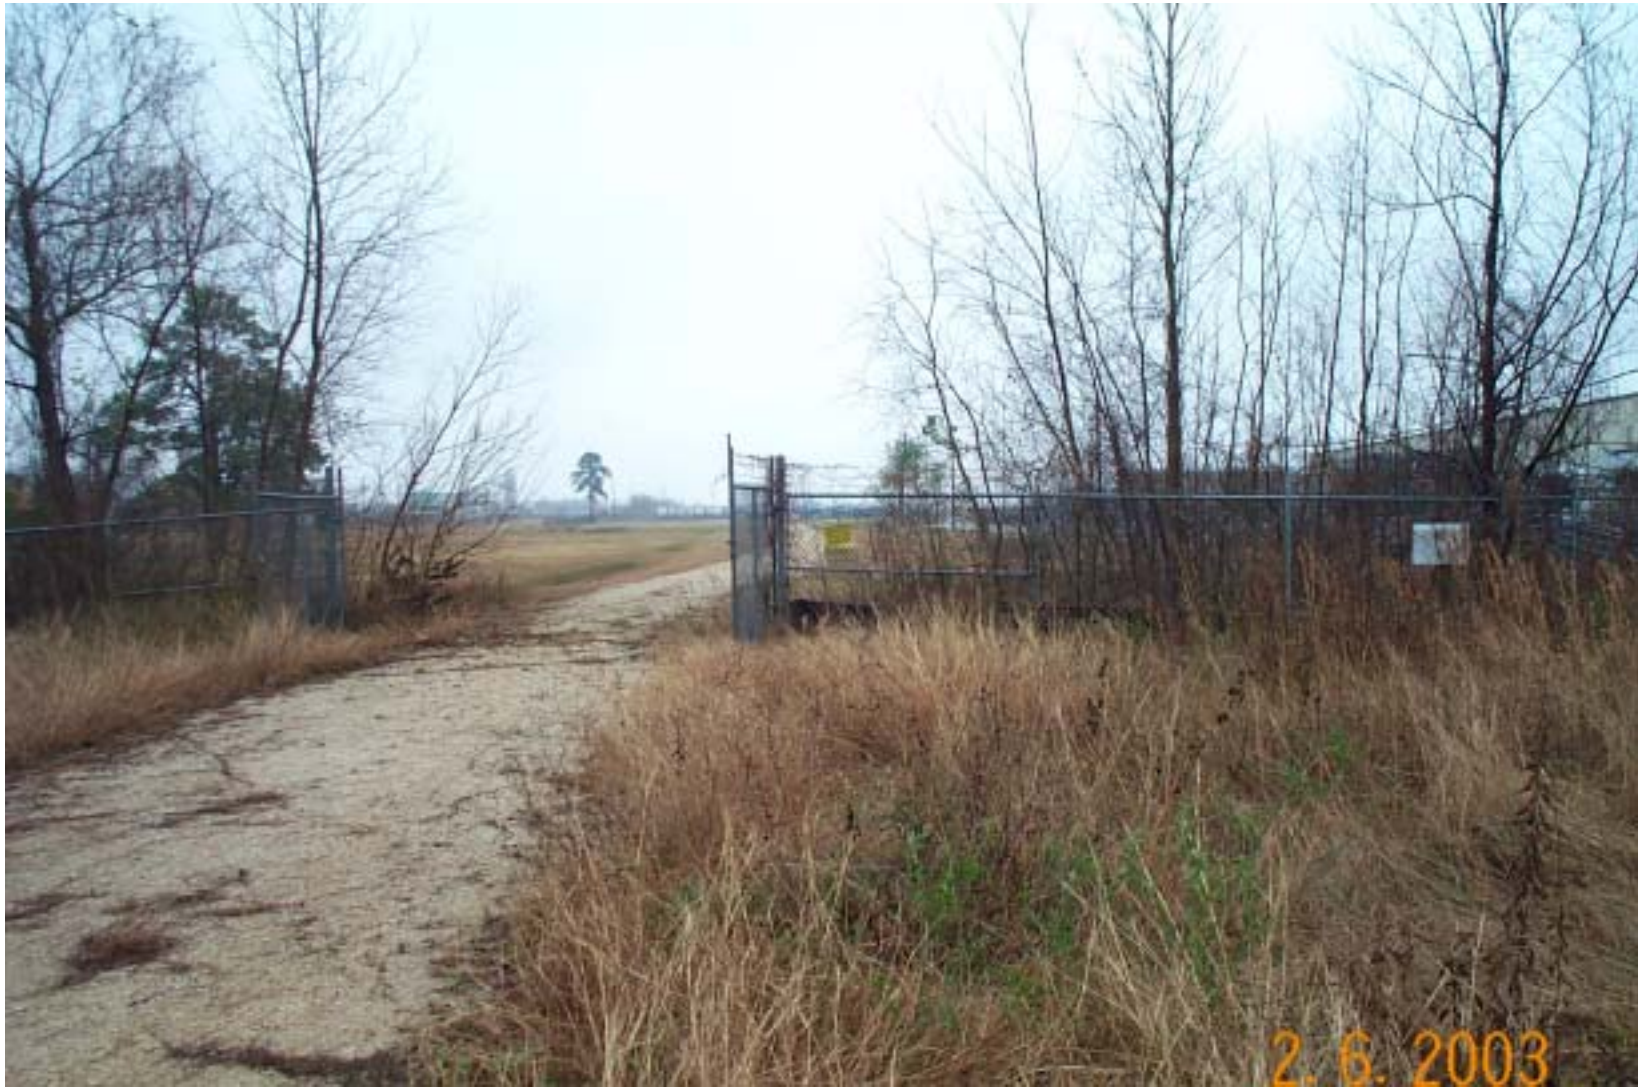
Photograph 17 of 53

Looking south from the biopile cell area, at the gate to the covered biopile area (normally closed).

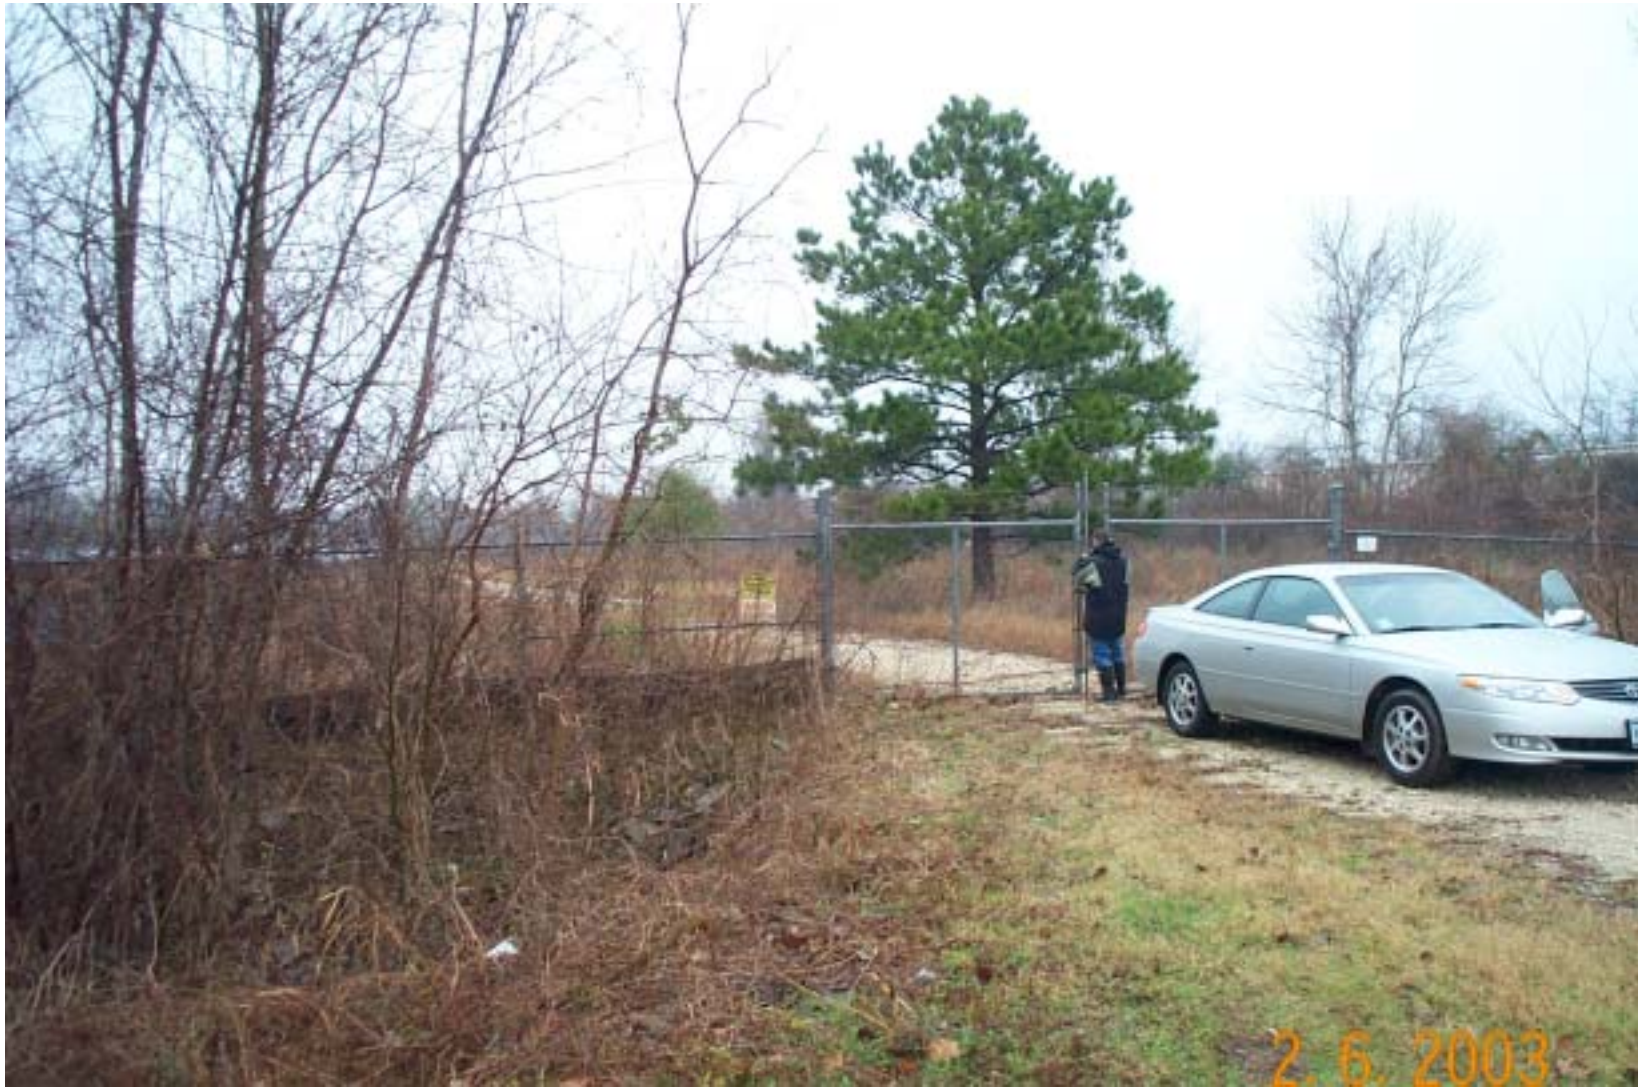
Photograph 19 of 53

Looking north towards the gate to the covered biopile area. Warning signs are located on the fence to the left of the gate.

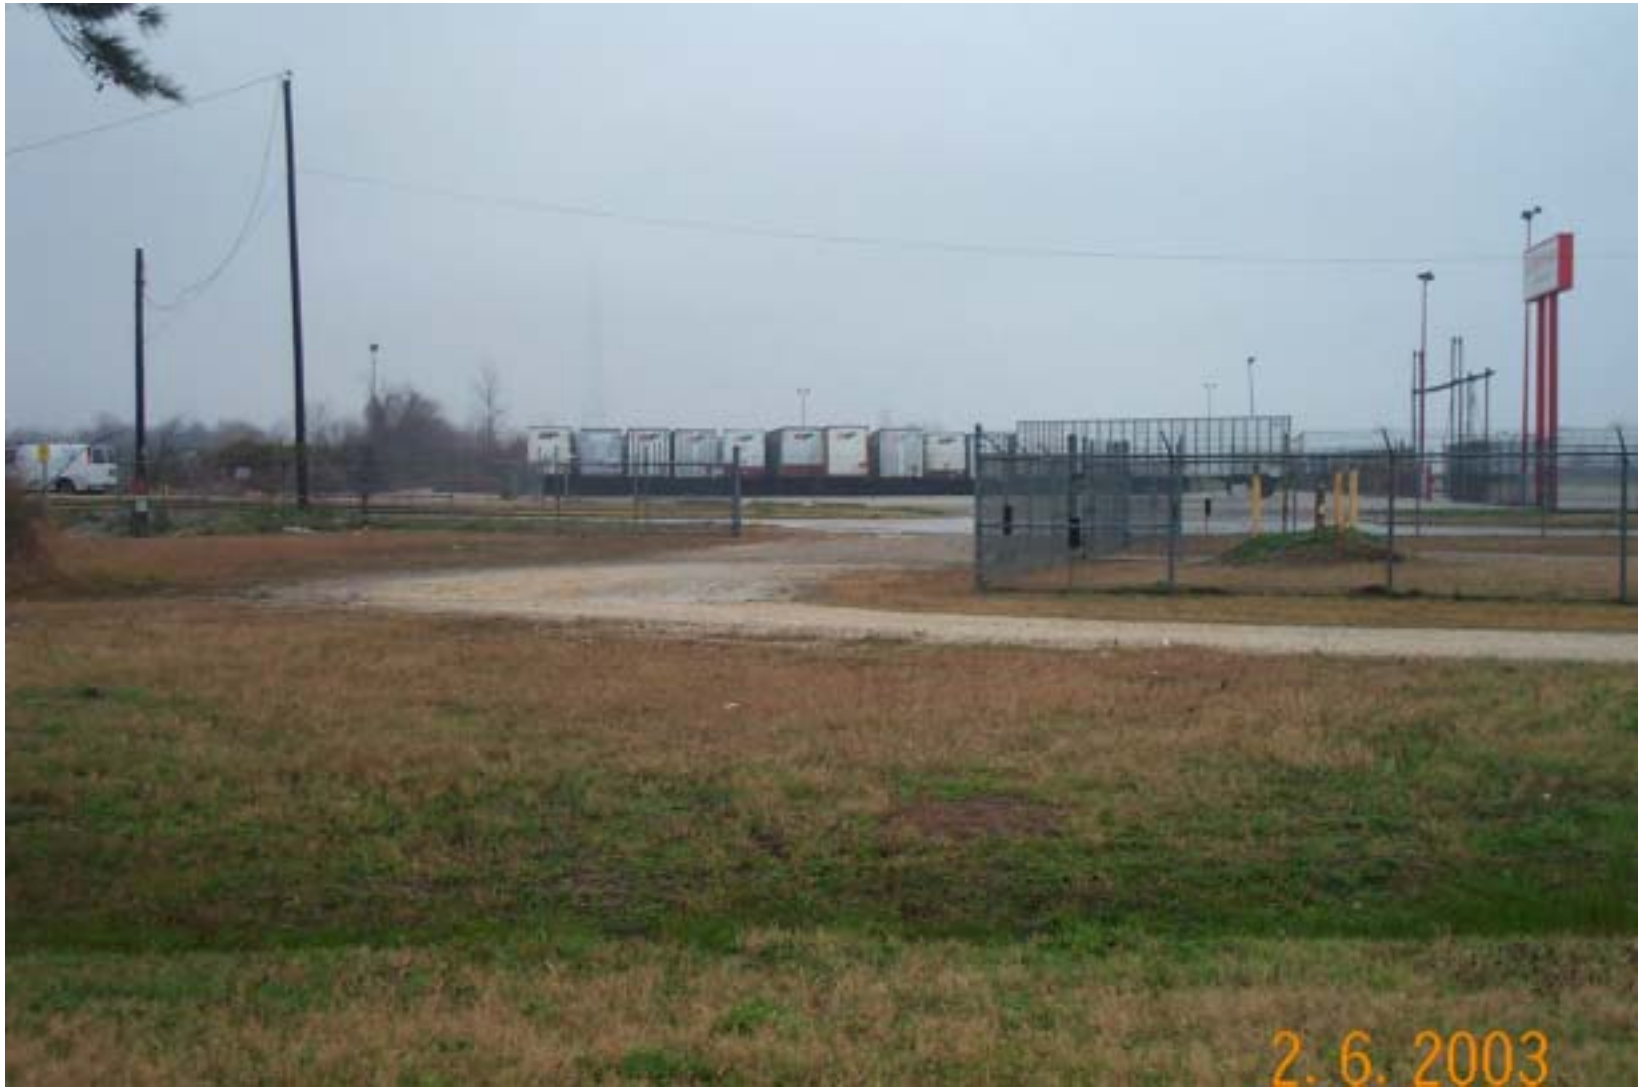
Photograph 31 of 53

Looking south at the site entrance from Cavalcade Street. The security fence around the treatment system can be seen in the right center of the photograph.

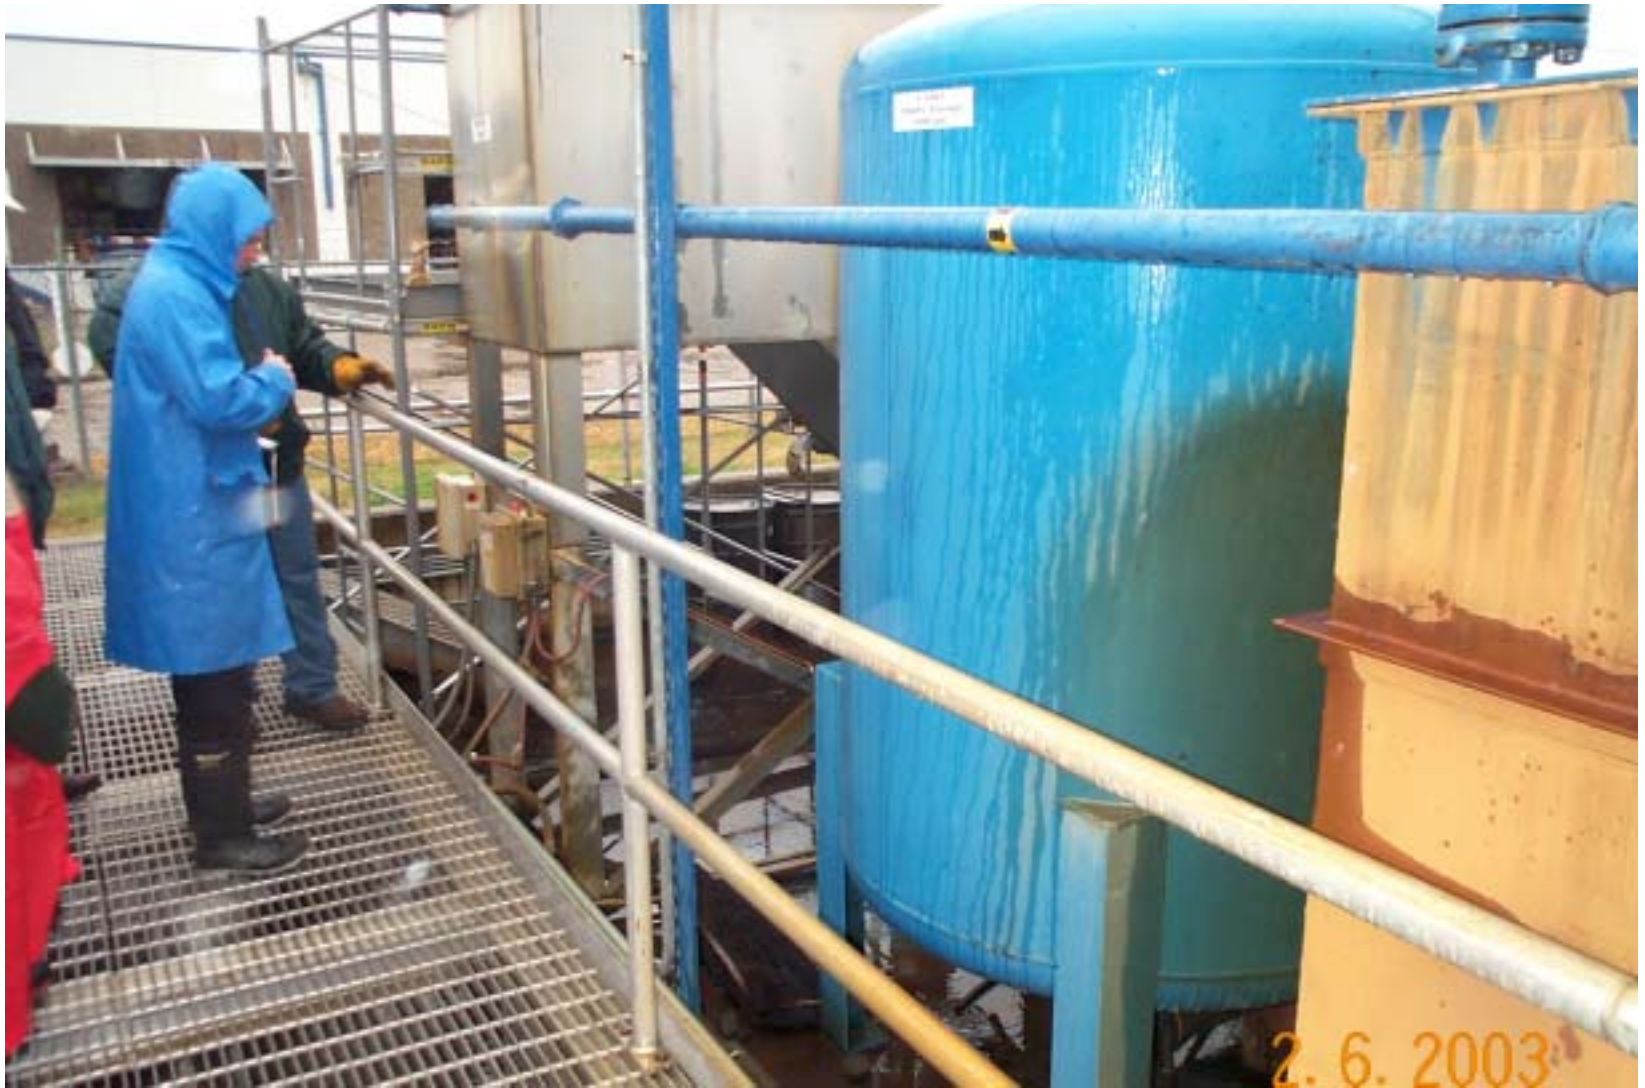
Photograph 40 of 53

Groundwater treatment system oil water separator in the left center of the photograph. The blue tank is for DNAPL storage (currently not used). The vessel on the right is an unused DNAPL separator.

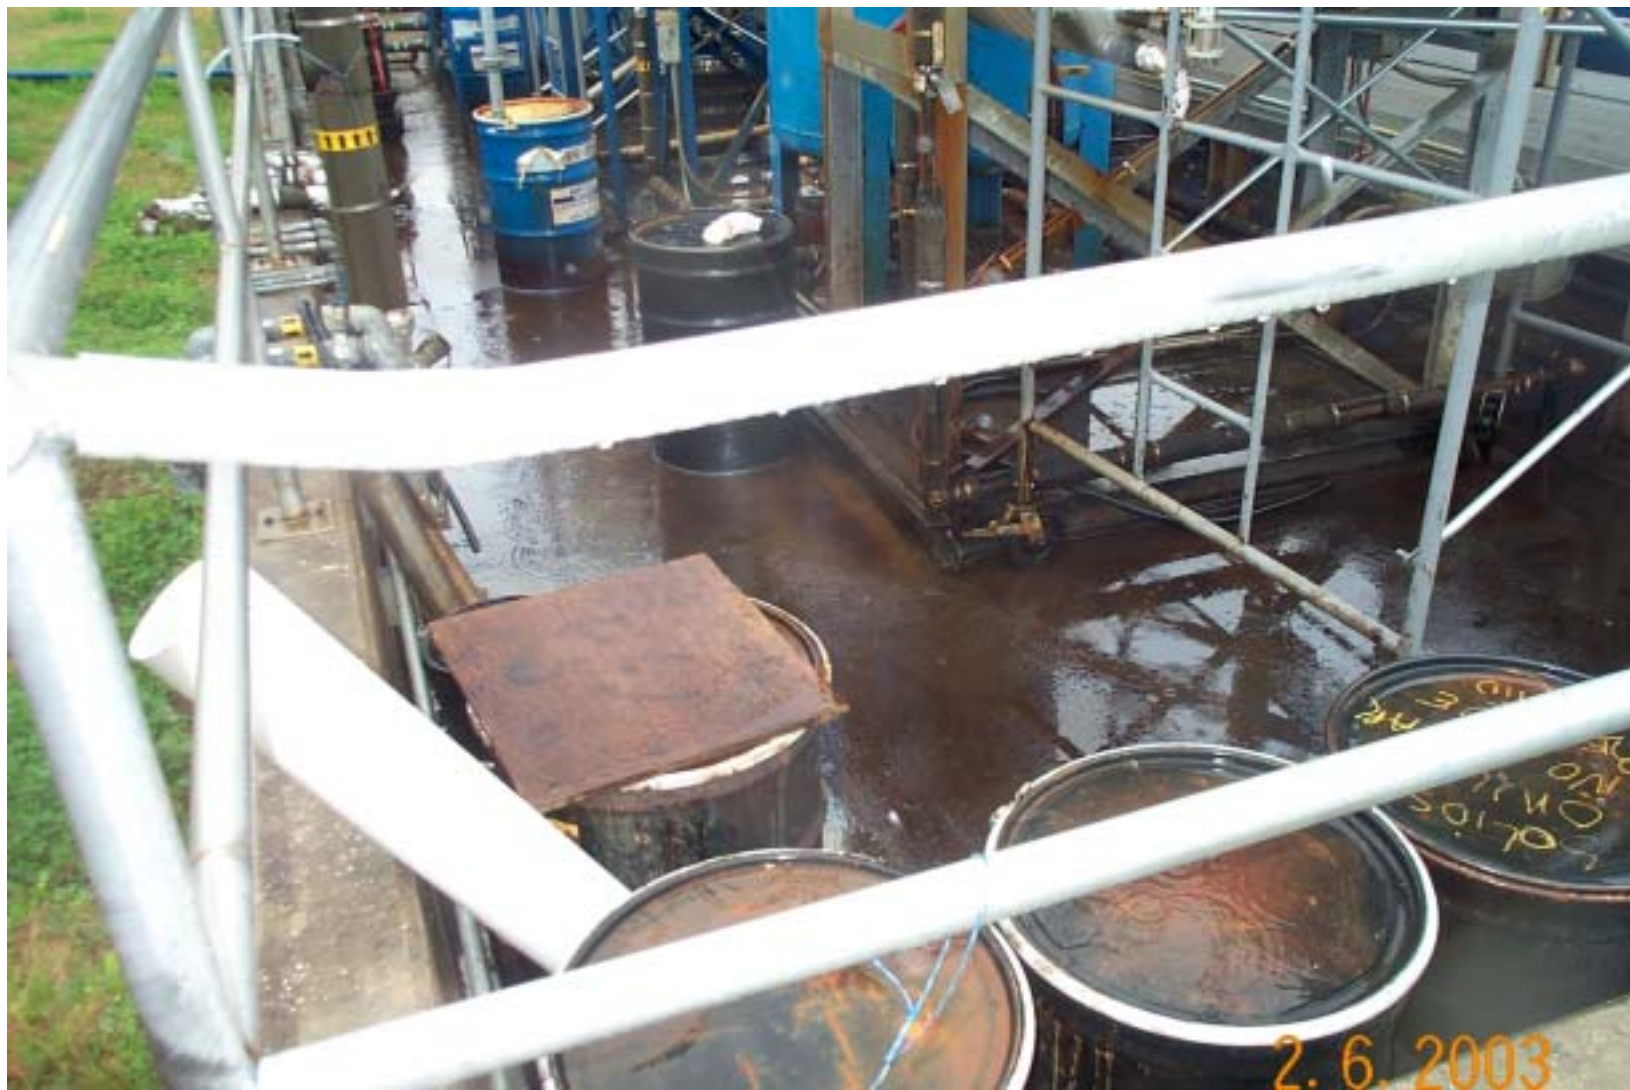
Photograph 43 of 53

Groundwater treatment system secondary containment structure. Drums in foreground contain DNAPL for disposal.

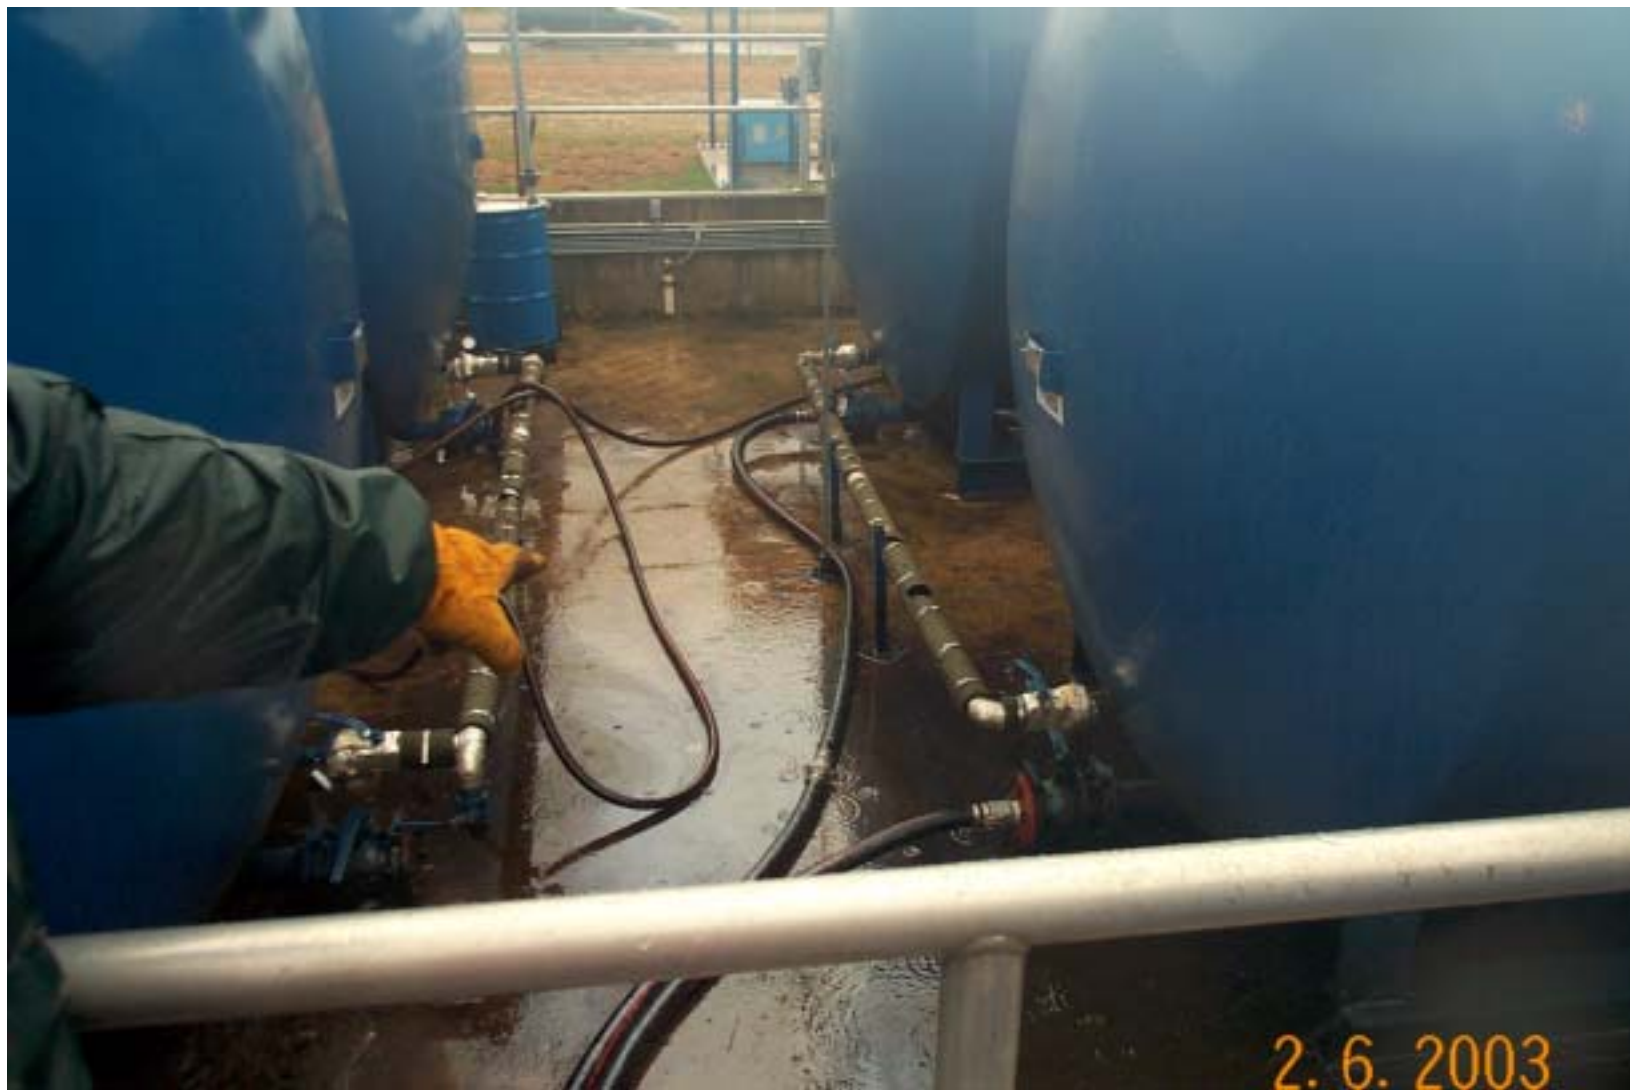
Photograph 47 of 53

Groundwater treatment system equalization and holding tanks.

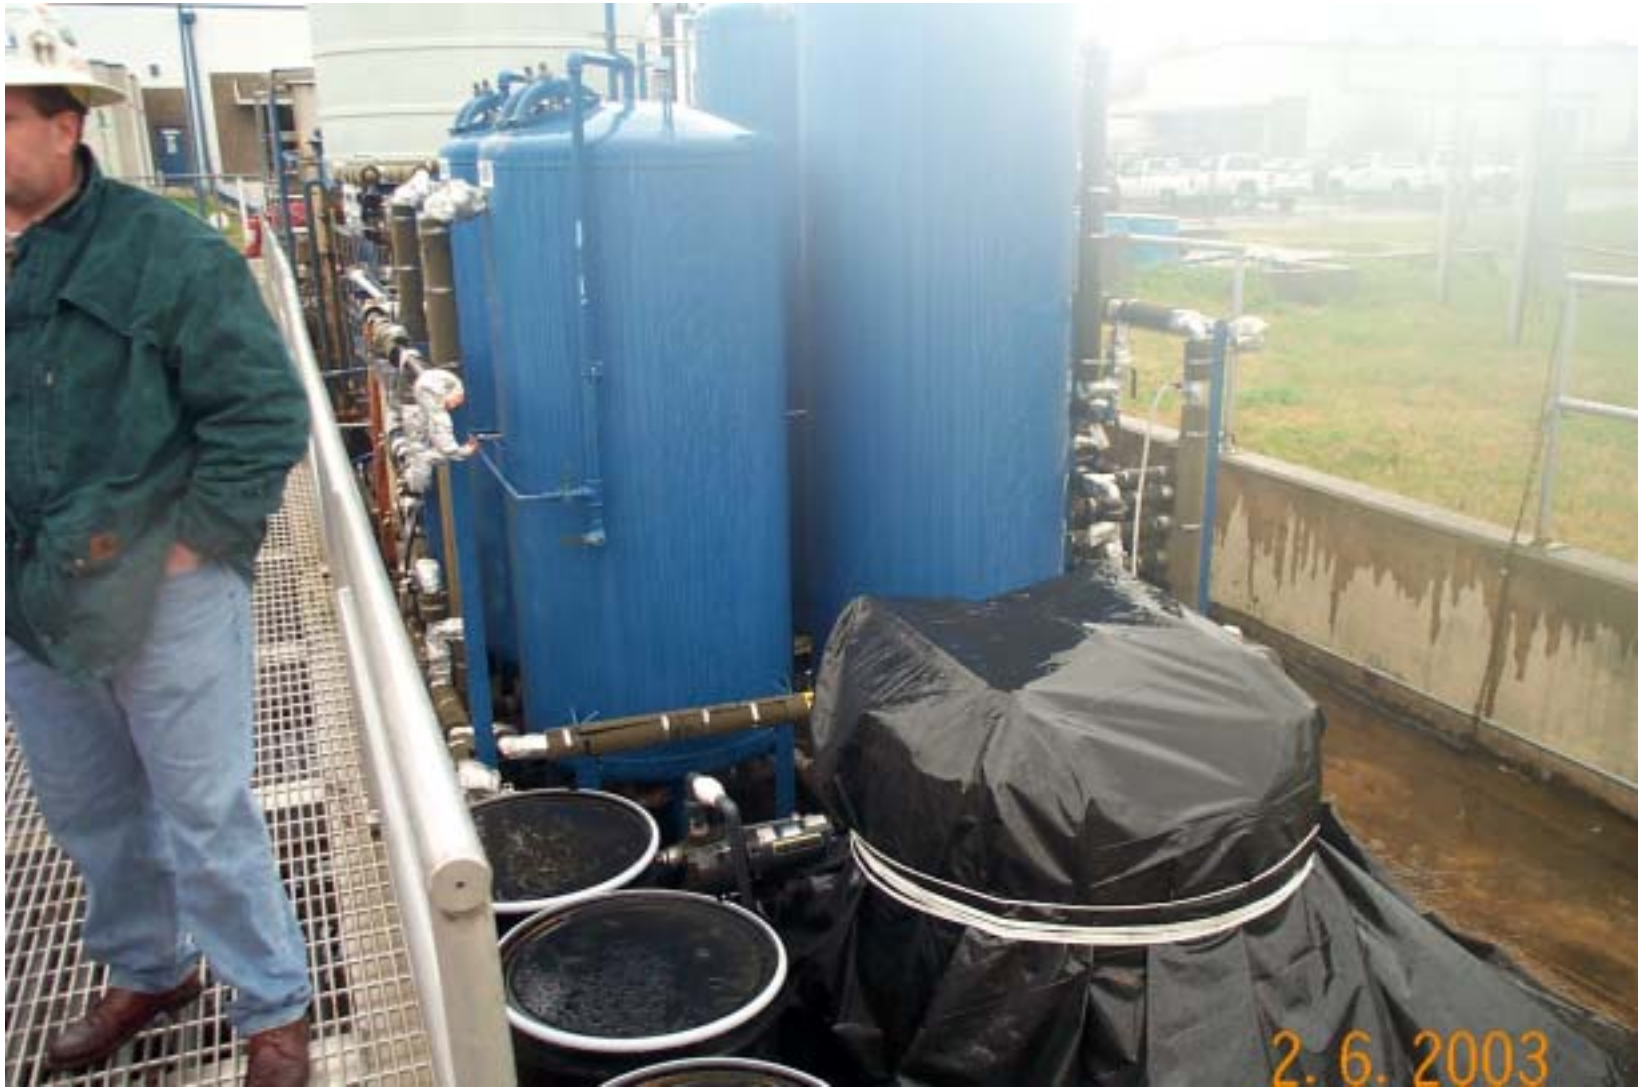
Photograph 48 of 53

Groundwater treatment system equalization and holding tanks.

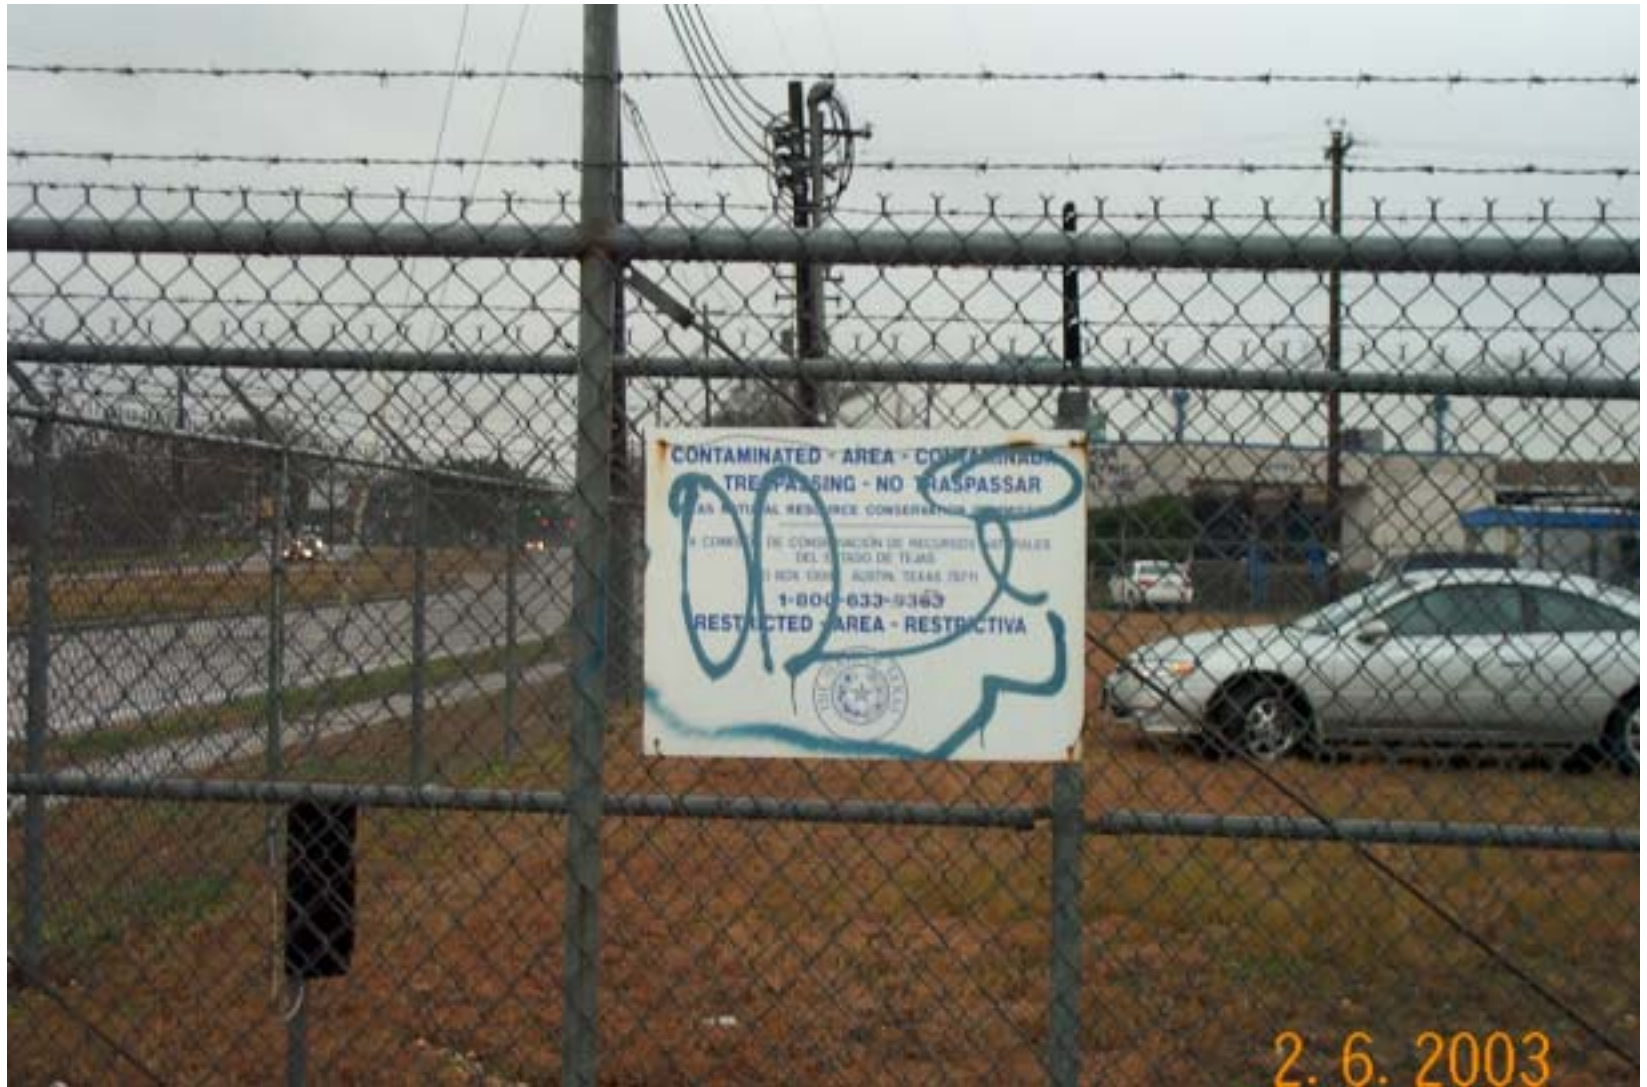
Photograph 50 of 53

Gate into the site with site information sign. Cavalcade Street is on the left. The gate to the groundwater system is on the left.

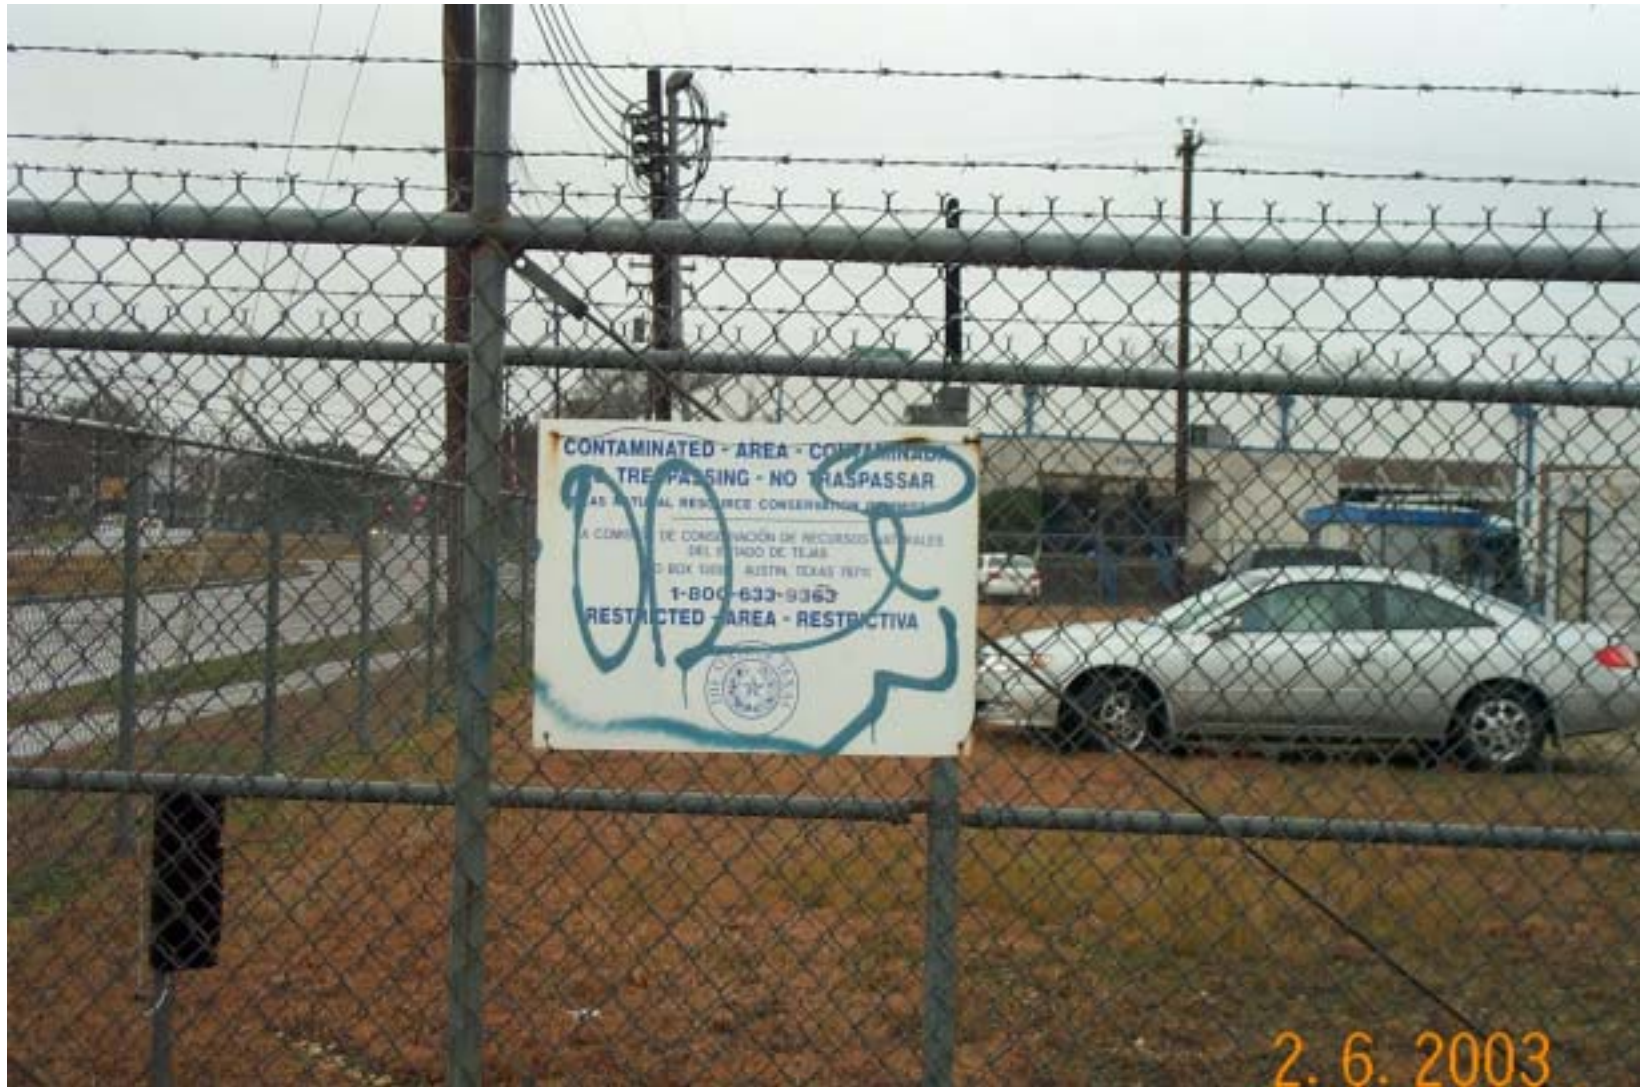
Photograph 51 of 53

Sign on the entry gate to the site. Cavalcade Street is on the left.
