First Five-Year Review Report

Sprague Road Ground Water Plume Superfund Site Odessa, Ector County, Texas

September 2008

FIRST FIVE-YEAR REVIEW REPORT
Sprague Road Ground Water Plume Superfund Site
EPA ID No. TX0001407444
Ector County, Texas

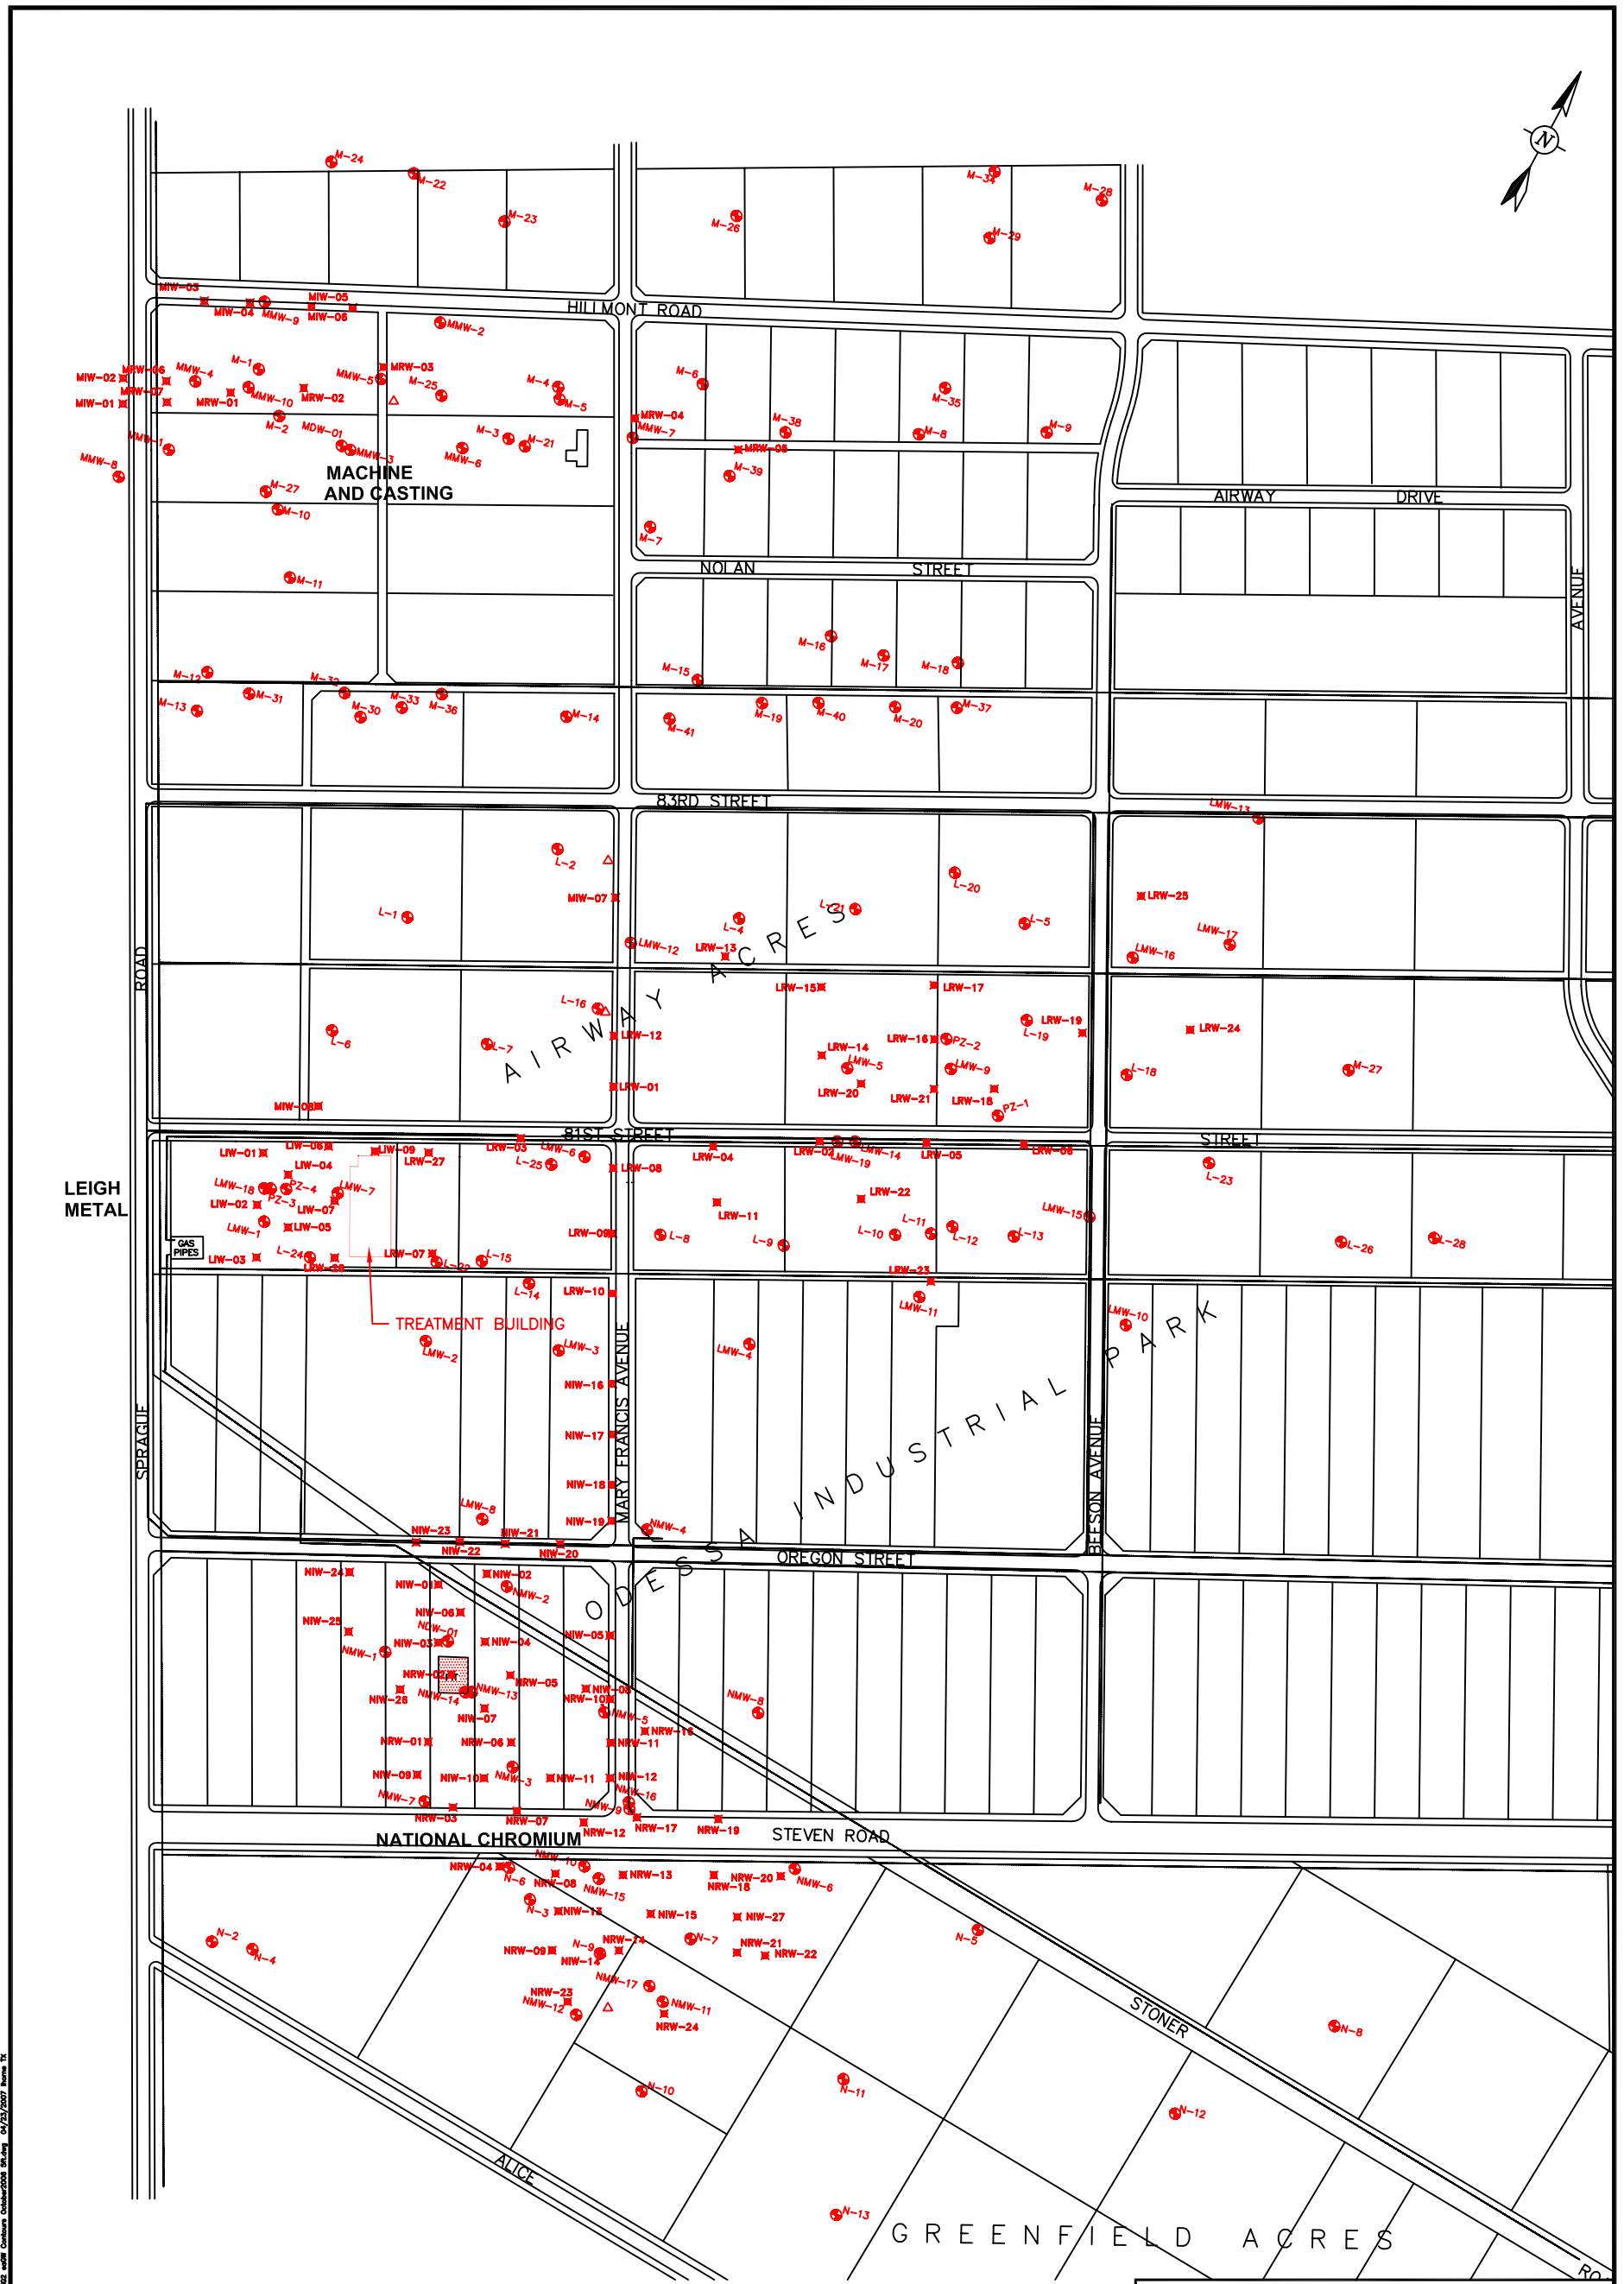
Figure 1: Well Location Map

The monitoring well network consists of 18 monitor wells and 21 privately owned wells at LM, 10 monitor wells and 18 privately owned wells at M&C, and 17 monitor wells and 6 privately owned wells at NCC. Figure 1 provides a site layout map that illustrates the current monitoring well network. Samples collected from the monitoring network are analyzed for total metals by EPA method 200.7. The chromium results are presented in ground water monitoring and semiannual operating reports. Data trends are discussed in Section 6.3.

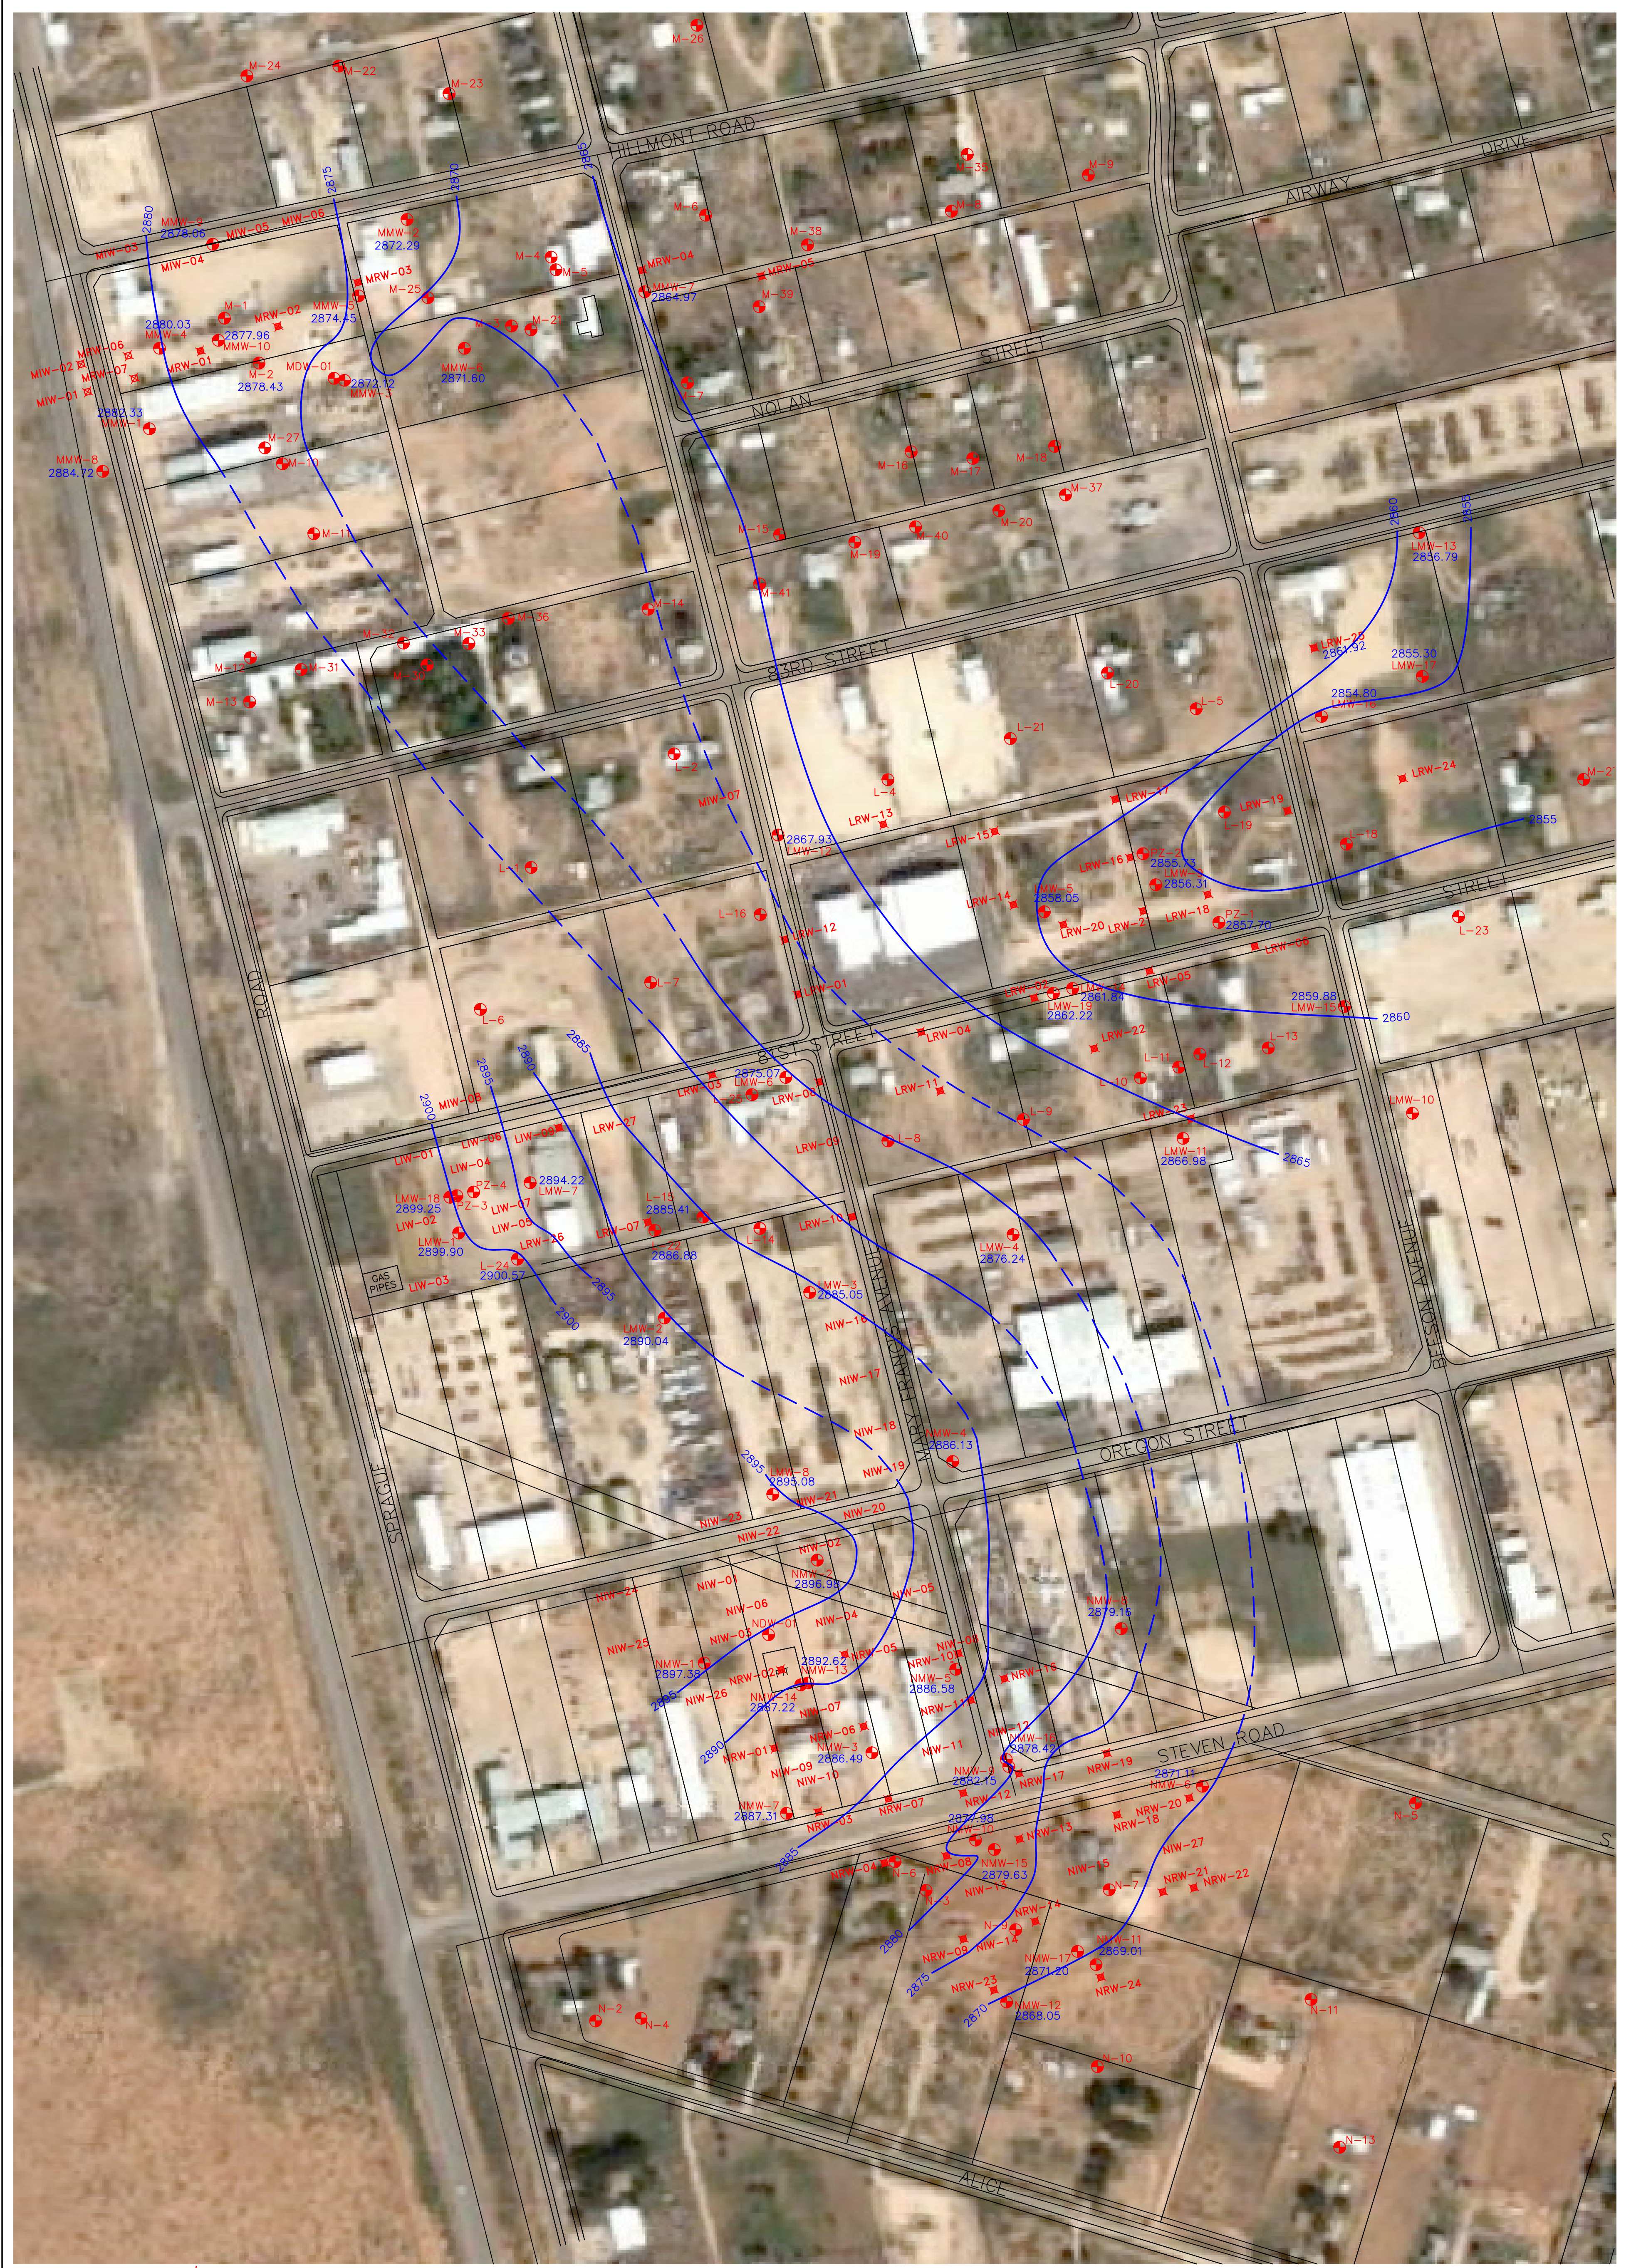
Figure 2: Potentiometric Surface Map (March 2008)

According to the March 2008 Potentiometric Surface Map, the ground water flows from the western portion of the Site to the east and southeast (Figure 2). This is consistent with the measured ground water flow direction in June 2003, which predates the startup of the treatment system (Tetra Tech 2005b).

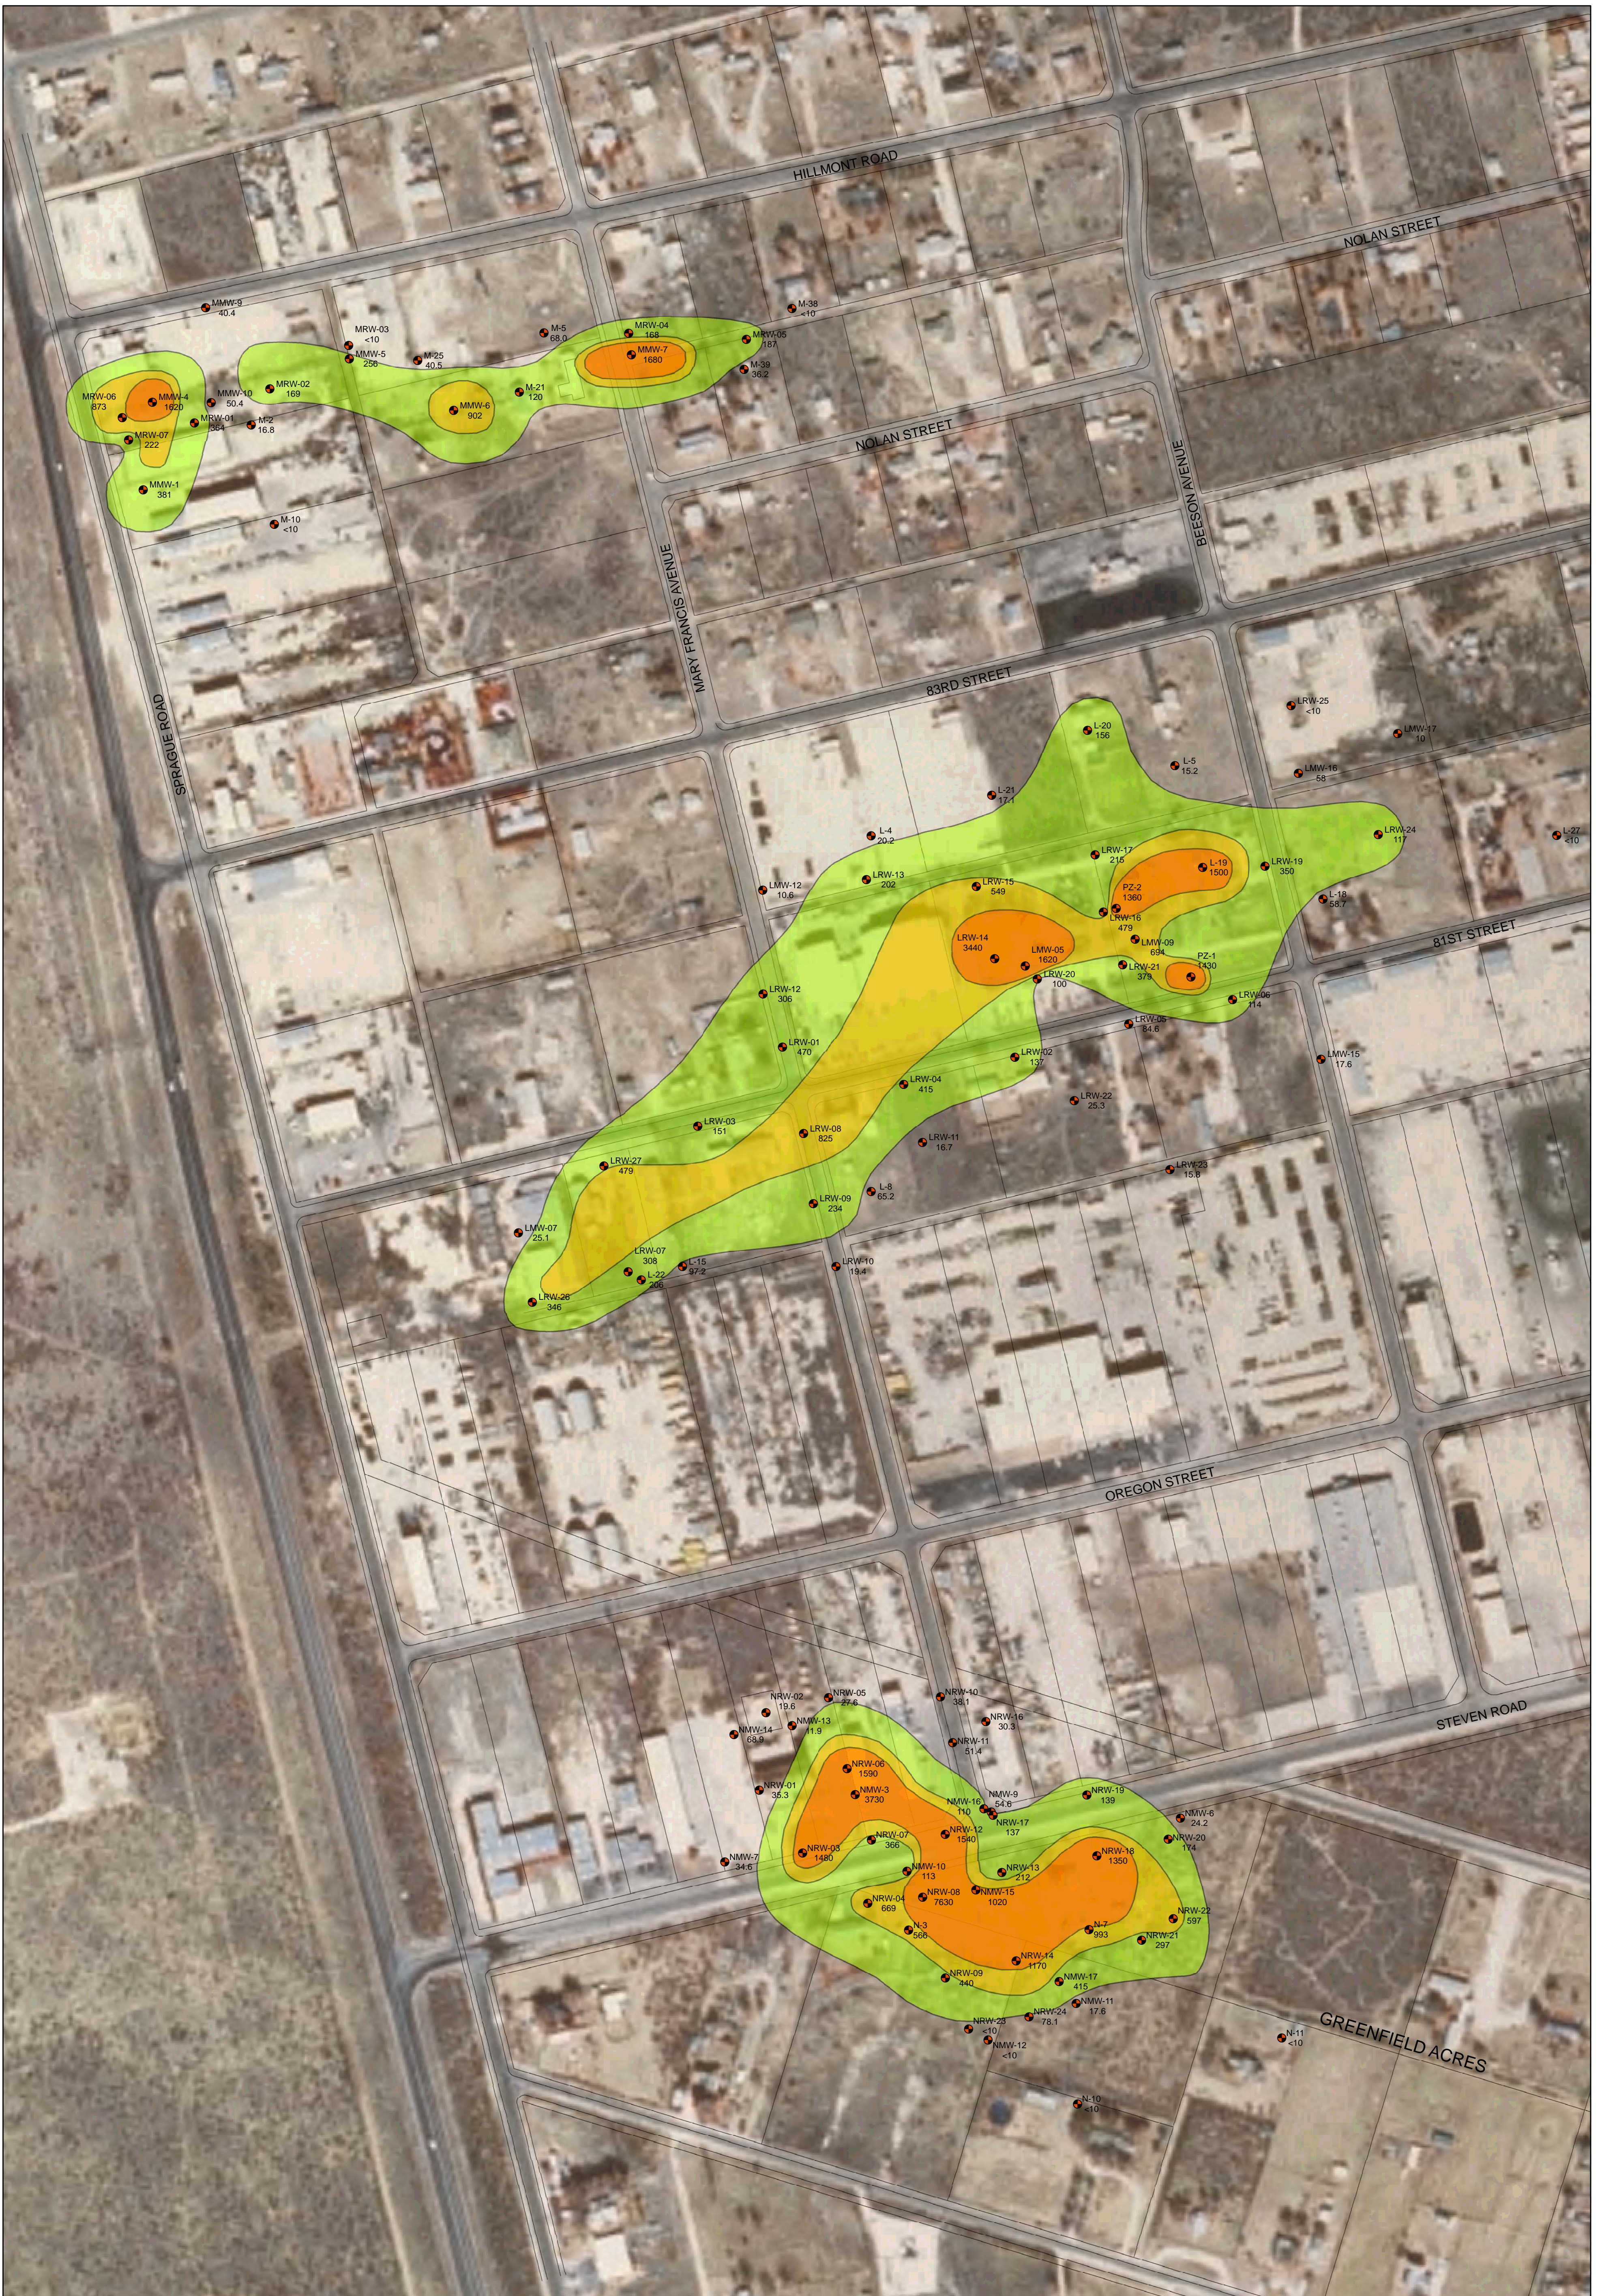
Figure 3: Chromium Concentrations Map (March 2008)

The highest chromium concentrations are located on the WFJ Drilling property, downgradient of the LM facility (Figure 2 and Figure 3). The overall size of the ground water plume remains similar to the footprint of the plume at startup, and it appears that the ground water extraction and treatment system is maintaining capture at this facility. Concentrations in several locations increased during the summer of 2007, which may correspond to the excessive amount of rainfall received during this time. Ground water concentration trends vary across the plume, with some exhibiting increasing concentrations, others decreasing; however, the maximum concentrations of chromium detected within the plume has decreased over time, from 14,000 µg/L prior to system startup (June 2003) to 3,440 µg/L in March 2008.
