U.S. Department
of Transportation

Federal Railroad
Administration

Human Factors Root Cause Analysis of Accidents/Incidents Involving Remote Control Locomotive Operations

Office of Research
and Development
Washington, DC 20590

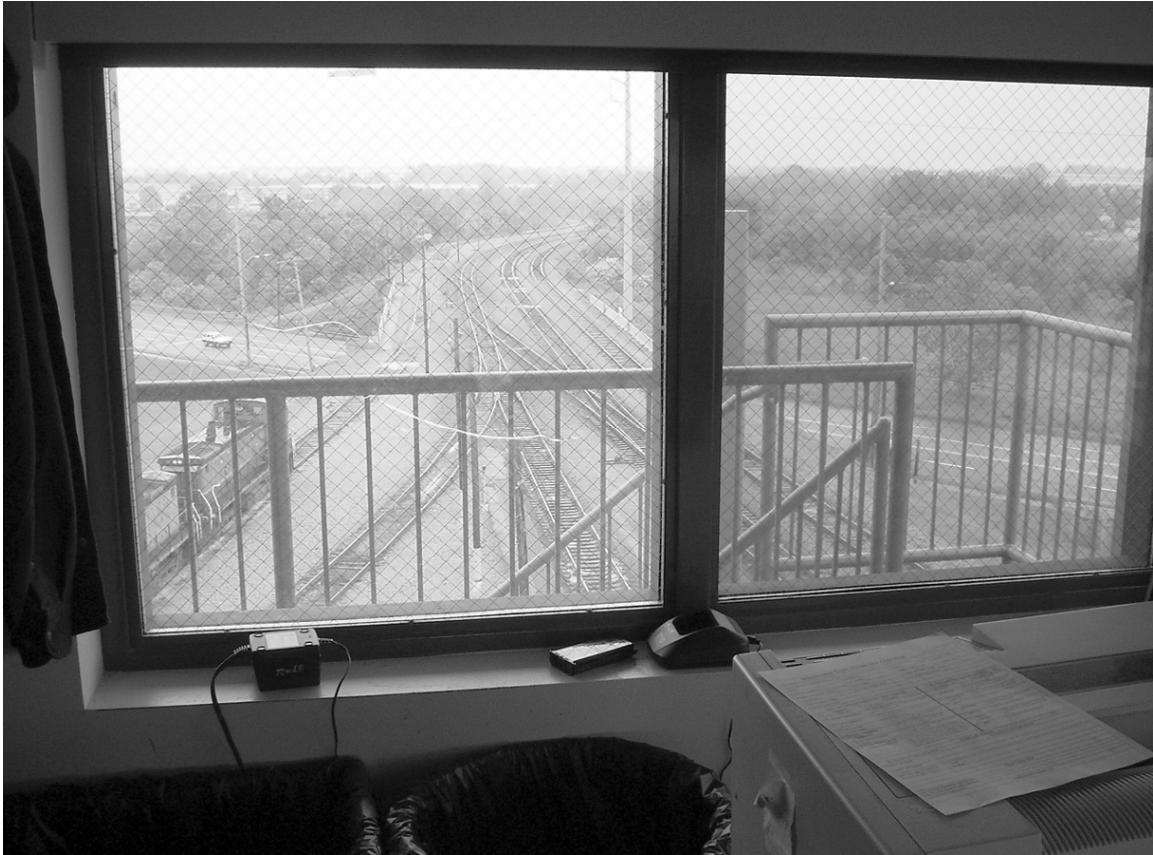
Figure 18. RCL1 southward view from yardmaster's office (far crossover out of sight)

- Loss of yardmaster situation awareness. During the previous move, the tower yardmaster intended to instruct 111 to reline the far crossover switch for straight movement. However, he misinterpreted a communication between 111 crewmembers discussing lining of a switch. The yardmaster believed the referenced switch being discussed by 111 crewmembers was the far crossover. He subsequently believed the far crossover was relined for straight movement. This loss of situation awareness was, at least in part, probably due to the yardmaster's large number of responsibilities. Monitoring radio traffic and keeping (mental) track of switch positions are only two of these responsibilities. Yardmaster responsibilities include communicating and coordinating with numerous train crews, other yardmasters and operators, and dispatchers, as well as strategically managing the flow of work in one or more sections of a yard. The large number of demands placed on the yardmaster places a significant workload, whereby monitored radio communications can be misunderstood, and awareness of the moment-by-moment switch positions and yard movements can be diminished or impaired. Furthermore, from his office in the hump tower, the tower yardmaster cannot visually confirm or check the status of the far crossover since this part of the yard, including the crossover switches, are beyond a curve (see Figure 18). *Supervisory factors/inadequate supervision.* **Probable contributing factor.**

Authors' Response: It is understood that the yardmaster has a number of responsibilities related to the management and general operation of the yard. It is also understood that the view of the yard from the yardmaster's office is better than at other yards. At this location, the yardmaster gives instructions to the yard crews regarding which lead tracks to use when making moves using these tracks. Thus, to some extent, the yardmaster does manage track occupancy within the yard. Given the intent of the yardmaster was to instruct 111 to reline the far crossover switch for straight movement during the previous move and his misinterpretation of a communication between 111 crewmembers regarding the intent of a crewmember to line a switch, it is reasonable to believe that the yardmaster was trying to keep apprised of the status of the lead tracks and crossovers in order to make subsequent assignments using the middle and hump lead tracks. However, for a variety of reasons, including the lack of direct line-of-sight to these tracks, the yardmaster's situation awareness was reduced. Had the yardmaster been aware of the switch position of the far crossover, it is reasonable to believe that the yardmaster would have communicated this information to the 111 and/or 222 crews, or instructed one of the crews to line the switch back for straight movement. Furthermore, had the yardmaster known that 222 was occupying the far crossover and middle lead, it is reasonable to believe the yardmaster would not have instructed the 111 crew to occupy the same track, or at a minimum, may have informed the 111 crew of the presence of 222 ahead of their movement. Thus, the authors cite the yardmaster's diminished situation awareness as a contributing factor, since, had the yardmaster been aware of the far crossover switch position or the exact location of the 222 crew, the collision would not have occurred due to yardmaster intervention.

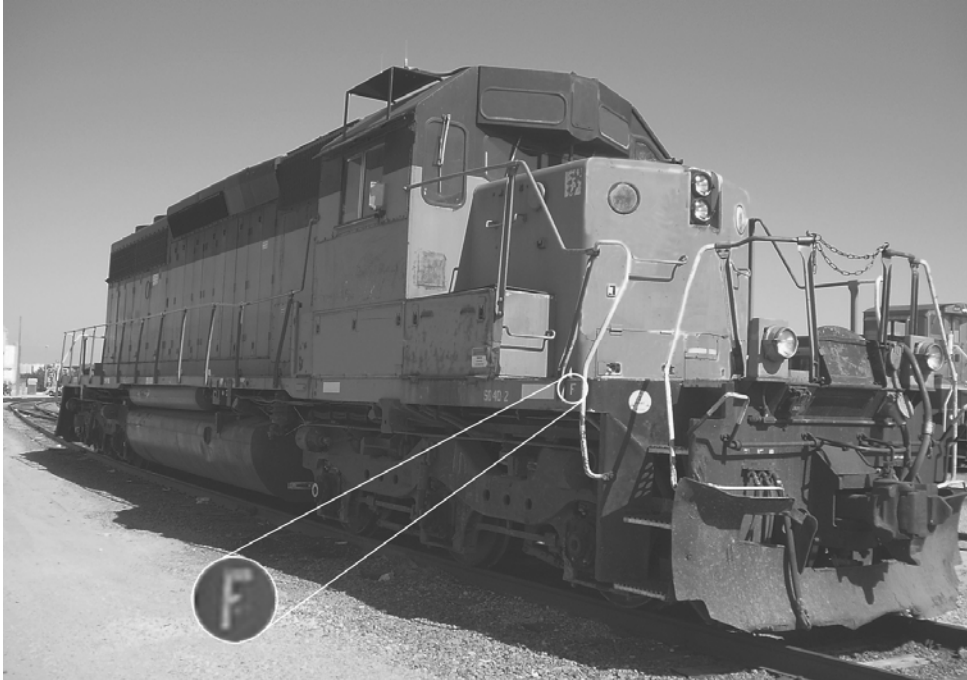
Figure 24. RCL2 view of short hood forward RCL with F highlighted

The locomotive used by the RCL crew had its short hood forward, denoted with an F stenciled on each side (see Figure 24). This meant that the short hood of the locomotive was always oriented in the forward (as opposed to reverse) direction of movement, so that forward on the reverser would move the RCL in the direction that the F was oriented—the short hood. Most locomotives at this yard are short hood forward, except yard switcher engines, which are long hood forward. Figure 25 depicts an example of a locomotive with its short and long hood labeled. As a general practice at this yard, locomotives used on the east end of the yard are oriented so that the short hood (forward) is facing eastward, while locomotives used on the west end are oriented with their short hood (forward) oriented westward.

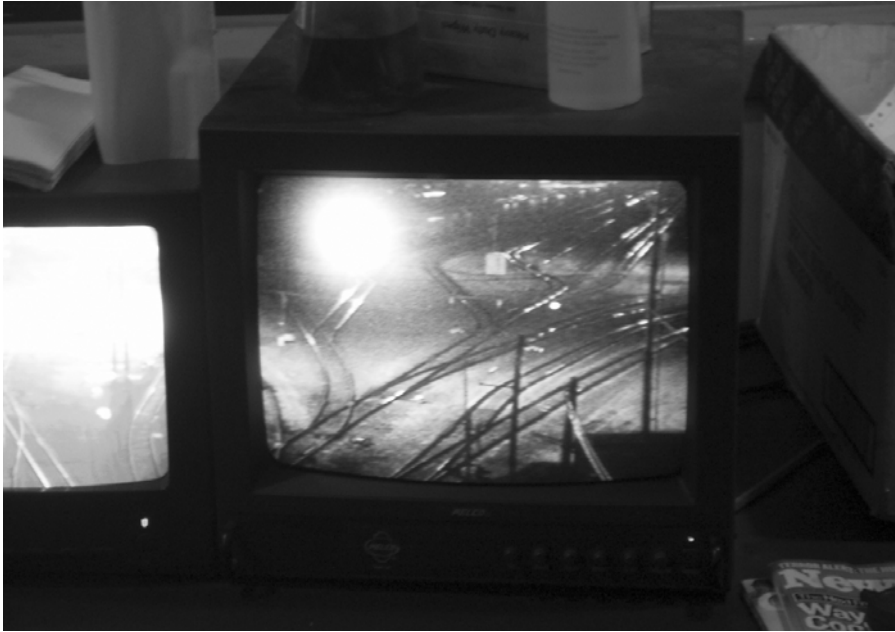
Figure 28. RCL2 eastward-looking camera view of west side of west end of receiving tracks from monitor located inside hump office

- Inadequate procedure for use of west side camera to monitor west end movements. Inside the hump office is a monitor to give crewmembers a view of the west side of the west end of the yard (see Figure 28), since this part of the yard is beyond line-of-sight. The camera is typically used when crews are making moves and operating in that part of the yard. However, at the time of the

collision, there existed no explicit procedure to require operators to use the camera to verify eastward moves to the hump to protect against an unintended westward move. *Organizational factors/organizational process/organizational practices and procedures.* **Probable contributing factor.**

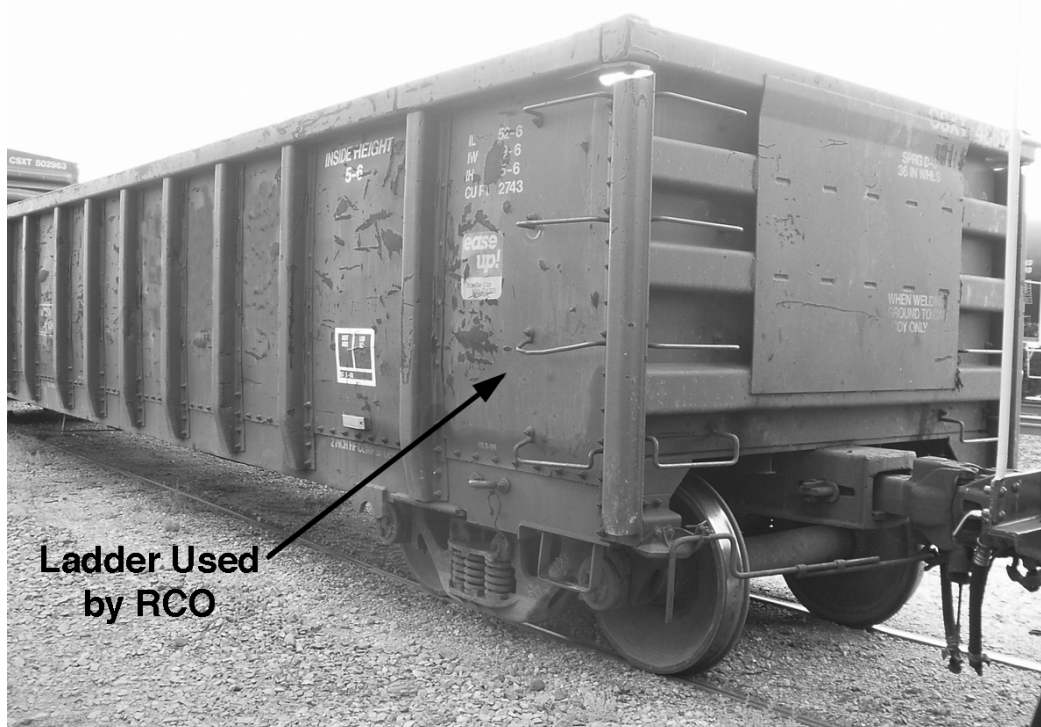
Figure 40. RCL4 gondola car and ladder where foreman was riding

The car the foreman rode was a 57 ft, 34 ton gondola car (see Figure 40). It was the second car from the front; the lead car was a flat car that contained a load of steel. In

addition to a ladder on each end of the car, each side has two ladders—one near the B, or brake, end and one near the A, or non-brake, end. The left side of the B end and the right side of the A end each have ladder configurations that contain a sill step and four rungs to allow a person to climb to the top of the gondola car (see Figure 41). These ladders also afford the RCO the option of standing on the sill step or one rung above the sill step while riding the car. The rung above the sill step is referred to as a double drop rung. It is designed to prevent an RCO's feet from sliding off the rung horizontally as he or she swings around from the end of the car to the side of the car¹⁹. Above the double drop rung are three more rungs. Generally, an RCO stands in either the sill step or the first rung above it. The RCO ordinarily holds onto the second or third rung, whichever is more comfortable. The ladders on the other two corner sides each have a sill step and two rungs (see Figure 42). These ladders are designed to allow the RCO to stand in the sill step and hold onto either of the ladder rungs. The spacing of the rungs does not permit an RCO to stand on them.

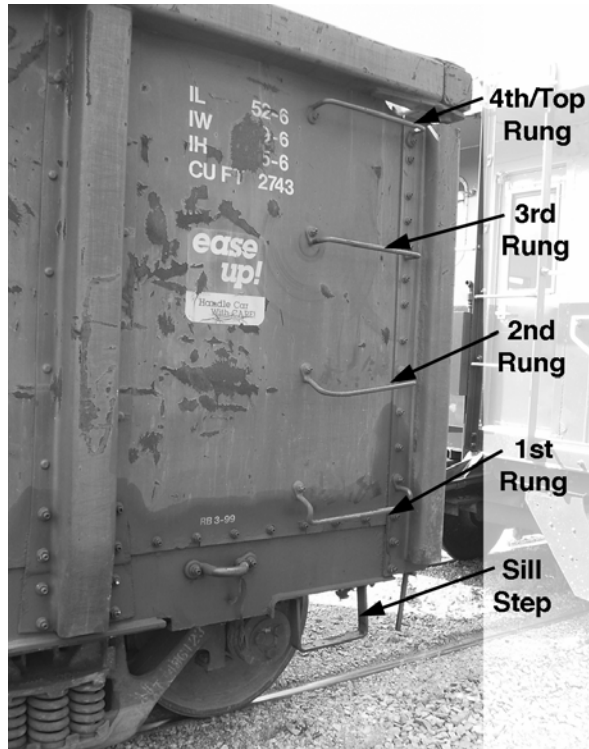
Figure 41. RCL4 A end ladder used by RCO foreman

The foreman rode the trailing, A end of the gondola car because of a preference to stand on the first ladder rung above the sill step. The ladder on the north side, leading end of the gondola only, contained a sill step to stand on and several ladder rungs to hold onto (see Figure 42). This configuration forces the rider to stand on the sill step. Because the sill step is recessed compared to the rest of the ladder rungs and side of the car (see Figure 43 and Figure 44), it can cause a rider's upper body to hang out, making it potentially dangerous when riding on a track with a narrow clearance²⁰ or if equipment is fouling the path. It may also be uncomfortable to some riders. In fact, the clearance between tracks 23 and 24 was considered narrow, although at the time of the injury, track 24 was empty. To avoid riding the sill step, the foreman rode the trailing end of the gondola car. There he was able to place his feet in the first ladder rung above the sill step and his hands on the top rung in order to pull himself, and ride, closer to the body of the car.

As the cut of cars approached the standing cut of cars in track 23, the foreman instructed his helper to stop before making the coupling. After the stop, the foreman began to dismount the car to get into position to receive the pitch from his helper and control the move at the coupling. At the time of the stop, the foreman's hands were on the top ladder rung, and his feet were on the first rung above the sill step. As he began to dismount, the foreman removed one foot from the ladder rung and tried to place it in on the sill step. As he lowered himself, his RCD struck a ladder rung and was shoved into his face, knocking his eyeglasses off, obstructing his view, and causing him to lose his balance. As a result, the foreman missed the sill step with his foot, lost his grip on the ladder, and fell to the ground.

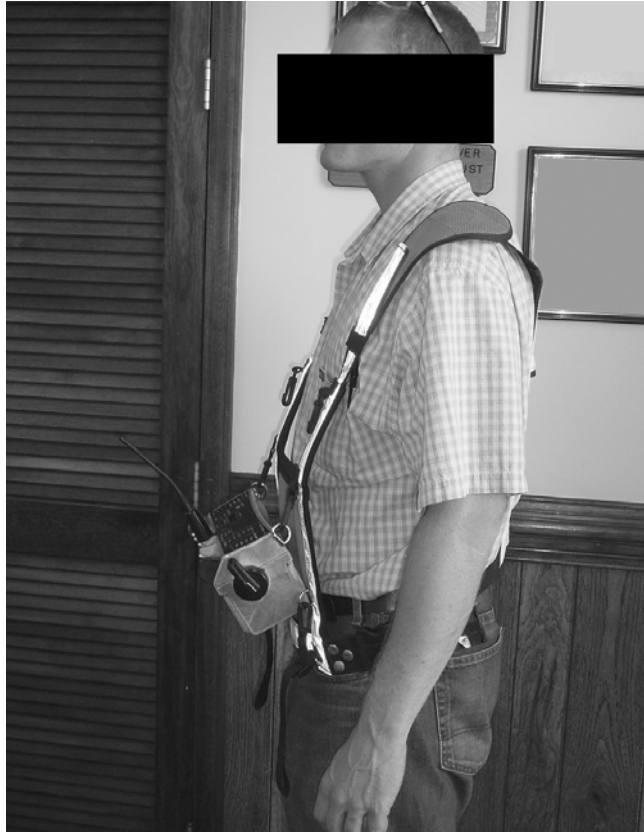
Figure 45. RCL4 side view of RCD involved in injury

- Temporary distraction. The foreman was temporarily distracted as he was dismounting the car when his RCD caught a ladder rung as he began to lower himself. The RCD raised up into the foreman's face, knocked his eyeglasses off, and obstructed his view of the sill step and ground beneath. *Operator acts/skill-based error/attention failure*. **Probable contributing factor.**

- Size, shape, and location of the RCD. The size and shape of the RCD, and its location worn on the foreman's chest (see Figure 45²¹), enabled the RCD to catch on a ladder rung and raise up into the foreman's face as the foreman dismounted the gondola. The RCD is 10 inch (in) long by 3.5 in wide by 4.5 in high (Cattron-Theimeg, 2002). In fact, it is common knowledge among RCOs that RCDs occasionally strike, or catch, railroad equipment (e.g., locomotive cab door). In this instance, the RCD got caught on a ladder rung as the foreman lowered himself. *Preconditions for operator acts/environmental factors/technological environment*. **Probable contributing factor.**

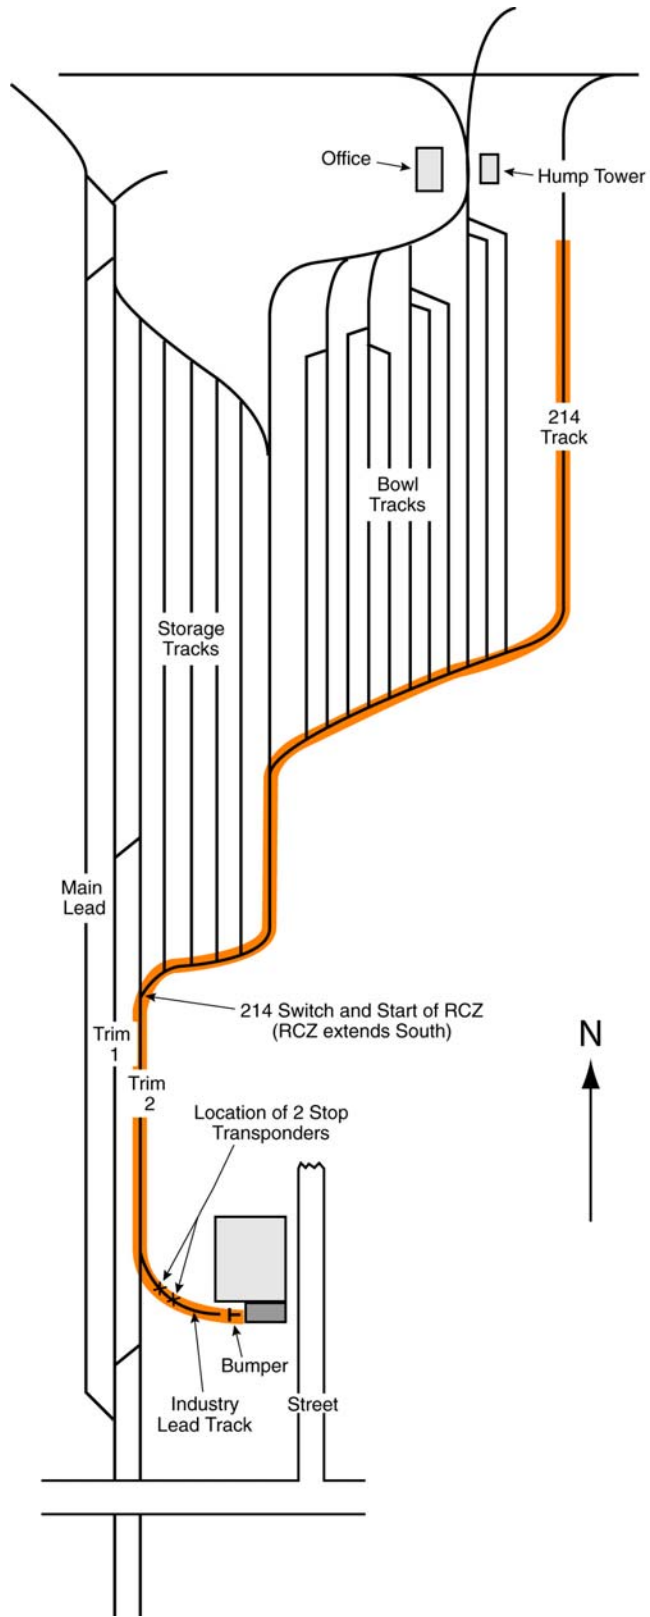
Figure 46. RCL5 yard layout with RCL path highlighted

The yard is laid out in a north-south direction. The hump, bowl, and storage tracks are all located toward the north end, while several trim, or pullback, tracks are located to the south (see Figure 46). Cars are humped into bowl tracks, and then cuts of cars are pulled southward out of the south end of the bowl track using trim tracks 1 and 2, and shoved back northward into the storage tracks. An industry also feeds into the trim 1 track south of the storage tracks using a curved industrial lead track (see Figure 47). At the end of the industrial lead, a bumping post denotes the end-of-track and prevents cars from rolling off the end-of-track.

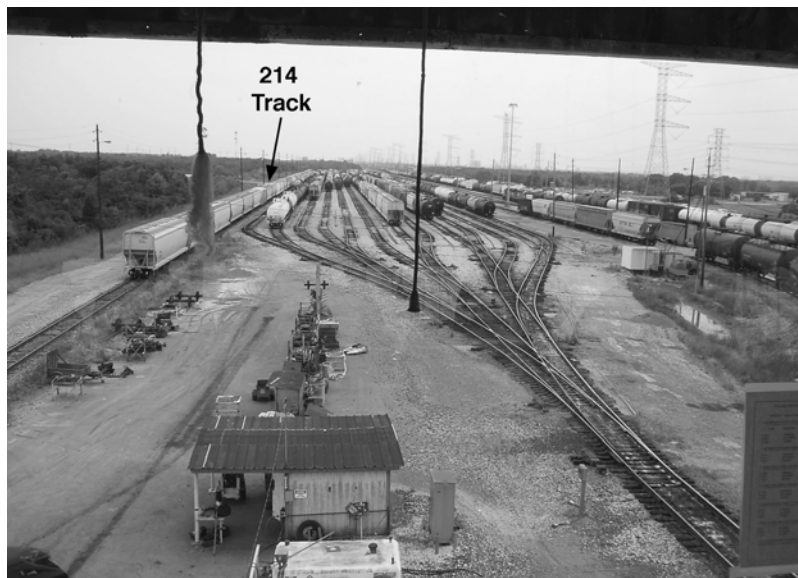
Figure 48. RCL5 southward view of bowl tracks and 214 track from hump tower

In addition, one track—track 214—is used to store long cuts of cars, among other uses (see Figure 48). Track 214 is located in the eastern part of the yard and runs southward and then westward, serving as a ladder track for the southern part of the bowl tracks. Track 214 then continues southward, serves as a ladder track for the storage tracks, and eventually feeds into the trim 2 track. Just south of the track 214 switch, an RCZ begins and runs southward along trim 1 and trim 2 tracks (see Figure 49).

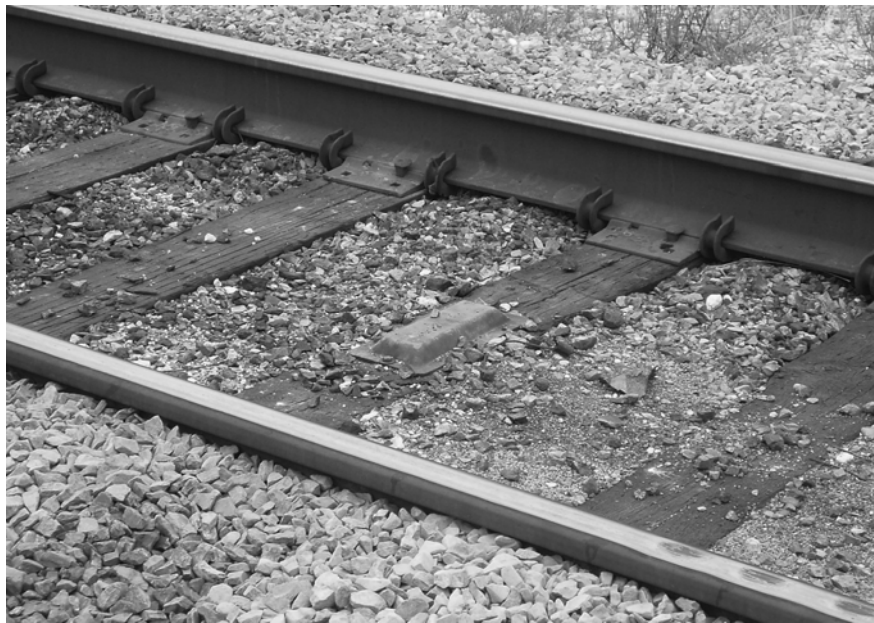
Figure 50. RCL5 passive track transponder

Trim 2 track is equipped with an automatic pullback protection system to provide PSP. The pullback protection system consists of an antenna underneath the RCL that searches for and reads passive track transponders embedded between the rails (see Figure 50 for an example). These passive transponders communicate speed directive information to the antenna as an RCL encounters the transponders. The antenna, in turn, communicates the information to the RCL to control the speed of the RCL. The first set of transponders communicates to the RCL that it is entering the pullback protection system and communicates a maximum prescribed speed for the RCL as it begins to travel down the pullback-protected track. Subsequent transponders communicate lower and lower speed information, so that the RCL is instructed to stop at designated location along the track based on two stop transponders. The start of the pullback protection system, as indicated by the location of the first track transponder, is just south of the track 214 switch and just north of the industrial lead turnout.

The brakeman, in control of the move, continued to shove the cut southward out of track 214 while looking for the cars they wanted to spot. At approximately 3:17:05 p.m., the RCL encountered the first industry pullback protection stop transponder (see Figure 50). The cut was presumed²⁵ to be traveling approximately 7.4 mph when it encountered this stop transponder. The RCL initiated a stop²⁶ as a result of encountering the stop transponder. Approximately 9 s later the cut derailed off the end-of-track and struck the building; it was traveling 6.3 mph at the time of derailment. Twenty-one seconds later the cut came to a stop. The crew received several warnings on their RCD as a result of the RCL encountering the track transponder, wheel slip, and subsequent derailment. The crew was unsure what had happened and drove their vehicle to the industry to investigate,

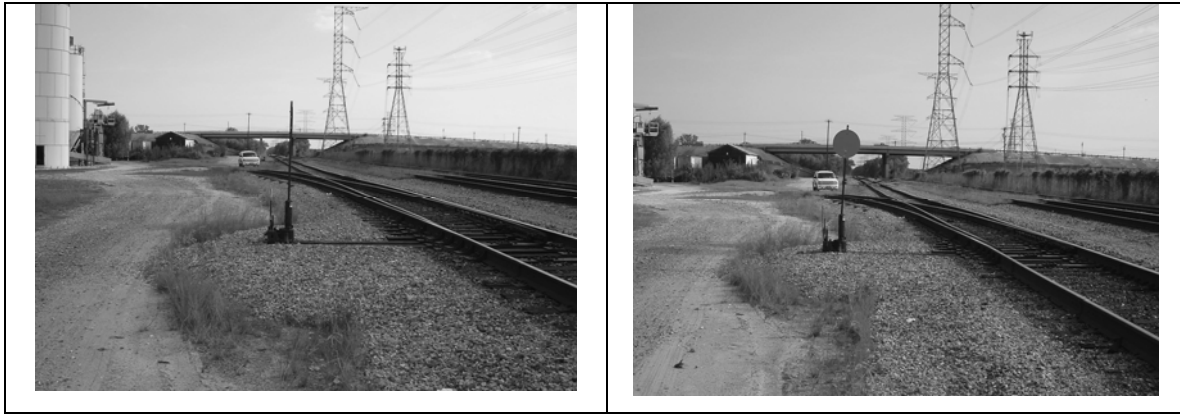
- RCL technology enabled the RCO to control his movement from a distance and thereby reduced RCO situation awareness. The use of RCL equipment, including RCZs and automatic pullback protection, enabled the RCOs to control cuts of cars at a significant distance away from the point of the movement. The presence of this technology enabled the RCOs to operate at a distance far enough away from the point of the movement where they could not visually detect the mislined switch or feel the movement of the cars and RCLs when they entered the industry turnout. Had an RCO been riding the point of the movement or had he been in a position further south to watch the point of the movement, this RCO likely would have noticed the industrial lead switch target indicating movement into the industry lead (see Figure 54). The crewmembers also would have noticed once the lead cars began to enter the industrial lead. By its very nature, the RCL technology reduced RCOs' situation awareness by enabling them to operate the

Figure 54. RCL5 industrial lead switch target communicating straight (trim 2) track movement (left) and industrial lead movement (right)

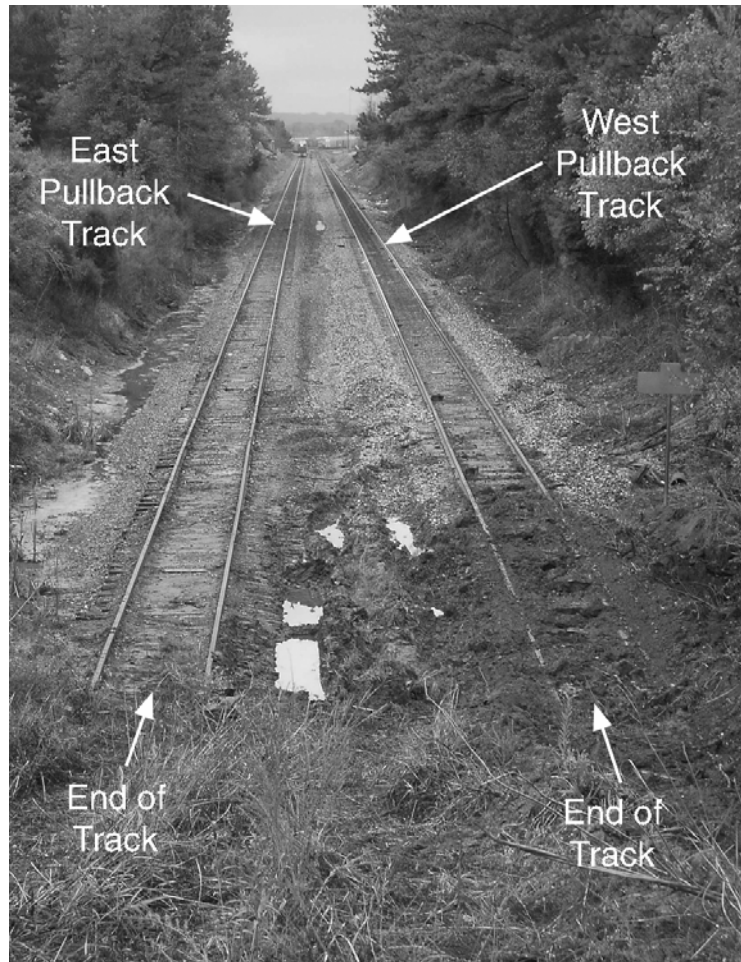
Figure 56. RCL6 southward view (from embankment) of east and west pullback tracks toward classification tracks and other parts of yard

Running approximately south to north, the yard consists of a number of receiving tracks, followed by a hump, a number of classification tracks, and two pullback tracks—an east and a west (see Figure 55). The pullback tracks each end at the lower portion of an embankment (see Figure 56). To the east and west of the classification tracks are a number of departure or forwarding tracks. A number of run-around, repair-in-place (RIP), and other service tracks are throughout the yard. Two towers exist—a hump tower positioned at the hump and a north end tower located at the juncture of the northern part of the classification tracks and the pullback tracks.

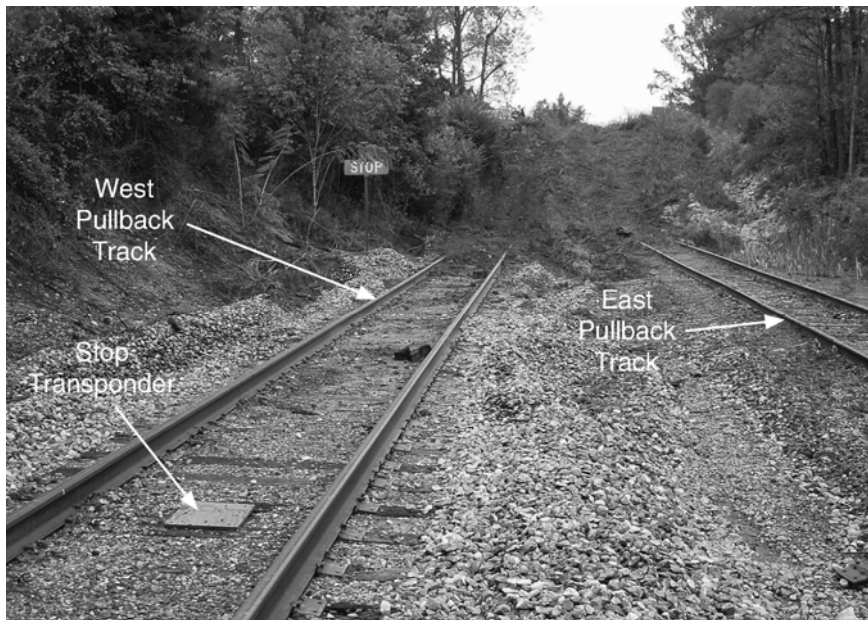
Figure 58. RCL6 northward view of east and west pullback tracks with view of embankment and pullback protection system transponder embedded in track

instruct the RCL to stop. The last stop transponder is located approximately 110 ft from the end of the track (see Figure 58). The accident occurred on the west pullback track.

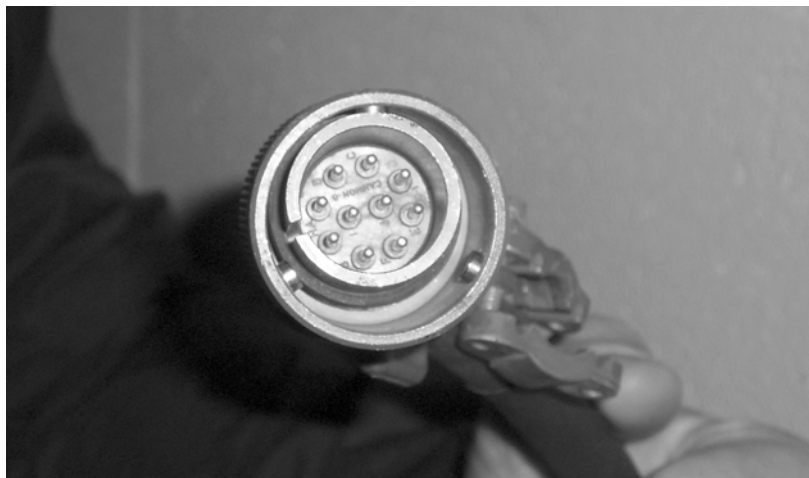
Figure 70. RCL6 view of antenna cable pins and connector

- The wire that communicates the presence of track transponders to the RCL OCC was broken. Investigation by the RCL, pullback protection system supplier, and railroad revealed that one of the wires in the antenna cable was broken at the connector pin solder joint (see Figure 69 and Figure 70). The result was that track transponder information was not being relayed from the antenna to the reader and OCC. Analysis by the supplier, however, found that the test transponder was being read. The design of the pullback protection system requires the antenna to periodically (several times per minute) poll the test transponder to ensure proper functioning of the antenna. If a failure occurs in reading the test transponder, then the pullback protection system is designed to stop the RCL. However, the night of the derailment no such problems occurred with the test transponder. Subsequent testing by the supplier revealed that the likely reason the OCC was receiving positive information about the presence of the test transponder but not receiving information regarding the presence of any track transponders, was because the information from the test transponder was being directly communicated to the antenna extension cable, above the point where the wire that communicates transponder presence and information was broken. It is suspected that the low power generated around the antenna, including the test transponder and cabling, enabled the antenna extension cable to act as a low power antenna, and consequently it attracted test transponder information directly from the test transponder to the wire within the antenna extension cable that communicates transponder-related information (see Figure 71). In doing so, the information skipped the antenna. However, the reader still received the test transponder information and thus believed the antenna to be working. The OCC believed that the antenna was functioning, and it had not encountered any track transponders. It is not clear when, at some point before the collision, the wire broke off at the

solder joint, nor why and how it broke. The wire was probably held loosely in position by the heat-shrink tubing that surrounded the wire-solder joint (see Figure 69), causing intermittent functioning and intermittent failures, of the pullback protection system, during the days before the derailment occurred. The cause of the broken wire connection is beyond the scope of this research. *Preconditions for operator acts/environmental factors/technological environment.*
Probable contributing factor.
