# **AQUETONG ROAD/ WINDY BUSH ROAD**

## **Road Safety Audit**

October 2007

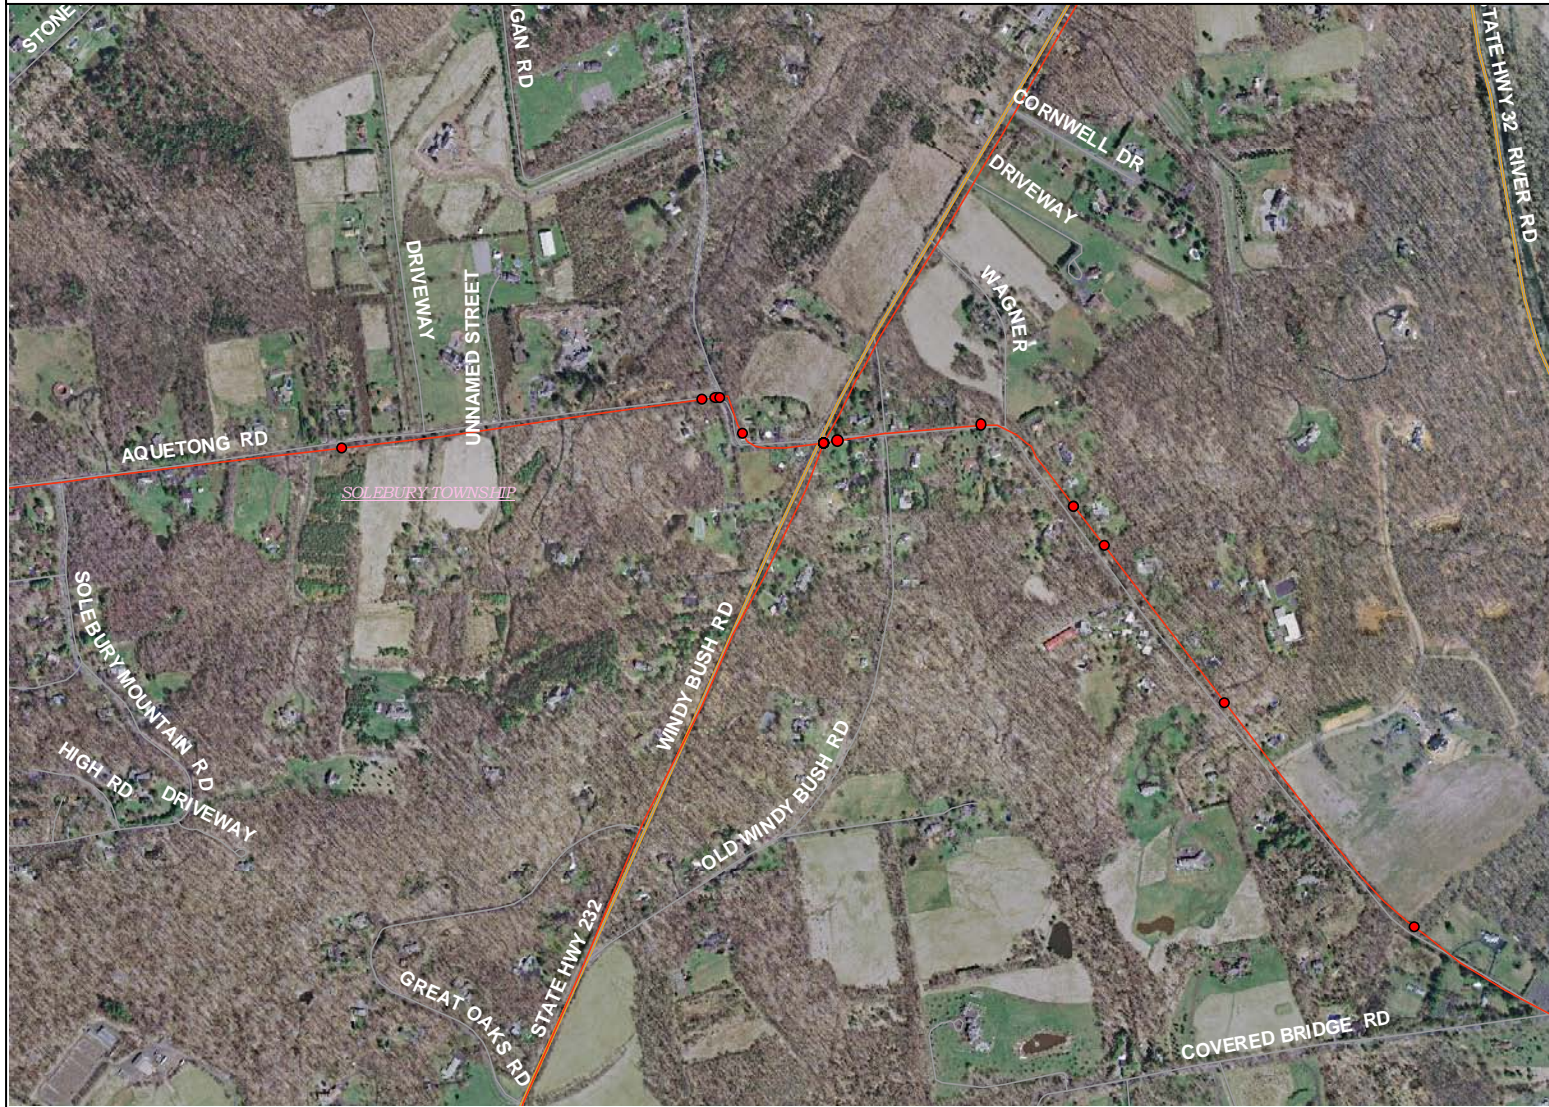
**1. Intersection of Aquetong Rd. and Windy Bush Rd., Study Area Limits**  
 Aquetong Rd. (seg 20/0 to seg 30/4566), Windy Bush Rd. (seg 270/0 to seg 270/2105)

COLLISION TYPE	
Angle	12
Hit Fixed Object	7
Opp Dir Sideswipe	2
Rear end	1
Head On	1
Pedestrian	1
Non Collision	1
<b>Total</b>	<b>25</b>
ILLUMINATION	
Daylight	16
Dark	7
Dusk	1
Unknown	1
<b>Total</b>	<b>25</b>
WEATHER	
Clear	15
Rain	4
Snow	3
Unknown	2
Sleet	1
<b>Total</b>	<b>25</b>
SEVERITY COUNT	
Fatalities	0
Major	1
Moderate	3
Minor	11

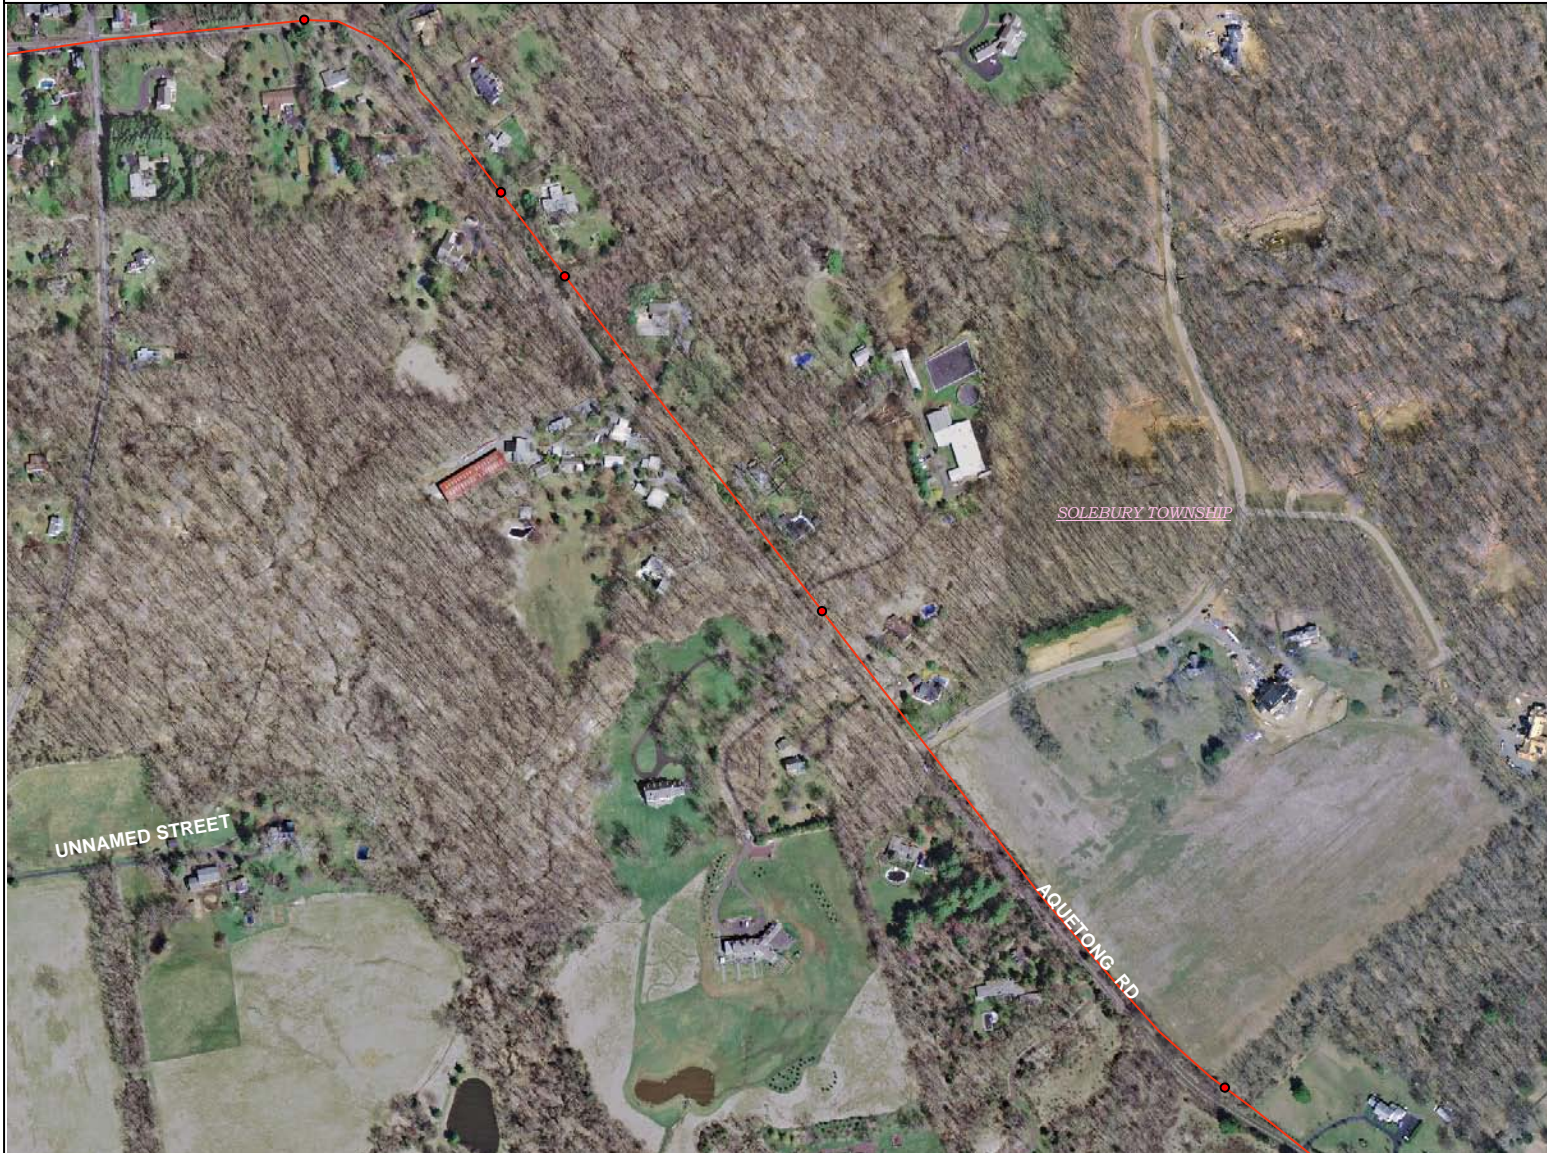
**2. Aquetong Rd. East of the Intersection**  
 Segment 20, Offset 980 to Segment 20, Offset 4604

COLLISION TYPE	
Hit Fixed Object	3
Opp Dir Sideswipe	2
Pedestrian	1
<b>Total</b>	<b>6</b>
ILLUMINATION	
Dark – no street lights	3
Daylight	2
Unknown	1
<b>Total</b>	<b>6</b>
WEATHER	
Snow	3
Sleet (hail)	1
Clear	1
Unknown	1
<b>Total</b>	<b>6</b>
SEVERITY COUNT	
Fatalities	0
Major	0
Moderate	2
Minor	1

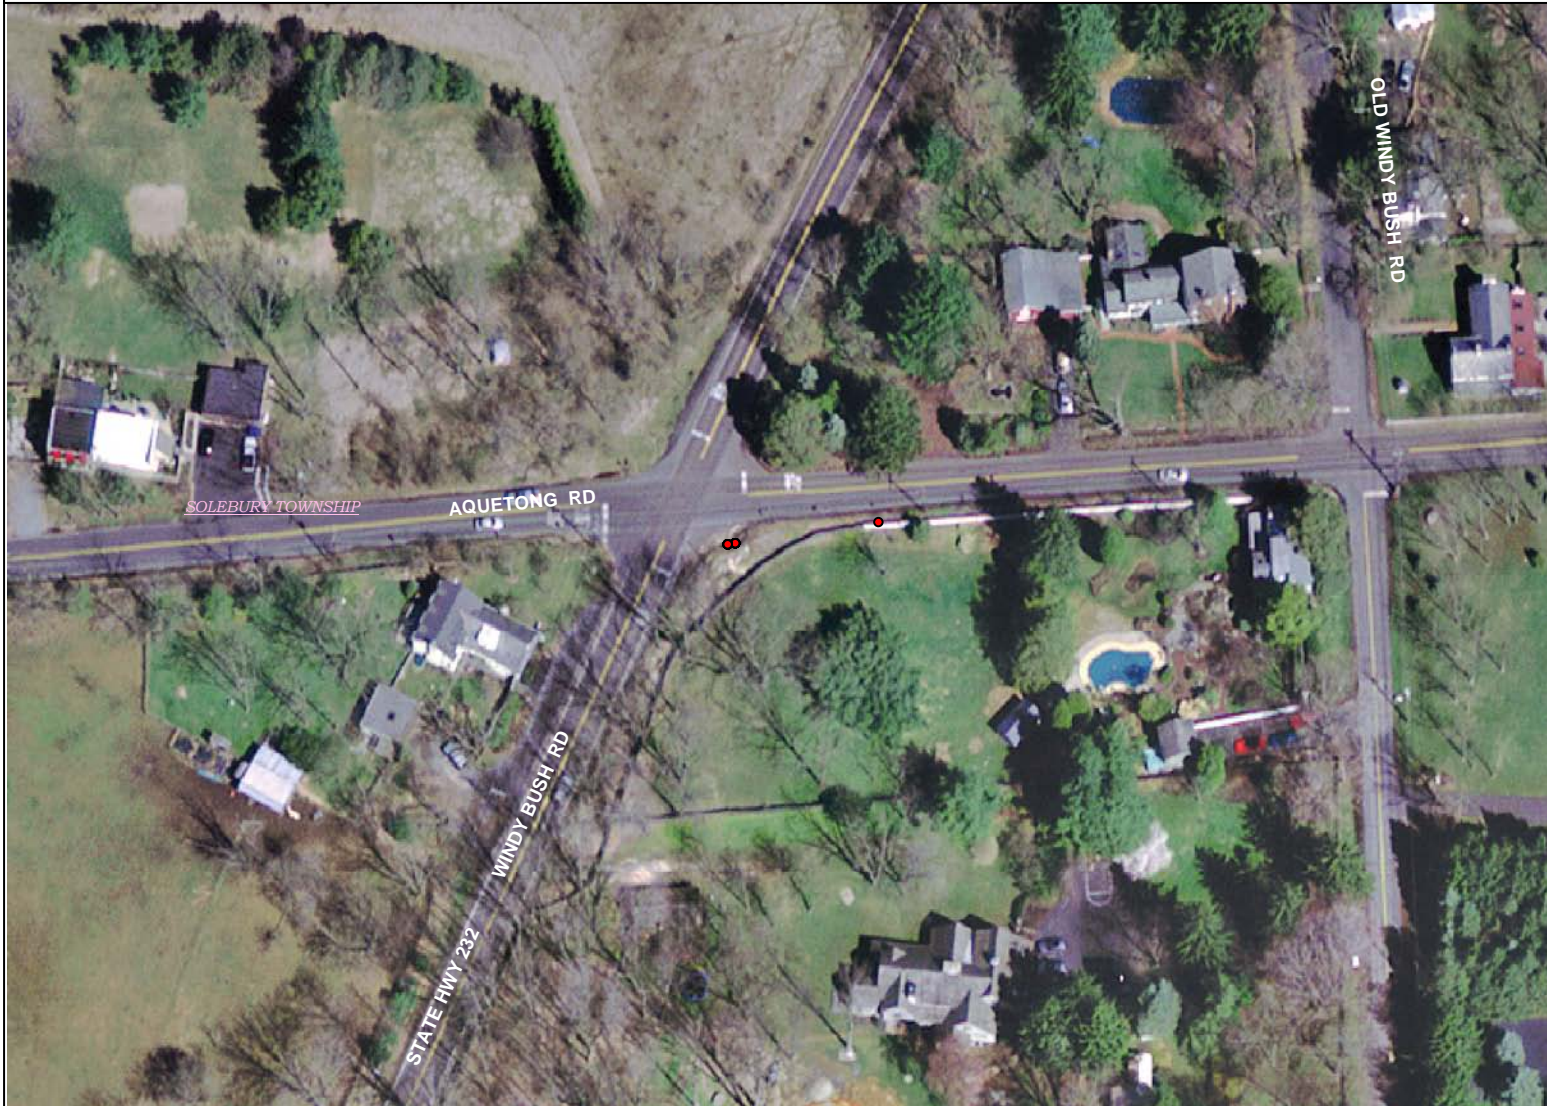
**3. Intersection of Aquetong Rd. and Windy Bush Rd.**  
 Segment 30, Offset 266 to Segment 30, Offset 341

COLLISION TYPE	
Angle	10
Hit fixed object	2
Non collision	1
Rear-end	1
<b>Total</b>	<b>14</b>
ILLUMINATION	
Daylight	11
Dark – no street lights	2
Dusk	1
<b>Total</b>	<b>14</b>
WEATHER	
Clear	10
Rain	3
Unknown	1
<b>Total</b>	<b>14</b>
SEVERITY COUNT	
Fatalities	0
Major	1
Moderate	1
Minor	8

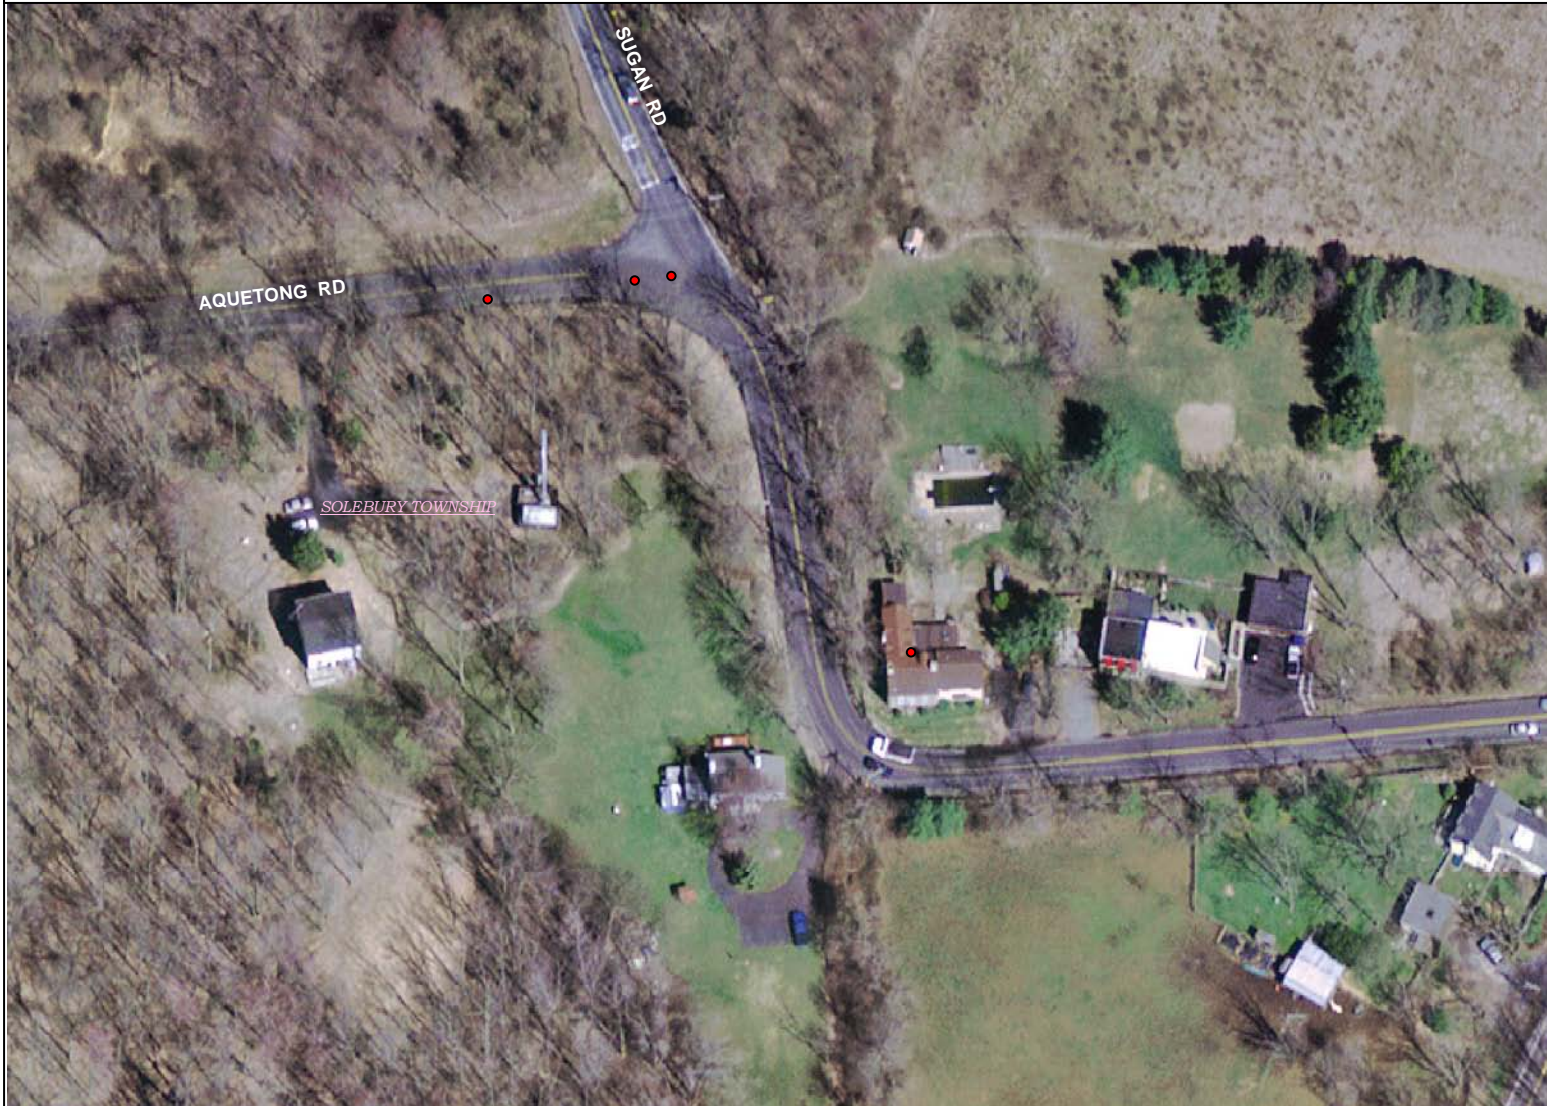
**4. Aquetong Rd. Curve at Sugan Rd.**  
 Segment 30, Offset 823 to Segment 30, Offset 1154

COLLISION TYPE	
Angle	2
Hit Fixed Object	1
Head On	1
<b>Total</b>	<b>4</b>
ILLUMINATION	
Daylight	3
Dark – no street lights	1
<b>Total</b>	<b>4</b>
WEATHER	
Clear	3
Rain	1
<b>Total</b>	<b>4</b>
SEVERITY COUNT	
Fatalities	0
Minor	1

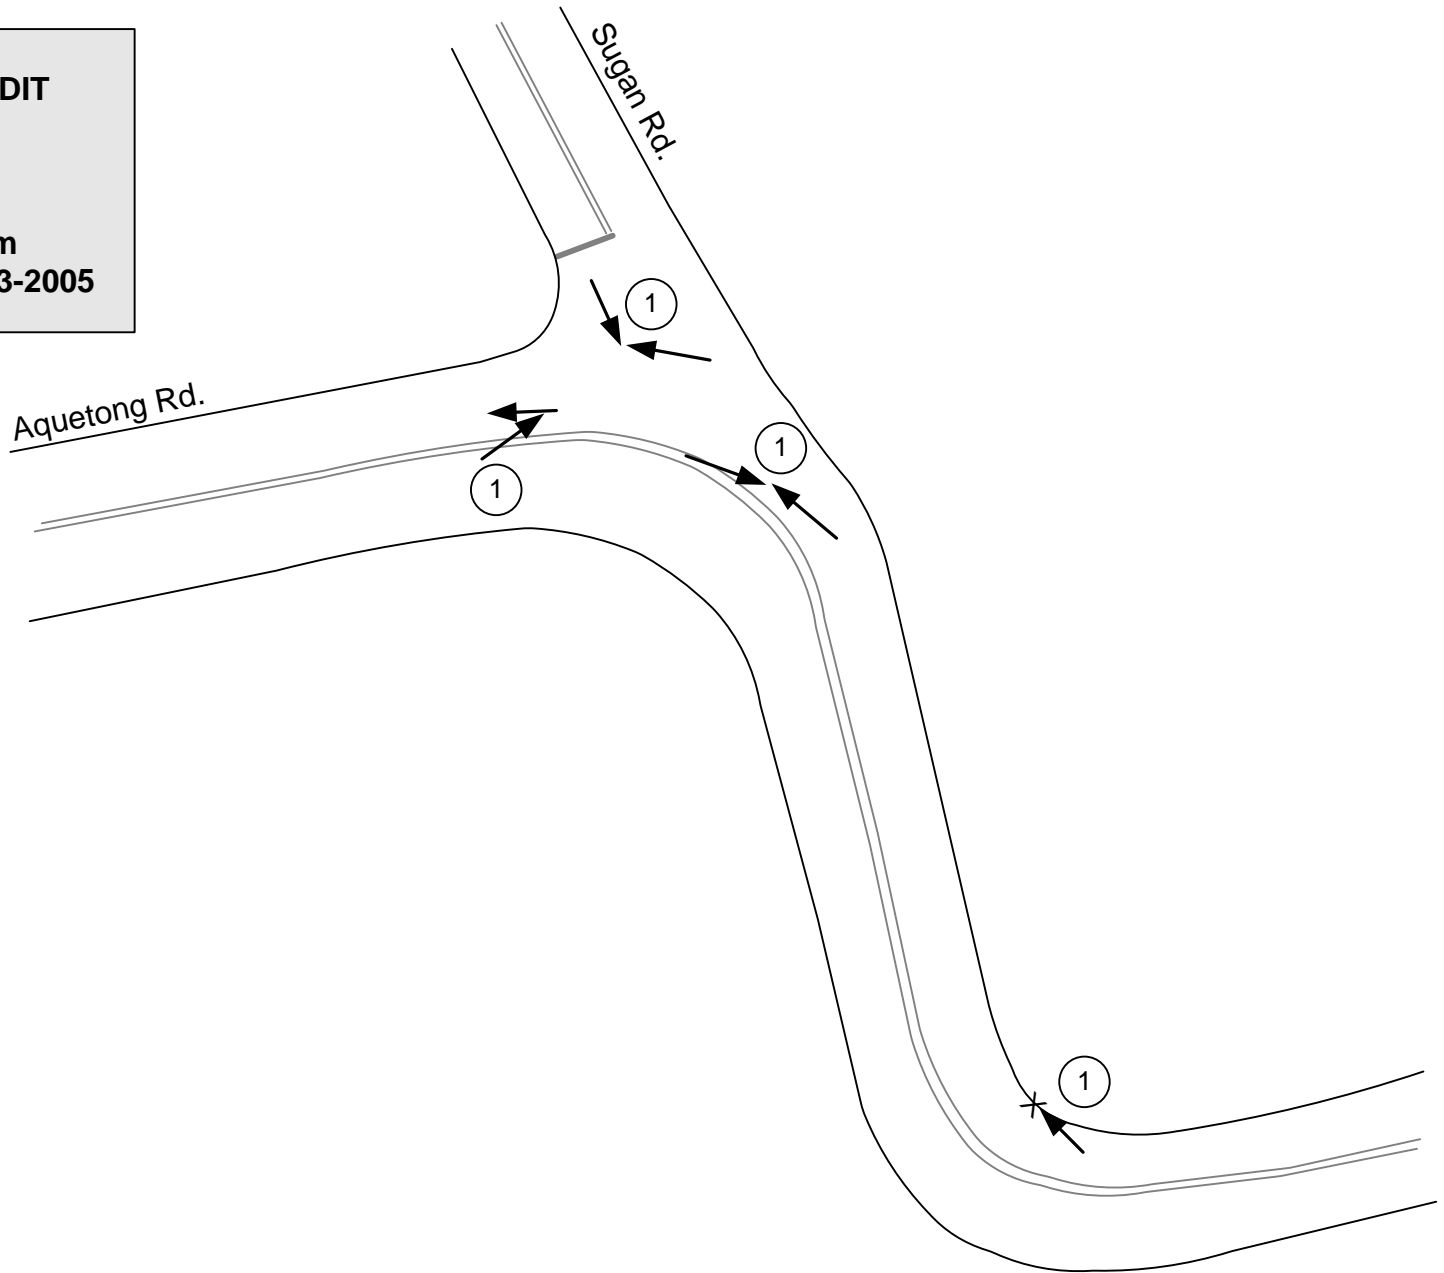
**ROAD SAFETY AUDIT**  
**Aquetong Rd.**  
**Curve at**  
**Sugan Rd.**  
**Collision Diagram**  
**Crash Data Years 2003-2005**

Total Crashes = 4  
 Pedestrian Crashes = 0

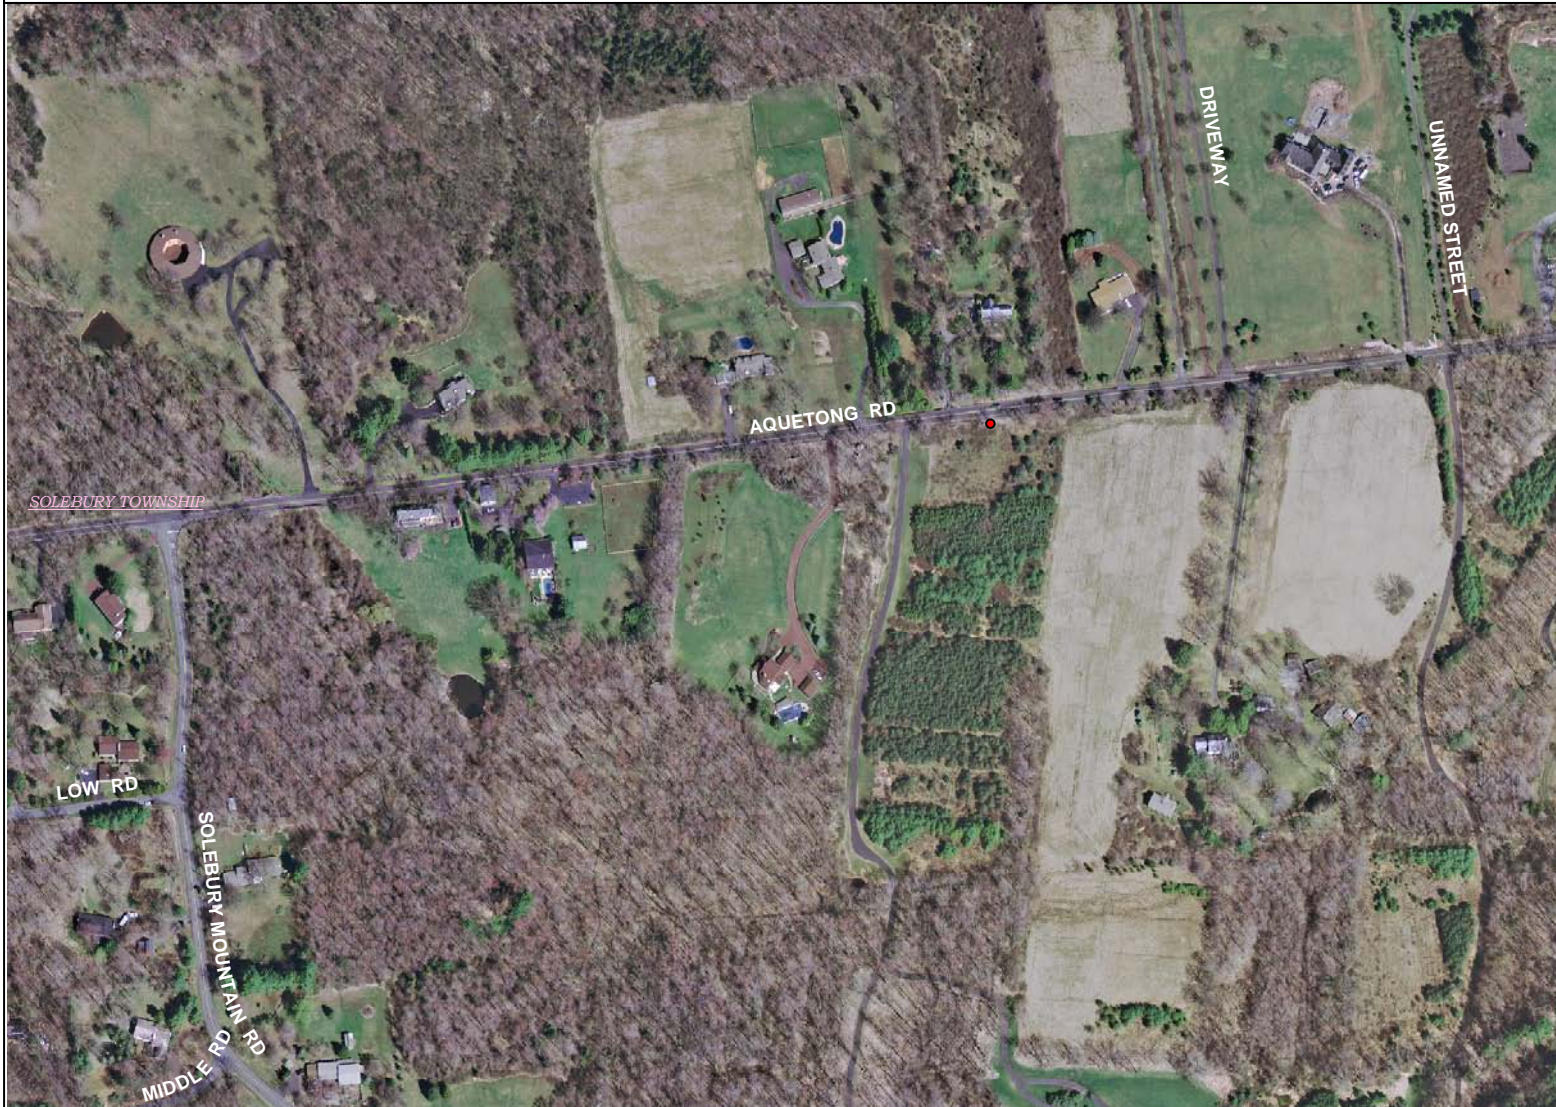
**5. Aquetong Rd. West of the Intersection**  
 Segment 30, Offset 2000 to Segment 30, Offset 4566

COLLISION TYPE	
Hit Fixed Object	1
<b>Total</b>	<b>1</b>
ILLUMINATION	
Dark – no street lights	1
<b>Total</b>	<b>1</b>
WEATHER	
Clear	1
<b>Total</b>	<b>1</b>
SEVERITY COUNT	
Fatalities	0
Minor	1
