Cape Hatteras National Seashore
Bodie Island Coast Guard Station

Historic Structure Report

2005

2005
Historic Structure Report
Bodie Island Coast Guard Station
Cape Hatteras National Seashore
Manteo, NC
LCS#: 07238

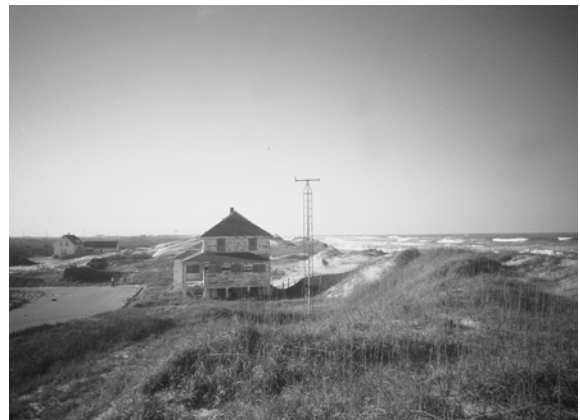
time, the dunes have grown and the shoreline has continued to move westward. The site around the station has changed significantly. The view of the once broad expanse of beach from the original front entrance portico is now blocked by large sand dunes that stand immediately east of the structure. The water's edge is now just beyond the sand dunes. This build-up of dunes, coupled with the removal of the original portico and the addition of offices on the east side in the 1960s, have changed the building's orientation. Today a paved drive from Highway 12 leads to a parking lot directly west of the building, and this elevation appears to be its front facade.

Figure C-1 Station from the south, showing dunes to the east and the relocated 1879 Station to the west

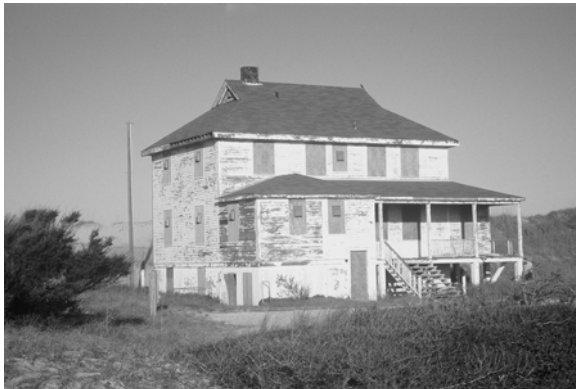
Figure C-2 Station from the northwest

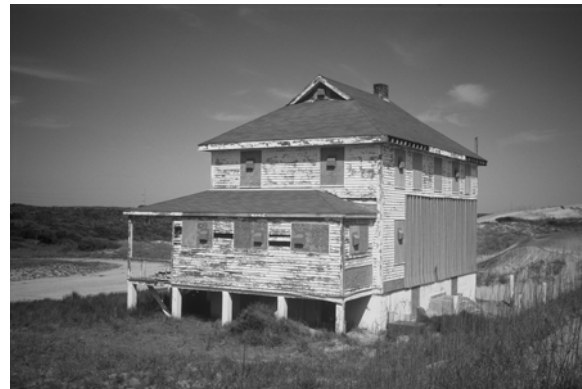
Figure C-3 Station from the southeast

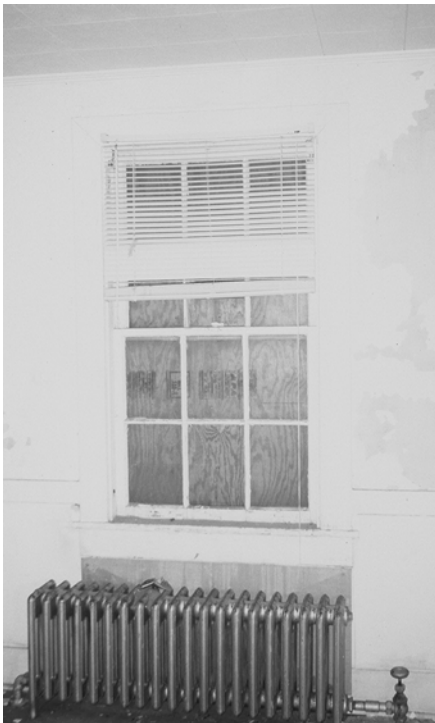
Some of these windows have small amounts of rot or separated elements, and many have

broken sash cords, but in general they are in stable condition due in large part to the mothballing of the building.

Figure C-7 Six-over-six window and radiator, probably both dating to 1925

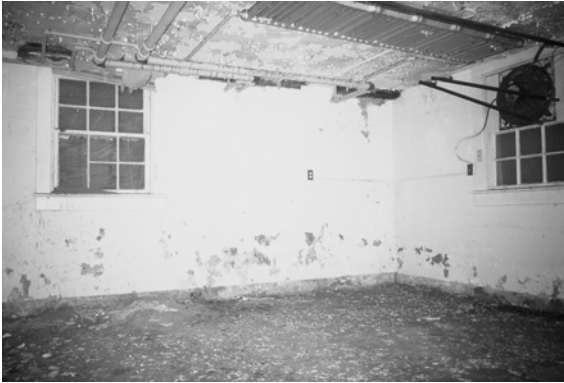
Figure C-9 Southeast corner of Room 001

- **Ceiling:** There is visible termite damage to the ceiling joists exposed in the southeast corner of the room and the adjoining east wall sill plate. The 9½" x 1¾" ceiling joists are 16" on center and run east-to-west. An I-beam that runs from north-to-south for the length of the house is visible from the corner of the wall south of the staircase to the south

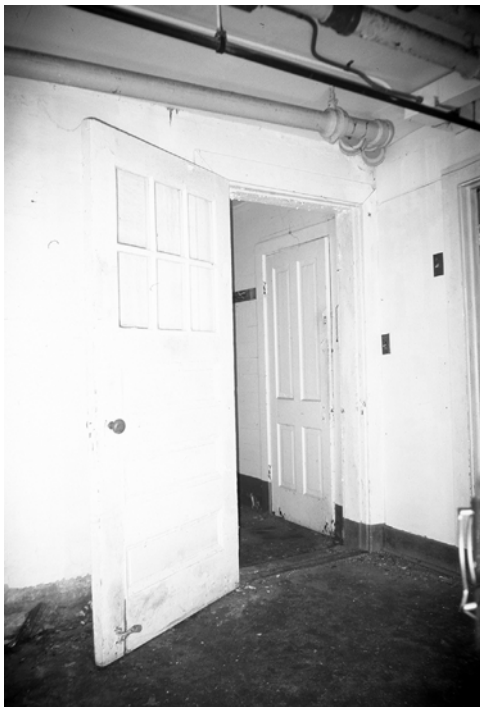
Figure C-10 1933 Doorway leading from the added west stair tower (Room 007)

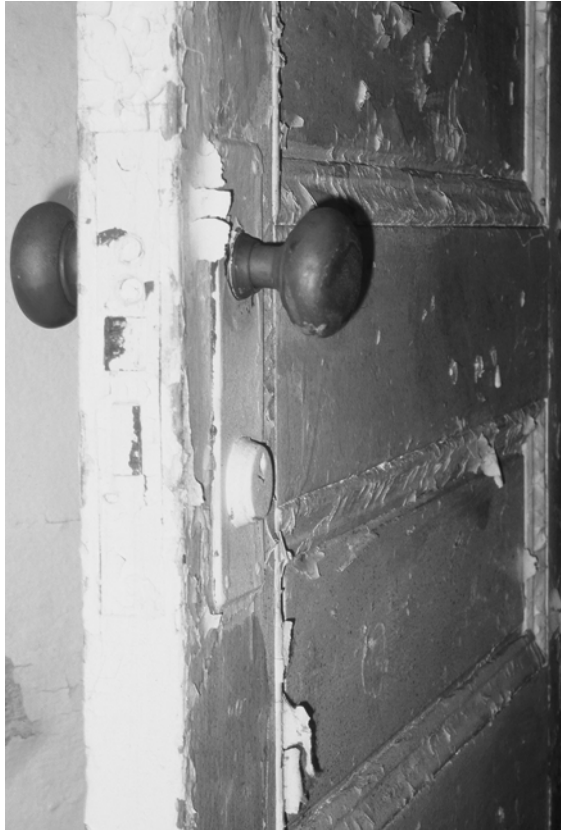
Figure C-11 Early back door's mortise lock

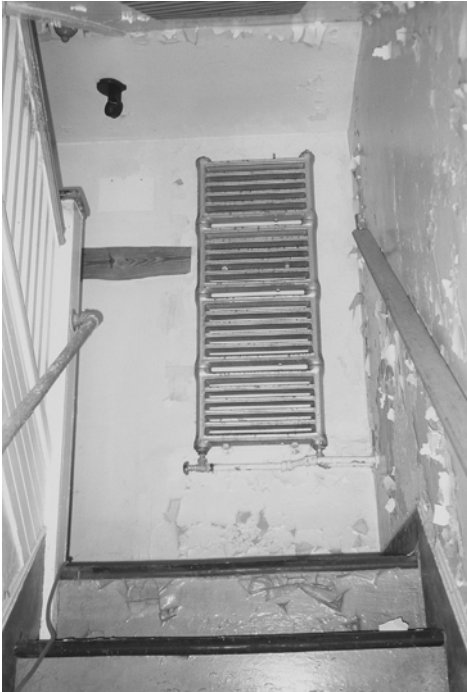
Figure C-14 Landing between first floor and basement

- **Finishes:** The walls, floor, and ceiling are all painted and are peeling extensively.
- **Mechanical & Electrical Systems:** Mounted on the east wall of the landing is a 24-fin, 1'-8" x 4'-6" wall radiator. Above the landing is a 1970s-vintage ceiling light missing the globe.
- **Other Features:** The staircase consists of a poured-in-place concrete intermediate landing. There are wood treads and risers from the intermediate landing to both the first floor and the basement. The lower run has a galvanized 1¼" pipe handrail on the north side and a wood handrail on the south side, apparently more recent by its lack of wear.

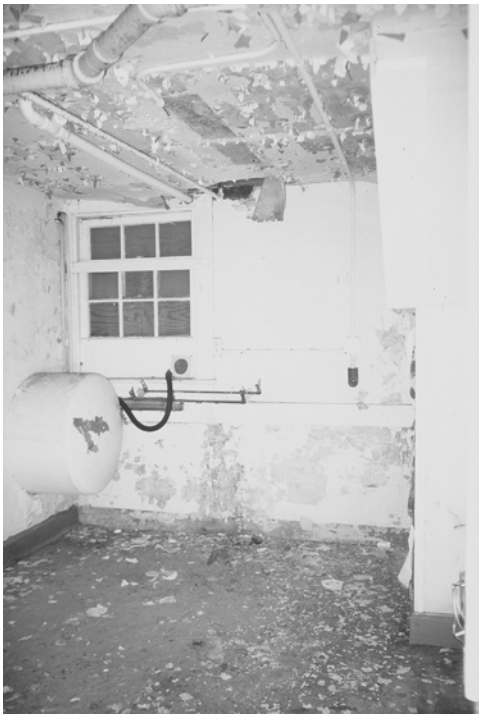
Figure C-15 Tank in Room 003

- *Other Features:* In the northeast corner of the room, part of the metal tank from the adjacent room is visible.

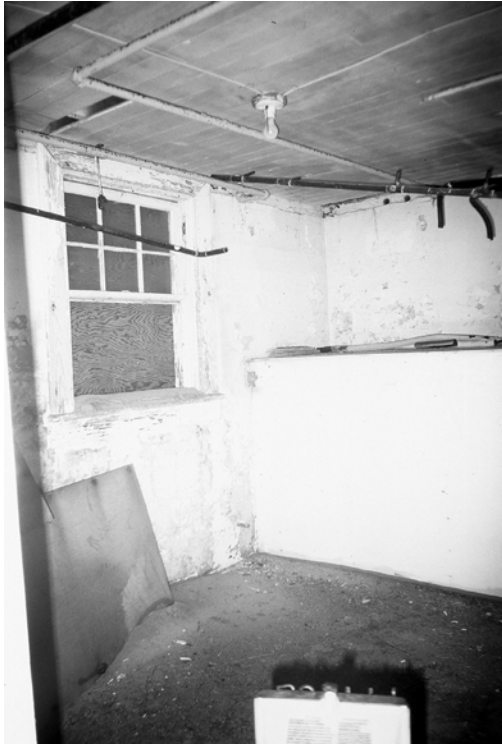
- *Windows:* The room's one window, a six-over-six light window with Type M-1 muntins, is on the north wall and has the original 1925-vintage Type C-1 casings. Its

Figure C-16 Northeast corner of Room 004

bottom sash is missing all three muntins and all of its panes of glass.

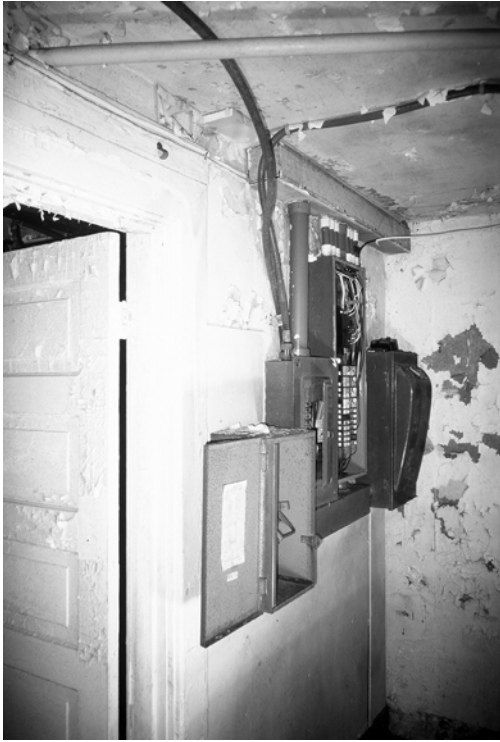
Figure C-17 Electrical Panels in Room 005

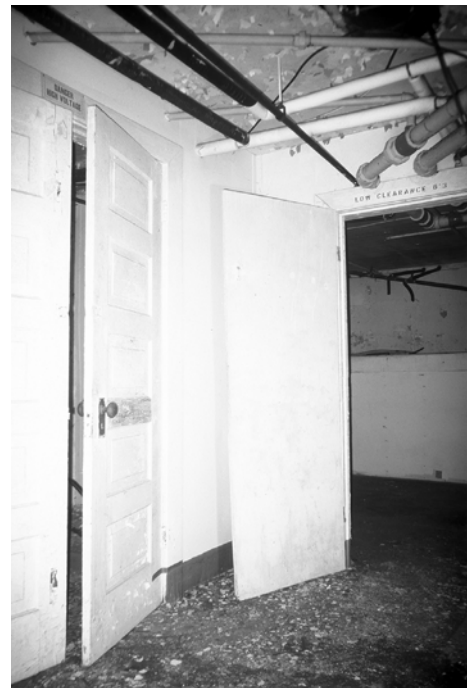
- *Doors:* The doorway from Room 004 to the boiler room (Room 006) has been lowered for overhead piping. The door casing is original, Type C-1, although cut down to fit the modified doorway dimensions. The door itself is made of plywood, a modern addition which probably occurred when the fuel oil system was installed.

wall is a pair of 1925-vintage, double doors, each five-panel and 2’-0” x 6’-6”. The doors have a mortise lock, 3½” five-knuckle butt hinges, and stile-mounted overhead and foot locks. The casing is also 1925-vintage, reused Type C-1.

Figure C-18 Reused 1925 double doors from Room 005 (L) and shortened doorway from Room 004 with modern door (R).

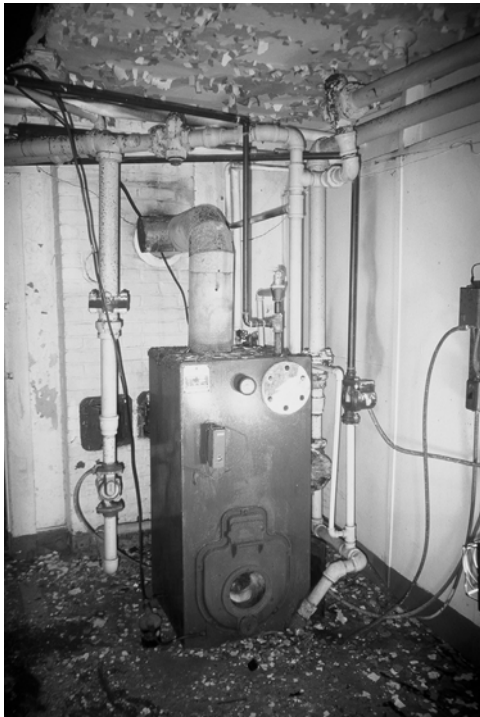
- **Ceiling:** The ceiling is sheathed with gypsum or plaster board.
- **Baseboards:** The east wall beside the chimney has the original, Type B-1 baseboard installed in 1933. The other walls have painted-on baseboard representations.
- **Finishes:** The walls, floor, ceiling, and trim are all painted and are peeling extensively.
- **Mechanical & Electrical Systems:** An inoperative oil boiler made by American

Radiator and Sanitary Corporation is in the southeast corner of the room. The model is A-3 # A35P series 1B J1. It is vented into the chimney with a 6" galvanized vent pipe. Production of this oil boiler stopped in 1968, when the company ceased operation. The company records no longer exist. The installation date is not known. The large fuel oil tank does not appear on the last NPS drawings of 1974. Electric wiring in flexible metal conduit is exposed on the walls. One ceramic ceiling light fixture is in place. In the northwest corner of the room is a Rheem

Figure C-19 Oil Boiler in Room 006

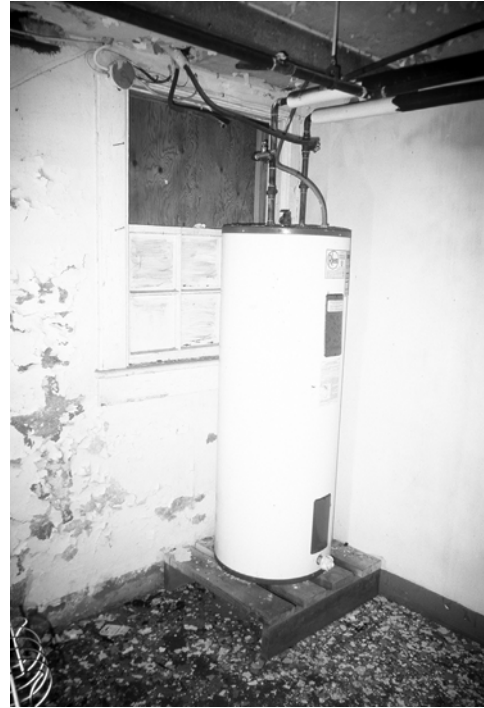
brand, 65-gallon electric water heater serial number R 048 8C02249 model 81V-66D; according to company records, the unit was constructed in April 1988.

Figure C-20 Electric water heater in Room 006
• *Other Features:* None are present.

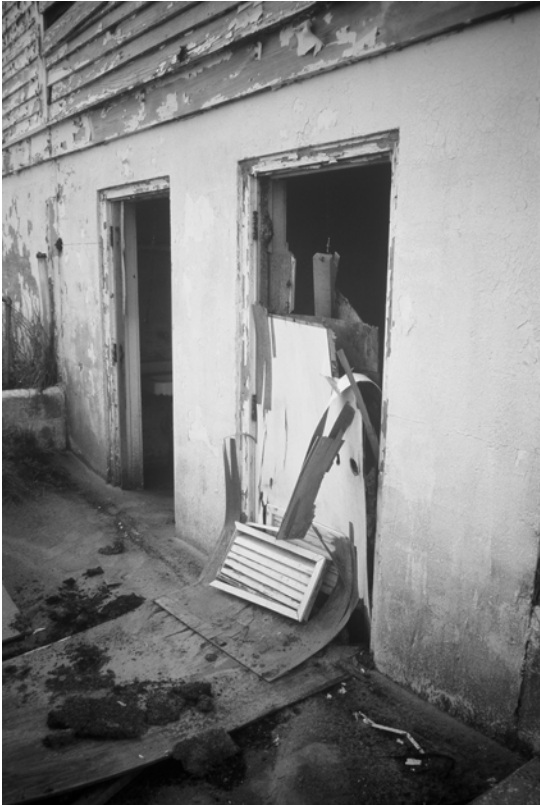
Figure C-22 Public Restrooms

- *Doors:* A wood slab door provides access from the exterior. The door has severe water and termite damage.

- *Doors:* The wood slab door providing access from the exterior is severely damaged by water and termites.

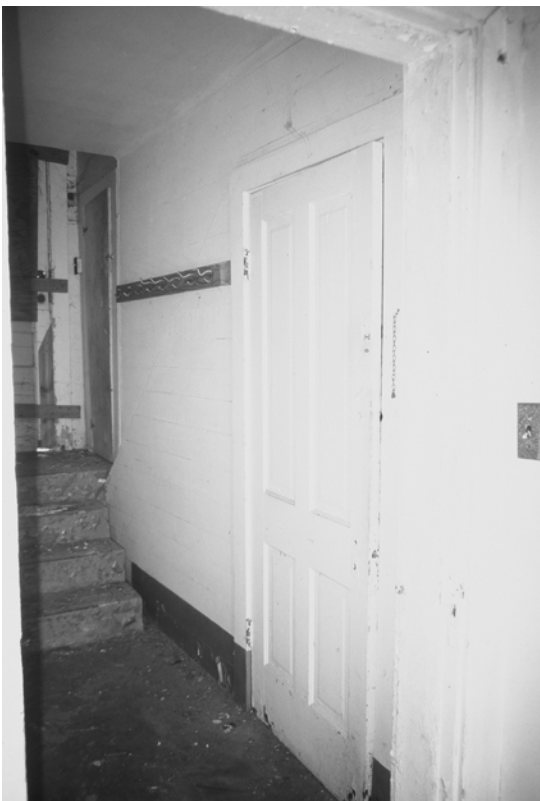
Figure C-21 Room 007

- *Flooring:* The floor is a poured concrete slab. On the west side of the hallway three concrete stairs lead up to a concrete landing. Wooden steps to the first floor have been removed.

- *Walls:* The south, west, and north walls are made of poured-in-place concrete. The wall creating the closet once beneath the stairs is a stud wall sheathed with pine tongue-and-groove boards of random widths ranging from 4¾" to 5¾" in ¼" increments. When the steps were removed in 1974, a stud wall, sheathed in 4¼" pine tongue-and-groove boards, enclosed the remainder of the space where the stairs had been located.

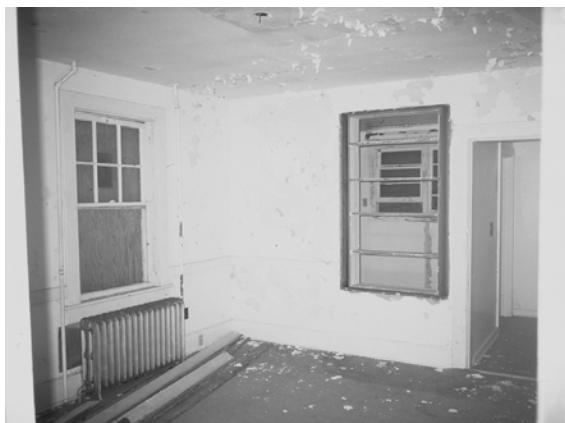
Figure C-23 Southeast corner of Room 101 with original window converted to an open bookcase

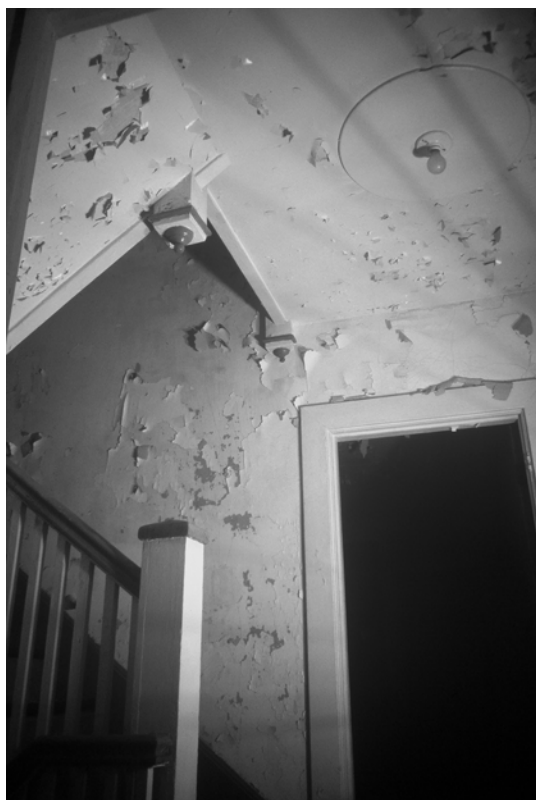
Figure C-24 Room 102 with plywood ceiling medallion and central light, staircase newel, balustrade, handrail, and pendants

- **Windows:** The room's one remaining window, a six-over-six light, 1925-era window with Type M-1 muntins, is on the east wall and is missing all of its muntins on the lower sash. A second window opening on the east wall was closed in 1962 when the east addition was constructed. Cracks in the gypsum or plaster board interior wall patch still indicate its original location.

- **Ceiling:** The ceiling is sheathed with gypsum or plaster board and has extensive water damage.
- **Baseboards:** The baseboard along the east wall is the original, 1925-era Type B-3, as is the baseboard on the east side of the door to Room 112 and the north side of the door to Room 108. The baseboards in the southwest corner of the room between the two doors are 1925-era, Type B-4. The baseboards on the north wall are Type B-11 from a 1974 repair.

- **Finishes:** The walls, ceiling, and trim are all painted and are peeling extensively.
- **Mechanical & Electrical Systems:** Surface-mounted wire molding is on the walls. The ceiling fixture is missing. There is one 1925-era cast iron 16-fin radiator with the dimensions 2'-1" x 3'-4" x 8" under the window. A galvanized, reflective heat shield is on the wall behind the radiator. There are two radiator pipes going up the east wall to the second floor.

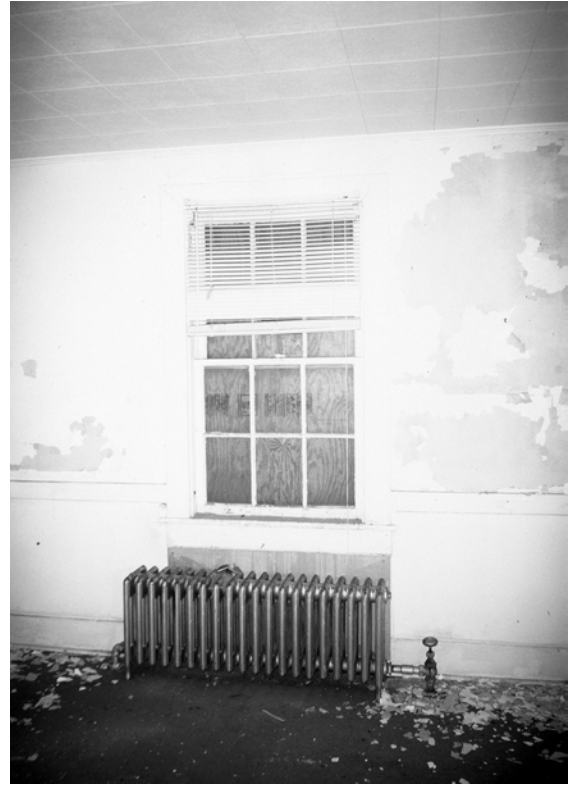
Figure C-25 Original window, Room 104

- **Windows:** The room's one remaining window is on the north wall and has the same 1925-era Type C-1 casing as the doors. It is a 1925-era six-over-six light window with 1925-era Type M-1 muntins. The window's bottom sash and top rail are cracked and out of alignment. One pane of glass is missing from the bottom sash.

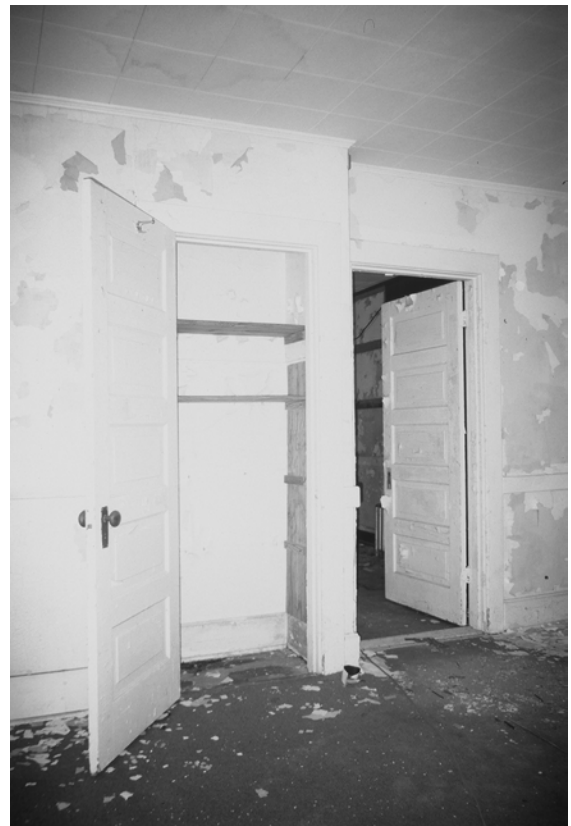
Figure C-26 Closet in Room 104

were used to create shelves at some point. All three walls of the closet have 1925-era Type B-3 baseboards and early ¾” quarter-round shoe moldings.

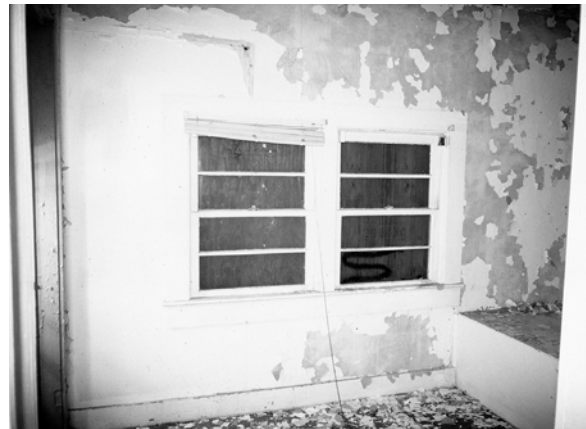
Figure C-29 Paired windows in the south wall of Room 109

- *Windows:* One pair of 1974-era two-over-two aluminum windows measuring 2'-4" x 3'-2" is on the south wall. It has 1974 Type C-11, mitered casing. One 1933-era four-over-four double-hung wood window with Type M-1 muntins and 1933 Type C-4 casing is on the west elevation.
- *Ceiling:* The ceiling is sheathed with gypsum or plaster board.
- *Baseboards:* Type B-10, 1962-era baseboards are on all walls.
- *Finishes:* Walls, ceiling, floor, and trim are painted.
- *Mechanical & Electrical Systems:* There is surface-mounted wire molding leading up to the ceiling, but no light fixture is mounted.

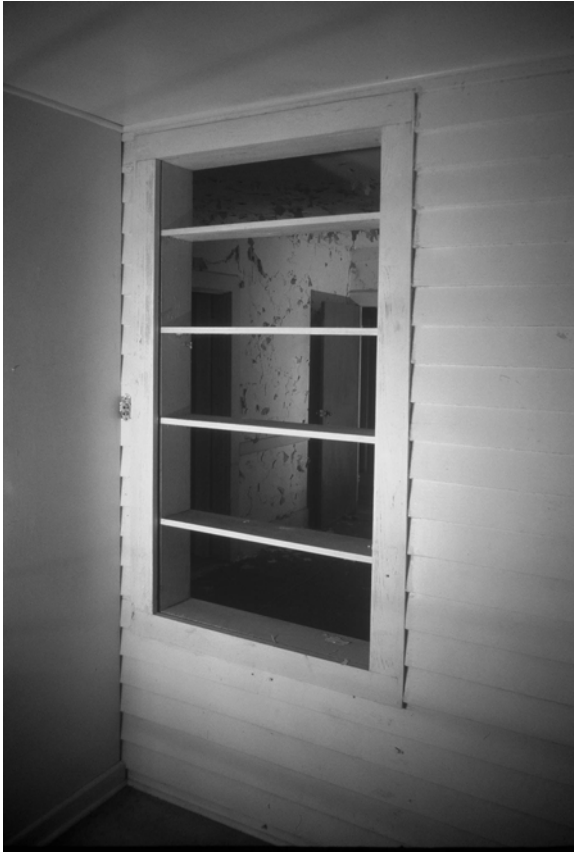
Figure C-31 Bookshelf created in original window opening in Room 111

- *Finishes:* The walls, ceiling, and trim are painted and peeling extensively.
- *Mechanical & Electrical Systems:* The room was lit by one fluorescent, ceiling-mounted light fixture.
- *Other Features:* An open bookshelf is located between this room and Room 101 in the original window opening on the north wall.

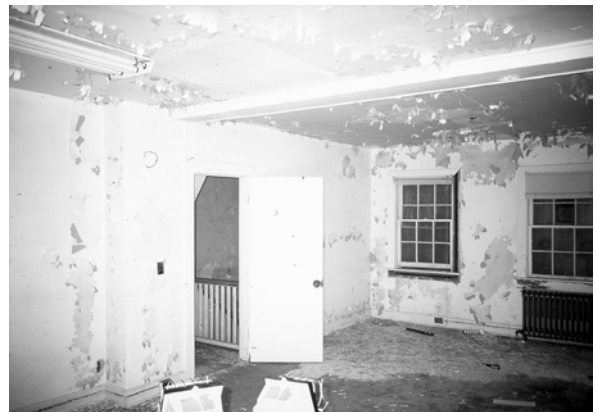
Figure C-33 Room 201

- *Flooring:* There is modern, commercial-grade wall-to-wall carpeting in poor condition in this room.
- *Walls:* The walls are sheathed with gypsum or plaster board on stud framing. There is a crack extending from the west corner of the doorjamb to the ceiling. Water damage is visible below the northernmost window on the east wall.
- *Doors:* The door from the stair hall, (Room 202) is a modern, hollow-core slab door that is 2'-8" x 6'-7". It has 1970s-era locking hardware and 3½", five-knuckle butt hinges. This doorway has 1933-era Type C-4 casing with mitered corners.

- *Windows:* The room's six windows are the original 1925 six-over-six Type M-1 windows, each with original Type C-1 mitered casings. All window units measure 3'-0" x 4'-6". The northernmost window on the east wall is missing its south section of casing, its apron, and two panes of glass. The southernmost window on the east wall has the bottom rail out of position in both sashes. The easternmost window on south wall is in good condition, while the westernmost is leaking above the lintel. The southernmost window on the west wall is missing one pane of glass from both the top and bottom sash. The northernmost window on the west wall is in good condition.

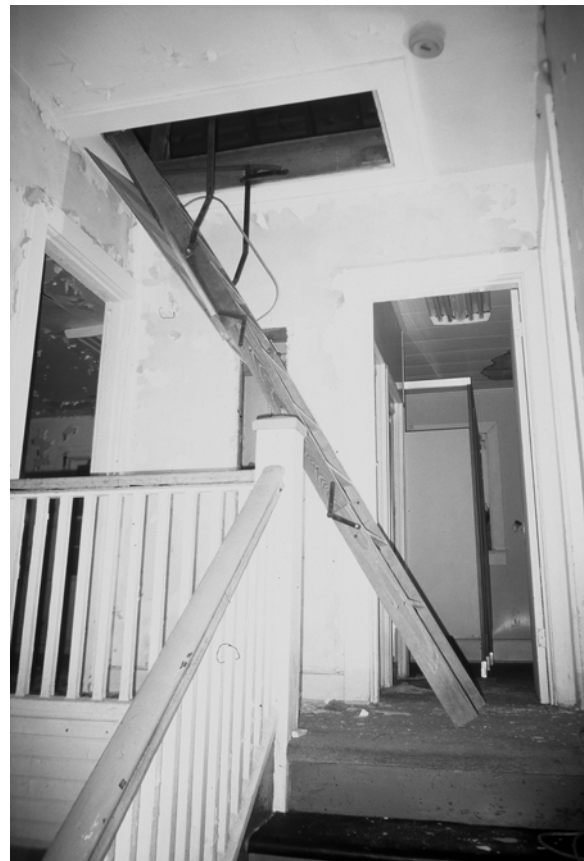
Figure C-34 Drop-down, folding attic stair in Room 202

- *Other Features:* The staircase has a plain 5" square newel post with a pyramidal cap. The balusters are 1" square and 3½" on center. In the ceiling in front of the door leading to Room 201 is a hatch framed with Type C-5 casing covering a 1970s-era drop-down folding attic stair. There are ghost marks of the earlier, presumably 1933-era ladder, on the hatch framing.

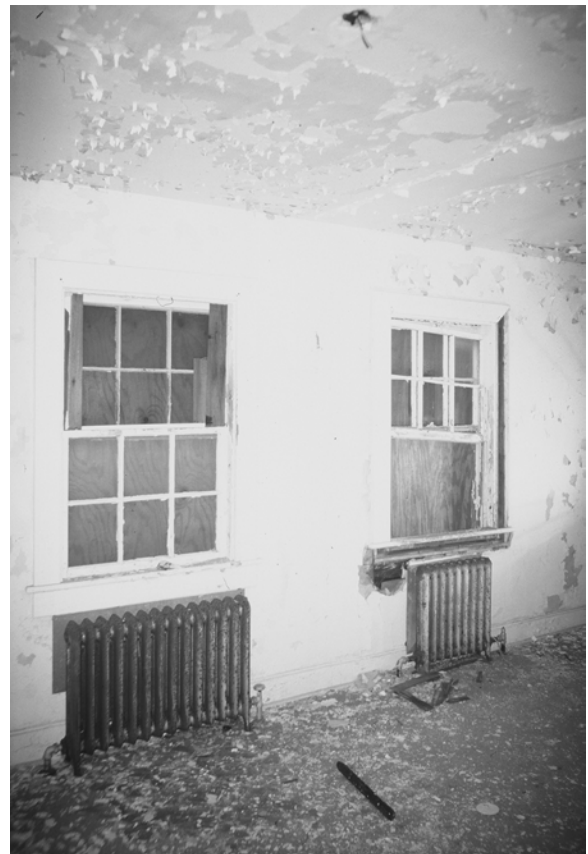
Figure C-35 Room 204

- **Windows:** The room's three windows, one on the north wall and two on the east wall, are the 1925 six-over-six Type M-1 windows. Both of the sashes are in place on the window on the north wall, but there is extensive water infiltration at the sill and damage to the wall below the window. The northernmost window on the east wall is missing three panes of glass from its top sash. The southernmost window on the east wall is missing a section of casing on the south jamb apron, its bottom rail is out of position, and its sash is out of square. The bottom sash is missing six panes of glass. This window also shows signs of water infiltration at the sill. All three windows have 1925-era Type C-1 casings.

- **Ceiling:** The ceiling is sheathed with gypsum or plaster board. It has a crack running east-to-west that corresponds to cracks on the east and west walls, and patches in the baseboards along those walls, where a dividing wall was removed in 1945.

- **Other Features:** A previous leak around the chimney stack has damaged the surrounding ceiling and associated wall elements.

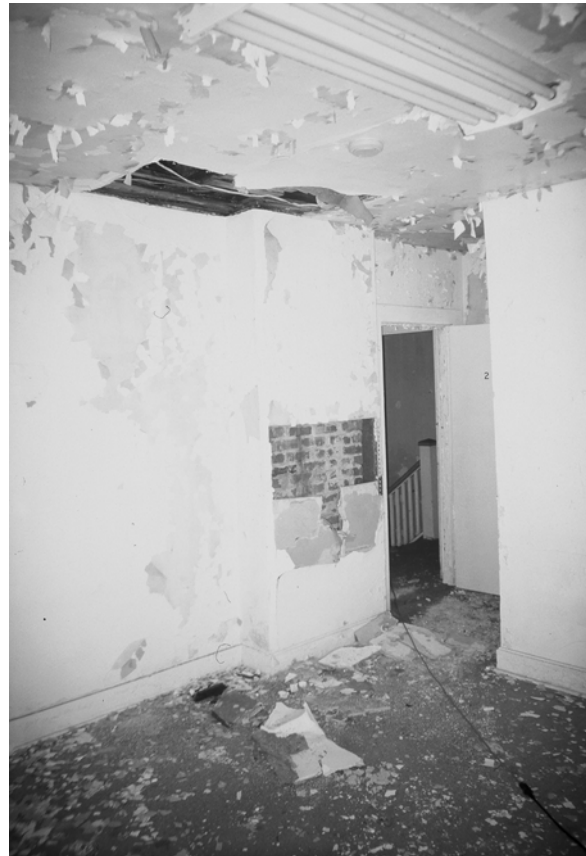
Figure C-36 Chimney in Room 205

- **Flooring:** Modern, commercial-grade, wall-to-wall carpeting in poor condition is on top of 2¼" tongue-and-groove flooring laid north-to-south.
- **Walls:** The walls are sheathed with gypsum or plaster board. There is water damage to the walls in proximity to the chimney stack on the west wall. Water damage is also present below the windows on the west and north wall elevations.
- **Doors:** The one doorway accessing the room is from the vestibule (Room 203). The door casing is 1925-era Type C-1 with mitered corners. A 1970s-era, 2'-8" x 6'-7", hollow-core slab door now swings into the room. It has 3½" modern butt hinges; however, it is missing its modern locking mechanism.

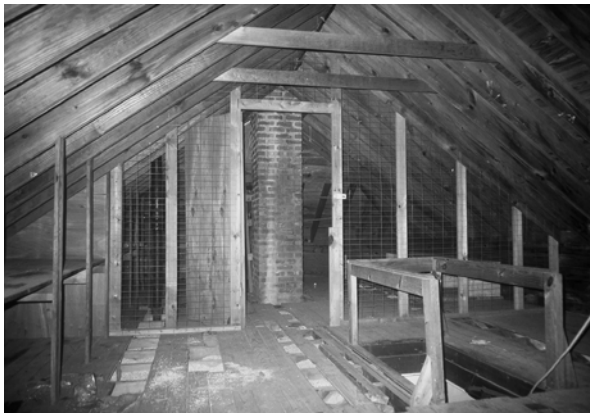
Figure C-38 Attic, Room 301

- **Doors:** None are present.
- **Windows:** The attic has two windows in small gables extending above the hipped roof, one on its north end and the other on its south end. Both the sash and subsill are out of place in the north window; water damage to the surrounding framing is visible. The south window’s top sash is in

place; however, the bottom sash has been replaced with a ventilation cover. The original sash is stored in the attic. There is some water penetration and minor damage at the window’s subsill.
