# Magnolia Plantation Gin Barn Historic Structure Report

CANE RIVER CREOLE NATIONAL HISTORICAL PARK  
MAGNOLIA PLANTATION

~ GIN BARN ~  
HISTORIC STRUCTURE REPORT

2004  
Historic Structure Report  
Gin Barn  
Cane River Creole National Historical Park  
Magnolia Plantation  
LCS#: 91561

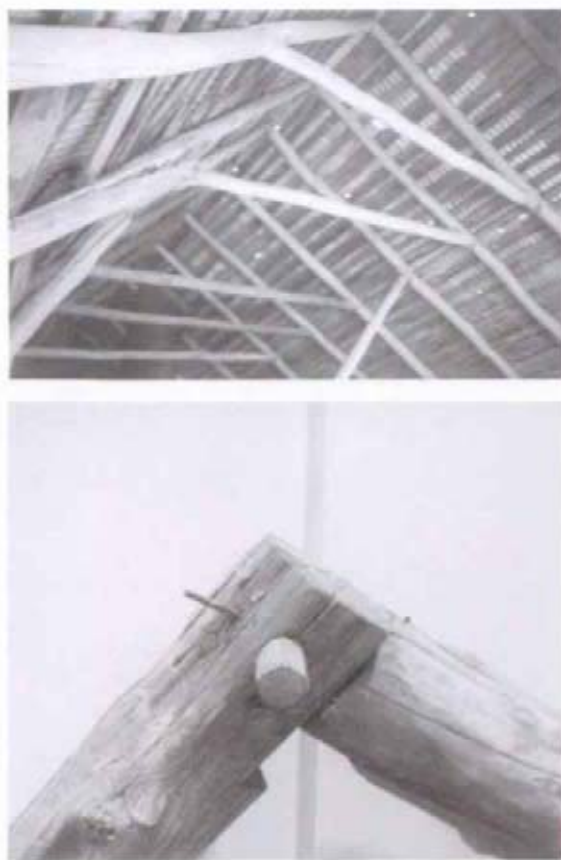
**Figure 8** Top, view of original roof prior to its removal in 1995; bottom, detail of salvaged rafters showing lapped and pegged ridge connection. (Upper image, Architectural Division, NPS-SERO, 1994; lower image, NPS-SERO-CRS, 2001)

buildings from the 1850s and later. Perhaps the most compelling evidence for an antebellum construction date was found in the pole-framed roof. Parts of two original pole rafters were preserved, complete with ridge connection, when the roof structure was replaced in 1995.<sup>47</sup> The lapped and pegged connection of these rafters is typical of the antebellum period but would be unusual in the postbellum period. The Magnolia store, for example, is thought to

47. The character of the connection and the presence of nineteenth-century cut nails in the surviving rafter ends prove conclusively that at least part of the roof removed in 1995 was original and not, as some have assumed, a modern reconstruction of the original roof.
48. There is no family tradition that the gin barn was burned in 1864 nor is there any certain mention of it in the French-American claims or the Maine regimental history.

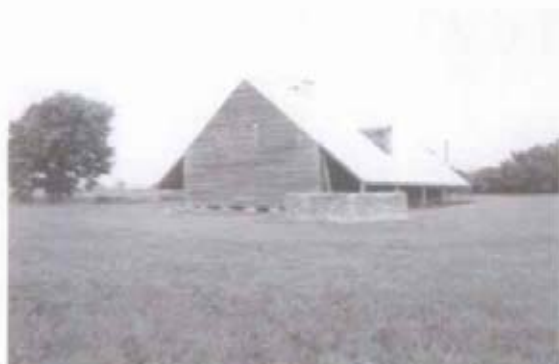
**Figure 13** View of Gin Barn from northeast, with cistern visible in foreground. (NPS-SERO-CRS, 2001)

- Conduct complete archeological investigation around and within footprint of present building.
- Repair and repoint cistern; preserve engine base.
- Define appropriate routing of visitors around building.
- Keep perimeter of building free of vegetation.

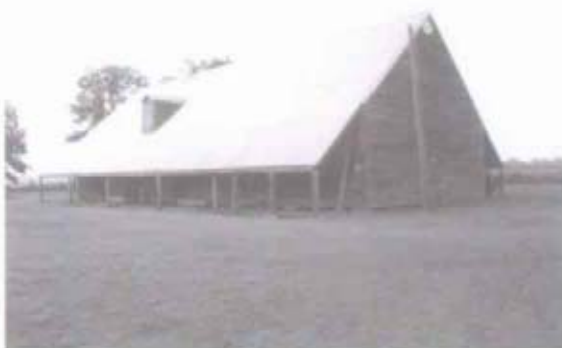
**Figure 14** View of Gin Barn from southwest. (NPS-SERO-CRS, 2001)

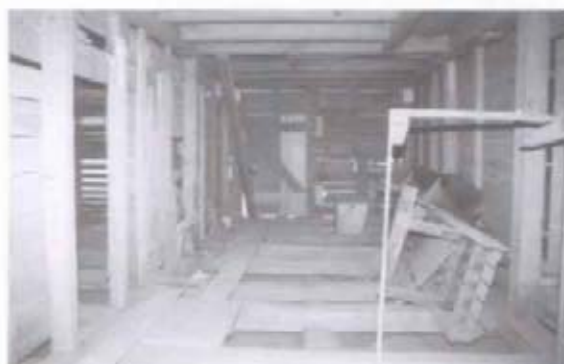
**Figure 15** View north in center room, originally used as a lint room. (NPS-SERO-CRS, 2001)

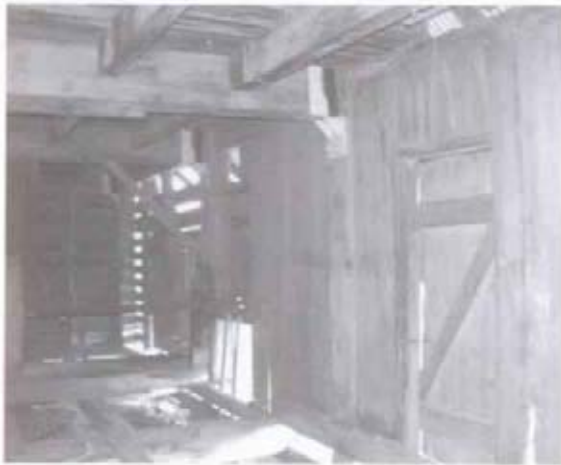
**Figure 16** View southeast in machinery room, in probable location of original seed room. (NPS-SERO-CRS, 2001)

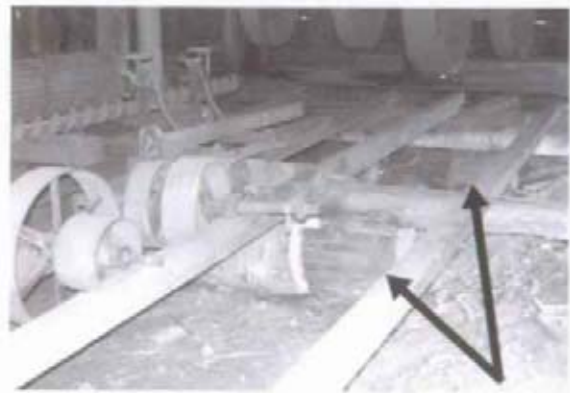
At the east end of the building is an older generation of piers that do not appear to relate to anything in the present building, although they might have been associated with the first cotton press or, perhaps, the first generation of steam equipment. Two of these piers are located near the center of the space. One is about 16" by 24", 12" high, and is lying on its side. The other, which is just behind the toppled pier, is about 12" by 24" with only two courses above grade. It is set at an angle that does not appear to relate to the present building. There may be other piers on the east side of the brick base to the steam press, but archeology will be necessary to confirm that. Curiously, the corners of both of the visible brick

**Figure 17** View of early brick piers under machinery room floor. (NPS-SERO-CRS, 2001)

- Preserve existing historic brick and stone piers (on interior) and brick foundation to steam-powered press.
- Add additional piers if necessary to provide adequate support for anticipated loads (see below).
- Repoint historic masonry as necessary.

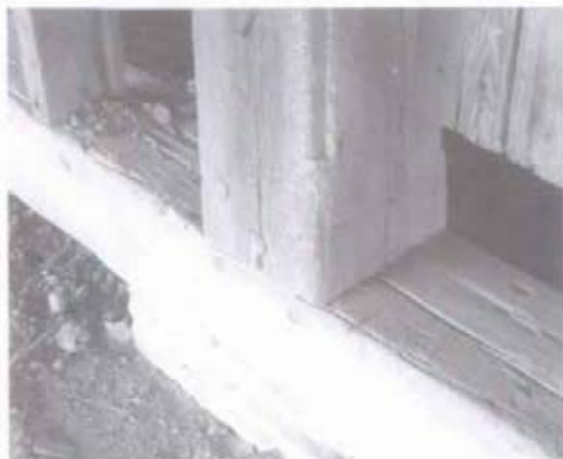
**Figure 19** View of typical sill and post with historic splined connection intact. (NPS-SERO-CRS, 2001)

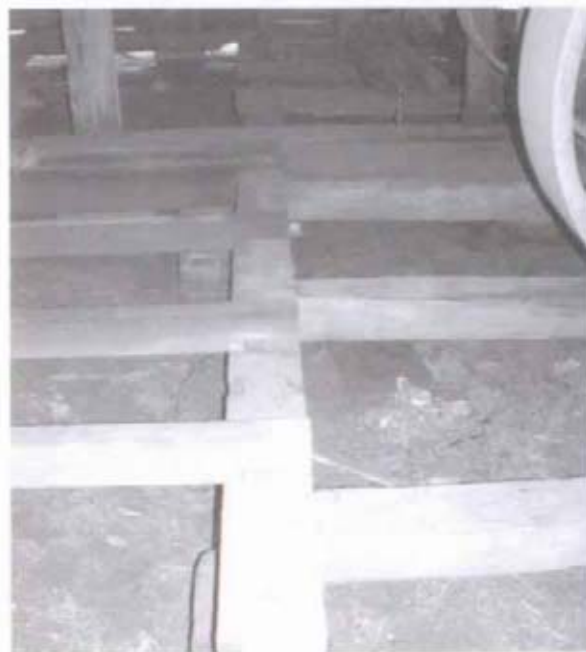
**Figure 21** View of floor framing at east end of Gin Barn. (NPS-SERO-CRS, 2001)

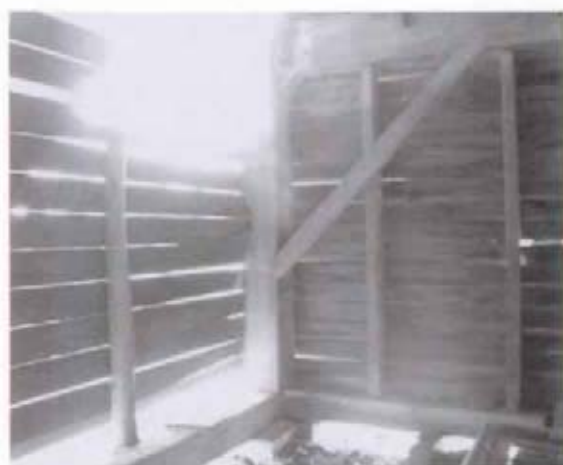
**Figure 25** View of southwest corner of barn; wall at right was added in the late nineteenth or early twentieth century. (NPS-SERO-CRS, 2001)

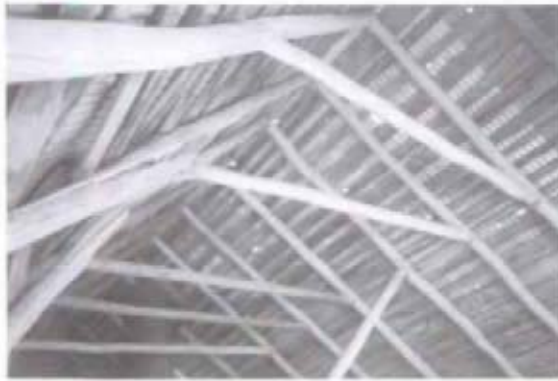
**Figure 27** View of original pole-rafter roof in 1995. (NPS-SERO-Architecture, 1995)

The original roof was entirely removed in 1995, but photographs show that it was originally framed with twenty- nine pairs of pole rafters, set on centers approximately 36" apart. Betty Hertzog remembers these rafters being a combination of cypress and black locust.<sup>59</sup> In addition, two of the original pole rafters (both cypress), complete with lapped- and- pegged ridge connection, have been preserved by the park and, as noted in the previous section, offer important clues to the building's origins.

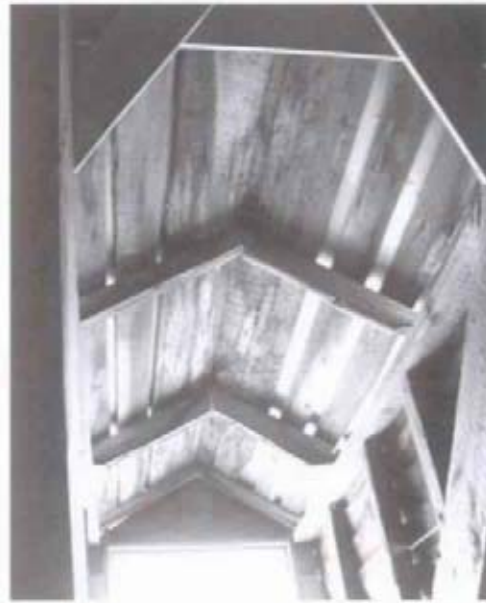
**Figure 29** View of south dormer with original framing and decking intact. (NPS-SERO-CRS, 2001)

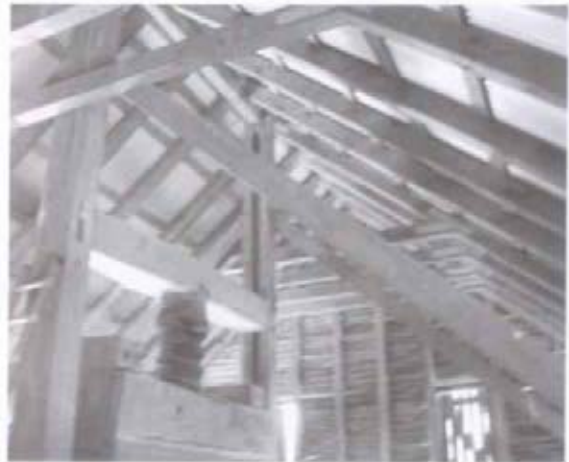
In 1995, the original pole rafters on the main roof were replaced by the existing rafters, which are 6" by 8", pressure- treated pine, set on centers 36" to 42" apart. Collar beams are the same size, with the connection reinforced by metal T- shaped plates. On the arcades, the rafters are 3" by 6" set on an outside beam 5½" by 7¼". Roofing is corrugated steel, specified as 18 gauge and attached with ½" self- tapping, hex- head, galvanized wood screws with sealing washers. Only the framing and decking of the two dormer roofs appears not to have been replaced in 1995.

**Figure 30** View southwest of roof framing installed in 1996. (NPS-SERO-CRS, 2001)

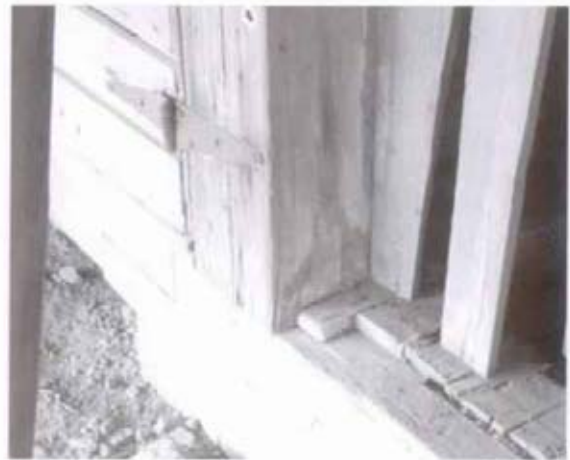
All of the flooring at the first floor level has disappeared except for fragments remaining under the sole plate at the south end of the lint room. Flooring at the second floor is typically 9" to 11" wide, generally ¾" thick.

**Figure 31** View of original flooring at south side of lint room. (NPS-SERO-CRS, 2001)

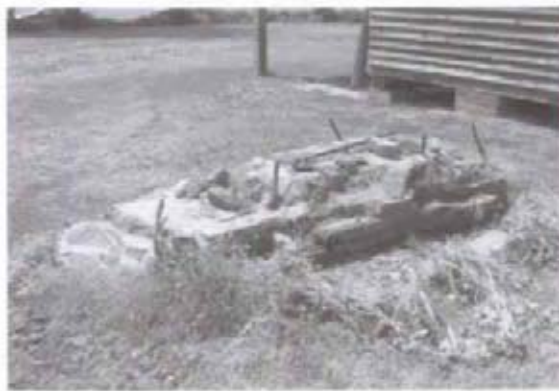
**Figure 37** View to southwest of brick foundation for steam engine. (NPS-SERO-CRS, 2001)

ground feature remaining from that structure is the brick base to which the engine was bolted. Measuring approximately 36" wide,

110" long, and 19" high, this feature consists of several courses of brick (generally 4" by 8½" by 2- 3/8") into which 1" threaded steel rods were

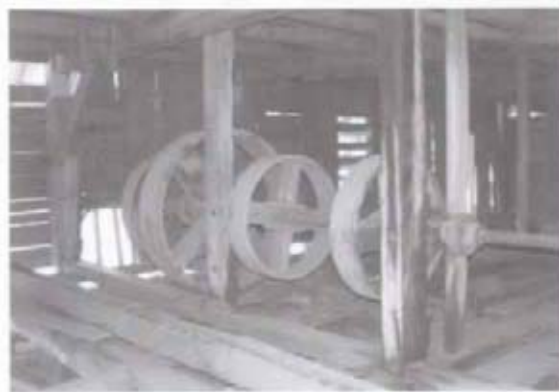
**Figure 38** View of belt-driven flywheels at east end of barn, which would have been connected by leather belts to the engine outside the building and to the machinery inside. (NPS-SERO-CRS, 2001)

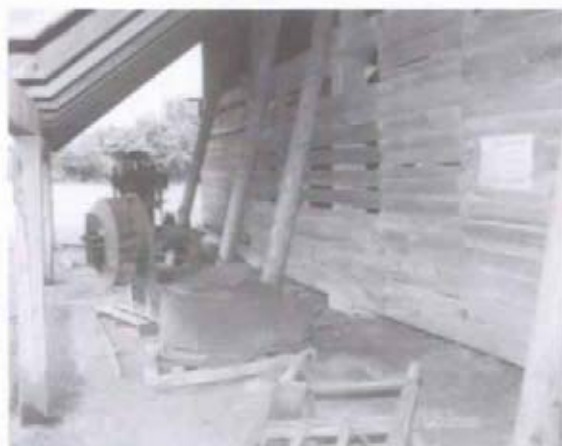
(see Appendix C), most of its components are present although the cotton suction apparatus is almost completely disassembled. The pneumatic elevator includes the fan now lying outside under the south arcade, various flue ducts lying around the second floor, and the vacuum box or separator, which is detached and lying under the condenser but was originally attached to the distributor above the gin stand. Both gin stands remain intact on the second floor. However, replacement of the roof in 1996 and of much of the siding in 1939 and 1982 has obliterated most evidence for how the gin's power train connected to the engine house and how seed was discarded from the system and transported to the seed house.

**Figure 42** View west under south arcade, showing blowers and other equipment associated with c. 1900 system gin. (NPS-SERO-CRS, 2001)

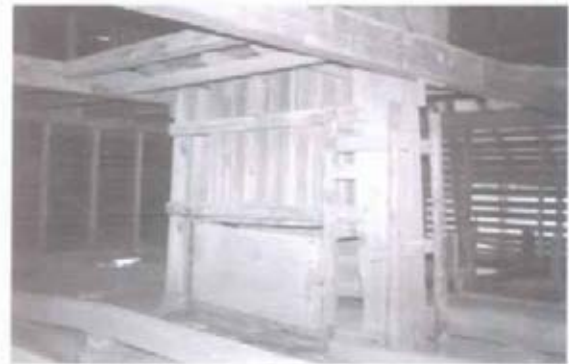
**Figure 46** View of cotton press at ground level, showing door where finished bale was removed. (NPS-SERO-CRS, 2001)

- Determine character and condition of press footing through archaeological investigation.
- Brace press with modern materials if necessary to insure structural stability.
- Avoid any disassembly or replacement of historic materials.
- Do not operate historic press; construct working scale model to demonstrate its operation to visitors.

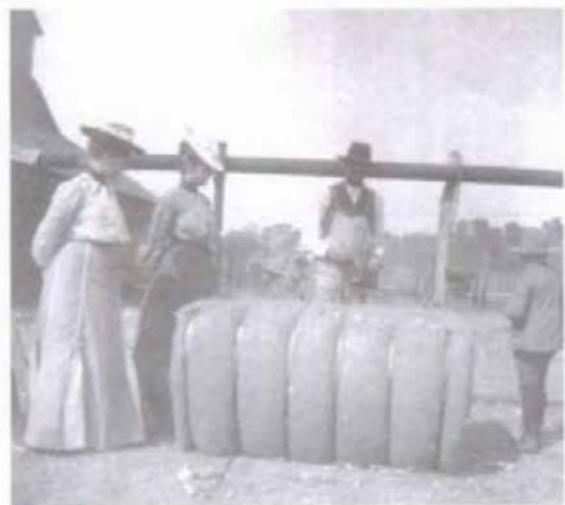
**Figure 48** View of Prud'hommes' gin at Oakland, showing elevated flue to transport seed from gin to seed house. A similar apparatus would have been used at the Magnolia gin, but has now disappeared. (NPS-SERO-CRS, 2001)
