# HISTORIC STRUCTURE REPORT The Wright Cycle Company Building

(HS - 01)

Dayton Aviation Heritage National Historical Park  
Dayton, Ohio

March 31, 1999  
Final Submission

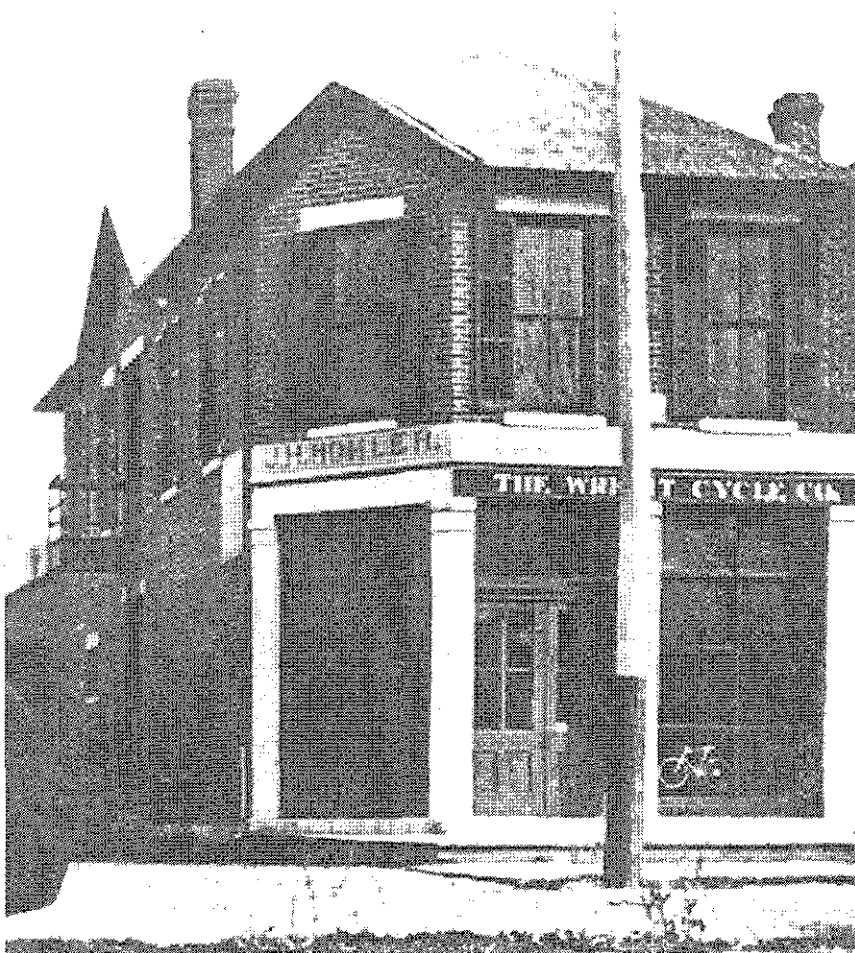
One brick chimney stack is clearly visible in this photo, between the two western-most, second floor windows on the north elevation. The hipped roof appears to be wood shingle, each face sloping up to the center, with gables above the northwest chamfered elevation and above the balcony on the north elevation. Just below the cornice, at the brick, is a continuous wood fascia. There is one downspout visible to the east of the beveled corner. Another chimney, belonging to a house on the adjacent lot, is visible to the south of this building. Note the placement of the chimney, the slope of that roof, and a portion of what appears to be a horizontal trim with dentils below it at the very right-hand edge of the photo.

There is a small one-story addition at the east elevation that projects past the north elevation, with a gable roof. While the body of the main building is brick masonry construction, the addition appears to have a different

*Figure 1* This is a detail, showing The Wright Cycle Company building in 1896, from a photo of Charles Webbert's niece taken by Lura Hoover. The original photograph is in a private collection. (Wright State University, Archives and Special Collection)

cladding material, presumably wood. An exterior doorway appears in the west face of the addition. There is no porch on the west elevation of the building. There also seems to be a small protrusion at the roof of the addition, which might be a chimney stack.

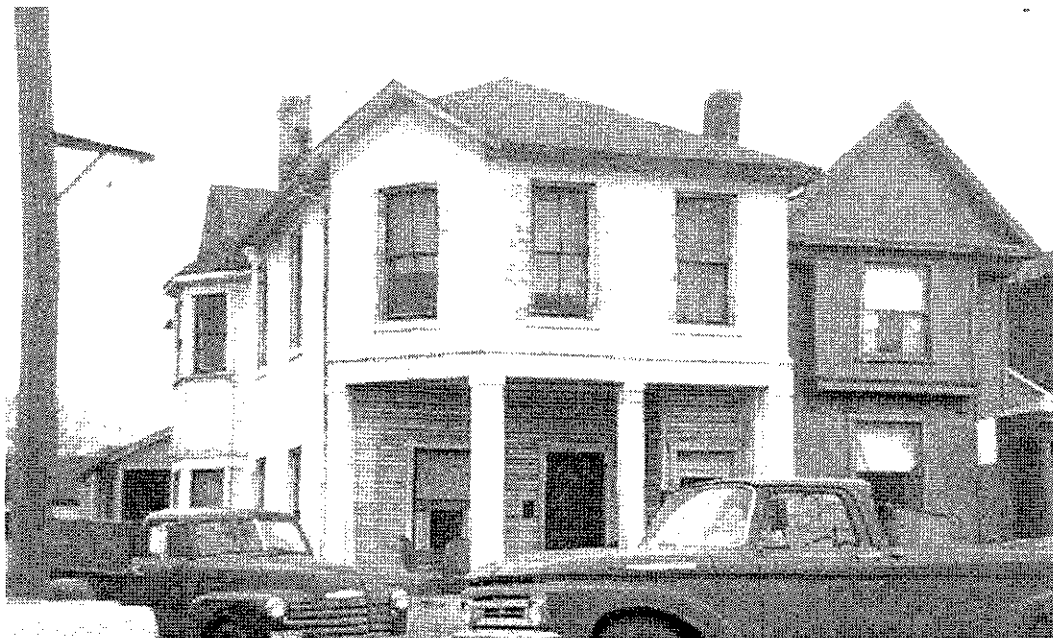
At the north elevation, a bay window has been added in the center of the elevation, where the 1896 doorways were once located. There is a one-over-one window in each of the bays, the body of which is also narrow, horizontal, wood siding. On the ground floor of the original structure, there are two newer window openings aligning with the two western-most windows of the second floor. The glazing of these four windows is not visible, but the second floor windows appear to be original; again, there are no shutters. Beyond the bay window, a portion of the rear addition is visible.

Gutters have been added to the roof. There is a downspout at the left side of the northwest elevation's gable, and another at the southwest corner of the building.

*Figure 2 This circa 1940 photo shows The Wright Cycle Company building after its conversion to a two-family residence. (Dayton Aviation Heritage National Historical Park Archives)*

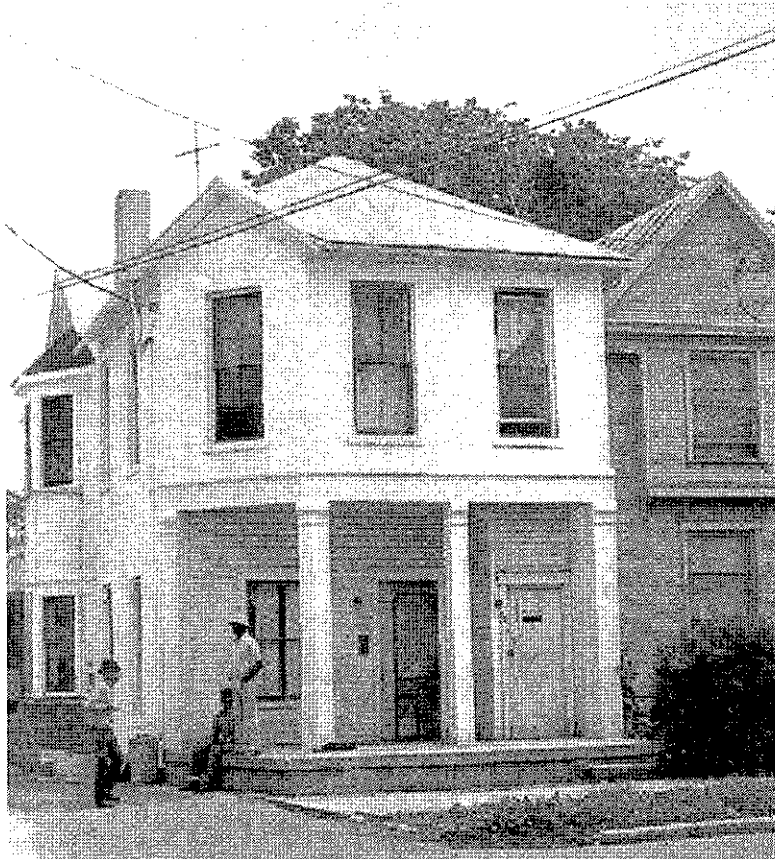
At the north elevation, a bay window has been added in the center of the elevation, where the 1896 doorways were once located. There is a one-over-one window in each of the bays, the body of which is also narrow, horizontal, wood siding, and the base of which is unpainted brick. On the ground floor of the original structure, there are two newer window openings that align with the two western-most windows of the second floor. The glazing of these four windows is not visible, but the upper windows appear to be original; again, there are no shutters. The bay window blocks the view of the eastern half of the north elevation.

The brick chimney on the north elevation is still in place although it is missing its corbelled detailing. The second chimney visible in the photo belongs to the adjacent house to the south. The shingles at the roof appear to have been replaced with rolled roofing membrane over the main body of the building, and dark shingles are visible over the bay window. The exterior stairway to the basement can be seen at the north elevation. Almost every surface of the building has been painted white.

*Figure 3 View of The Wright Cycle Company building in 1982. (Aviation Trail, Inc.)*

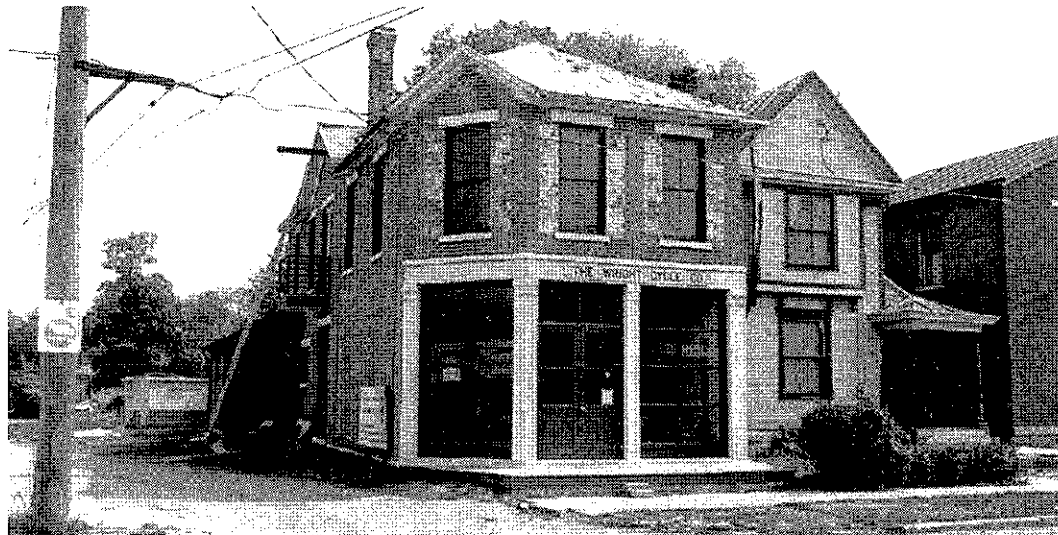
Figure 4 View of The Wright Cycle Company building in 1986 with most of the restoration work completed. Photo courtesy of Aviation Trail, Inc.

- The replacement shutters only have two divisions, while the original shutters were divided into three sections, as evidenced in the 1896 photo.
- The small square window on the north elevation at the first floor is not in the same location as the window in the 1896 photo. Originally, the window was centered between the two second floor windows above it.

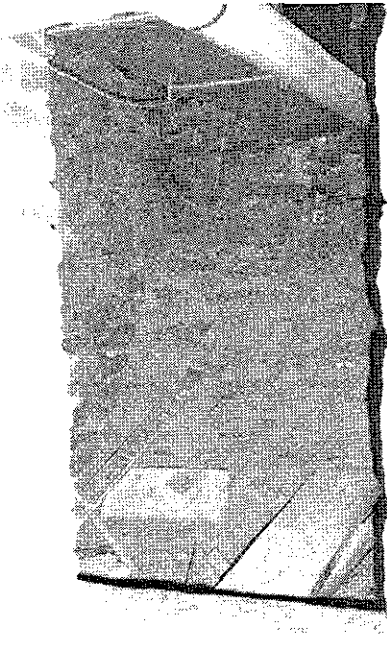
The basement is constructed of original stone rubble walls. The walls at the northwest corner are chamfered, reflecting the above-ground building configuration. At the east wall is an additional, partially excavated, 4'x6' area with masonry walls and a sloped, unfinished floor. This was an exterior stair to the basement (Figure 1) which was probably closed off when the rear addition was constructed prior to 1896. The basement floor is a concrete slab. On the floor north of the stair opening is a semicircular concrete pad which is believed to be original. This may have served as a stove or furnace base.

Figure 1: The cavity of the former exterior basement stair.

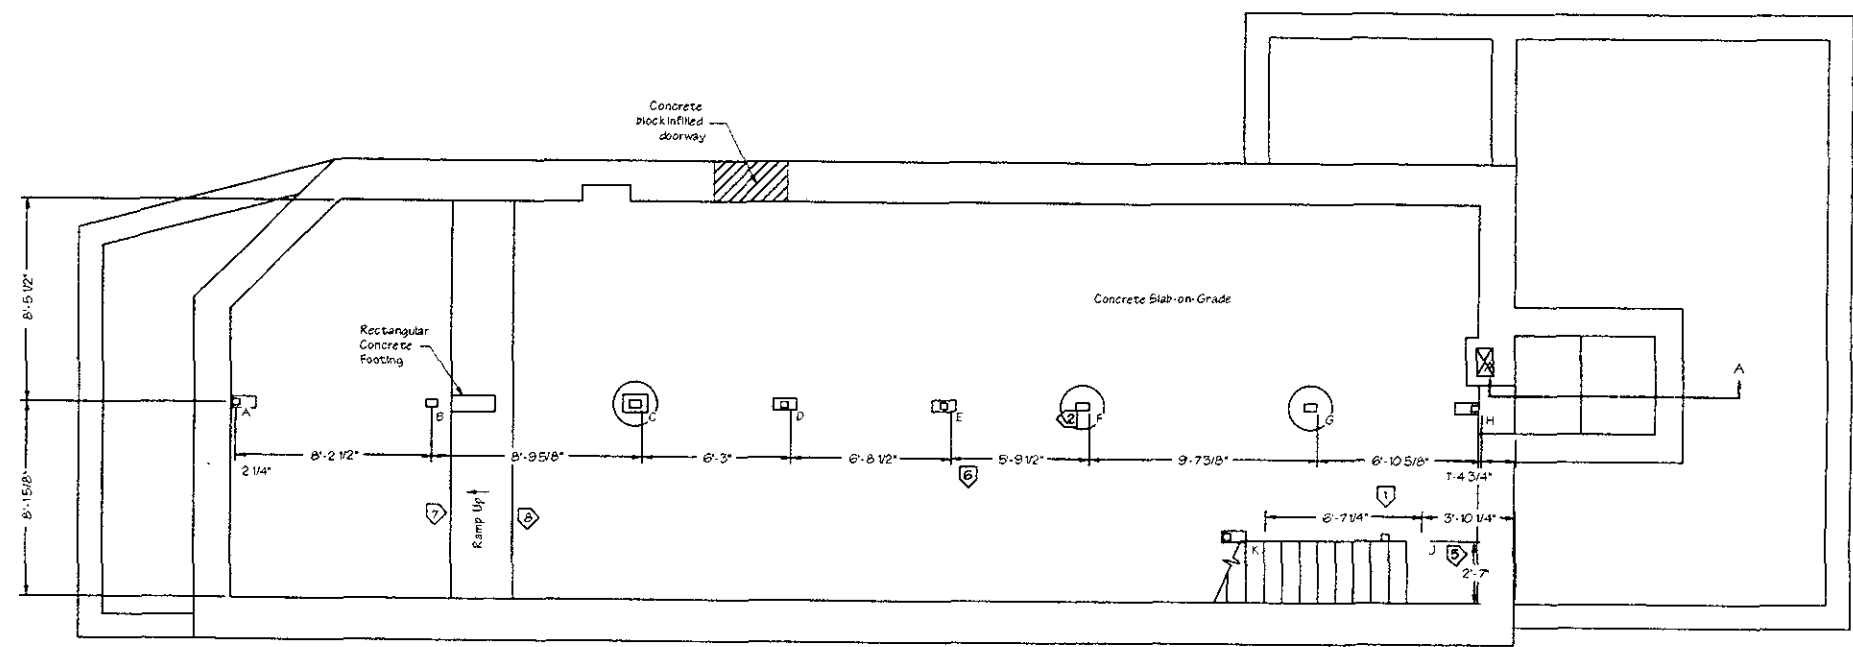
Column	Size	Movement of the Top of the Column in the		Bearing on	Notes/Comments
		East-West Direction	North-South Direction		
A	3-1/2" x 3-1/2"	1-3/4" Towards the West	Reasonably Plumb	4" Concrete Block	
B	3-7/8" x 5-7/8"	Reasonably Plumb	3/4" Towards the North	Concrete Slab	
C	3-7/8" x 5-7/8"	1" Towards the East	1-1/4" Towards the North	Concrete Mound Cover over Stone	Beam Joint
D	3-3/8" x 3-3/8"	Reasonably Plumb	3/4" Towards the North	4" Concrete Block	Bowed in the N-S Direction
E	3-1/2" x 3-1/2"	5/8" Towards the West	Plumb	4" Concrete Block	
F	3-3/4" x 6-1/4"	1" Toward the East	Reasonably Plumb	Concrete Mound Cover over Wood Plank on Stone	Beam Joint
G	3-3/4" x 6"	Reasonably Plumb	Reasonably Plumb	Concrete Mound	
H	3-1/2" x 3-5/8"	Plumb	1/2" Toward the North	4" Concrete Block	
J	3-1/2" x 3-1/2"	N.A.	N.A.	Concrete Slab	No obvious movement noticeable
K	3-1/2" x 5-1/2"	N.A.	N.A.	4" Concrete Block	No obvious movement noticeable

- FIGURE KEY**  
 The number inside the polygon corresponds to the figure number used in the report. The point of the polygon indicates the direction from which the photograph was taken. The polygon symbol is placed in the approximate location where the photograph was taken.
- South Foundation Wall at Stair
  - Columns E (in Foreground) and D (in Background)
  - Eastern Connection Between Stair Header, Joist and Wood Post
  - Joists Rotted on South Bearings and New Metal Joist Hangers
  - Termite Damaged Joists
  - Western End of First Floor Framing

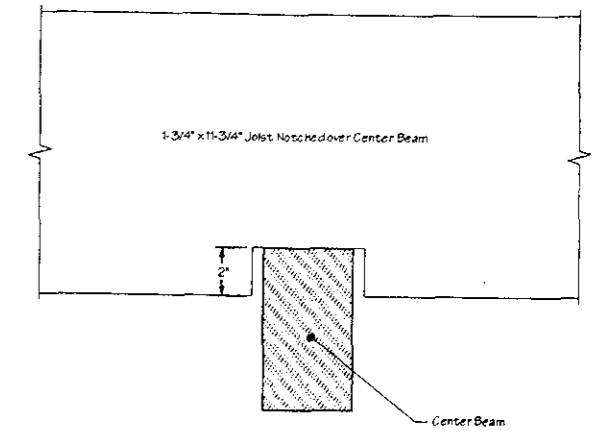
DETAIL A-A: Joists Notched over Center Beam
