HISTORIC STRUCTURE REPORT

FORT McHENRY

HISTORICAL AND ARCHITECTURAL DATA

FORT McHENRY NATIONAL MONUMENT AND HISTORIC SHRINE

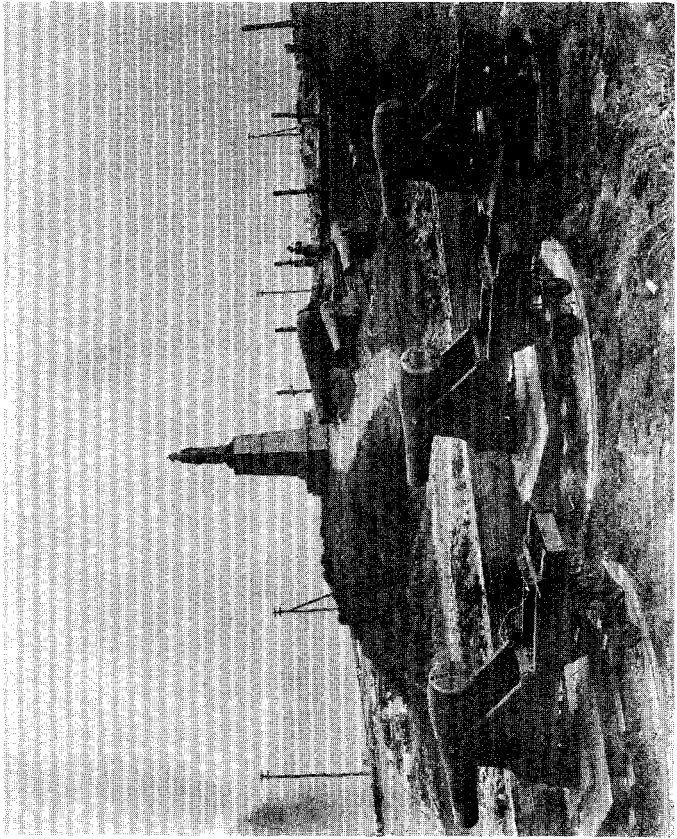
Illustration No. 9.

The water battery, HS 14. This photo is said to be from World War I period, about 1918. It is noted, however, that none of the general hospital buildings appear on the glacis. What is apparent is the complete lack of maintenance of the parapet and other sodding. The Armistead statue has since been moved.

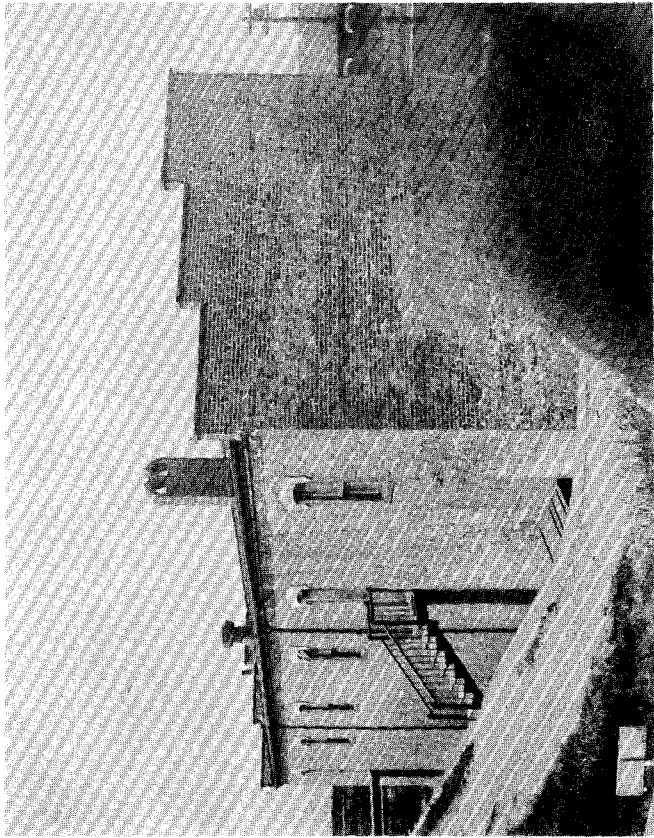
Illustration No. 14

Rear of barracks, HS 5, probably between 1905 and 1922.
Note stairs to worn terreplein.

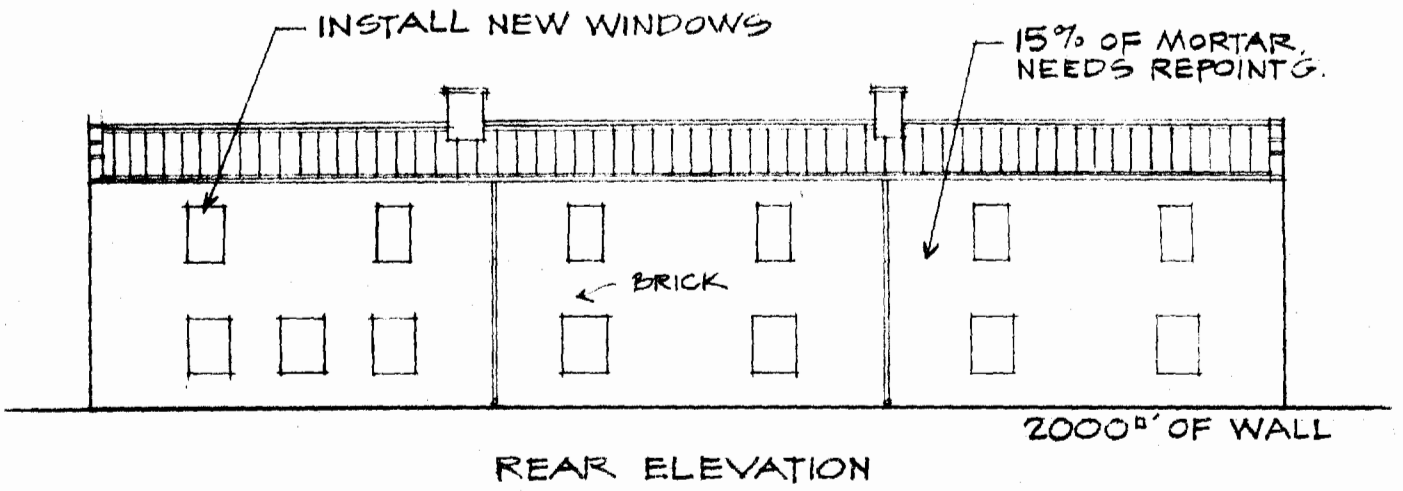
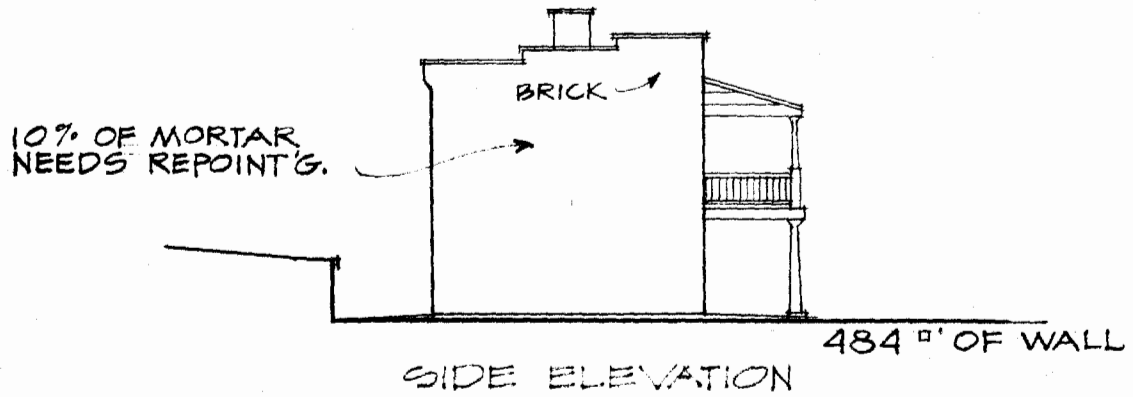
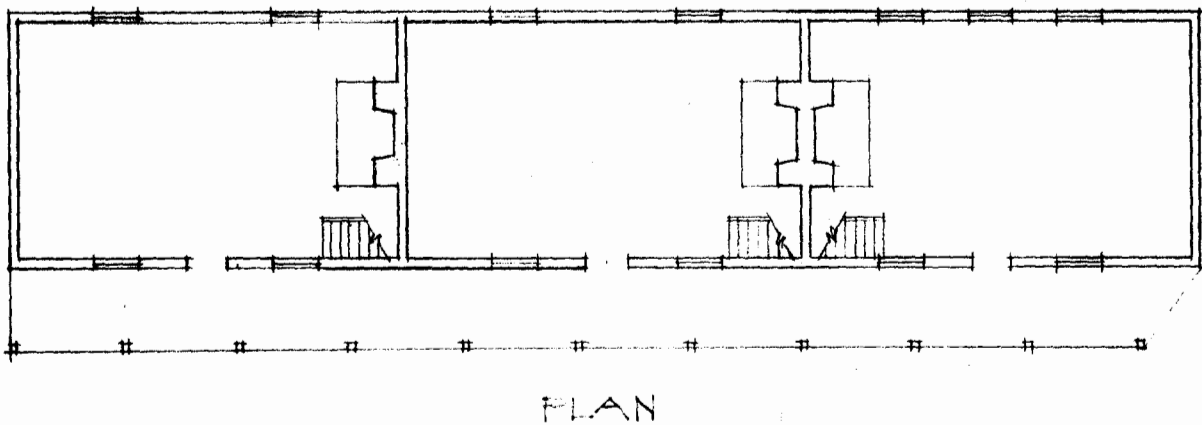
Drawing No. 10.

No. 2 enlisted men's barracks, HS 5.

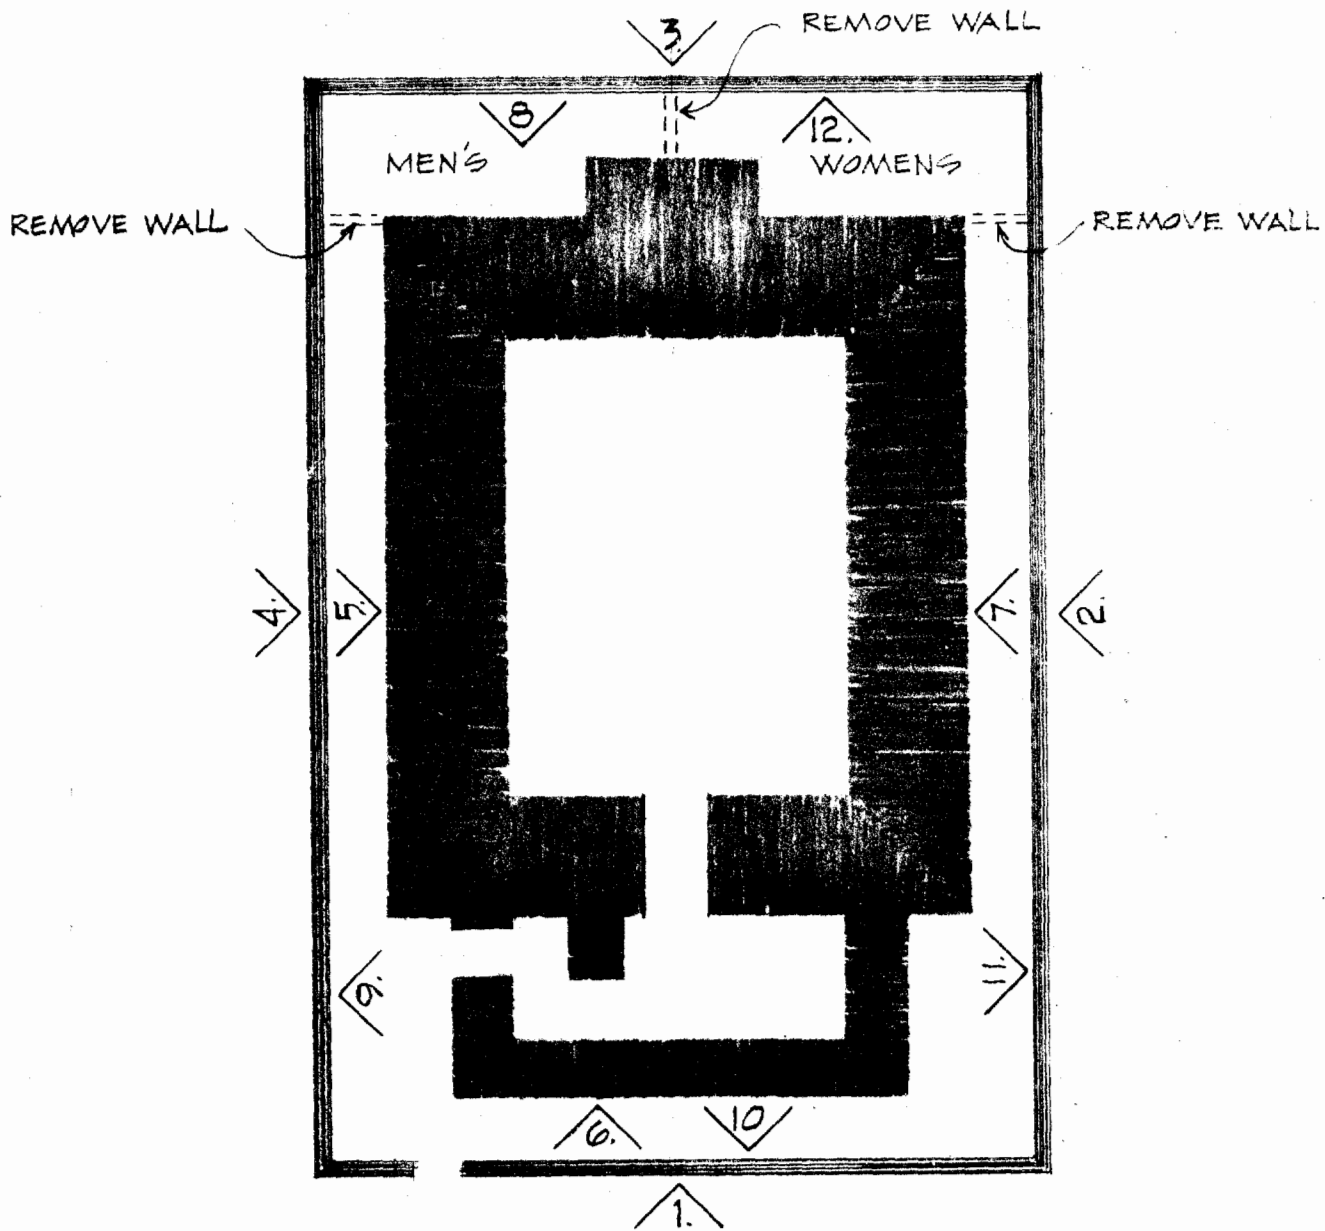
Drawing No. 11.

Key--plan of Civil War magazine.

5. At the Civil War magazine repoint loose and missing mortar at all exterior walls, reconstruct roof gutters, reconstruct roof framing at gutters, and remove existing bathhouse rooms.

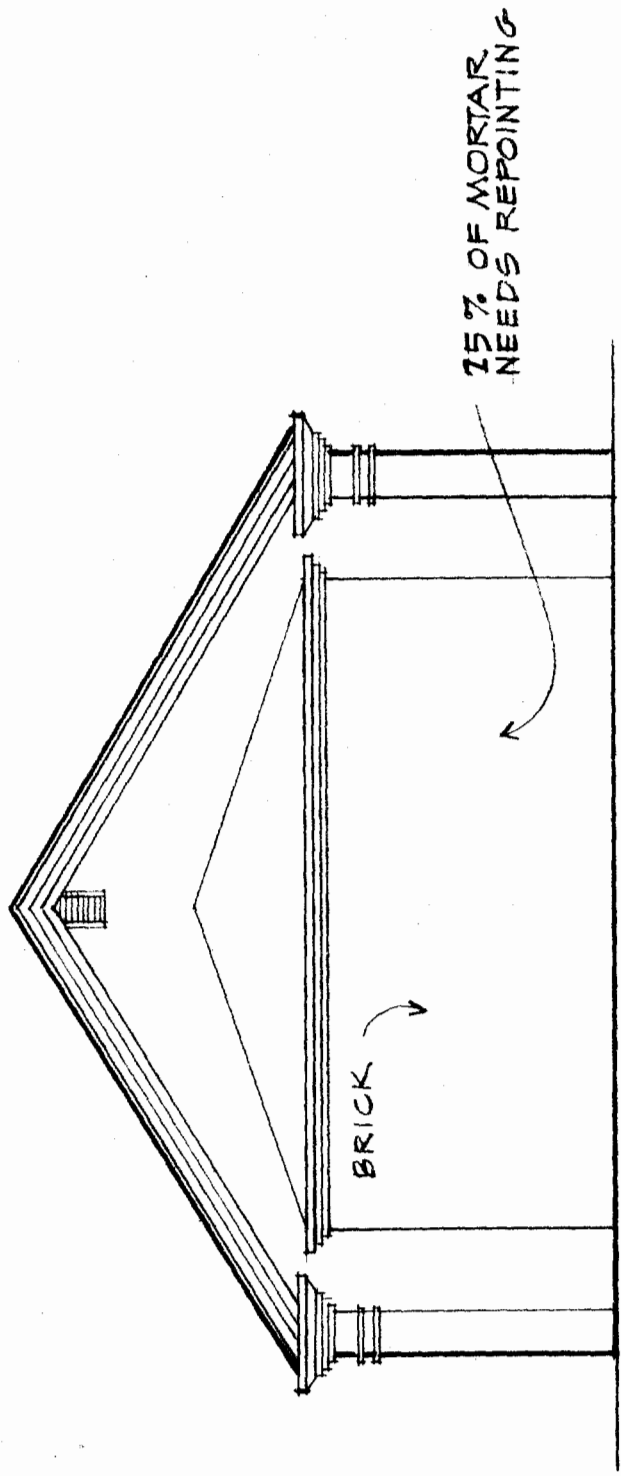
Drawings Nos. 12-16.

Elevations of Civil War magazine.

REPLACE EXIST. COPPER GUTTER

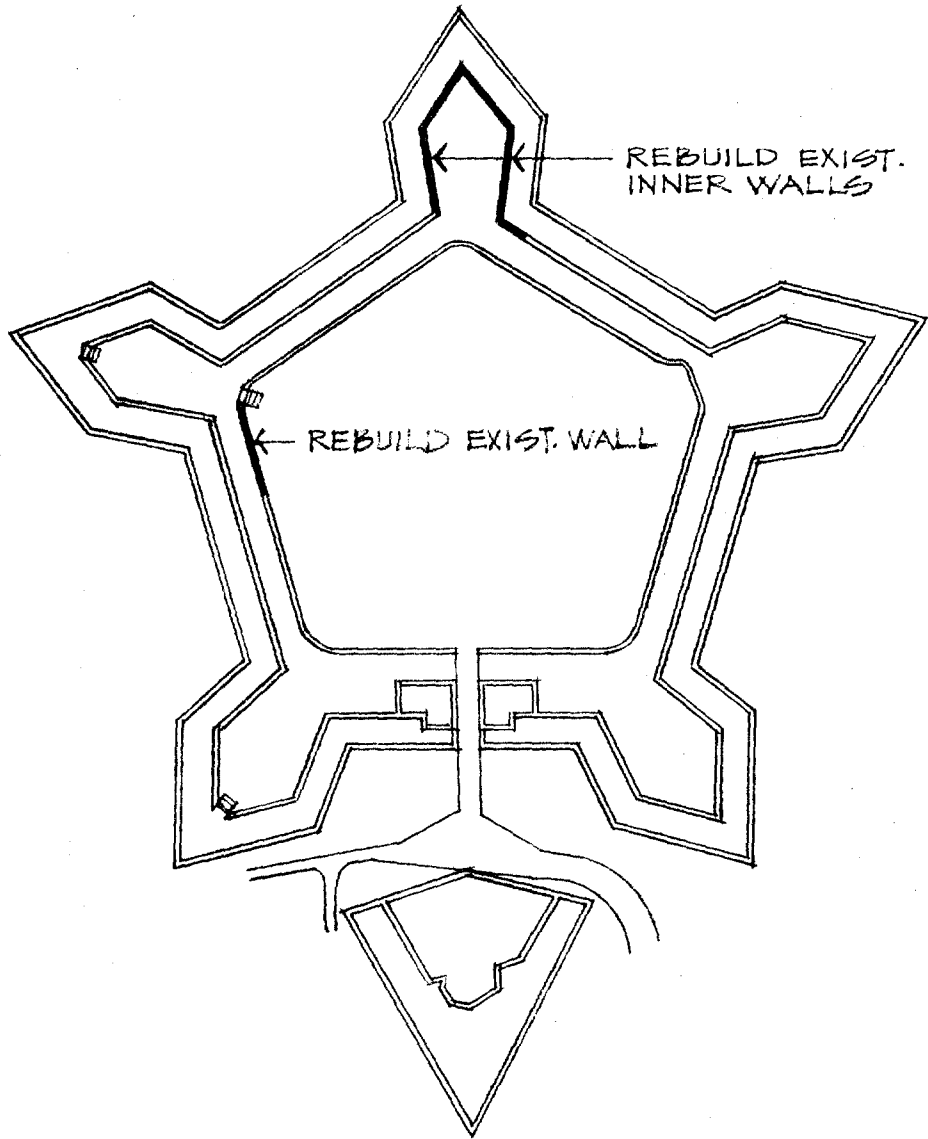
Drawing No. 17.

Fort walls--exterior and interior.

1. Repoint with lime mortar and native sand all loose and missing mortar on the exterior walls of the Star Fort, ravelin, and the six fort buildings. Replace all missing or broken bricks in all of these walls. Realign all capstones that have slipped out of position and repoint their mortar joints. Remove all plant material from wall surfaces and spray these surfaces with plant toxins. Clean corner quoins and remove old mortar on flat surfaces of stones. Reconstruct all inner fort walls where walls have become unstable and moved out of alignment.

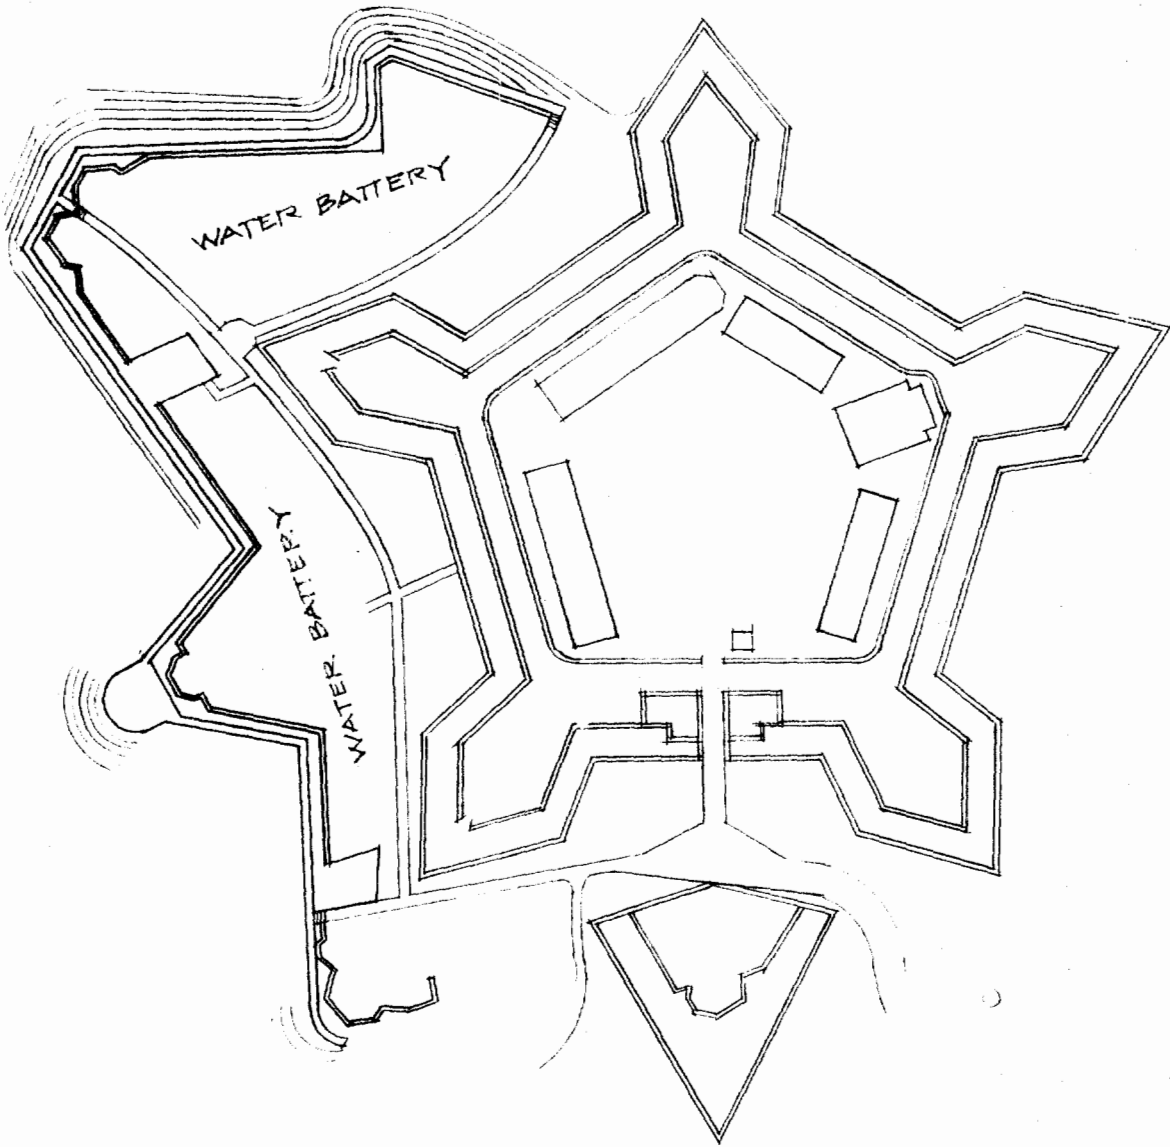
Drawing No. 18.

Water batterys.

1. Reconstruct all brick walls where brick has slipped out of alignment.
2. Repoint all brick walls with missing mortar.
3. Replace all earth that has slipped away from the bombproof shelters.
4. Waterproof the bombproof shelters.
5. Remove all large plants growing near the bombproof shelters.
