historic structures report
architectural data section
volume two
may 1981

HISTORIC STRUCTURES REPORT
ARCHITECTURAL DATA SECTION
FLOYD BENNETT FIELD
GATEWAY NATIONAL RECREATION AREA
VOLUME II

By
Susan Simpson

UNITED STATES DEPARTMENT OF THE INTERIOR
NATIONAL PARK SERVICE
DENVER SERVICE CENTER
MID-ATLANTIC/NORTH ATLANTIC TEAM
BRANCH OF HISTORIC PRESERVATION
DENVER, COLORADO

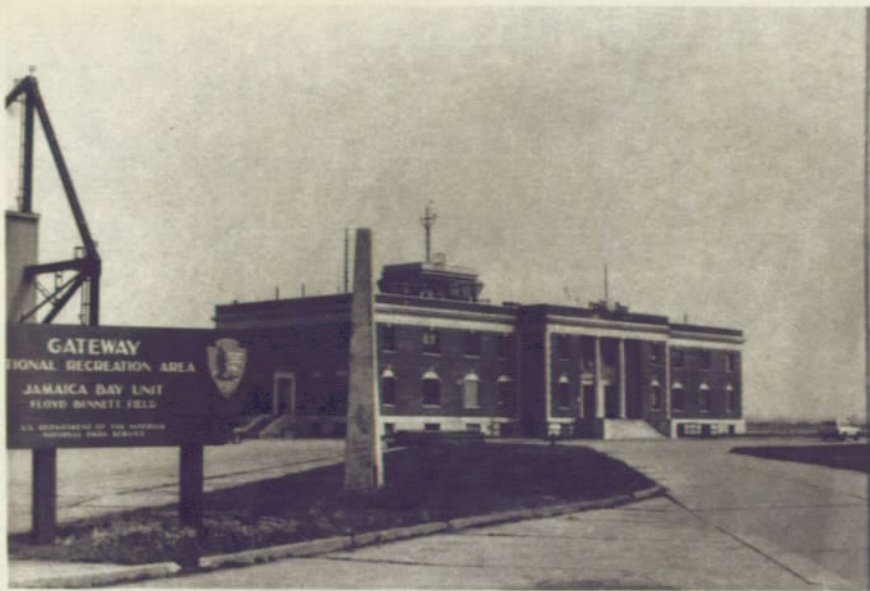
Administration Building - West Elevation, 1979

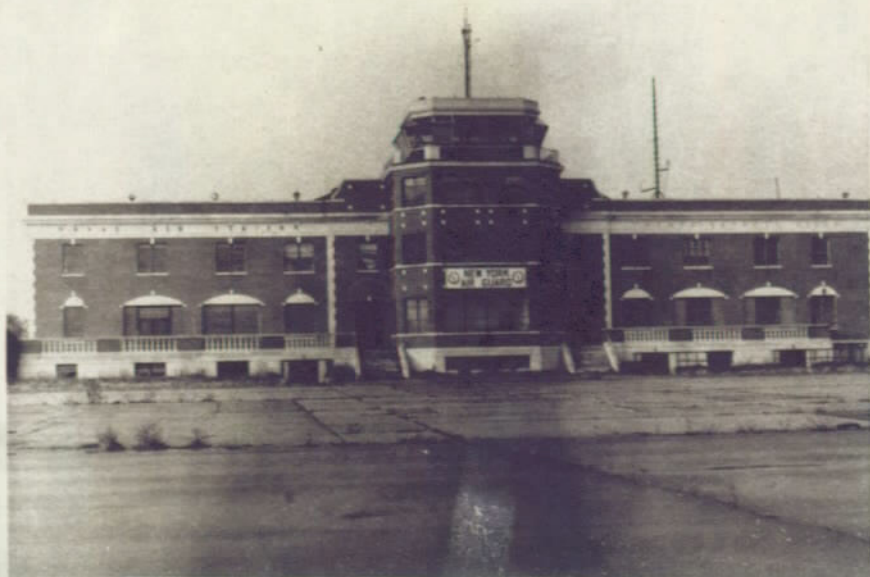
Administration Building - East Elevation, 1979
Note half circle ghosts above entry doors at
either side of the tower where leaded glass
canopies were attached.

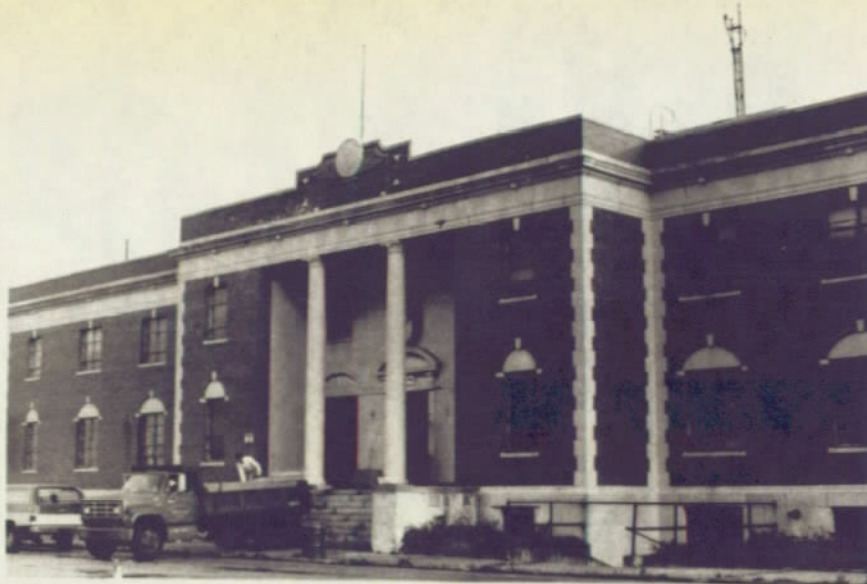
Main entry from Flatbush Avenue. Copper letters and bronze eagle have been stripped from this elevation. October 1978.

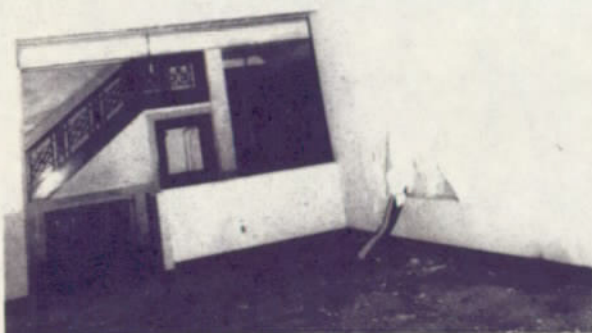
The ceilings of this lobby
area and the surrounding
second-floor halls were
brightly stencilled.

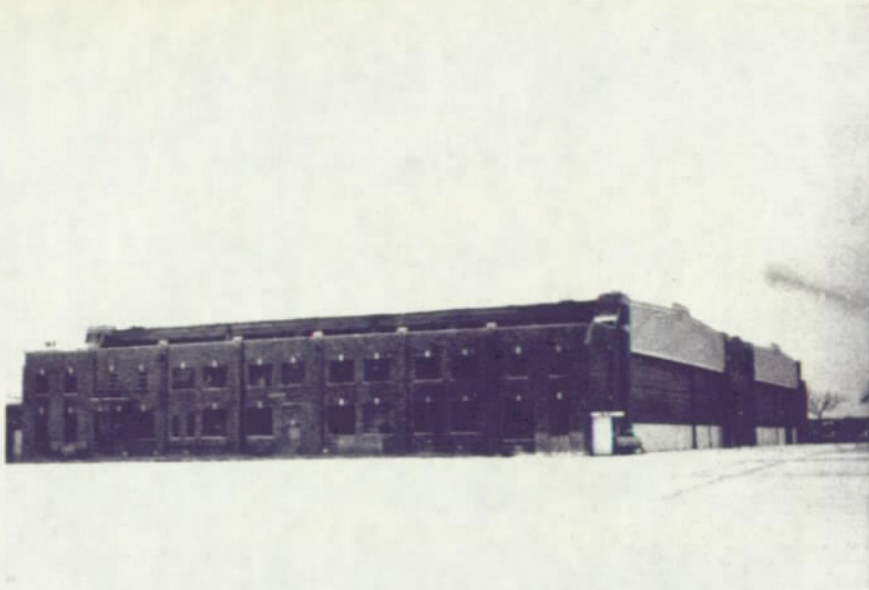
Hangar Complex 3 - Northeast elevation
January 1979.

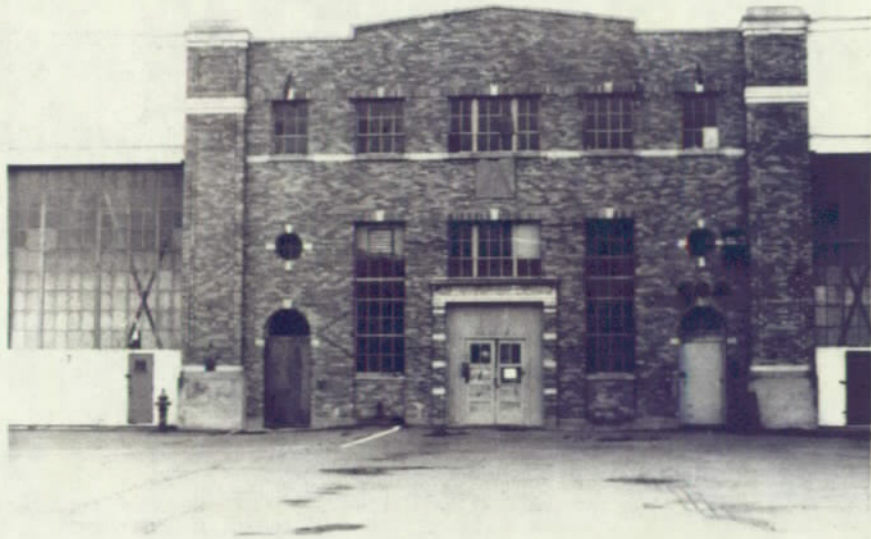
Hangar Complex 3 - WPA infill - North elevation
October 1978.

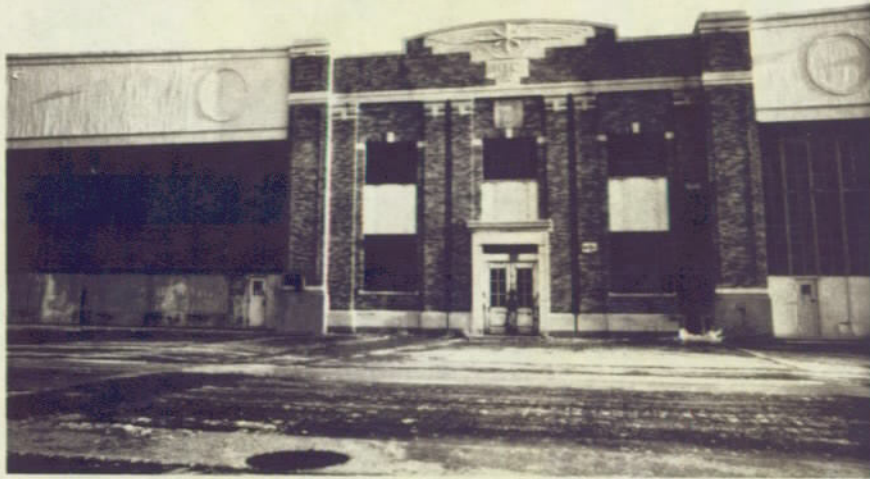
Decorative facade of infill's north elevation -
note art deco cast stone panels and propellor
January 1979

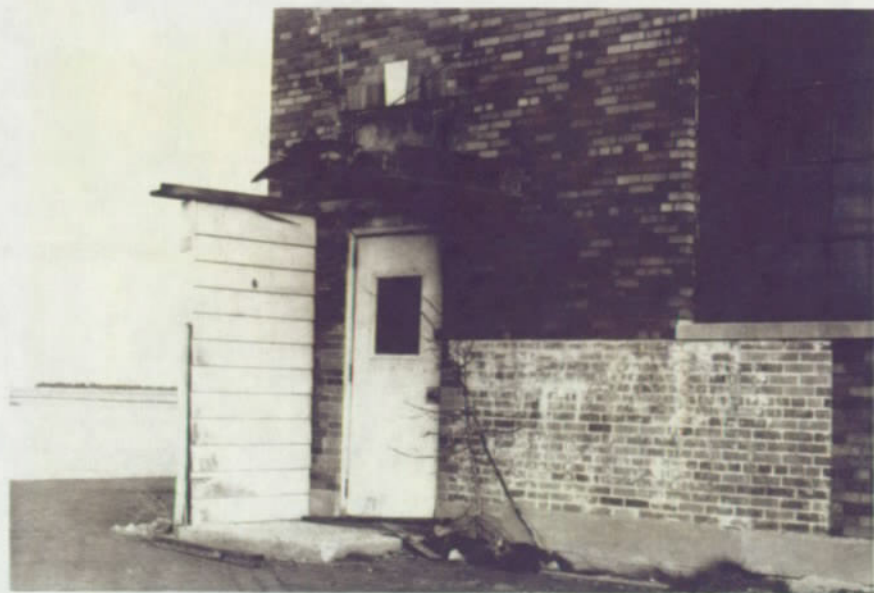
East Hangar Leanto - north door - arch above
has been flattened and opening sealed , April 1979

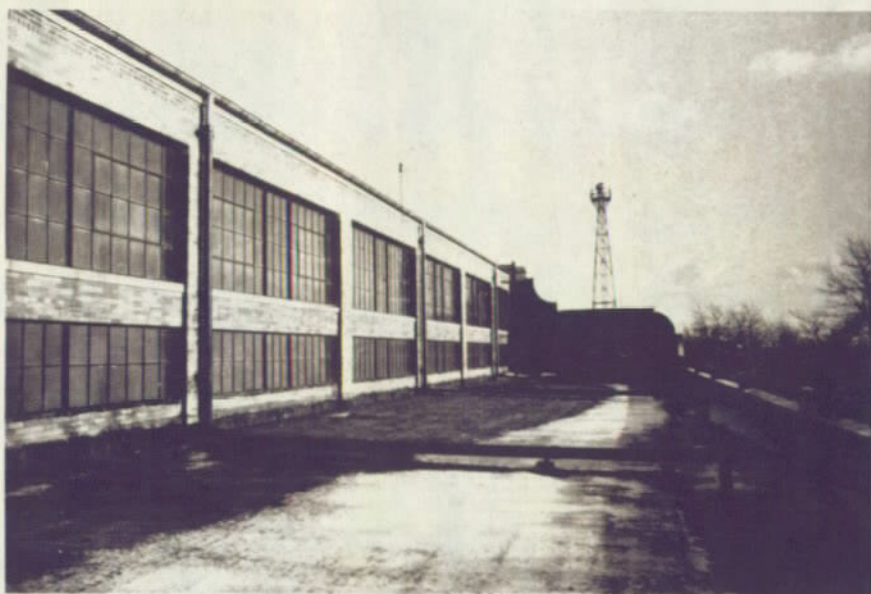
Roof of Hangar Complex 5, West Hangar Lean-to
January 1979

The roof framing is still basically sound but the wood decking is rapidly deteriorating. Deterioration occurs at about 60 percent of the east hangar lean-to, 15 percent of the east hangar, 30 percent of the WPA infill, 15 percent of the west hangar, and 50 percent of the west hangar lean-to.

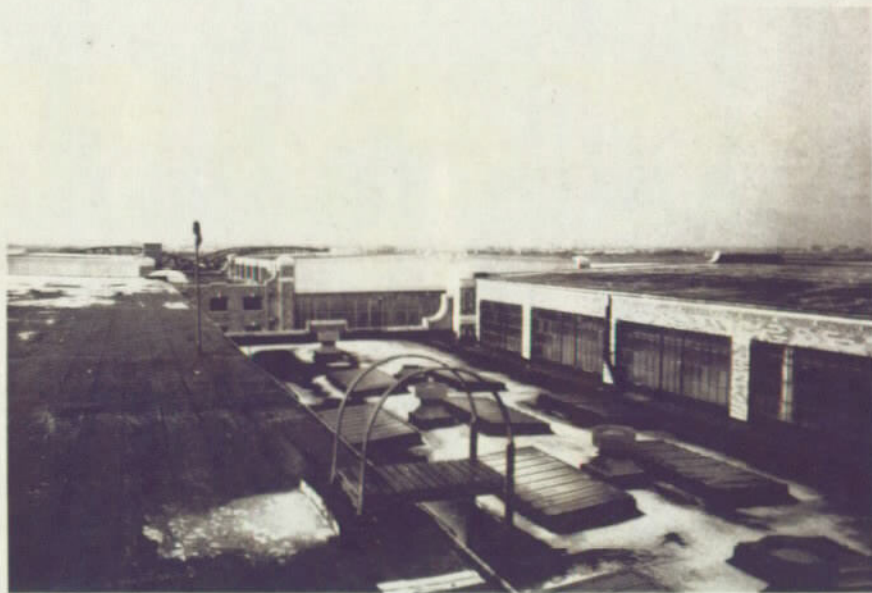
Roof of Hangar Complex 5, WPA Infill
January 1979

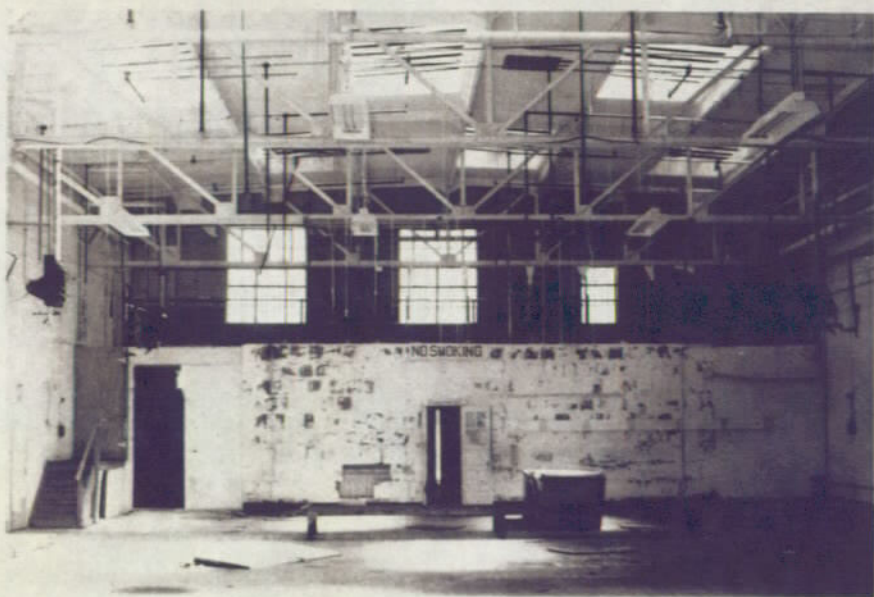
Interior WPA Infill, Hangar Complex 5
June 1979

This is in fair condition (better than either lean-to). Roof leakage is also apparent here, and skylights have broken glass and weathered flashing.

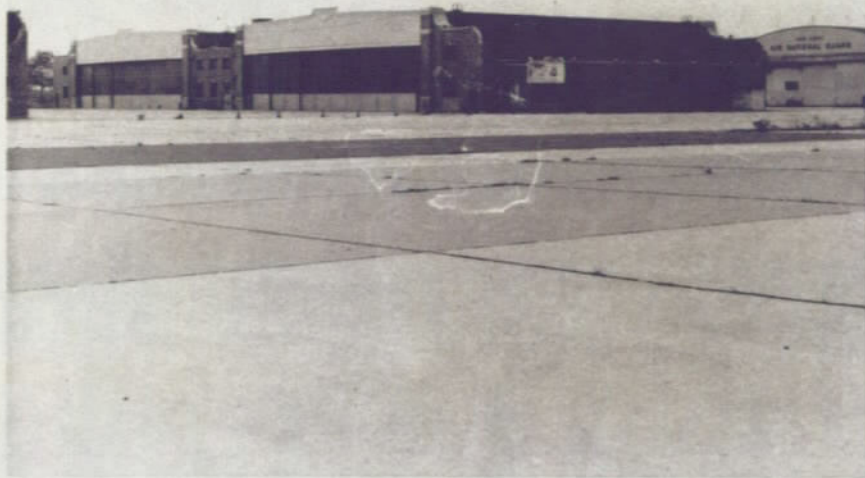
South Elevation - Hangar Complex 6
June 1979

The high parapets at the south elevation are loose with deteriorated mortar.

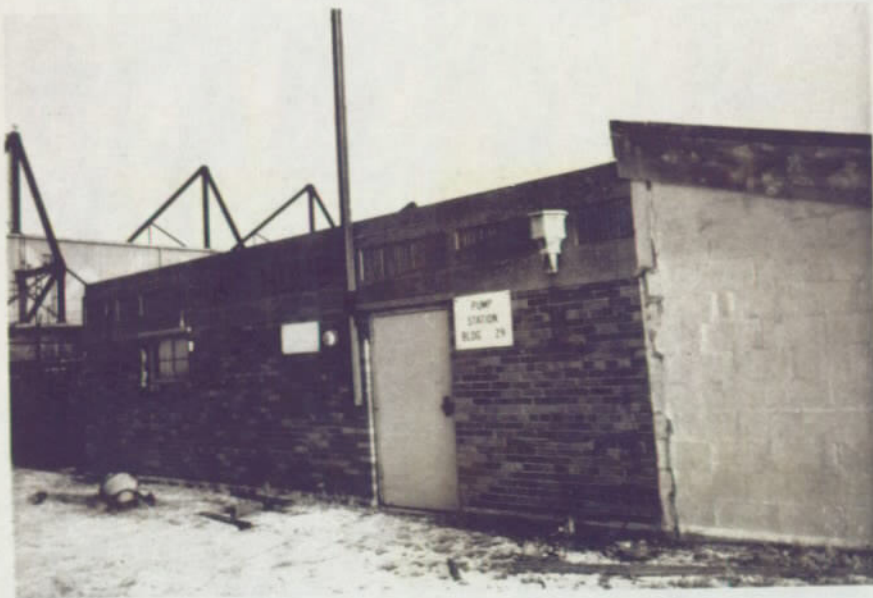
North Elevation. January 1979

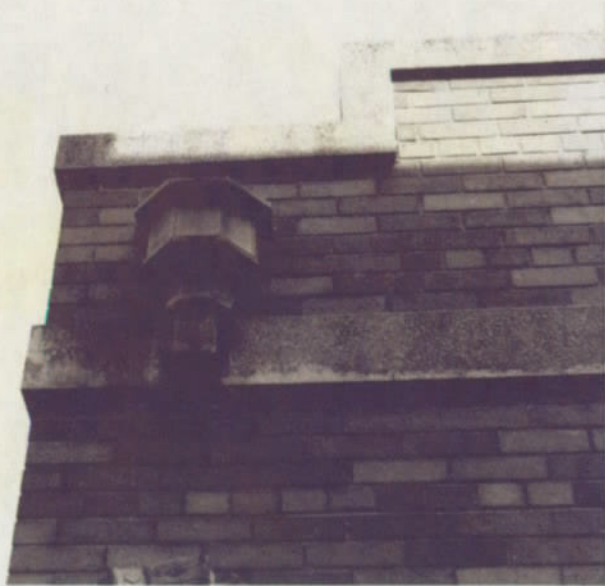
The northeast scupper and all of the downspouts are missing.

Northwest - scupper detail. October 1978

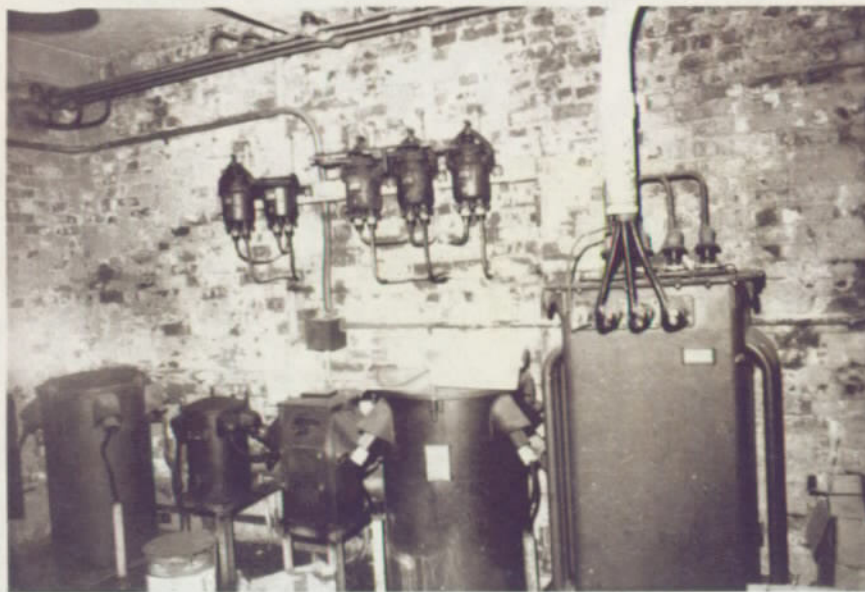
Typical interior wall - inside original wing.
