# Grand Canyon Park Headquarters

Historic Structure Report

**GRAND CANYON**  
National Park • Arizona

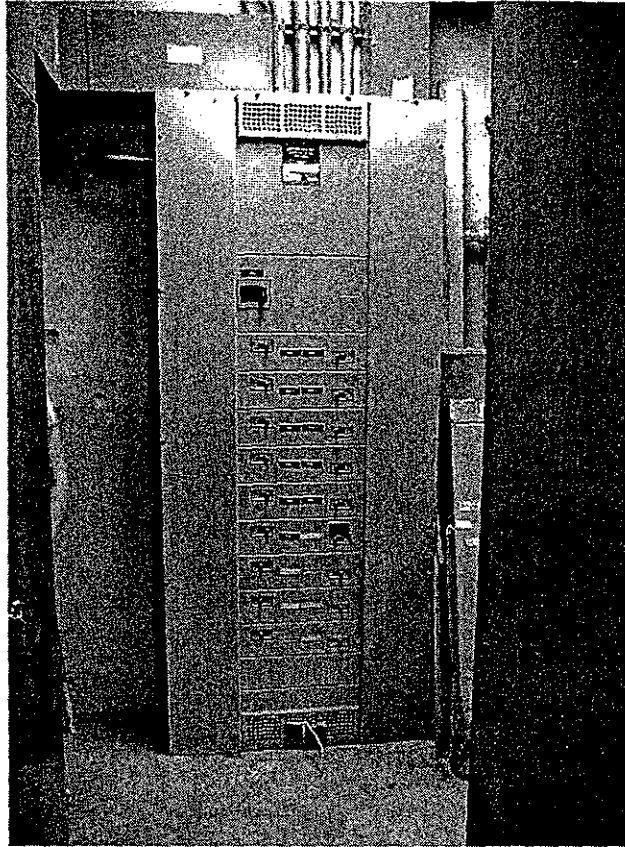
e: Main Electrical Distribution Panel
