KIRK STREET AGENTS' HOUSE

Lowell National Historical Park

KIRK STREET AGENTS' HOUSE
HISTORIC STRUCTURE REPORT
Lowell National Historical Park
Lowell, Massachusetts

Maureen K. Phillips

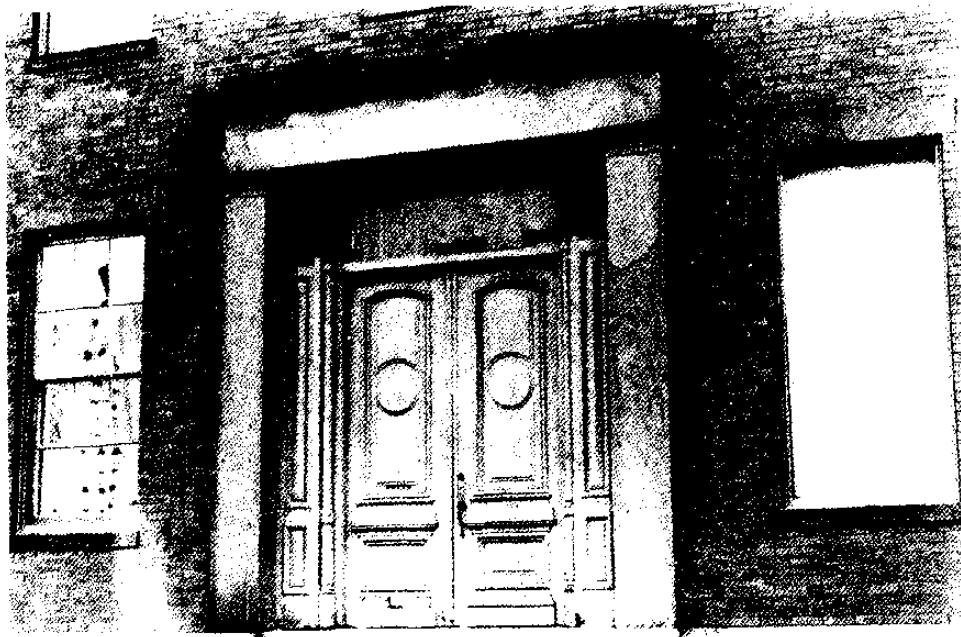
Figure 47. Main Block, West Elevation: South-Unit Entrance.

South-Unit Entrance. The wooden trim, transom, and double doors of the south unit's doorway (D102) date to the 1870's. The trim (fig. 47) consists of narrow raised paneling surrounding a transom and the doorway opening. The paneling on either side of the doorway opening was edged with a narrow engaged column.

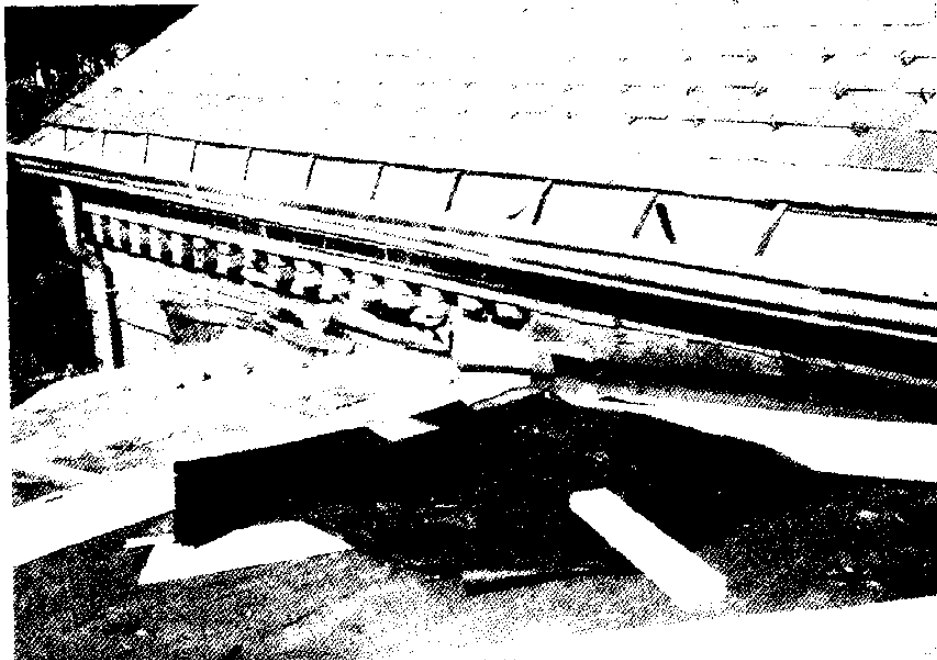
Figure 65. South-Unit Stair Tower: Roof at Junction with Main Block.

On the ell, the nonhistoric built-up tar and gravel roof was removed. The sheet-metal roof underneath was first recorded and then replaced with sheet-metal roofing of flat-seam, pan construction and flashing to match the former sheet-metal roof (fig. 65). The built-in wood gutters were connected to downspouts at the southeast, southwest, and northeast ends of the eaves. The roof was then painted.

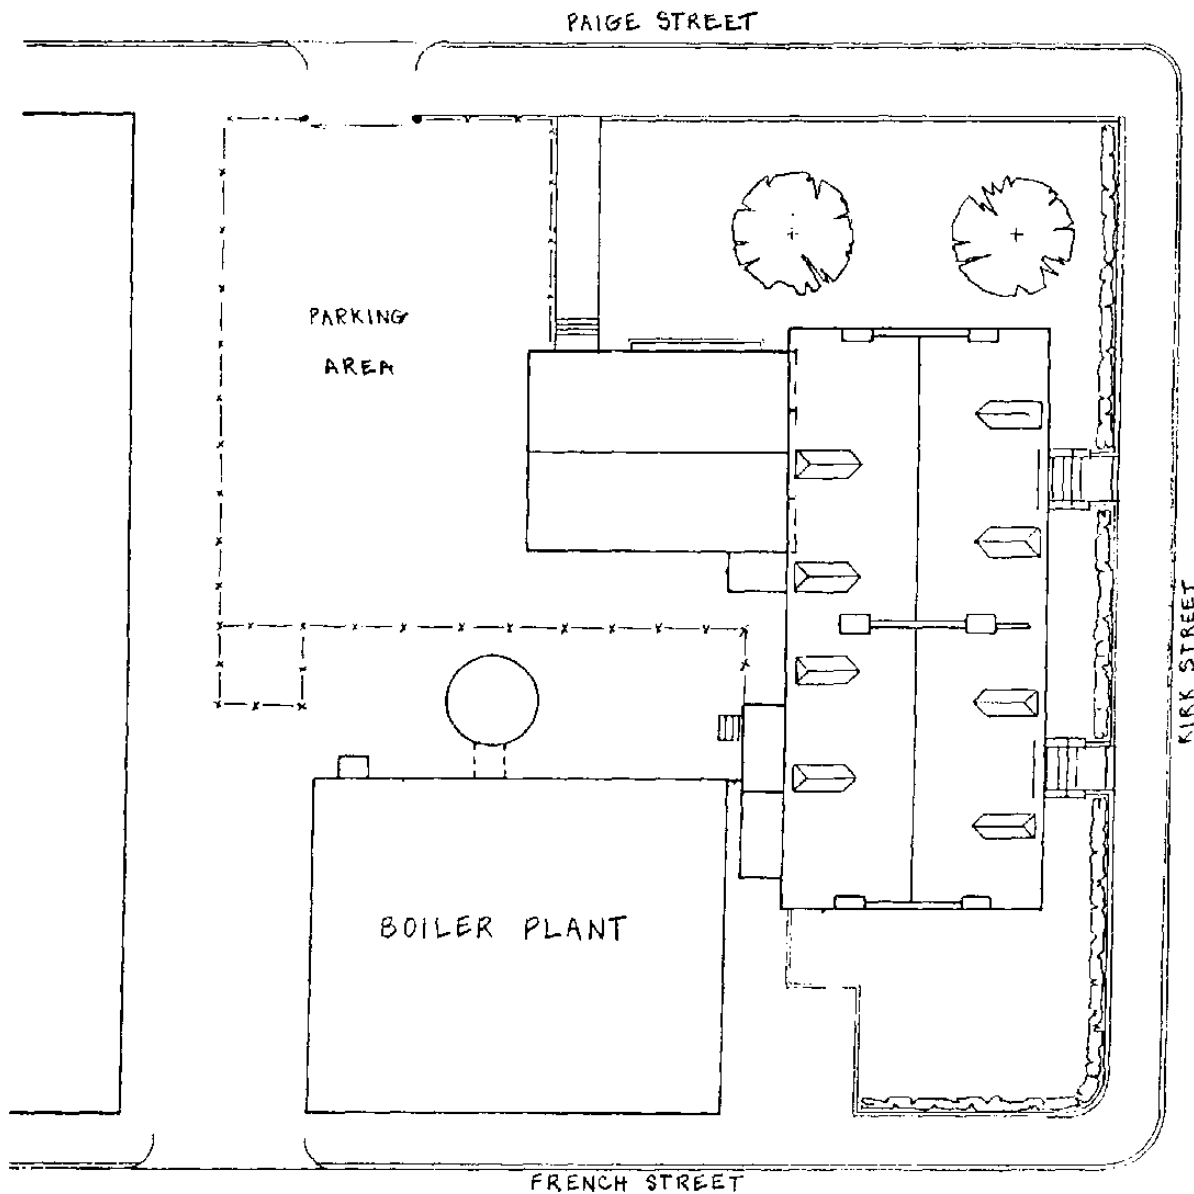
Figure 66. Site Plan of Kirk Street Agents' House.

A masonry curb runs along the west, Kirk Street side of the Agents' House property (see figure 66). Most of the curb—from the south boundary to a point 30 feet north of the north unit's entrance walkway—consists of the original beveled granite curb. North of this curb is a 10-foot-long section of replacement granite curbing. The remaining curb consists of modern poured concrete that extends around the corner onto the north boundary.

The black chain-link fence that runs along the east section of the south boundary continues halfway across the east side of the property, enclosing a modern parking area. It then turns west, approaches the rear wall of the main block, then runs north to intersect the north unit's stair tower (see figure 66).

Figure 66 shows the present configuration of the Agents' House site. The large 1922 boiler plant is situated where the north unit's ell and its attached shed were formerly located. The shed formerly attached to the rear of the south unit's ell has been removed; the site is now occupied by an asphalt-paved parking lot. Two other buildings are situated behind (to the east of) the Agents' House. On Paige Street is the Clement McDonough Arts Magnet School, built as the Manual Training School circa 1901 on the former site of the Boott stables. On French Street is the 1939 Lowell Trade School, which occupies the former site of the Boott Overseer's Block.

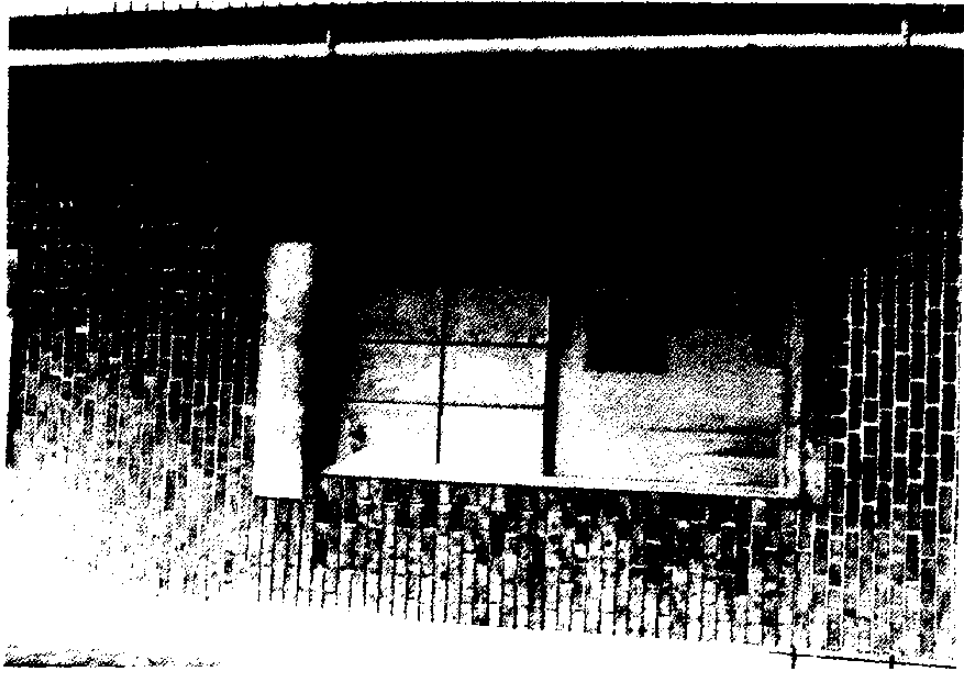
Figure 74. North-Unit Stair Tower, North
Elevation: Window W124.

The north brick wall of the stair tower is also in good condition. Some areas show signs of having been repointed, especially under the first-story window (fig. 74). Other areas are in need of repointing, but the mortar loss does not seem to be severe.

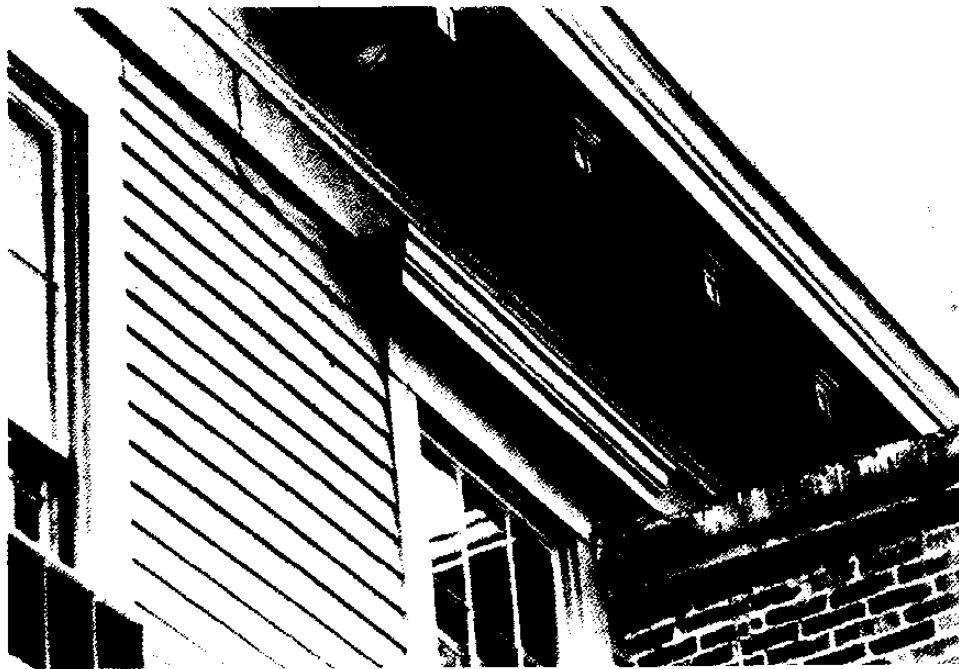
Figure 82. Ell, North (Rear-Yard) Elevation: Window W224 with Cornice Hood (circa 1859-1878).

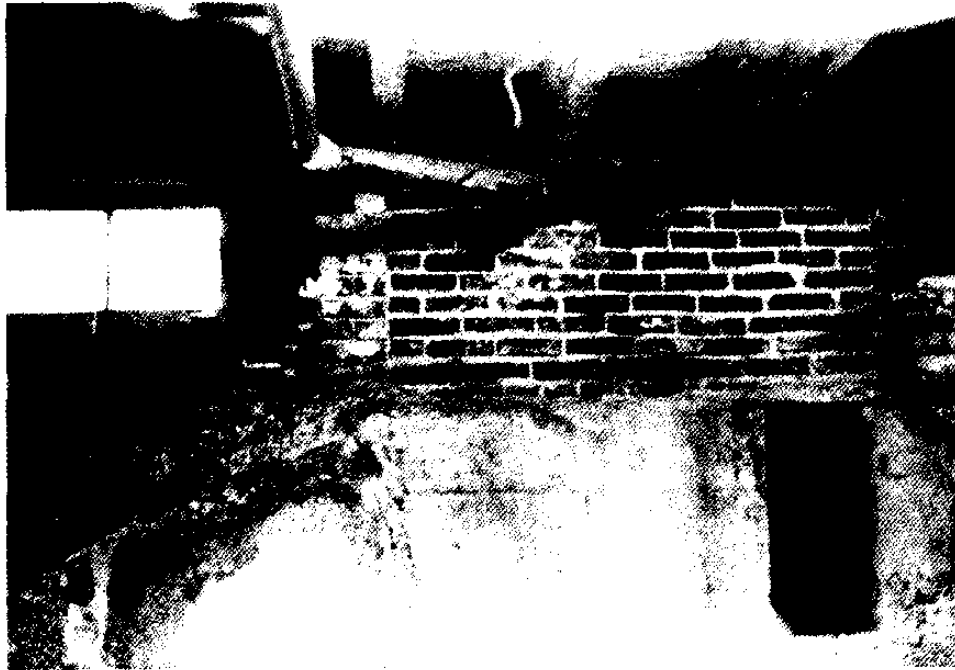
Doorways. There are currently no doorways in the ell cellar. The remnants of two former doorway-type openings can be seen in the walls of the ell. One is a bricked-up opening in the north wall, east of W009 (fig. 33); see Chapter III for further discussion of this feature. The other former doorway is thought to have been an original bulkhead (fig. 88); it is now blocked with concrete blocks and bricks.

Figure 88. Room E001 (Ell Cellar), East Wall: Blocked 1847 Bulkhead Opening.

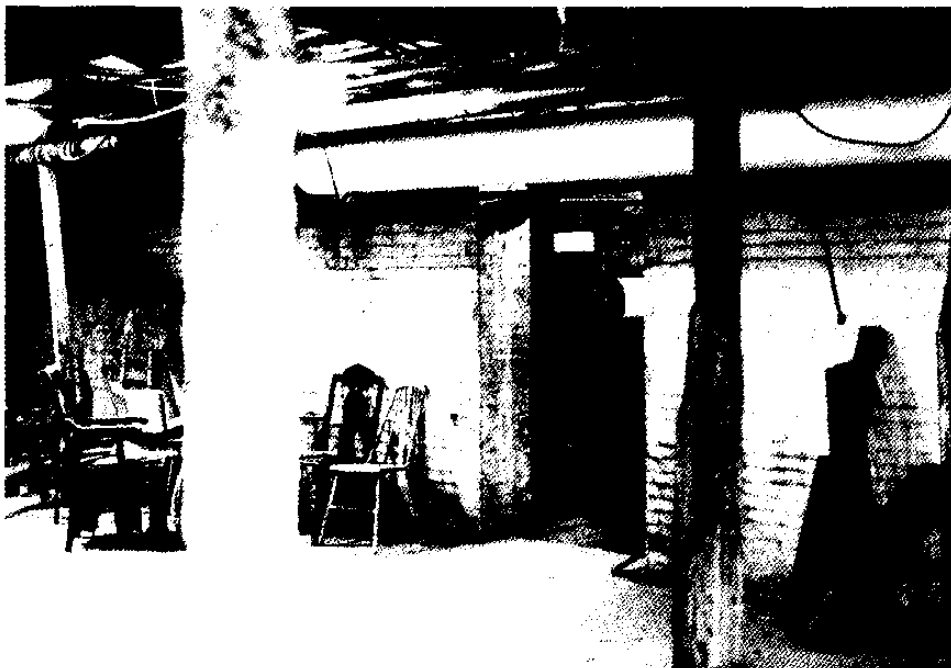
Doorways. A large doorway in the east wall of the cellar (see figure 89) leads to the adjacent stair-tower cellar. This is an original doorway that was enlarged circa 1922.

Heating and Plumbing Equipment. Large heating pipes run through a hole in the east foundation wall and across the room at ceiling level (see figure 89). They pass through a hole in the south, party wall to reach the south unit's main-block cellar.

Figure 89. Room N001 (Main-Block Cellar of North Unit), Looking East.

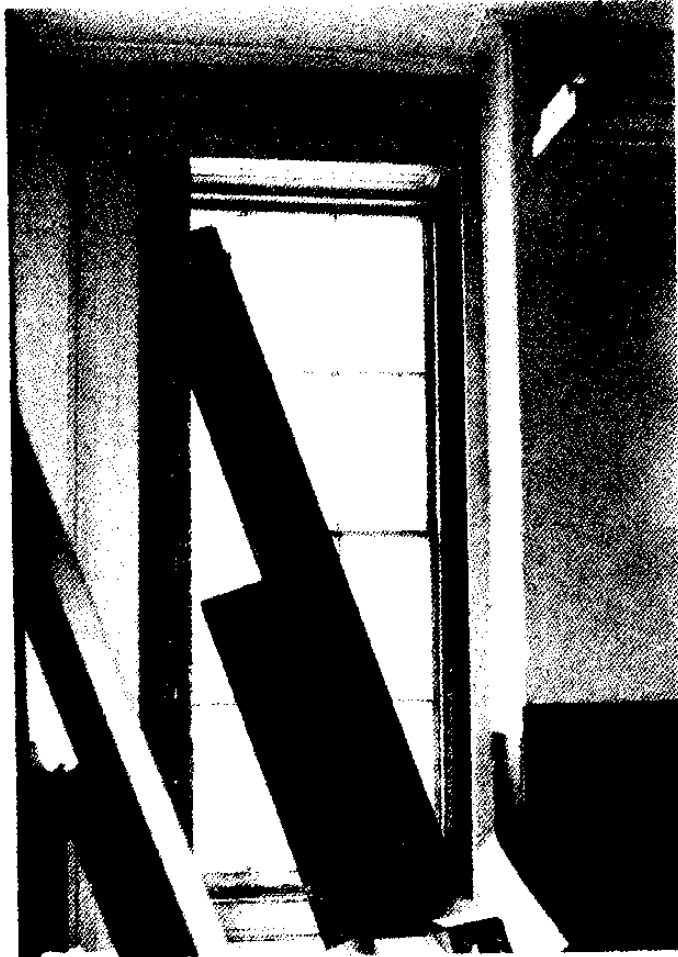
Window W129, at the west end of the north wall, is in poor condition (fig. 92). The surround, interior blinds, and sashes are original, but the blinds are hanging from a single hinge, some of the lower reveal panels are missing, and the sash stops are gouged and split.

Figure 92. Room N101, West (Drawing Room) Portion,
North Wall: Window W129.

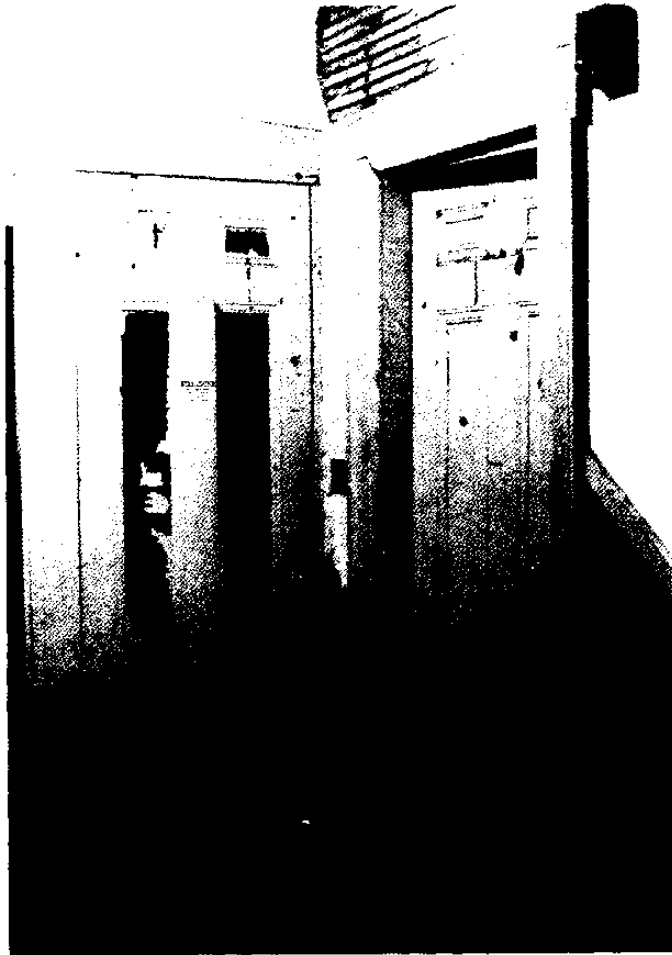
Walls. Original lath and plaster appear to be extant on the east wall and on the south stair wall. Some of this is failing, exposing the 1847 lath (fig. 94). Ca.-1922 plaster is found on most of the north wall. The west ends of the north and south walls (west of D209 and D210) consist of ca.-1945 plasterboard. A section of 1/8-inch plywood covers a 4- by 4 1/2-foot section of the south wall just west of D210.

Doorways. The two doorways in the east half of the stair hall (D211 and D212) are original. They have retained their original Type-J surrounds and six-panel doors. The paint on both doorways is failing (fig. 94).

Figure 94. Room S202 (South-Unit Stair Hall), East End.

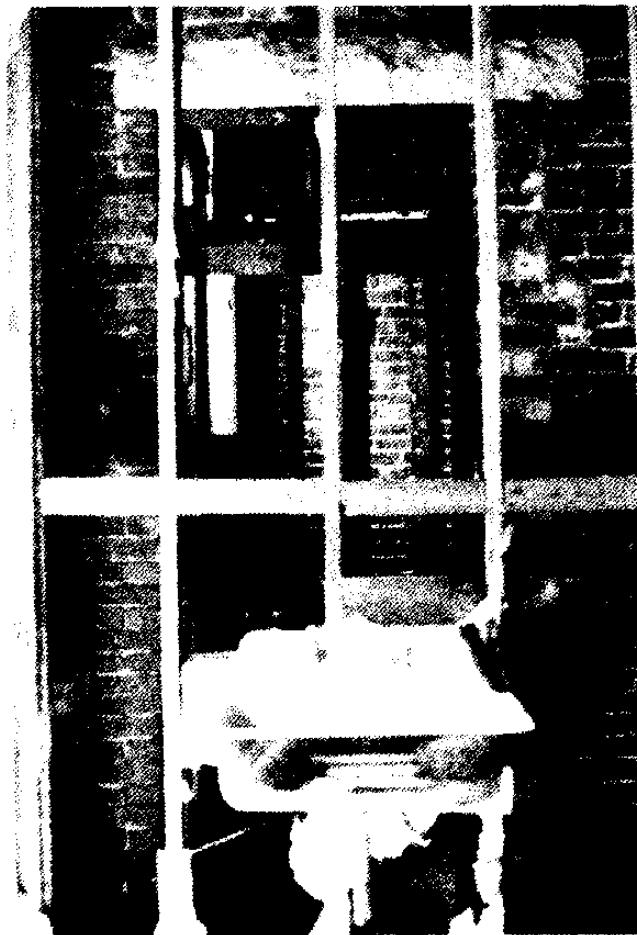
Doorways. The only doorway in N204 sits in the south end of the west brick wall (203). It is a ca.-1922 doorway that leads into Room N201. Before the room was gutted, this doorway had a plain, narrow surround and a plain door with two large recessed panels. The two toilet stalls had doorways with plain surrounds; their doors had disappeared, so their appearance is not known. The demolition work revealed the rough edges in the west brick wall where D203 had been punched through it. It also exposed the original doorway to N201, located at the north end of the west wall (fig. 96).

Figure 96. Room N201, East (Bedroom) Portion, East Wall:
Exposed 1847 Doorway.

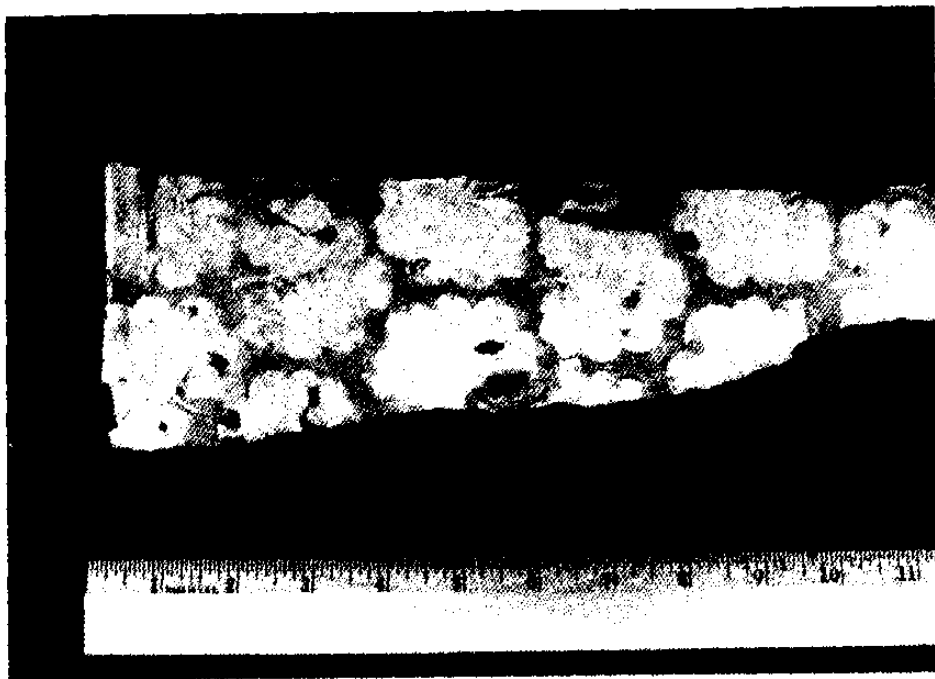
Figure 102. Wallpaper: Layer #1 in Rooms S301, S303, and S305 (circa 1847-1850).

Small fragments of wallpaper with three identifiable layers were found in former bedroom S301. Layer #1 was composed of rag fibers. Its design had a background of green painted around white "shamrocks" 2 inches wide (fig. 102). The wallpaper appeared to have been an early machine-printed paper. The rag-fiber paper, the early machine-printing method, and the relatively small pattern indicates that this paper predates 1855, and may be original to the house.

Layer #1 is the same first "shamrock" layer found in S301 (fig. 102), which has been dated to 1847-1855. Layer #2 is also composed of rag fibers, and has a machine-printed foliate design in blue and green with gold edges on a white ground (fig. 103). This paper has been dated to circa 1855-1865.

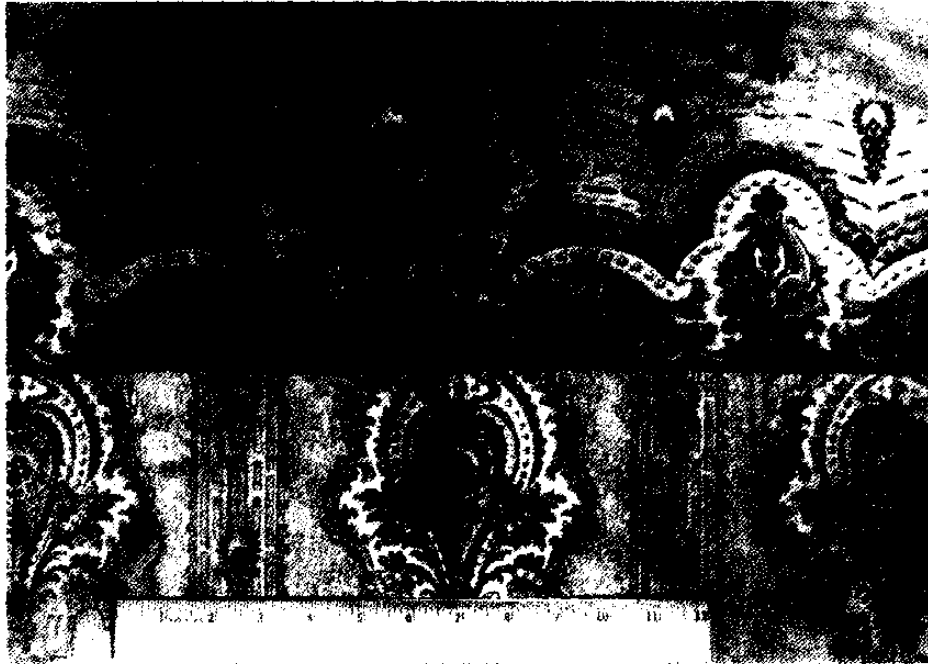
Figure 104. Wallpaper: Layer #4 (Top Layer) in Rooms S303 and S305.

Layer #4 is thought to date to circa 1895-1905. It is a mechanical wood pulp, machine-printed paper with vertical bands of large foliate medallions in burgundy, green, and dark green on a white ground (fig. 104). It was hung in this room with a ceiling paper that had a small white floral pattern on a background of tiny white dots.

Layer #4 is the same top layer found on the walls of the central hall and in Room S303 (fig. 104).

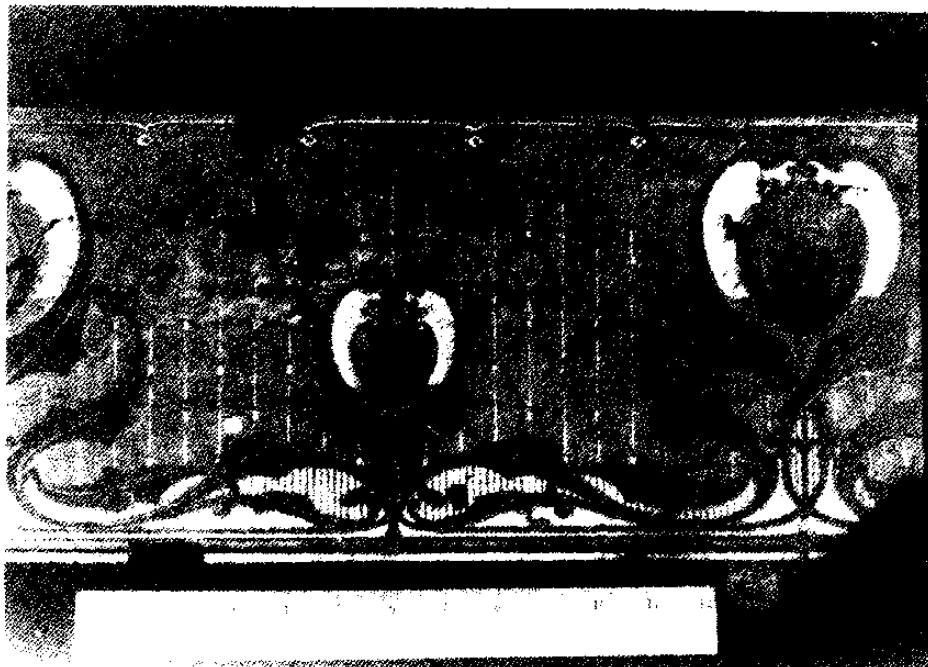
Figure 105. Wallpaper: Layer #4 (Top Layer) in Room S304.

Layer #4 has an Art Nouveau design, machine-printed in brown, black, and sparkling turquoise green on a dark green, diamond-shaped background (fig. 105). This paper is also composed of mechanical wood pulp and has been dated to circa 1895-1900.

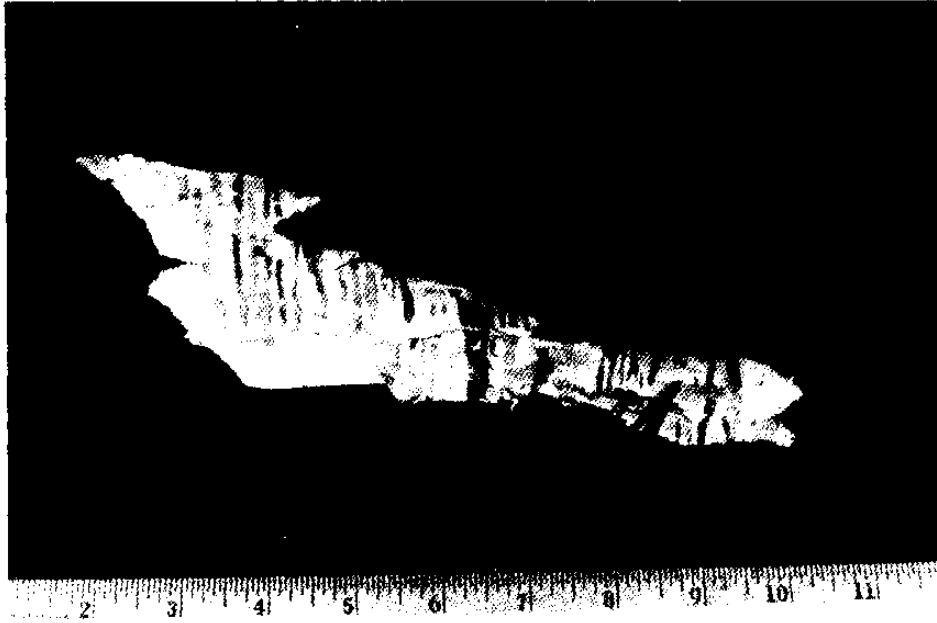
Figure 106. Wallpaper: Layer #1 in Room S306.

This former bedroom has retained six layers, more than the other third-story rooms. Layer #1 is composed of rag fibers, and has an early machine-printed, indeterminate design of dark green and brown on white (fig. 106). This paper may be original to the construction of the Agents' House and has been dated to 1847-1850.
