Submerged Cultural Resources Site Report

NOQUEBAY

APOSTLE ISLANDS NATIONAL LAKESHORE

**SUBMERGED CULTURAL RESOURCES SITE REPORT:
NOQUEBAY**

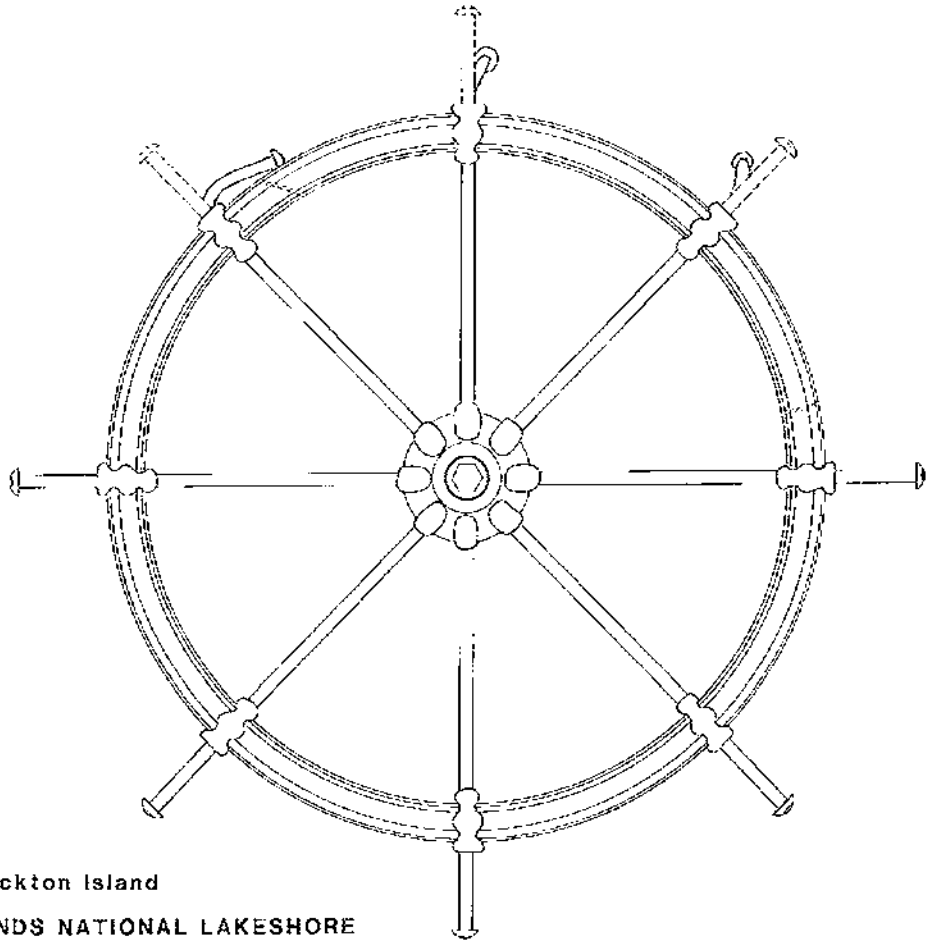
Figure 7: Ship's Wheel

Several artifacts were discovered during excavation of the wheel and steering mechanism; they included: a length of wire cable 1 inch in diameter, not attached to the wheel; 9 square spikes varying in size from 5 to 9 inches long by 1/16 inch in cross section; 6 round nails varying in size from 8 to 14 inches and 3/4 inch in diameter; and a 1-by-4 inch piece of tongue and groove board, painted beige, with a small segment of canvas attached via small nails. These items were identified, measured, and left in place under the wheel and steering assembly.

Following the mapping, photo, and video documentation of this feature, it was reburied. This was done to protect the wheel from winter storms, ice action, and possible vandalism.

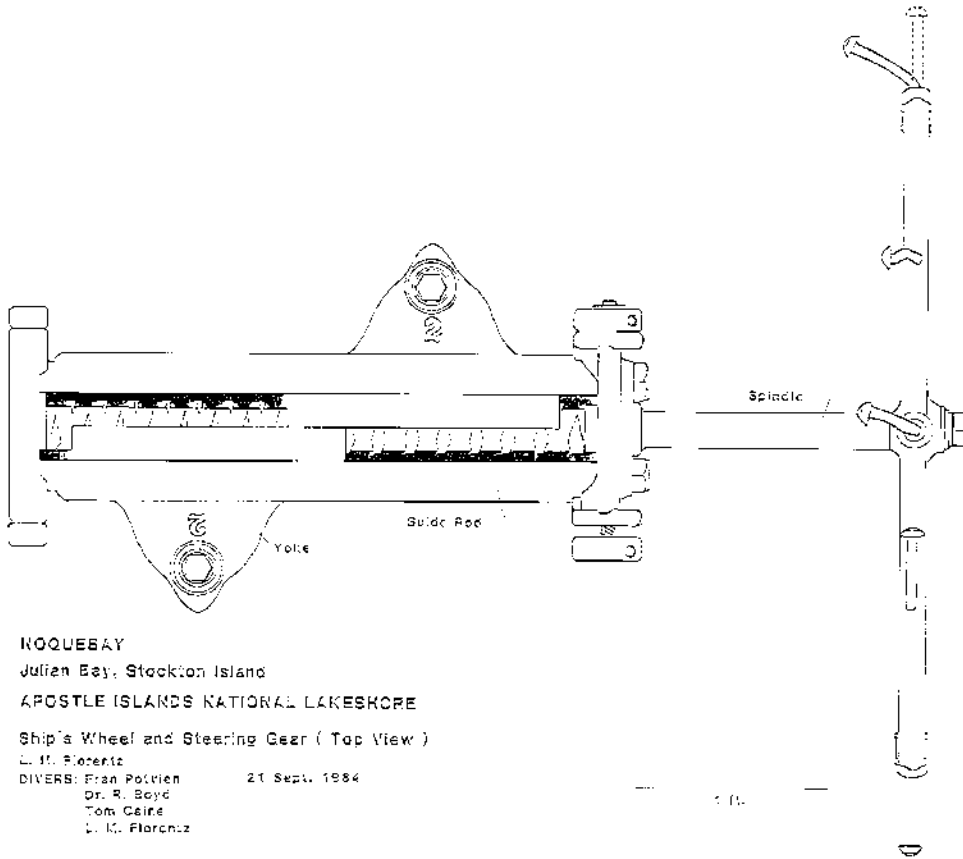
Figure 8: Steering Gear

Plate 7: After excavation, the entire wheel and steering assembly were exposed. The mechanical, or "patent steering gear," came into use in the latter half of the 1800s. The wheel and worm gear are in an excellent state of preservation.

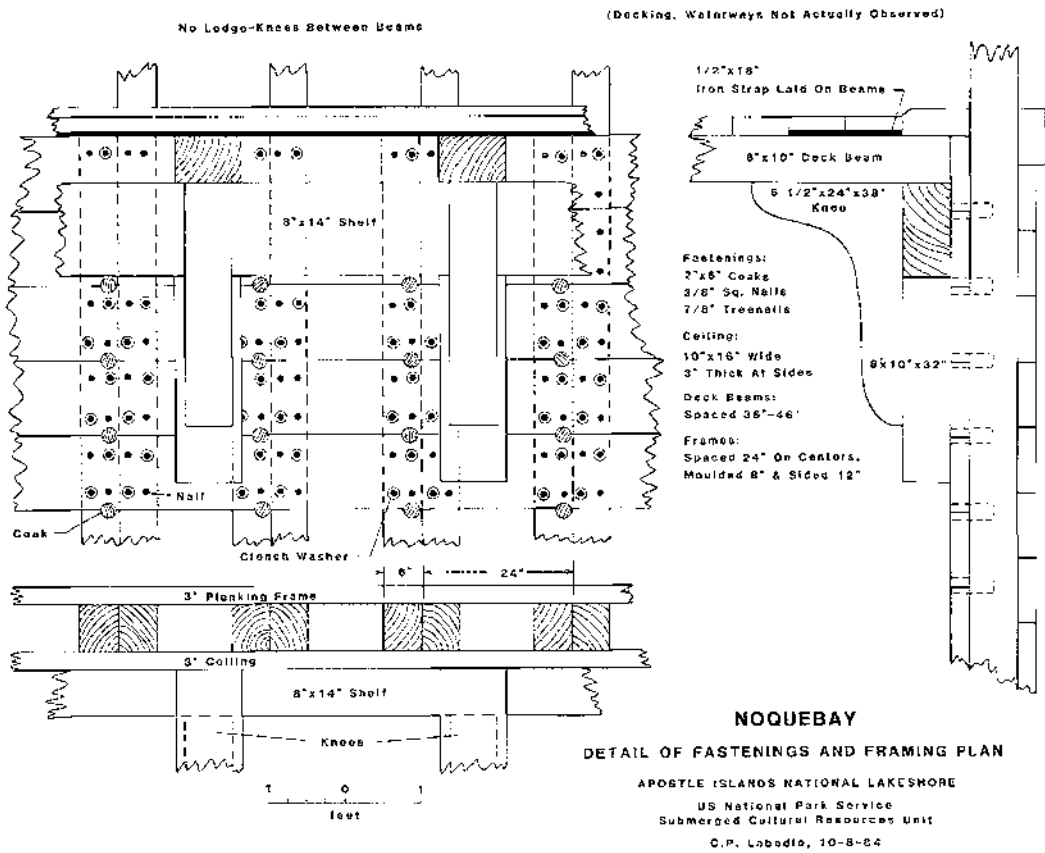
Figure 11: Detail of Fastenings and Framing Plan

the bilge ceiling. These are wooden "dowels" which are laid into the surface of two adjoining timbers to prevent slipping or sliding endways, i.e., longitudinally. The bilge ceiling has 2-inch coaks, spaced on 24 inch centers, falling between frames. The bilge ceiling fasteners differ from the ceiling on the bottom only in that the double fasteners alternately have 1-inch diameter clench washers (Figure 11). This fastening pattern begins at the turn of the bilge and continues to the main deck.

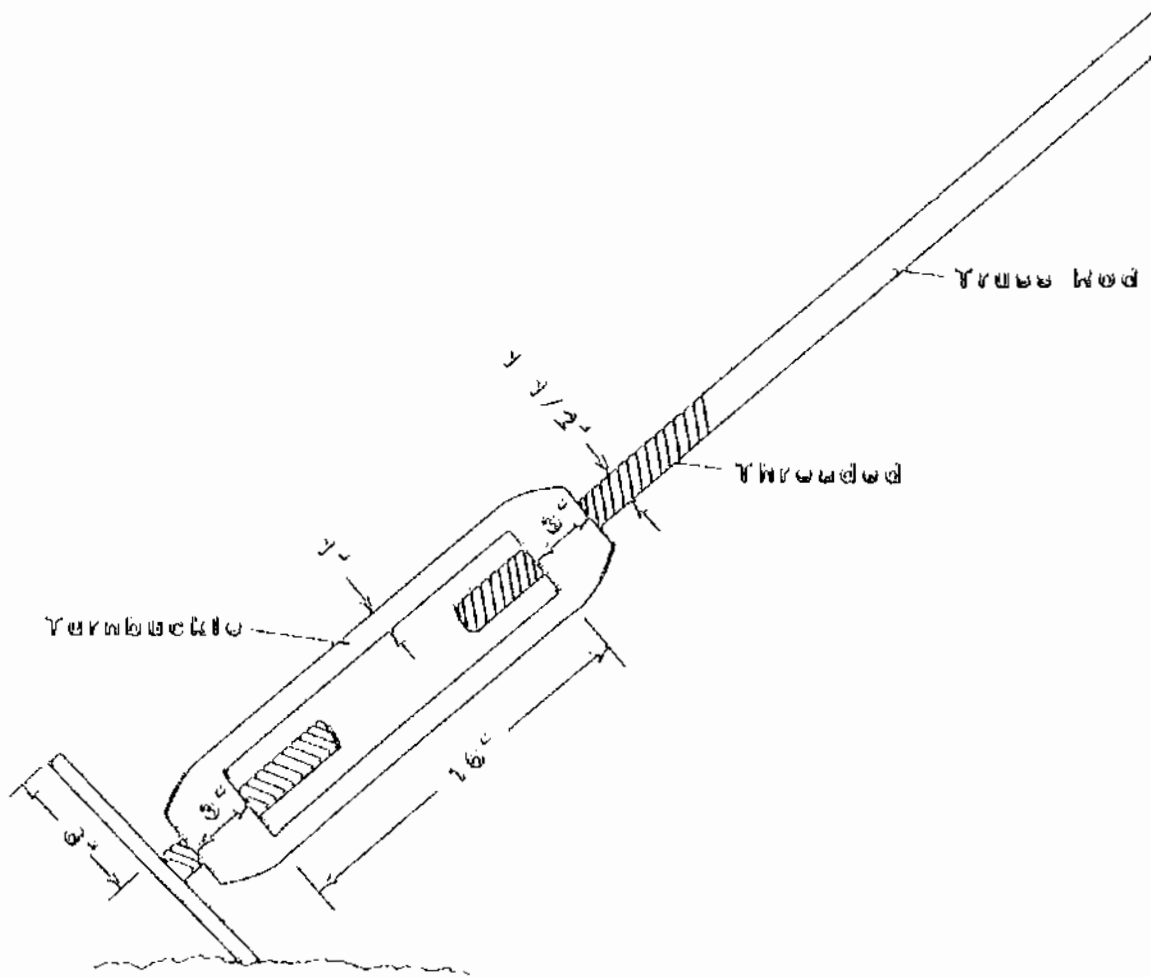
Figure 12: Detail of Turnbuckles

At base line point 160, adjacent to the starboard sister keelson, a 25 foot section of truss rod begins. This section of rod, with a 22-by-4-inch turnbuckle, is one of several represented on the site. The rod is uniformly 1-1/2 inches in diameter; where it articulates with the turnbuckle it is threaded to facilitate connecting and adjustment. There are 5 articulated turnbuckles exposed on the site that are either 22 inches or 24 inches long. Two of the turnbuckles are 24 inches by 4-1/2 inches and three are 22 inches by 5-1/2 inches. It is probable that at least one additional turnbuckle would have been used on this vessel, making a total of six.

In some of the cases the rod and turnbuckles also had flat plates in association. The turnbuckle on the starboard side near base line point 165 has such a plate. It is 4 feet from the end of the turnbuckle and is 6 by 5 1/2 by 1 inch. The plate is not perpendicular to the rod, rather it is at a slight angle to the rod. Two other similar plates were found on sections of rod, one of which is in association with a turnbuckle. The plate and turnbuckle, located on the starboard sister keelson near base line point 202, is reproduced in Figure 12. The plate with this turnbuckle is the same size as the plate at base line point 165, however this plate is only 1 inch from the turnbuckle and is perpendicular to it. One additional plate

The truss rod was designed to reduce longitudinal hogging of the hull. The turnbuckles were used to tighten sections of rod, pulling the vessel bow and stern up. It appears that the rod passed up through the deck near the bow, similar to truss rod found on another Great Lakes schooner WILLIE LOUTIT (Plate 11), ran down the deck to the stern and then below again. The plates found on rod were probably for deck reinforcement and protection at the points where the rod passed through the deck planking. Internal strengthening was particularly important on NOQUEBAY, since she had no mainmast and no forestays connecting the remaining masts (see historic photo, Plate 3). If NOQUEBAY had continuous forestays they would have provided some additional longitudinal strength to the hull, perhaps without the necessity for a truss rod. Further, the relatively light planking on this vessel's hull also contributed to the need for longitudinal strengthening (C. P. Labadie, personal communication).

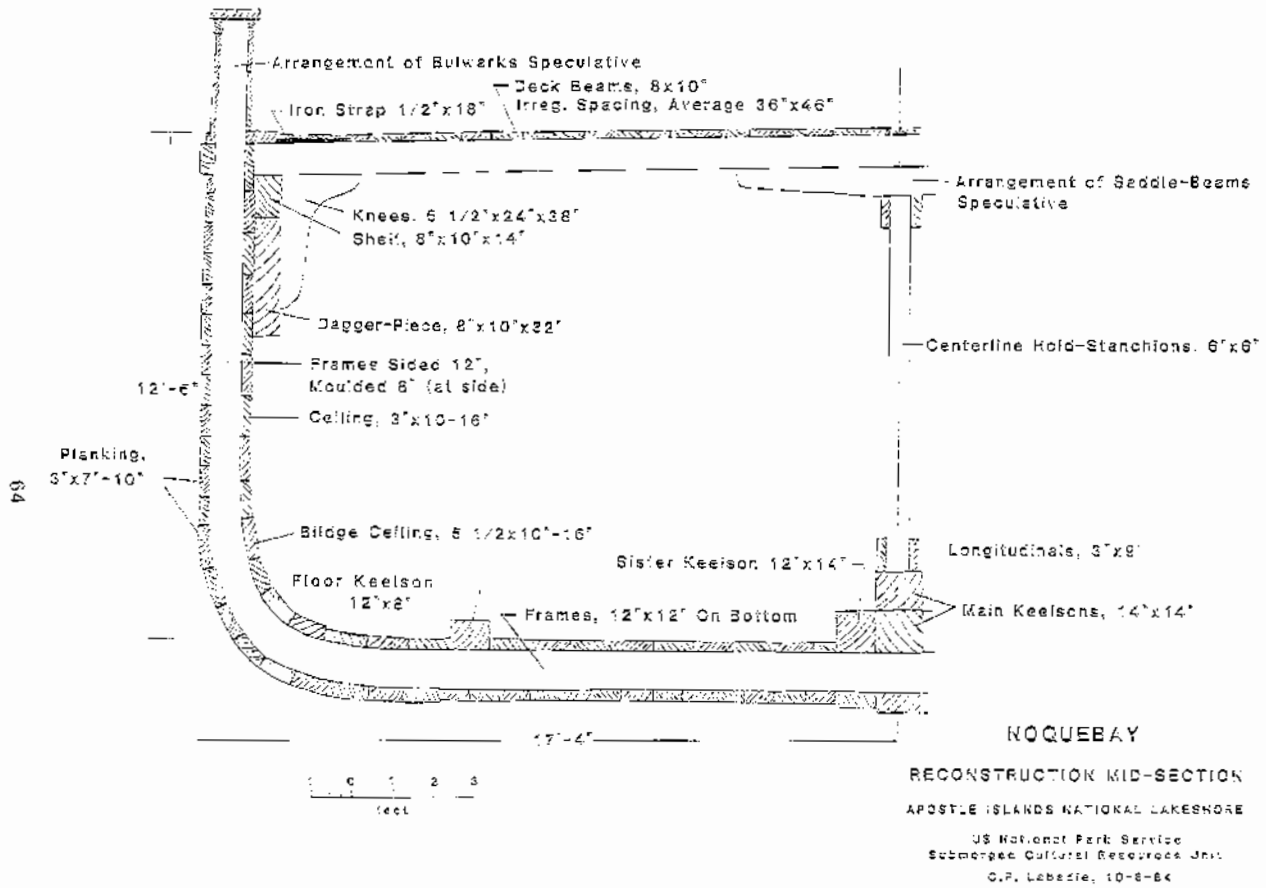
Figure 13: Hull Cross Section

Transverse strains cause the sides of a vessel to bow out or in. Transverse strains are much greater than longitudinal strains and as soon as a vessel moves, inclines, or pitches and rolls, transverse water pressure works to alter the shape of the vessel. If the framing, especially at connections between deck beams and side framing, is not strong enough or properly fastened, the knees, as well as the framing of the decks and bilges, will begin to loosen (Desmond 1919:35). In an effort to deal with this problem, the builders used a wide strap (Plate 13), running longitudinally at the level of the main deck. The strap was probably placed directly over the deck beams, at the level of the decking, and tied into the deck beams and knees by fasteners (Figure 13).

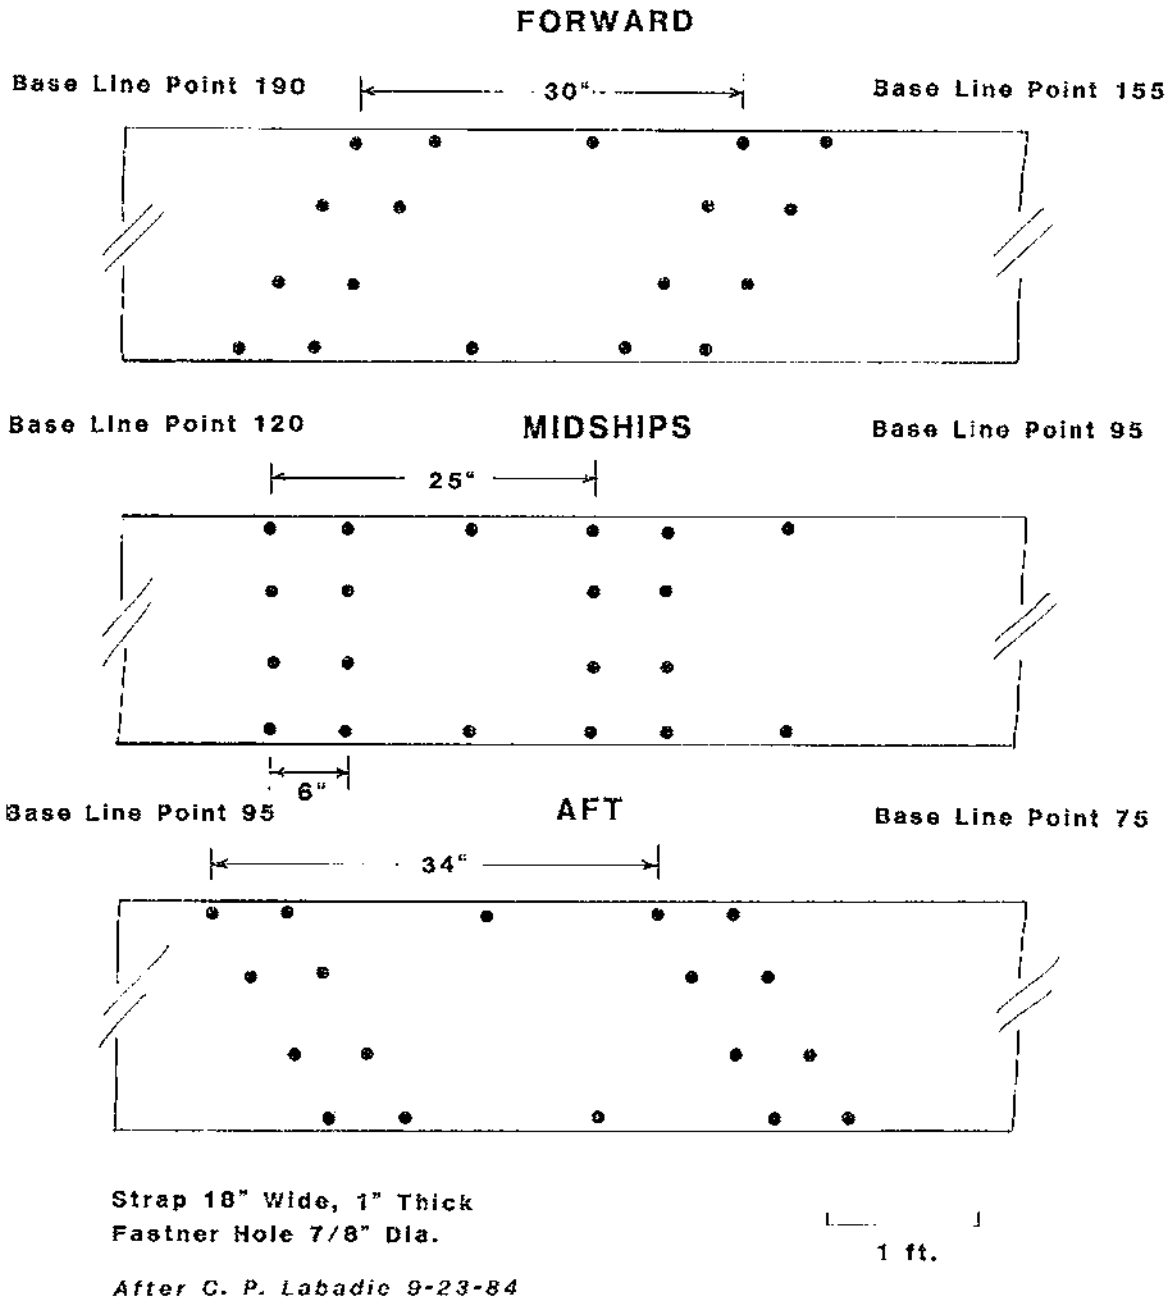
Figure 14: Hogging Strap Detail

the ceiling thickness is reduced from 5 inches to 3 inches. A 29-foot piece of hogging strap is near the frames of this piece.
