SAGAMORE HILL HOME OF THEODORE ROOSEVELT

HISTORIC STRUCTURE REPORT

**Sagamore Hill National Historic Site
Oyster Bay, New York**

Written 1988

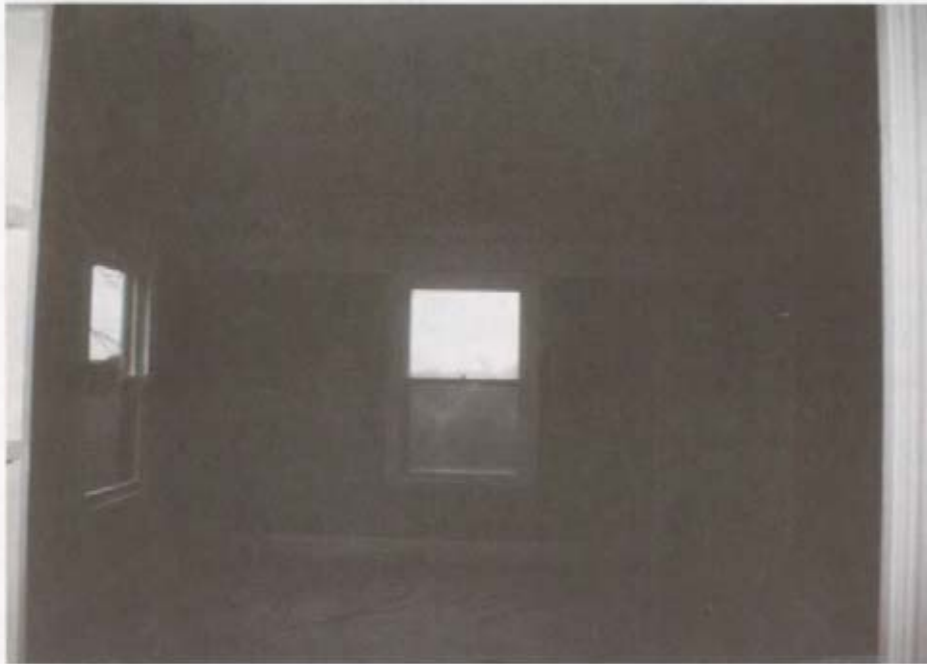
Gate Room: After Restoration

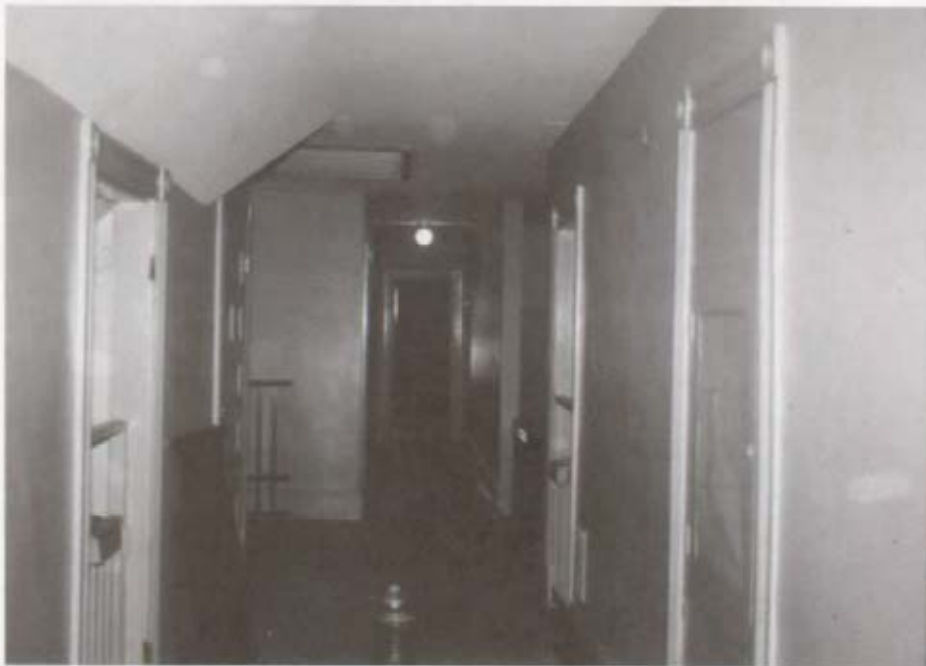
Third Floor Hall: Before Restoration

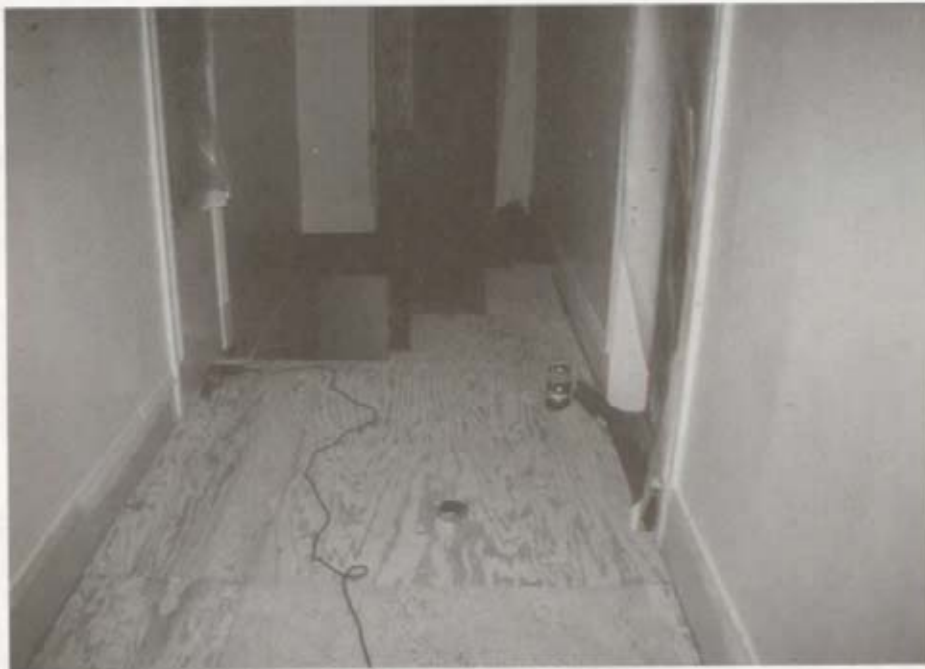
Third Floor Hall: Plywood Installed On Floor

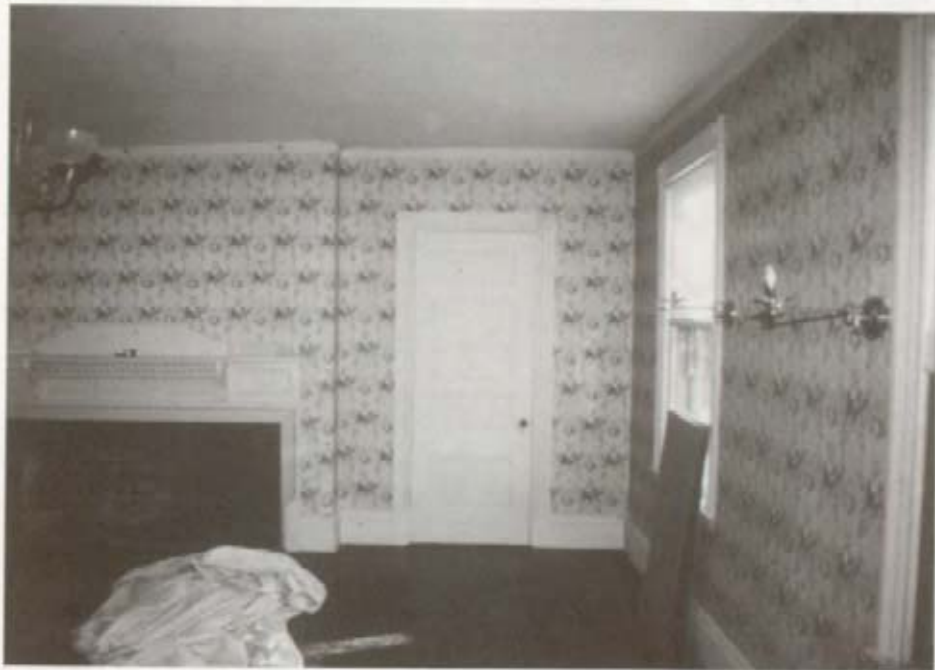
South Bedroom: Before Restoration

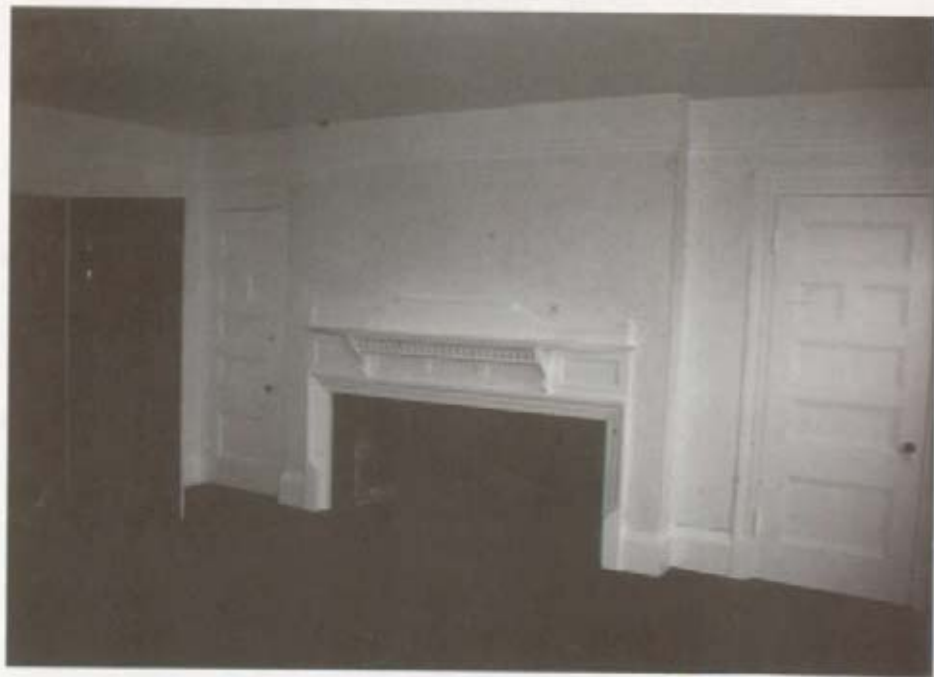
South Bedroom: After Restoration (ready for wallapering).

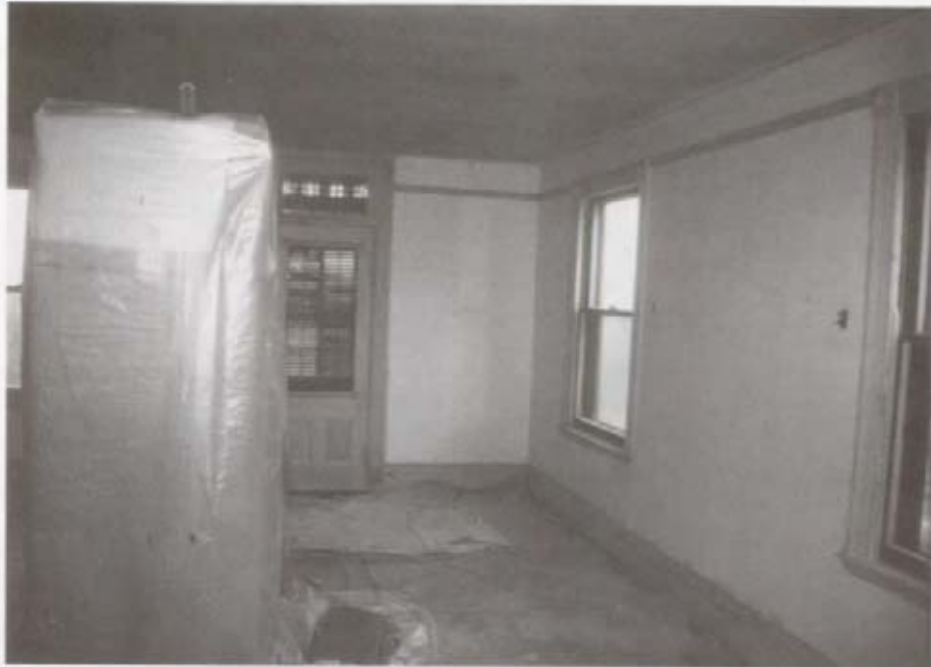
**Mother's Room: During Restoration (wallpaper removed,
picture molding lowered).**

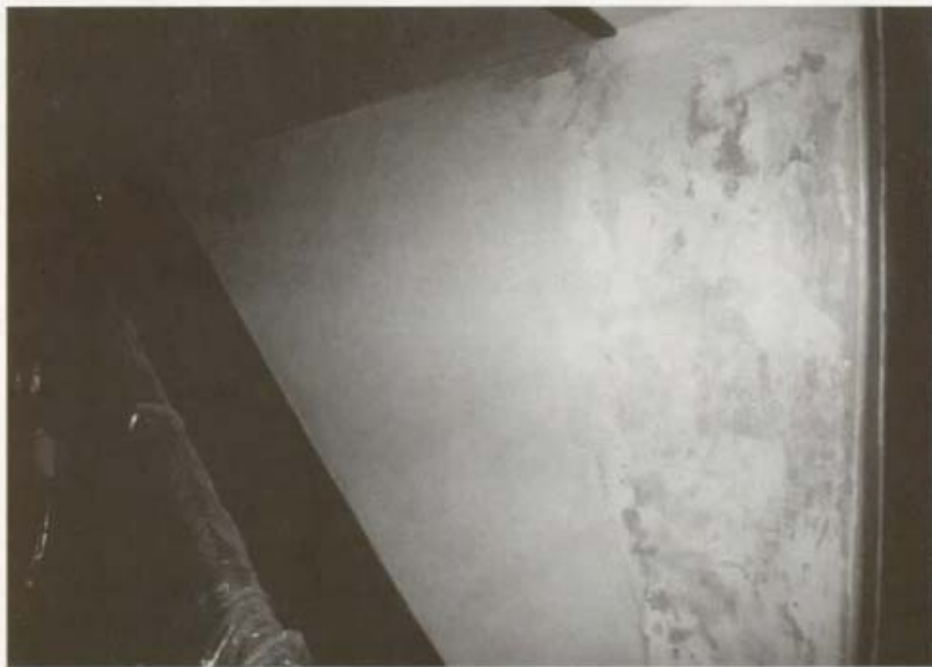
Second Floor Rear Hall Stairway: After Replastering

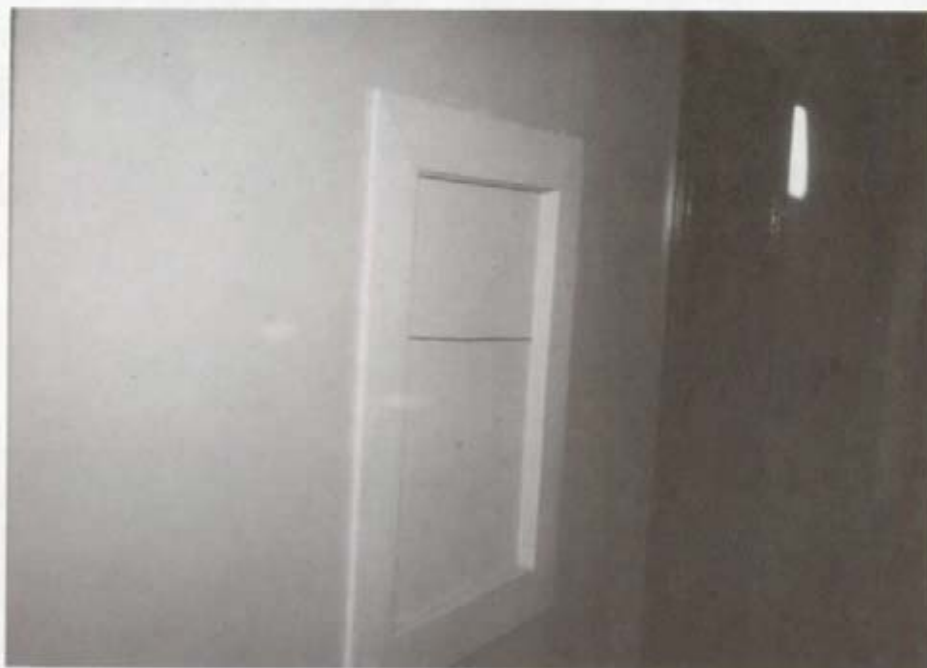
Typical Firebox Location in Hallway: Before Restoration

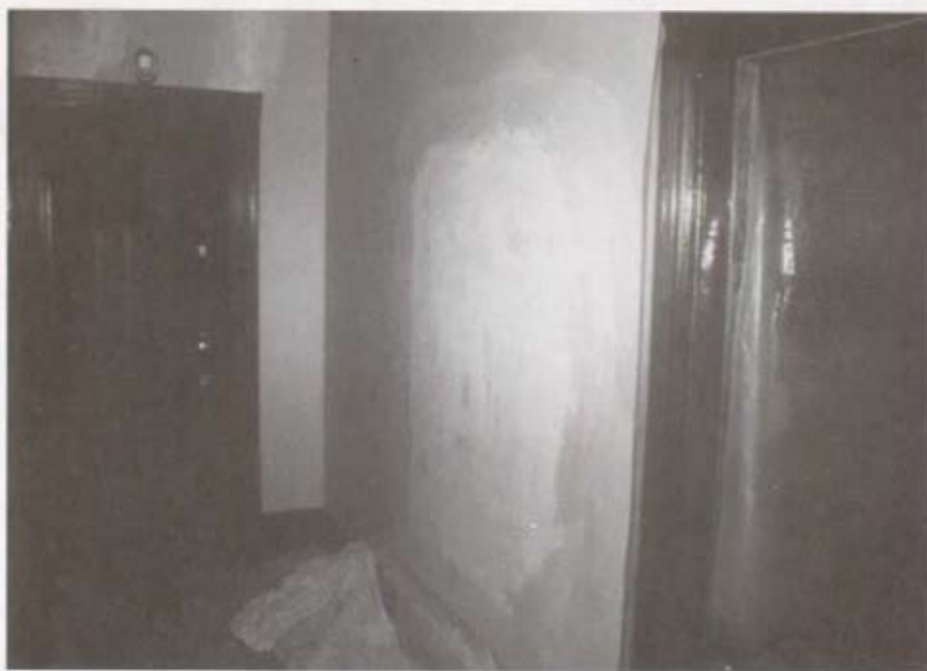
Typical Firebox Location After Removal and Replastering
