ANSLEY WILCOX HOUSE

Theodore Roosevelt Inaugural
National Historic Site
Buffalo, Erie County, New York

HISTORIC STRUCTURE REPORT

October 2006

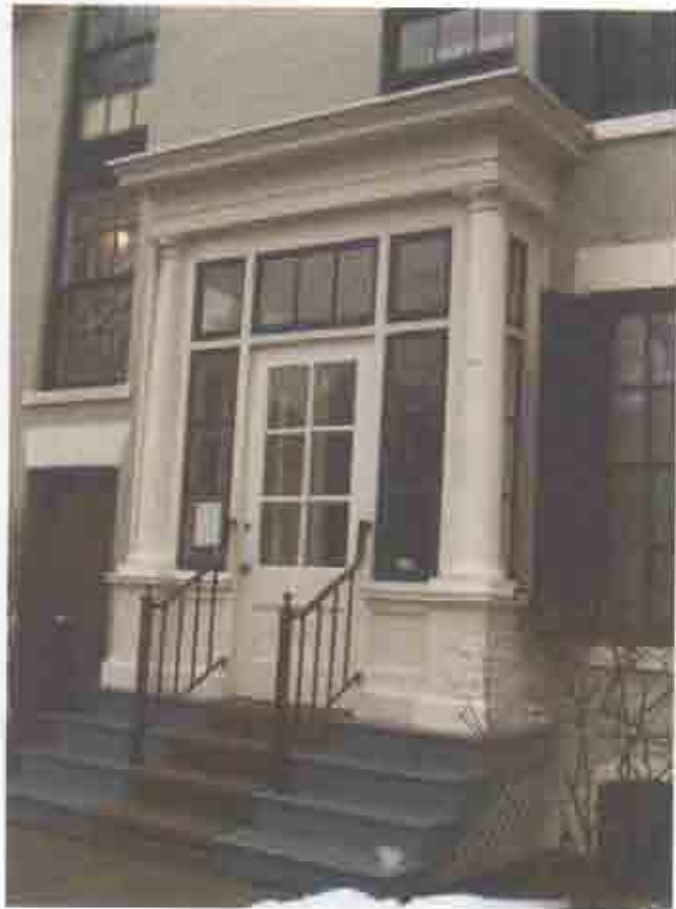
Figure 2.9. North elevation, ca.- 1971 glazing and missing basement window.

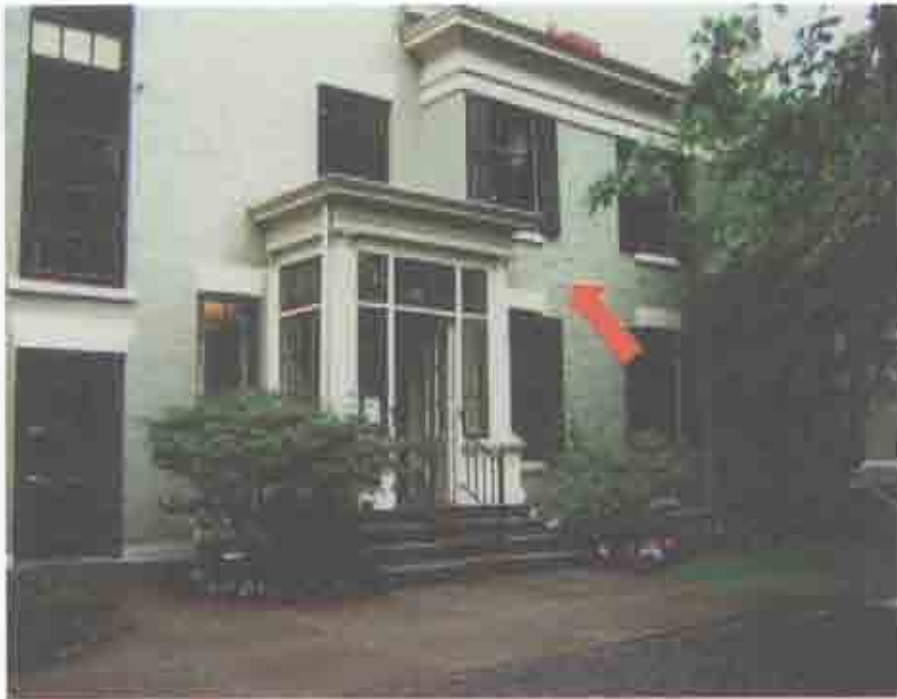
Figure 2.13. North elevation, location of brickwork scars from formerly attached barracks building.

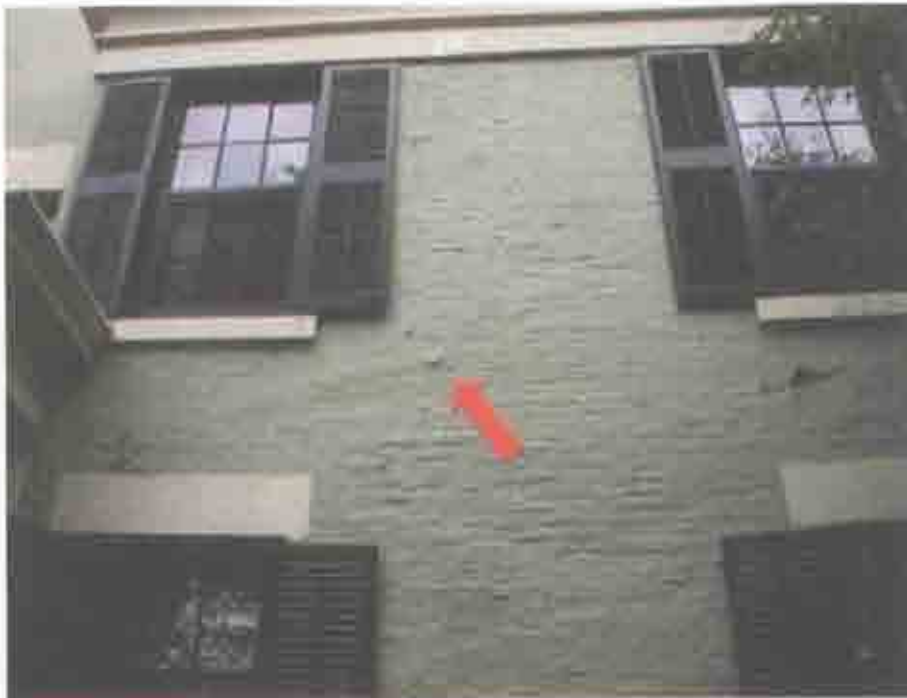
Figure 2.14. North elevation, detail of brickwork scars from formerly attached barracks building.

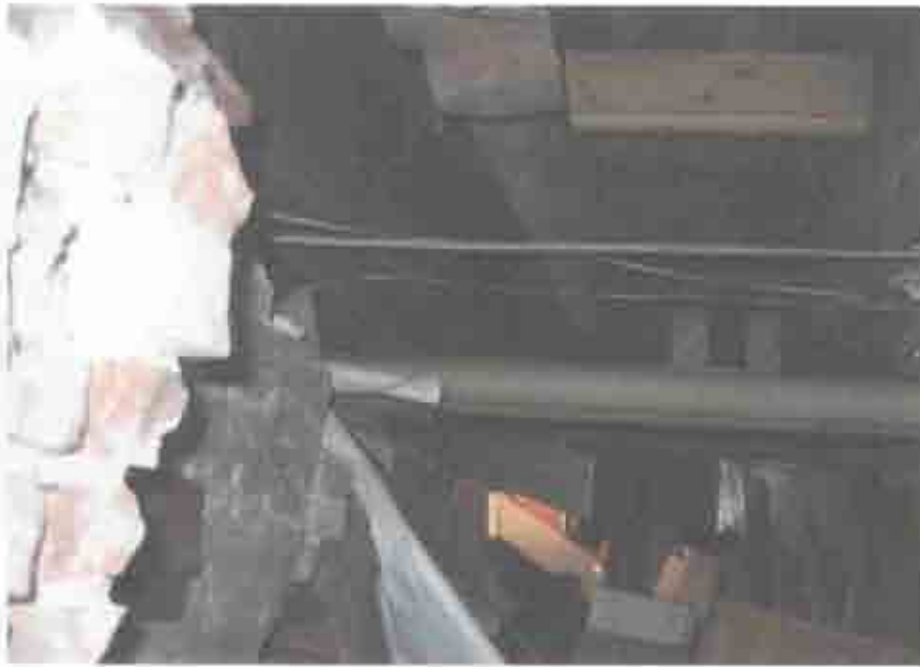
The first-floor framing is exposed. However, there are cut nails protruding from the underside of floor joists, suggesting that there was previously a plaster ceiling in the chamber. (See Figure 2.24.)

Figure 2.24. Room 001a (central brick furnace chamber), interior.

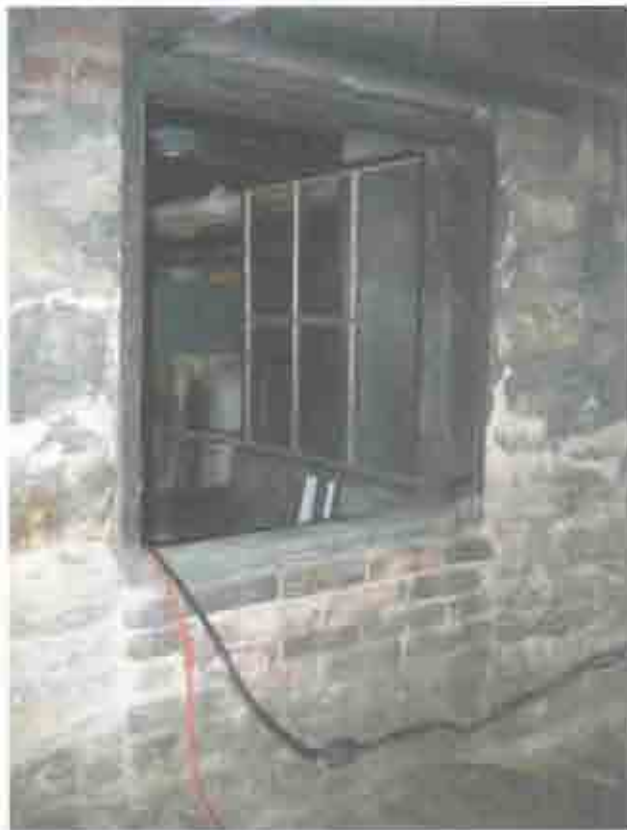
Figure 2.27. Room 001c (areaway below west portico), showing brick infill and casement window at former doorway opening.

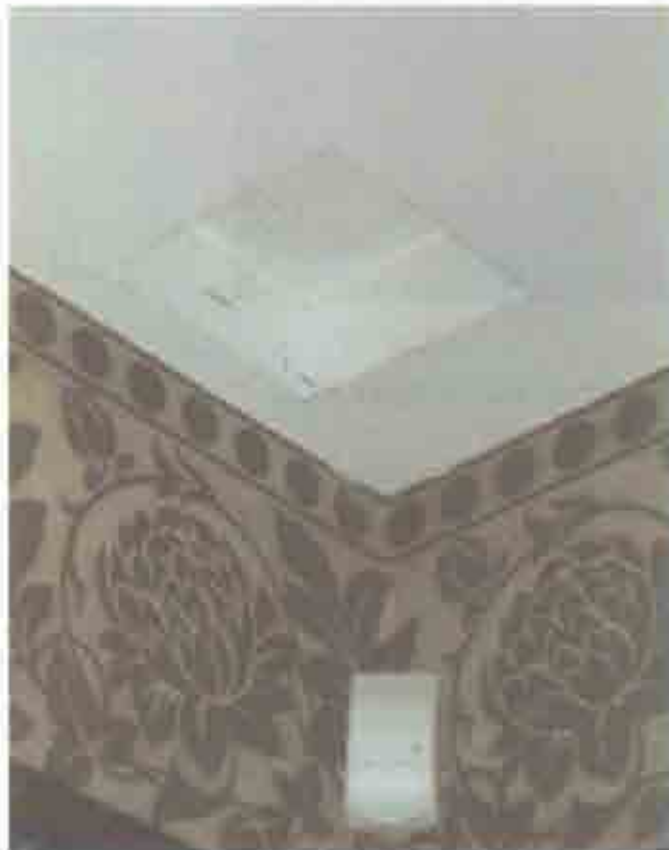
Figure 2.37. Room 104 (Library), post- 1935 ceiling opening.

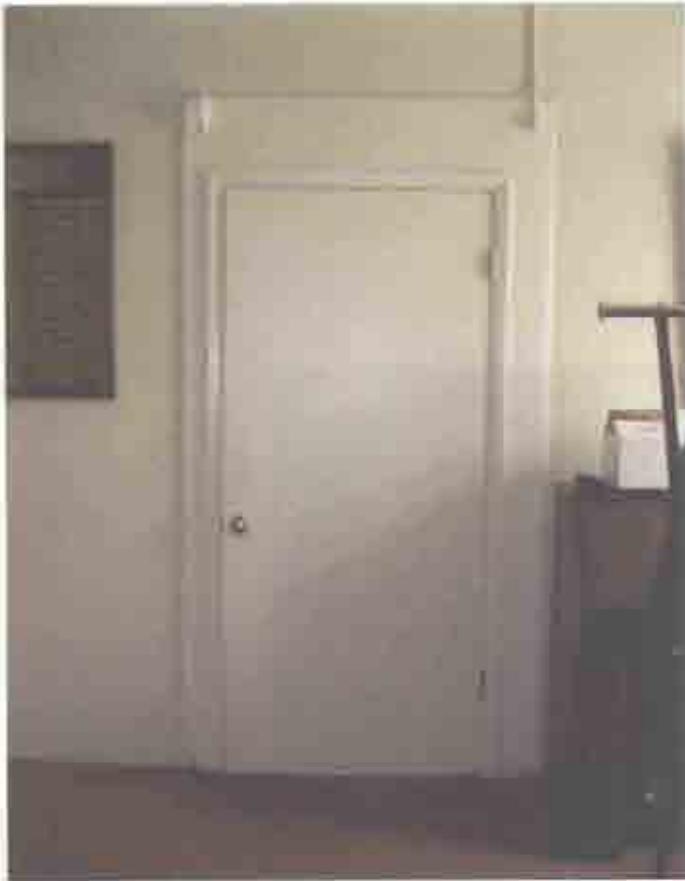
Figure 2.46. Room 112 (Kitchen), north wall, 1896 window opening converted to doorway.

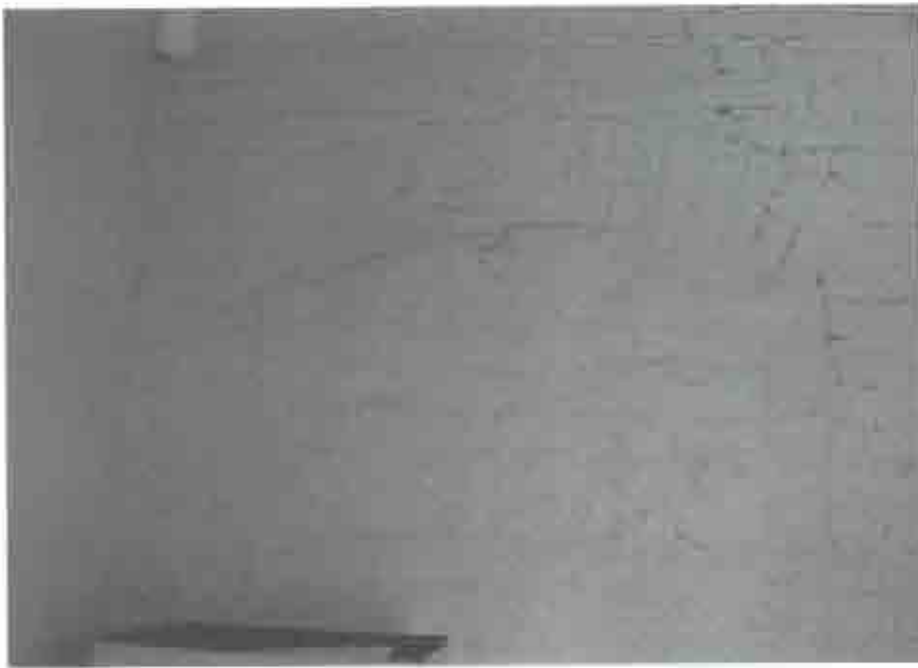
Figure 2.50. Room 115 in the 1938 addition, north wall, infilled arched window opening in brick wall of former carriage house.

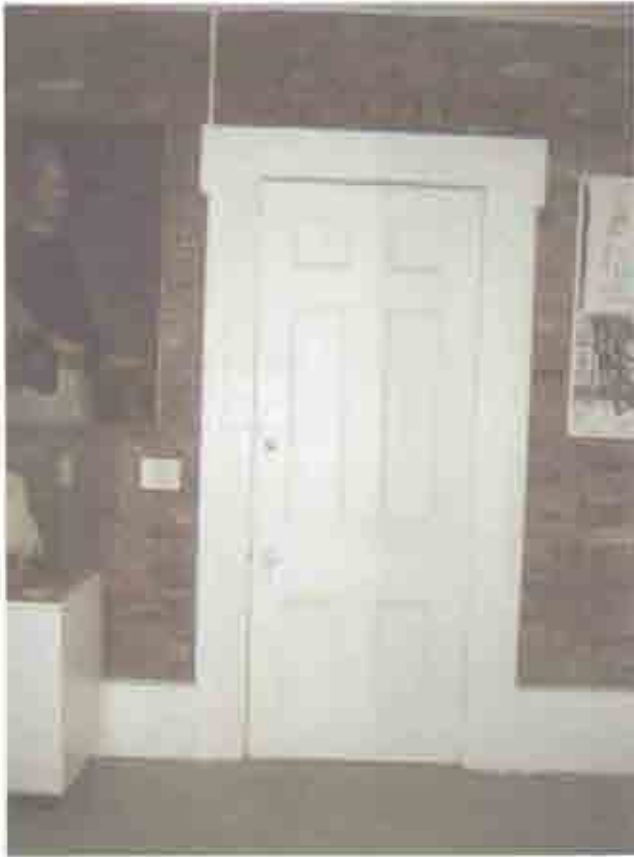
This doorway is the remnant of a doorway between the original stair hall and the second- story hall in the 1896 addition (room 203). In 1896, this was a wide opening with a soffit supported on ornamented console brackets. (See Appendix B.) The iron lintel for this opening is still visible in Room 203. (See Figure 2.54.) By 1938, the wide opening was partially filled with brick and reduced to the present doorway.

Figure 2.54. Room 203
(Second-Story Back Hall),
west wall, pre-1938 doorway
and brick infill.

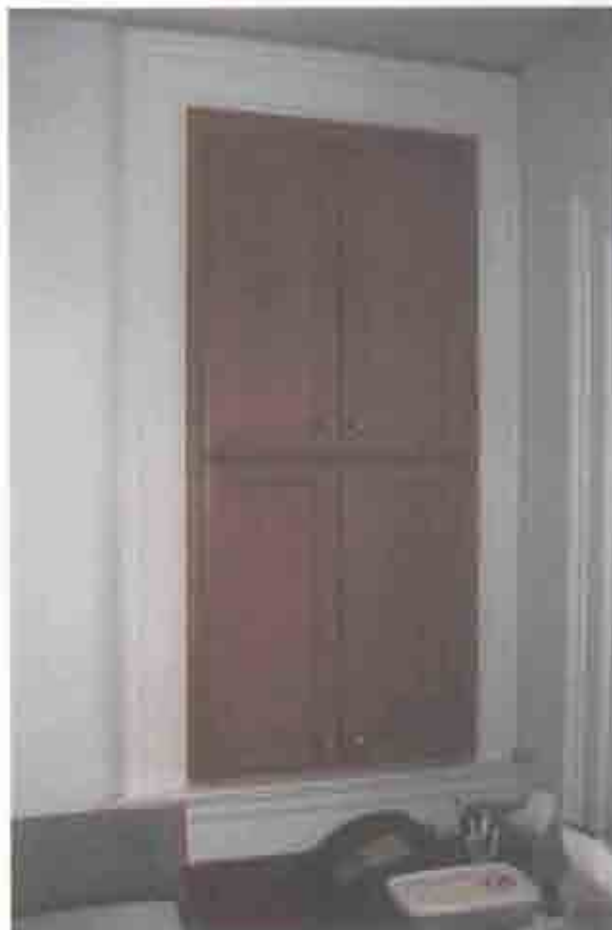
The west wall is furred plaster on original brick with its 1896 fabric remaining intact. In the center of the room is a doorway to the original part of the house, with flat molded and mitered casings. The door swings into the original structure – the reverse of the swing indicated on the 1896 drawings. At the north end of the west wall is a similar doorway that opens to a modern cabinet set into the doorway recess. (See Figure 2.59.) This doorway is labeled on the 1896

Figure 2.59. Room 204,
west wall, "old closet"
with modern cabinet
insert.

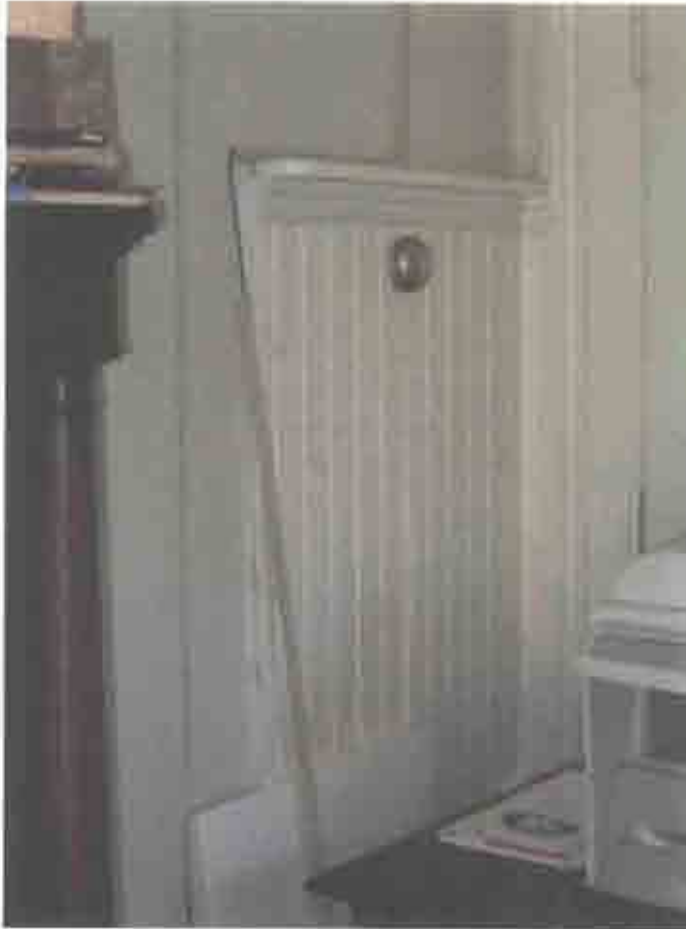
The present north wall consists of two sections, reflecting its 1896 construction. The west section is an 1896 frame partition with lath and plaster and a molded wood baseboard. A doorway connects to the Back Hall (room 203); it is cased with molded and mitered boards and plinth blocks, and has a paneled door. The east section was formerly a thin frame partition containing a wide opening to the walk-in closet in the southeast corner of the Back Hall. At the east end of the wall was the side of the chimney breast for the first-story Kitchen. This configuration is documented by the 1896 architectural drawings. The walk-in closet was removed after 1971, and the opening to it infilled with a frame partition and gypsum plasterboard. Remnants of a tongue-and-groove wood wainscot survive at the east end of the north wall, on the side of the chimney. It displays vertical "V"-groove boards, and a molded dado cap and shelf. (See Figure 2.60.) It probably dates to 1896.

Figure 2.60. Room 206,
wainscot remnant at north
end of east wall.

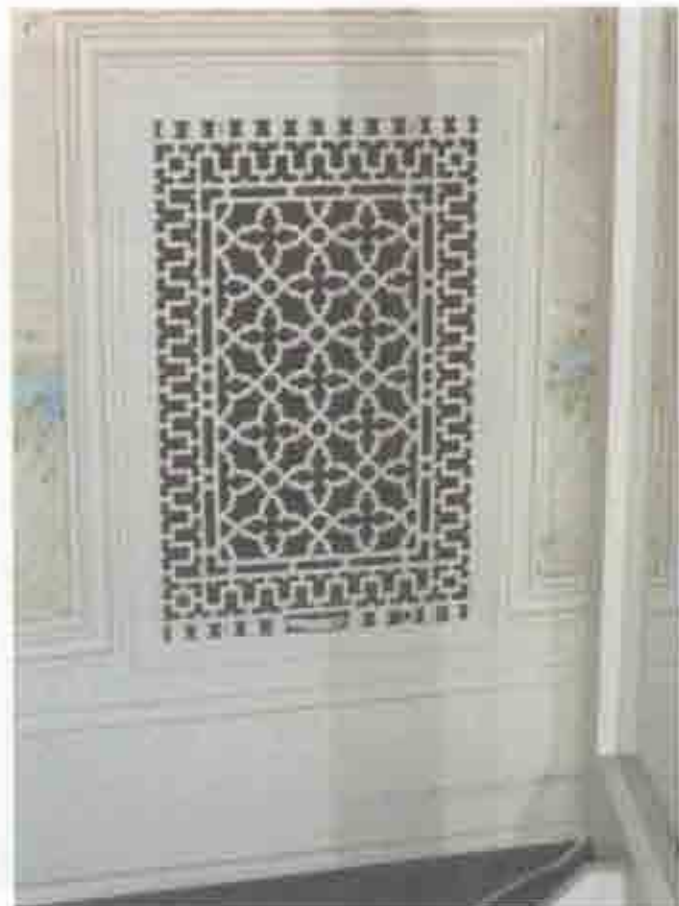
On the west wall are two doorways with paneled jambs and paneled wood doors. The south door is presently fixed and blocked from the adjacent room (room 206). Between the two doorways is an ornamented wall register, which is cased with molded wood boards matching the baseboards. (See Figure 2.63.) This is shown on the 1896 architectural drawings.

Figure 2.63. Room 207,
wall register.

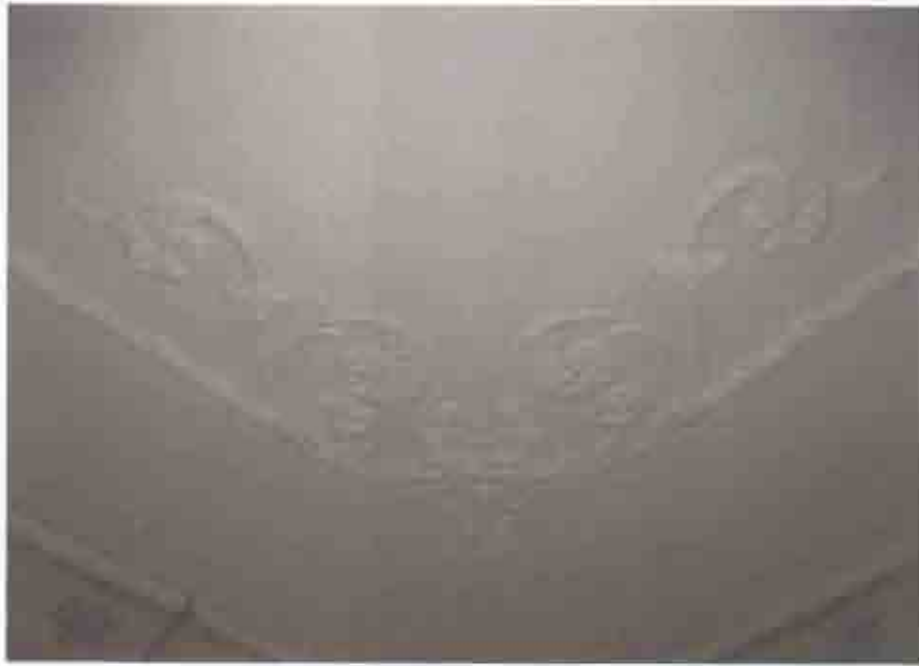
The ceiling is flat lath and plaster with plaster relief or appliqué ornament. (See Figure 2.64.)

Figure 2.64. Room 207, ceiling.

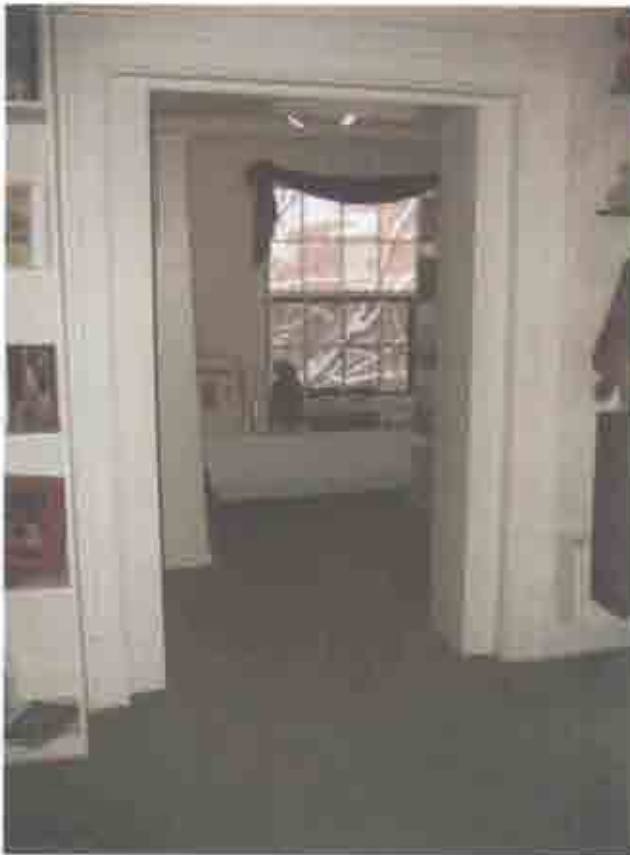
Centered on the east wall is a projecting chimney breast with brick hearth and facing, and a mantelpiece similar to that in the adjacent bedroom (room 207). At the center of the north wall is a former 1896 window opening that was converted to a doorway in 1938 to access the new addition of that date. The brick below the window sill was removed, the paneled skirt and jambs were removed, and the opening was narrowed to create the doorway. This opening is cased with the original salvaged window trim. (See Figure 2.65.)

Figure 2.65. Room 208, north wall, 1896 window converted to doorway in 1938.

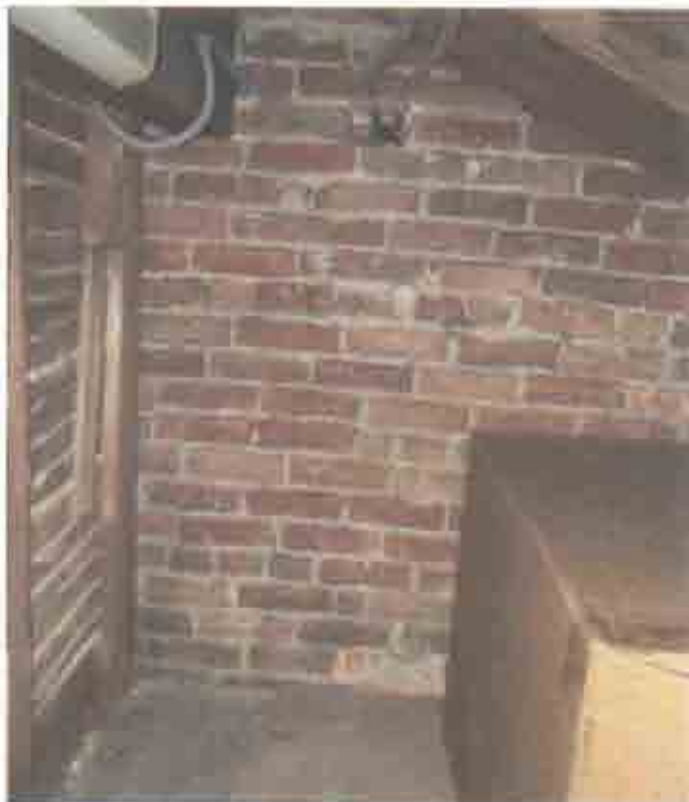
The east wall is the interior surface of the original brick gable end wall. (See Figure 2.70.) The end wall is three bricks (12 inches) thick. The brick is laid in common bond with headers at every eighth course. Individual bricks are regularly formed, but vary in color from pale salmon to deep red, suggesting a somewhat uneven temper. Joints are filled to the surface with bedding mortar and struck flush.

Figure 2.70. Room 308a,
looking east toward original
brick gable end wall.

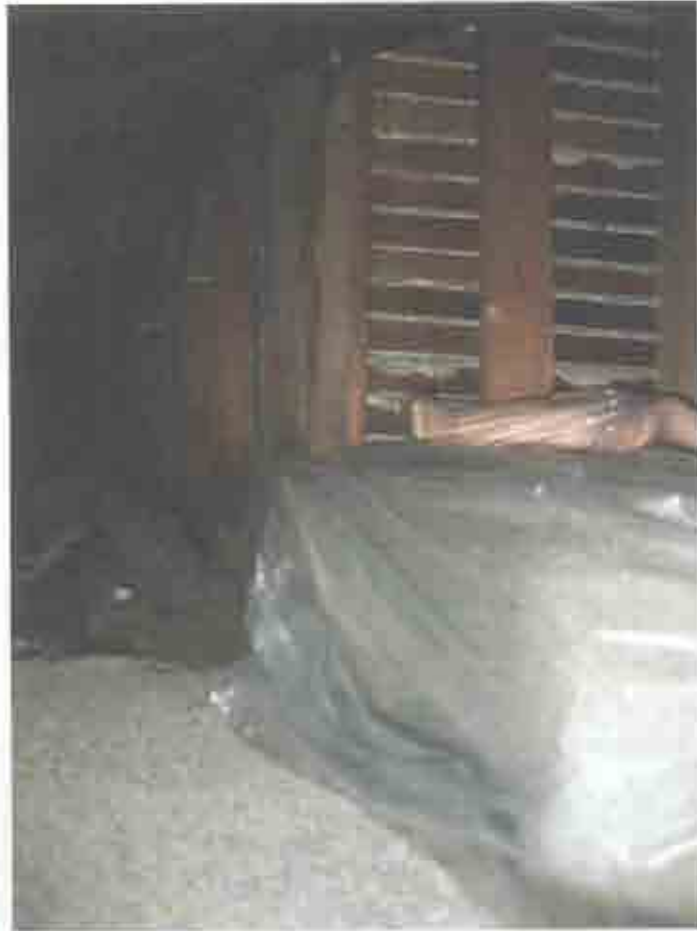
The west wall is formed by the back sides of the dormer in room 309 and that room's closet (309a). It can be seen that the frame partitions of the dormer and the closet walls consist entirely of sawn lumber and sawn wood lath, indicating a later period of construction than the knee walls, probably dating to the Wilcox occupancy. (See Figure 2.71.)

Figure 2.71. Room 308a, looking west toward dormer cheek wall.

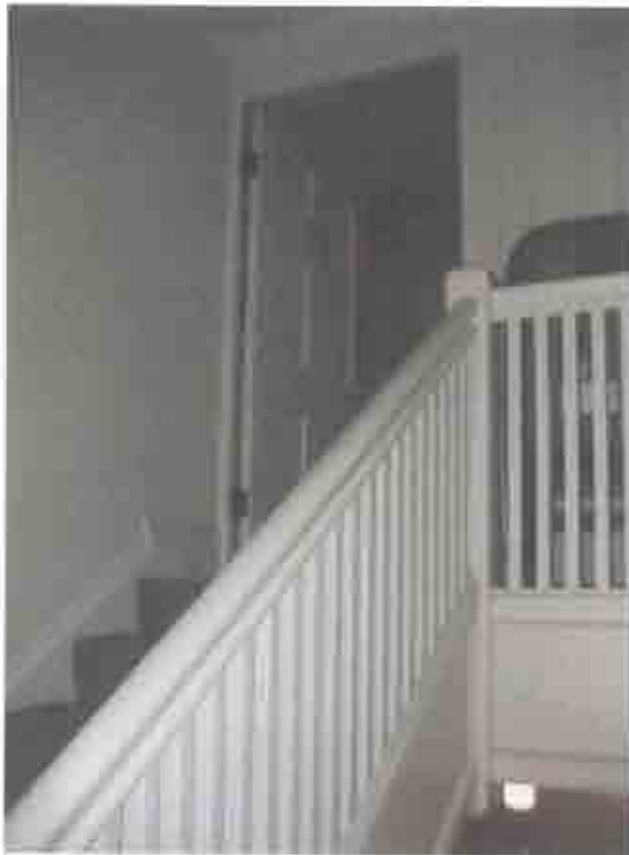
The east and west walls are 1896 frame partitions with lath and plaster finish. There are 8- inch- high molded baseboards on the east wall, and 9 ½- inch- high baseboards with a more complex molded profile on the west wall descending to the second story. No attempt was made to align and miter the sloped baseboard on the staircase with the level baseboard on the landings. This fact underscores the room's utilitarian character. (See Figures 2.72 and 2.73.)

Figure 2.72. Room 301
(North Staircase).

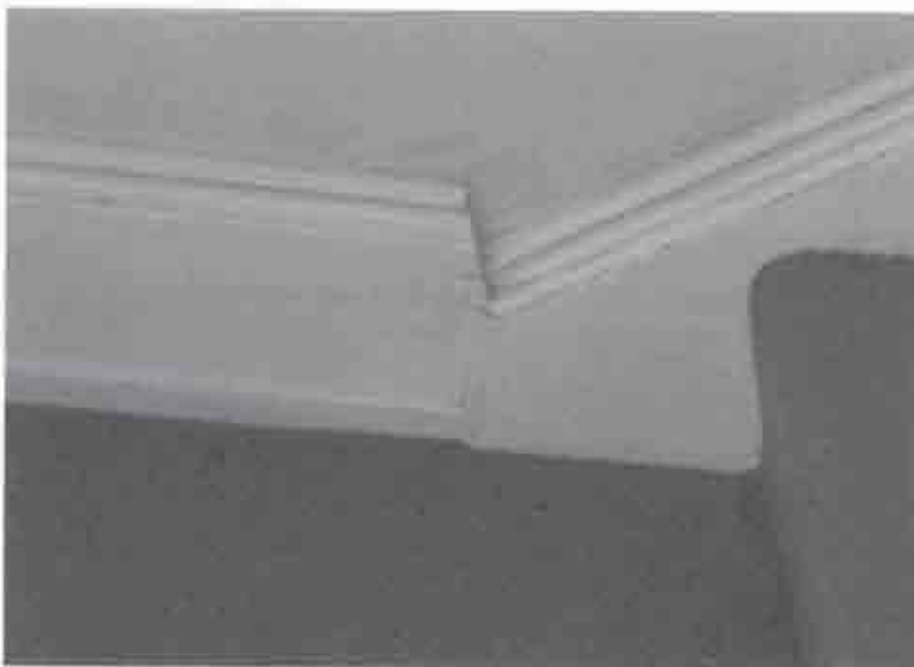
The inside stair stringer is raised above the tread nosings, and supports the balusters and handrail. The balustrade consists of newel posts 4 ¾ inches square at each landing, with a molded hand rail measuring 3 ¾ inches spanning between the newels. Balusters are 1¾ inches square and 3 inches on center. (See Figure 2.73.)

Figure 2.73. Room 301 (North Staircase), baseboard.

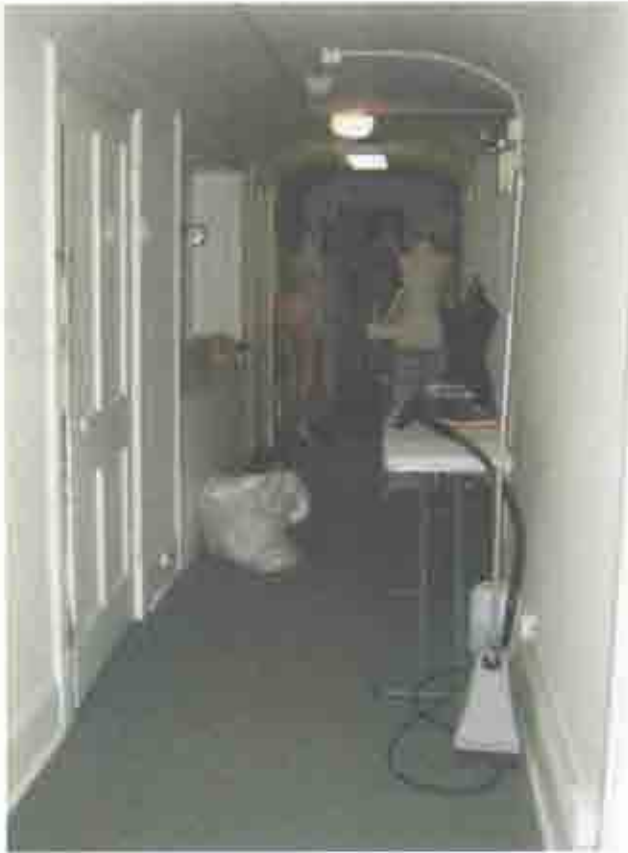
Room 302 is shown on the 1896 architectural drawings, and it remains as originally designed. (See Figure 2.74.)

Figure 2.74.
Room 302 (Hall).

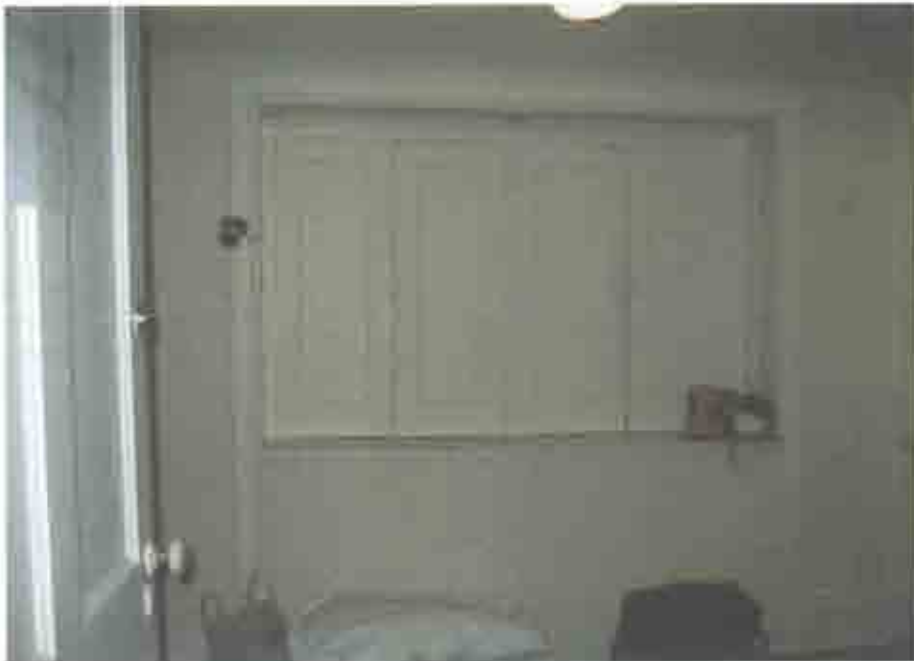
Opposite the staircase is a linen closet recessed into the south wall. (See Figure 2.75.) This closet consists of two compartments, each enclosed by a pair of paneled wood doors and lined with double- beaded cedar boards 5 inches wide. There are two wood shelves in each compartment. Below the doors is a plywood panel, where drawers were probably originally located. (See the description of the built- in cabinet in room 306.).

Figure 2.75. Room 302 (Hall), south- wall linen closet.

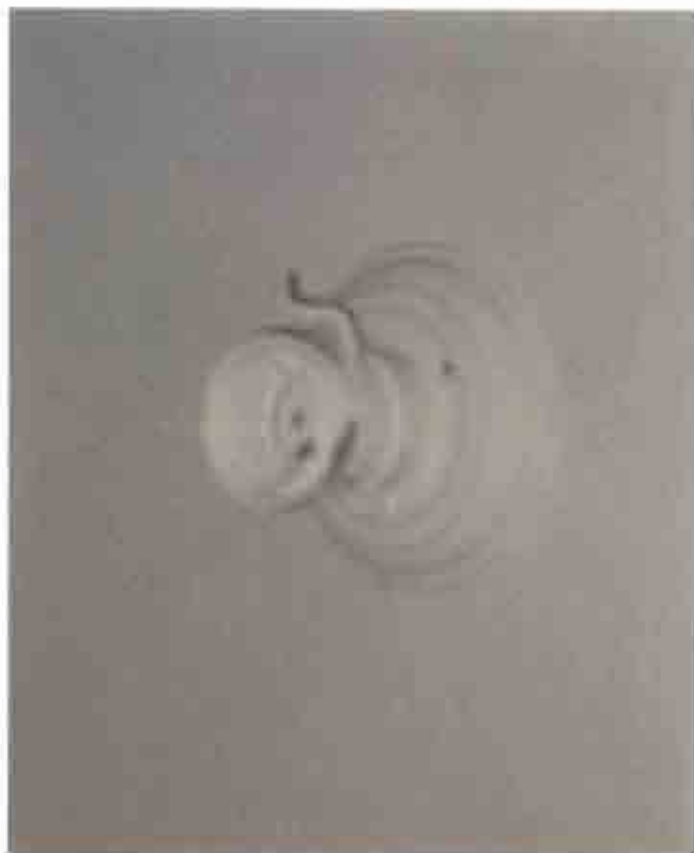
At the east end of the south wall is a speaking tube and spun- metal whistle piece. (See Figure 2.76.) According to the 1896 specifications, speaking- tube communication was provided between the first- story Kitchen and the third- story servants' hall. The whistle piece has been crushed by the swing of the door to room 305. A turned wood doorstop is mounted on the baseboard below, and was probably added after the damage. (See Figure 2.77.) It is identical to the doorstop at the doorway to the North Staircase (room 301).

Figure 2.76. Room 302 (Hall), wall-mounted speaking-tube fixture.

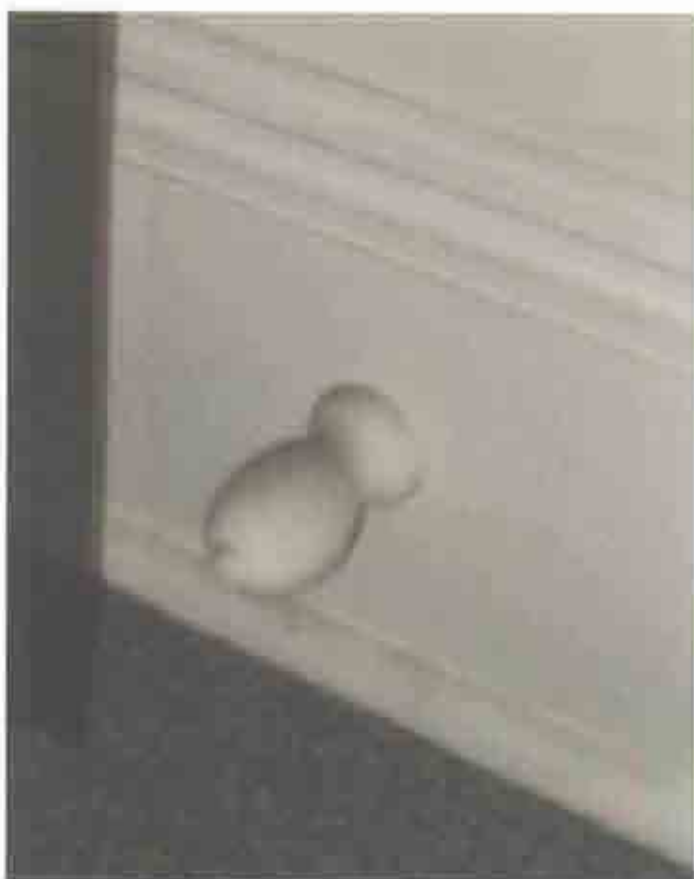
Figure 2.77. Room 302 (Hall), doorstop below speaking-tube fixture.

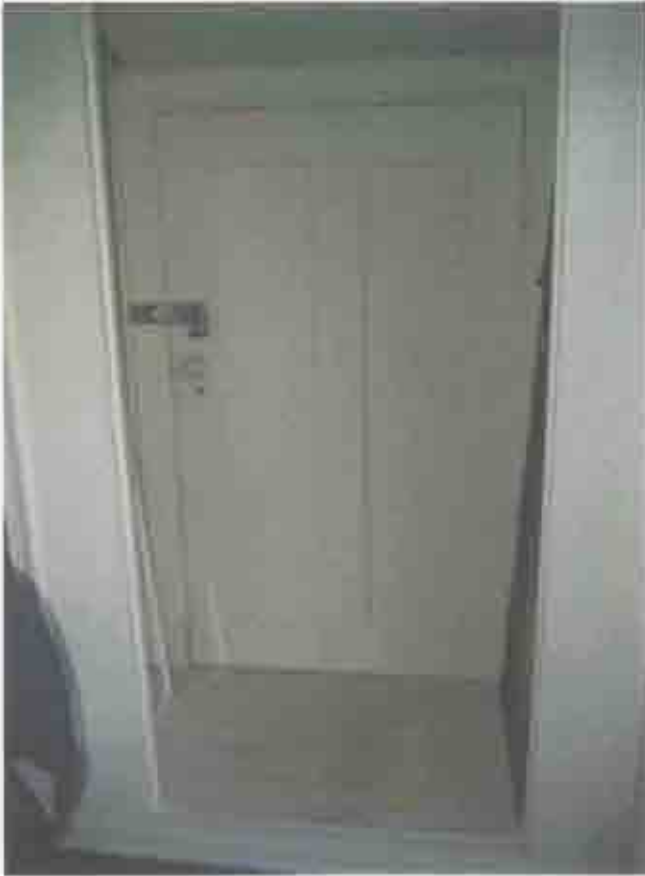
Doorway and window casings are plain boards with mitered corners and molded edges; doorway casings also have plinth blocks. The door to room 305a is a two- panel wood door situated at the back of the northeast closet. (See Figure 2.78.) The door to room 305b is a plywood panel; the doorway's casing is missing.

Figure 2.78. Room 305, northeast closet containing doorway to room 305a.

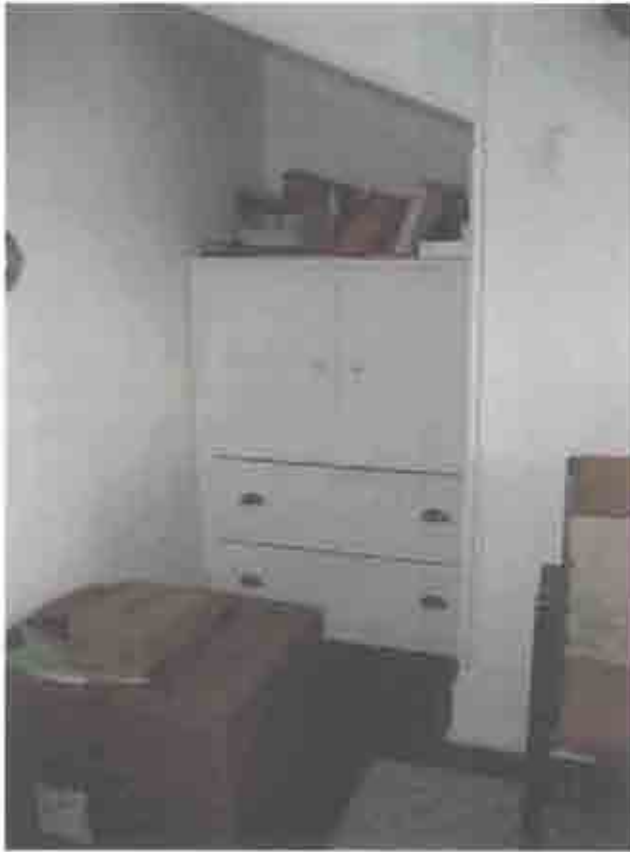
In the northeast corner of the room (anteroom) there is a recess containing a built- in wood cabinet. The edges of this recess are covered by wood corner guards with ornamental turnings. The cabinet front consists of a pair of flush doors and two drawers with metal pulls. The pair of doors probably replaced two additional drawers. To the right of the cabinet (also in the anteroom space) is an oval wall bracket for a light fixture. (See Figures 2.80 and 2.81.)

Figure 2.80. Room 306, recess with built-in wood cabinet.

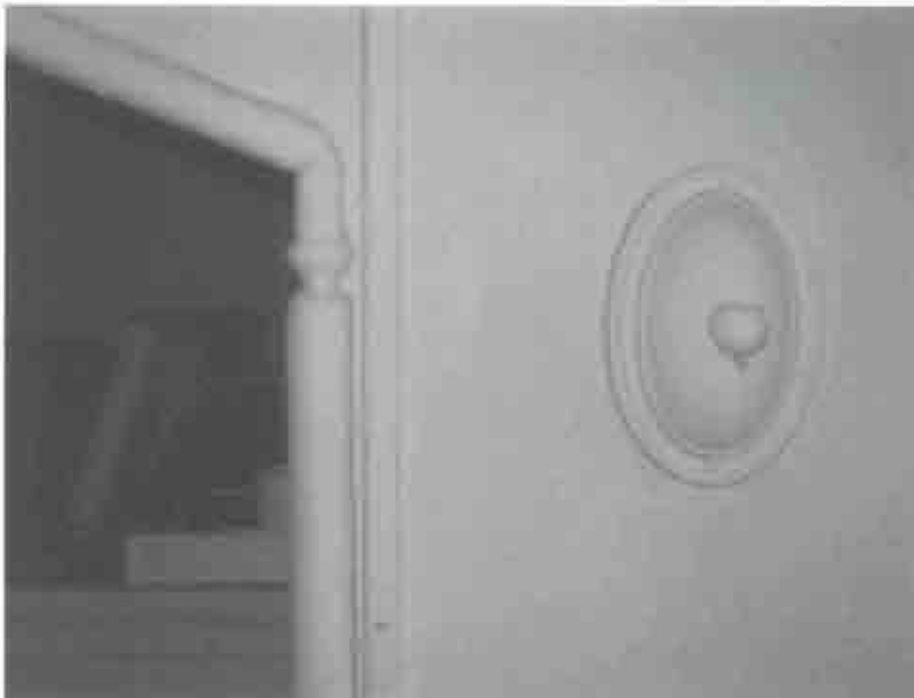
Figure 2.81. Room 306, wood corner guard on edge of recess, and remnant of light fixture.

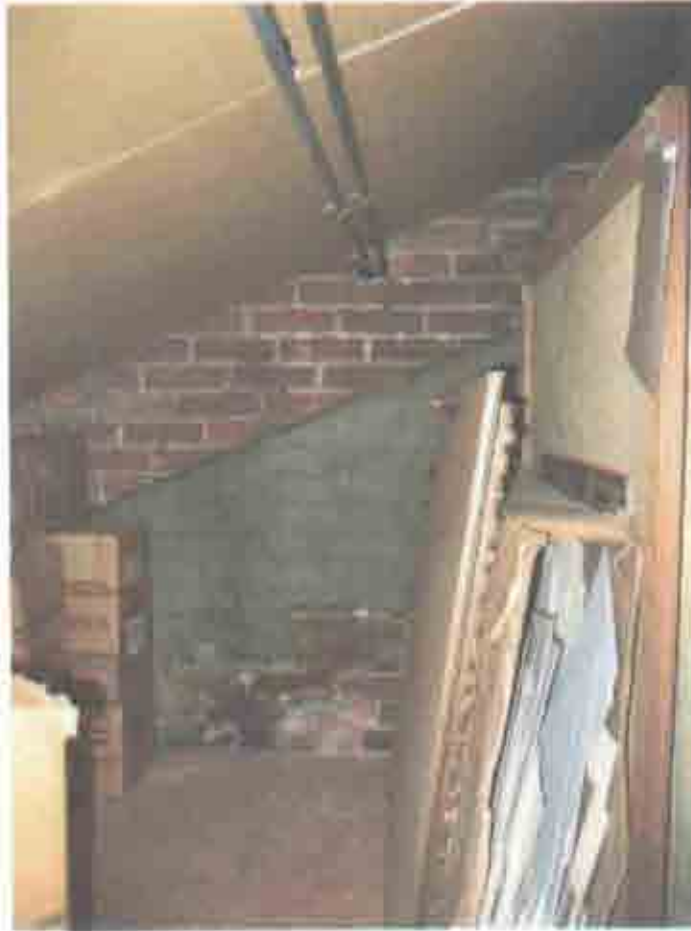
The north and east walls are unfinished frame partitions, revealing the back side of the sawn wood lath and plaster finishes in rooms 302, 302b, and 306. The west wall is the original brick gable end wall. On this wall, remnants of the stepped flashing for the roof of the 1864- 1865 addition survive. Above the flashing are multiple paint coatings that extend up to the line of the former wood frieze, now removed. (See Figure 2.82). The south wall is the 1896 brick gable end wall, which holds an ornamentally leaded lunette window. The arch of this window is formed by two rows of brick headers. The boiler room chimney passes through this room to the roof.

Figure 2.82. Room 307, looking west toward original brick gable end wall, showing roof line of 1864- 1865 addition and paint evidence.
