historic structure report

U.S.S. CAIRO

U.S.S. CAIRO
VICKSBURG NATIONAL MILITARY PARK
VICKSBURG, MISSISSIPPI

United States Department of the Interior
National Park Service
Denver Service Center

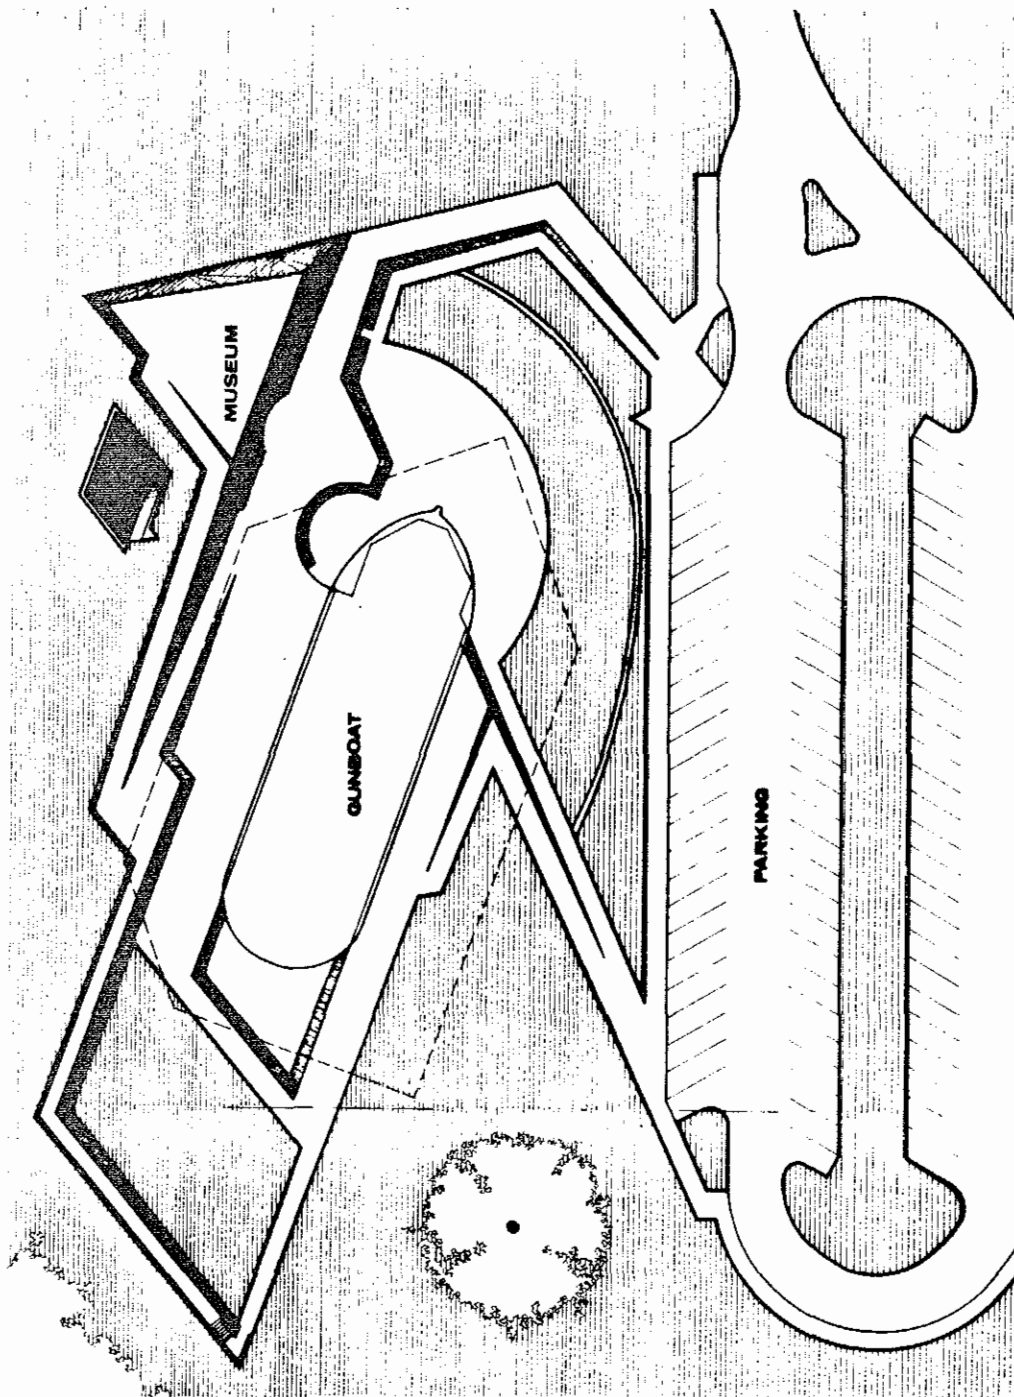
Figure 7: Site plan of the Cairo complex, showing the dry berth, museum, parking, access, and viewing ramps.

The overall site for the Cairo complex is described in the Administrative Data Section. A description of the display of the restored gunboat and companion structures follows (see figure 7).

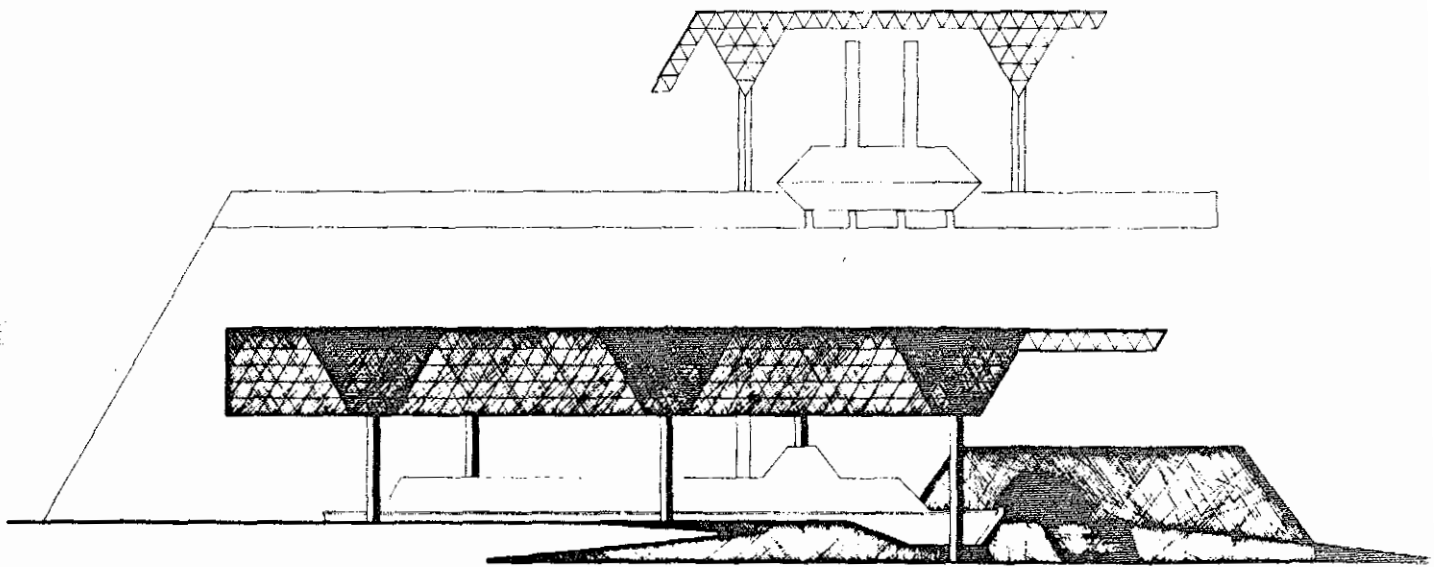
A 245' x 130' five-column shelter to protect the Cairo from further weathering damage was completed in 1980 (figure 8). It includes skylights, roof drainage, and lighting in its construction. The shelter design supplements the angular site scene and protects the boat without impairing views of the craft from the immediate area (figure 8).

The steel cover is allowing the Cairo timbers to achieve an air-dry condition that should inhibit further decay. Chemical preservation treatment will supplement the protective benefits of the cover by providing long-term insecticide, shrinkage protection, and water repellancy for the wooden portions of the Cairo hull. Similar cover structures successfully protect the remains of three other Civil War

Figure 8: Section and west side elevation of the Cairo space frame cover. The entrance to the museum is on the lower right.

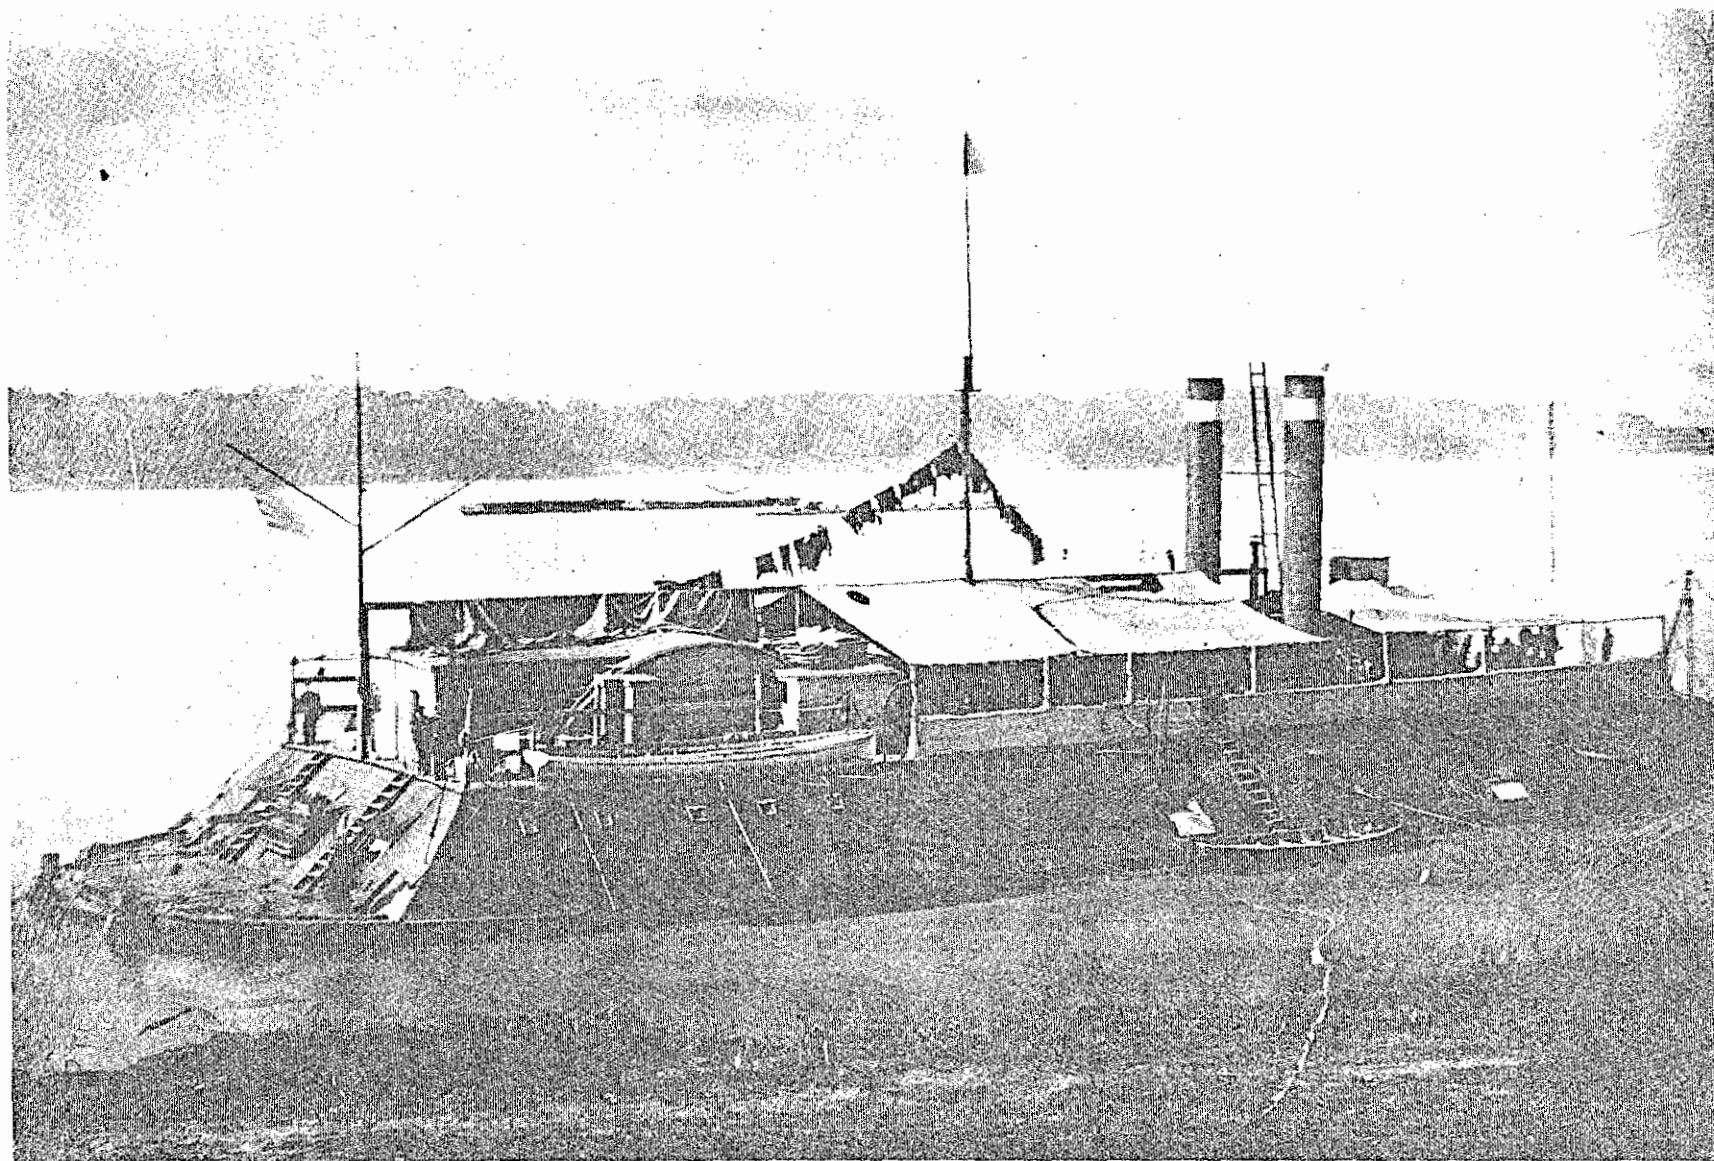
Figure 9: The U.S.S. Cincinnati, a sister ship to the Cairo, which was sunk by a Confederate ram at Plum Point. National Archives photo.

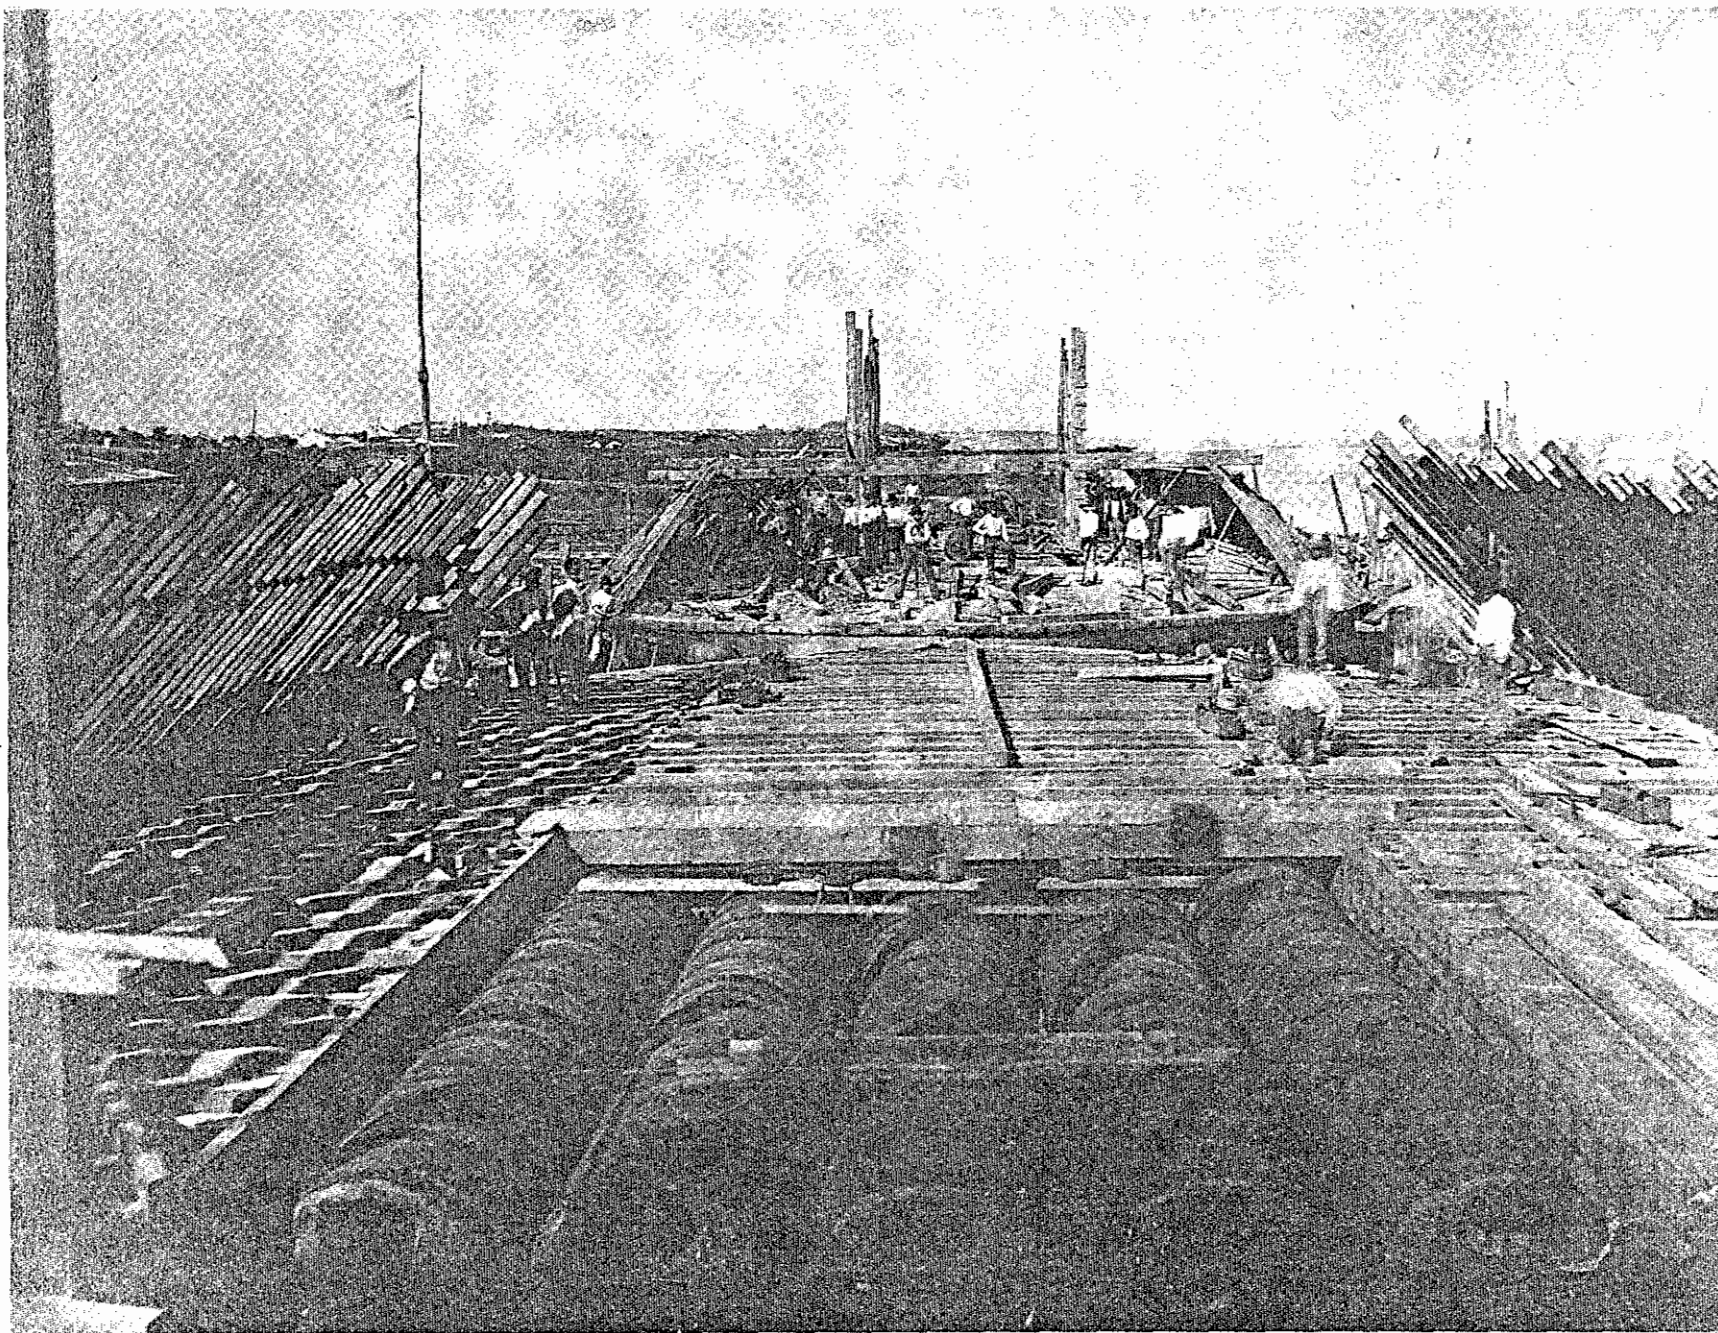
Figure 10: Gunboats under construction, built bow to bow. The five boilers are in place on the vessel in the foreground. National Archives photo.

Figure 11: Two City Class gunboats on the shipways at the yard in Carondelet, Missouri. National Archives photo.

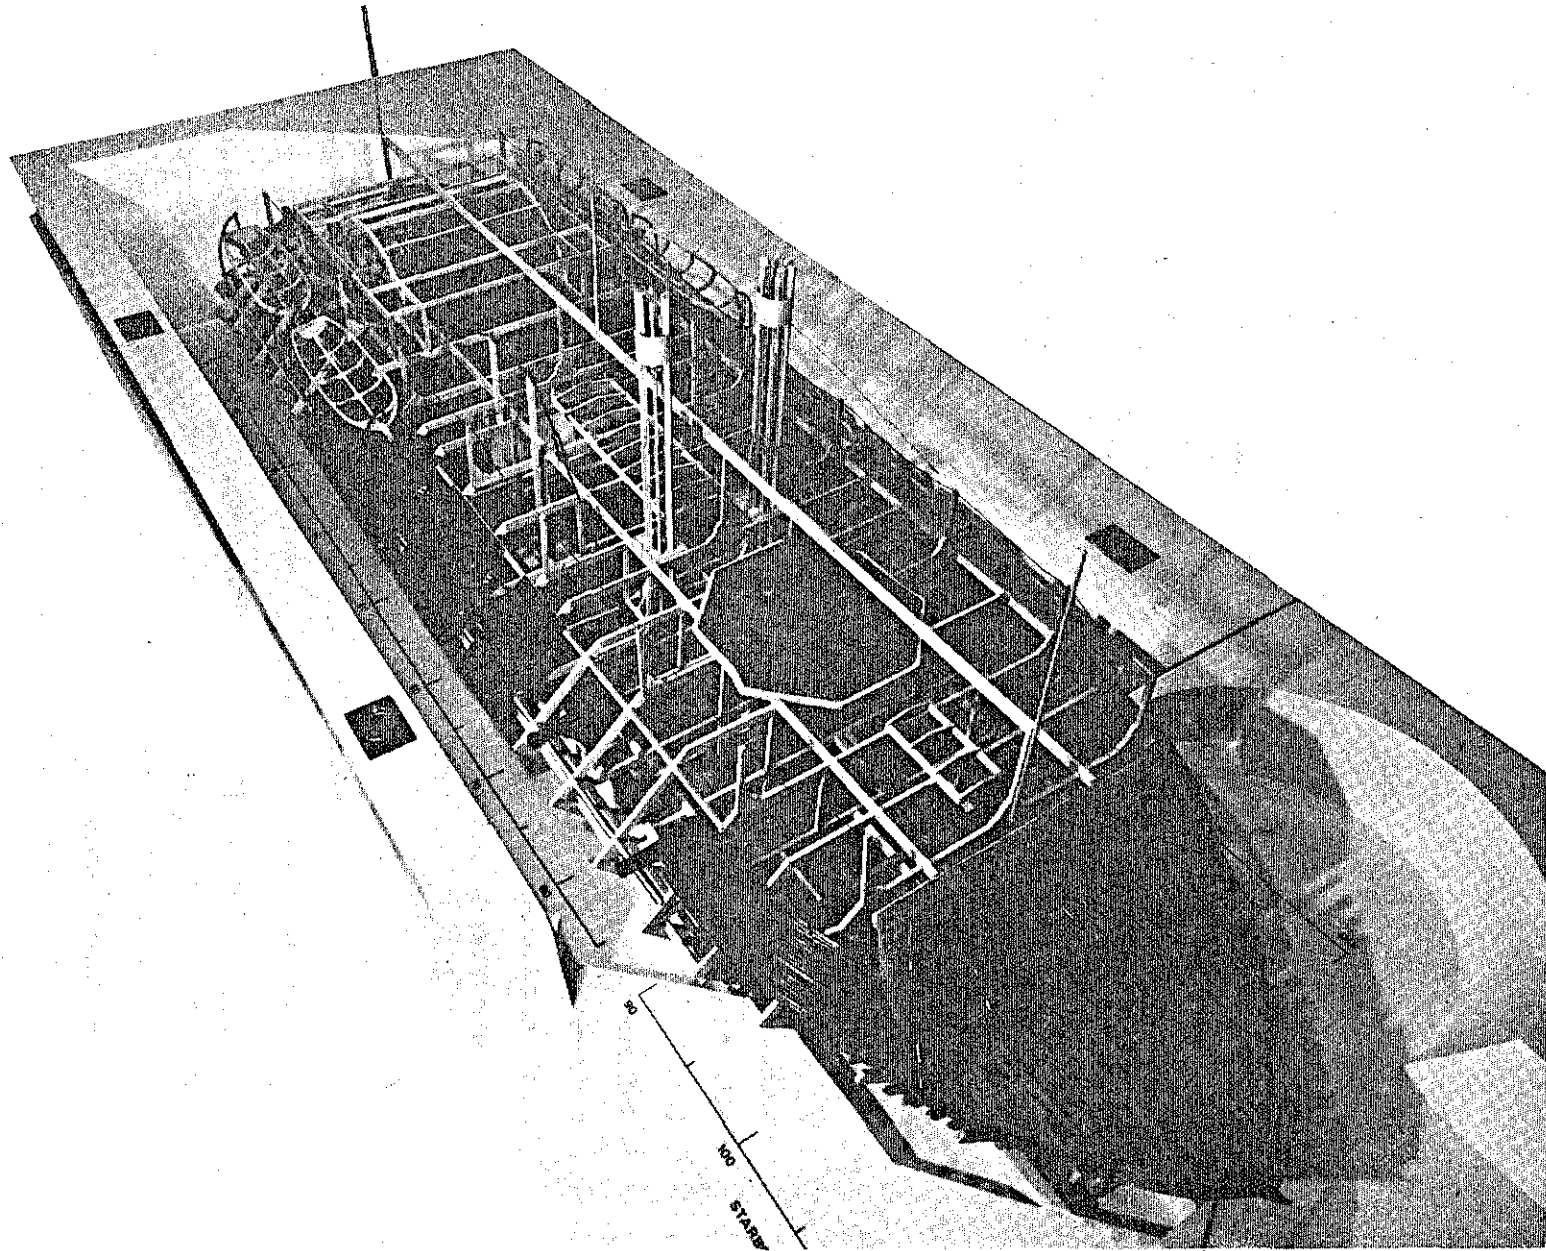
Figure 12: The Cairo research model, placed within a scaled model of the dry berth, provides a view of the completed gunboat restoration plan. NPS photo by Les Siroky.

Figure 13: The scale torpedo (mine) blast hole in the port bow is evident in this photo of the model. Modelmaking was helpful in solving the oft-conflicting requirements of engineering, interpretive, and preservation problems that faced the architects. NPS photo by Les Siroky.

The proposed new structural support system is designed to both support all the Cairo historic fabric remains in their proper places and visually link the various surviving components together by ghosting the outline and form of the missing gunboat sections (figure 12). Ghosting will unify and define the existing disjunct image that the Cairo fabric now conveys. Totally missing parts of the boat such as the hurricane deck, after casemates, stacks, ship's boats, and wheelhouse will be outlined in framework form by the ghosting of alternative E.

Clean detailing of the new structural system connections and locating the new support members in positions approximate to the original ironclad's construction will enhance the display without overwhelming the historic fabric (figure 13).

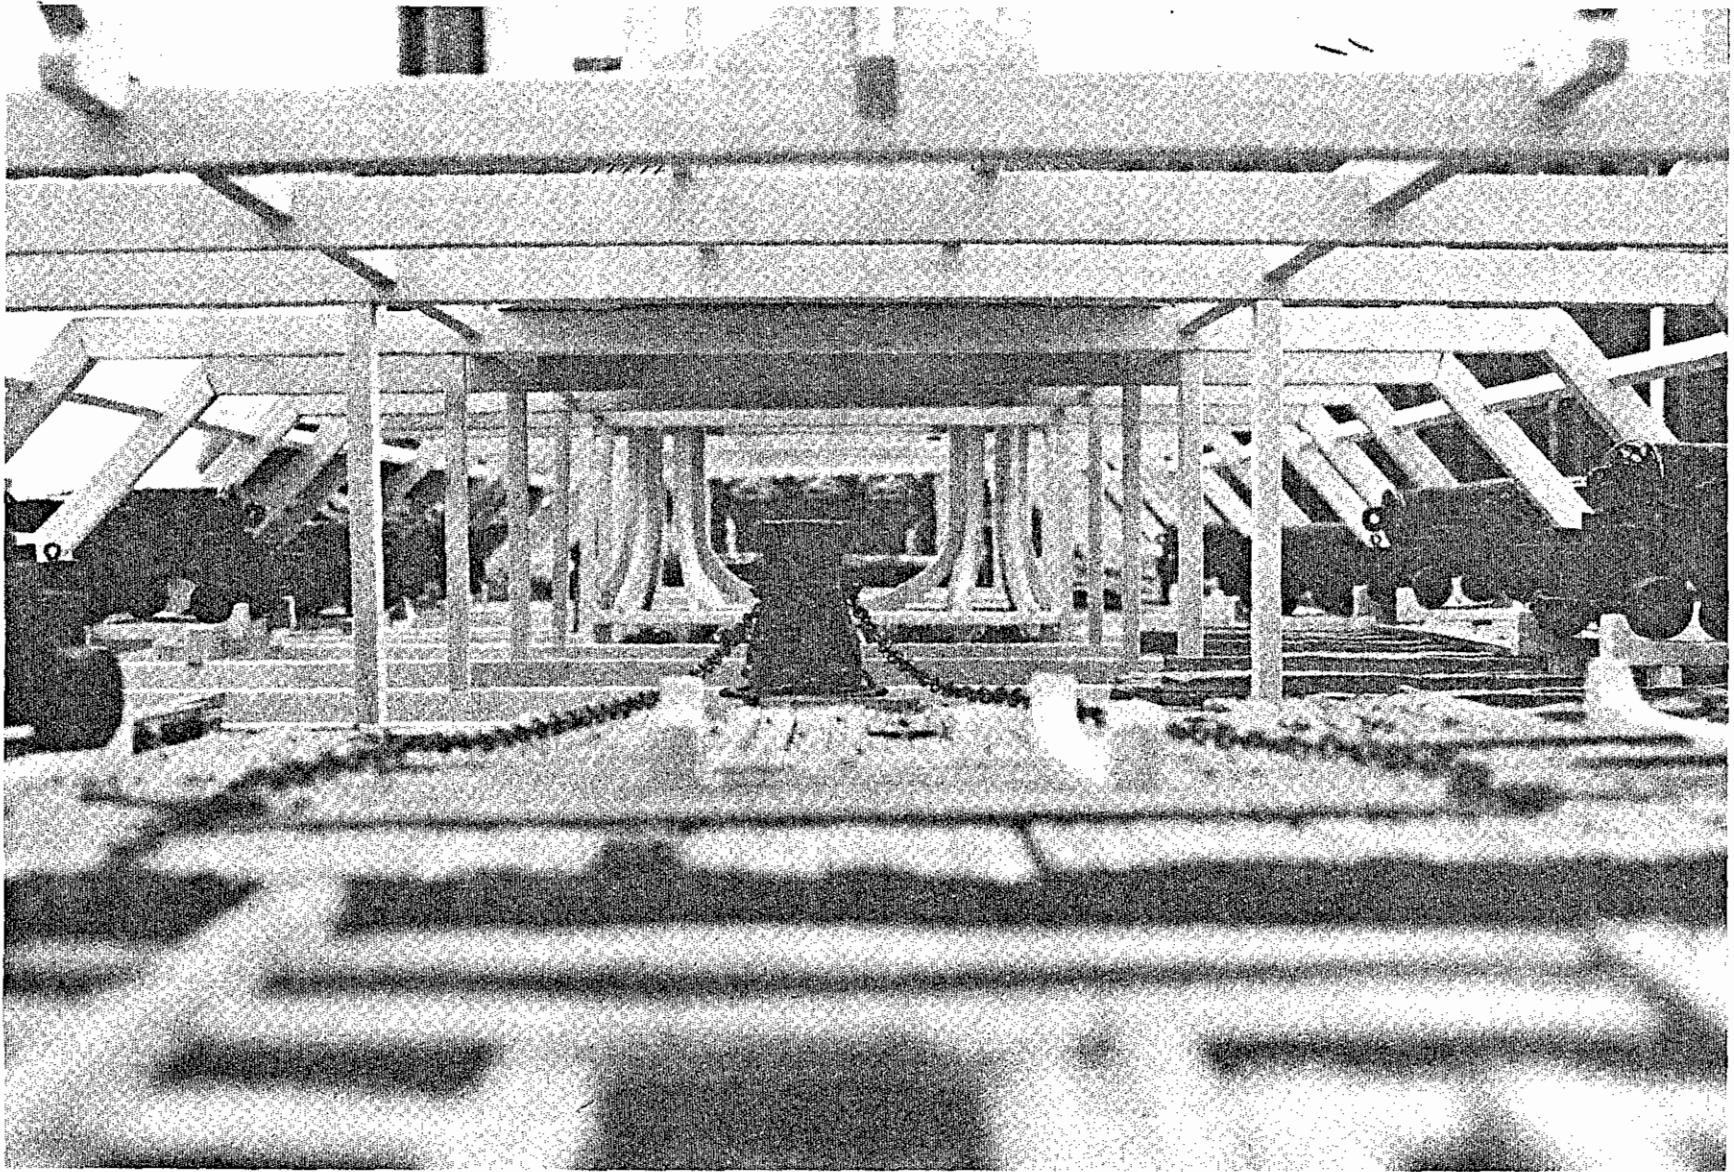
Figure 14: Interior view of the Cairo model, looking aft, simulates the eventual visitor's perspective. NPS photo by Doulgas Ashley.

Alternative E also proposes a visitor access ramp or "bridge" across the Cairo at approximately midships (figures 14 & 15). This midships bridge, spanning the berth, will allow views of the propulsion system, armament, and interior spaces from an "onboard" position.

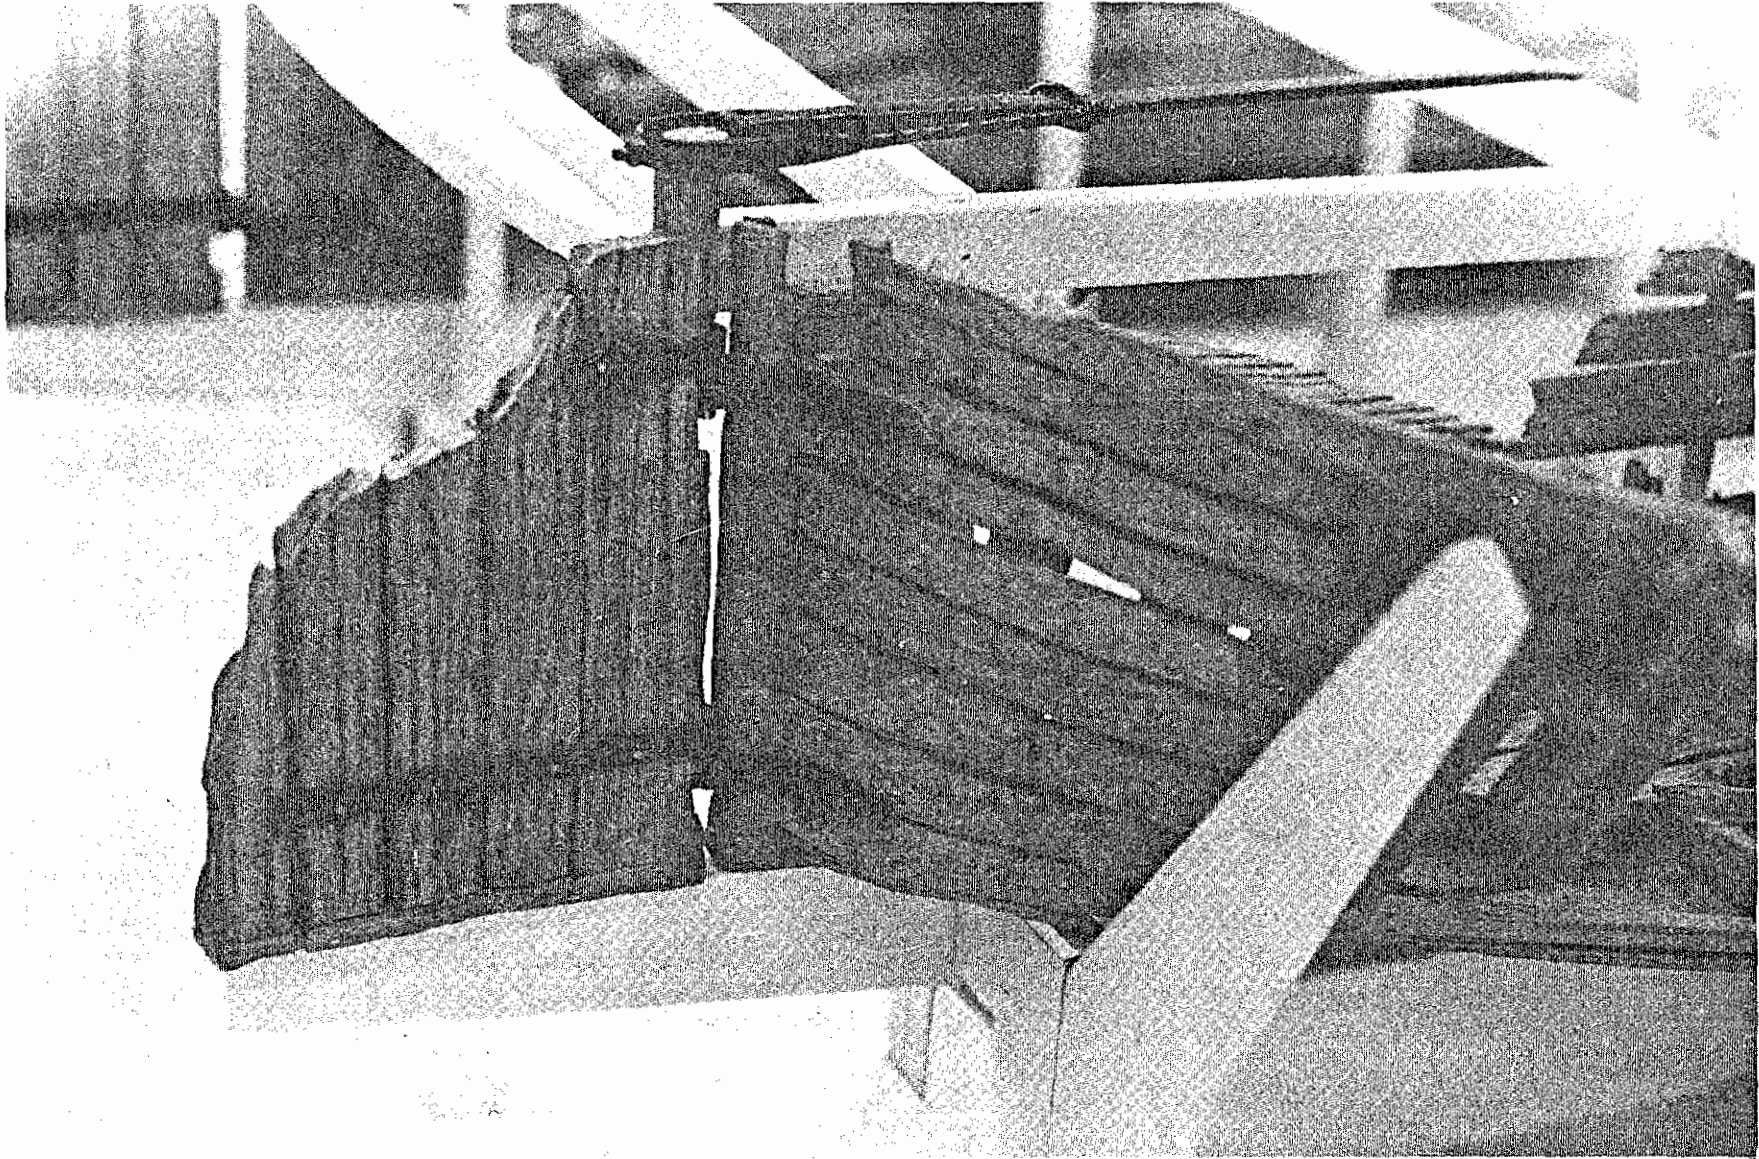
Figure 15: Detail of the modeled sternpost section and rudder, supported by the scaled version of the specially designed glue-laminated structure. NPS photo by Douglas Ashley.
