CULTURAL LANDSCAPE REPORT FOR PARK HEADQUARTERS

DENALI NATIONAL PARK & PRESERVE

SITE HISTORY, EXISTING CONDITIONS, ANALYSIS & TREATMENT

NATIONAL PARK SERVICE, BOSTON, MASSACHUSETTS, 2008

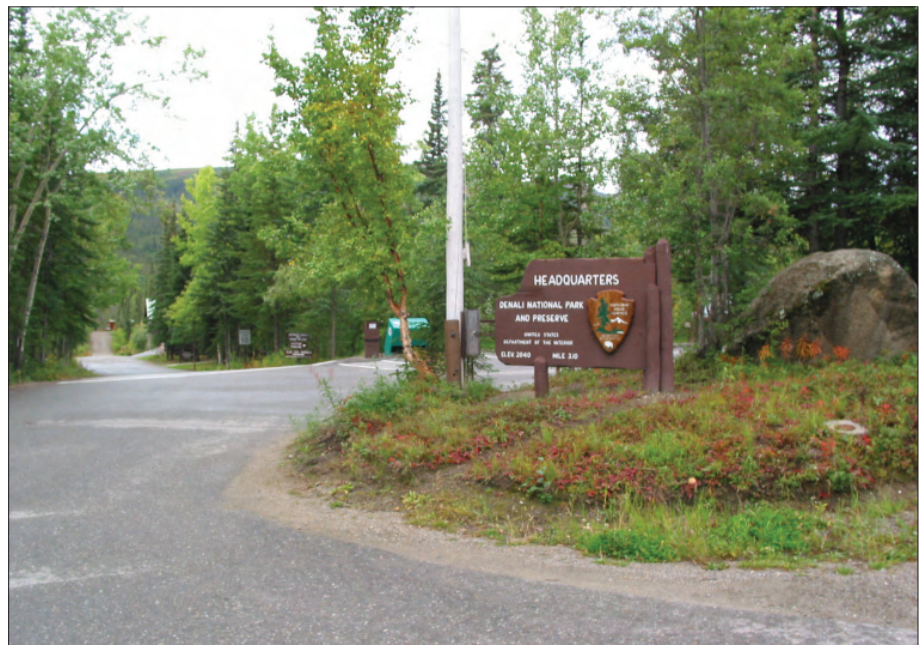
Figure 4.2. Preserving Headquarters Entrance Area Character - The preservation of this historic entrance to park headquarters is critical to the successful rehabilitation of the landscape. Designed in the 1920s to mark the park headquarters as the symbolic "seat of order and authority... and as an "instrument of control" in a remote wilderness, the entrance is the site of component features including a vegetated traffic island, flagpole, park sign, and boulder that are consistent with the scale and rustic character of the Denali Park Headquarters National Historic District (OCLP, 2006).

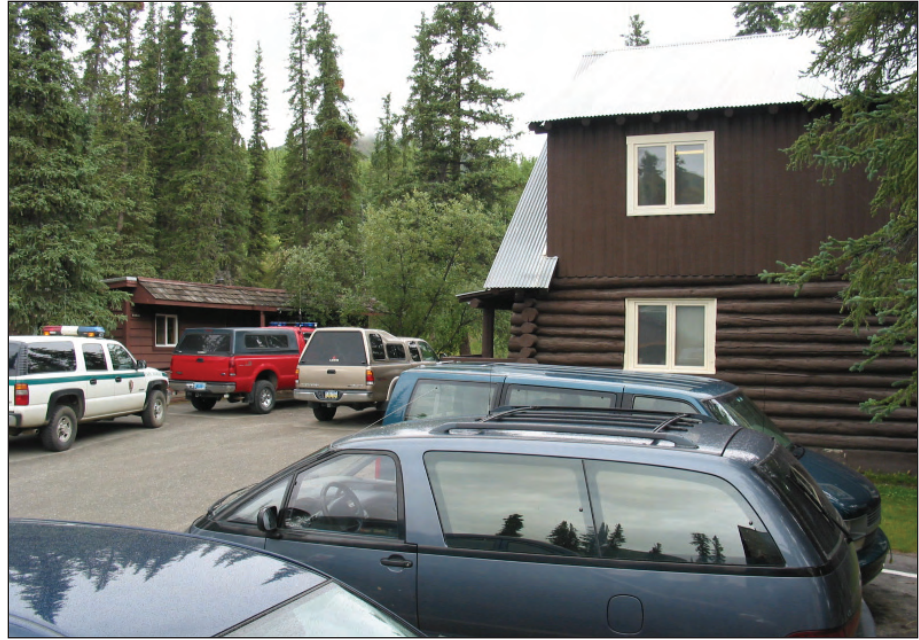
Figure 4.3. Preserving Headquarters Core Area Character - Relocating parking out of the center, toward the perimeter of the historic district is fundamental to the overall rehabilitation of the historic landscape. Following the end of World War II, the landscape at the center of the cluster of rustic buildings in the park headquarters was paved with bituminous concrete in order to provide additional parking (OCLP, 2006).

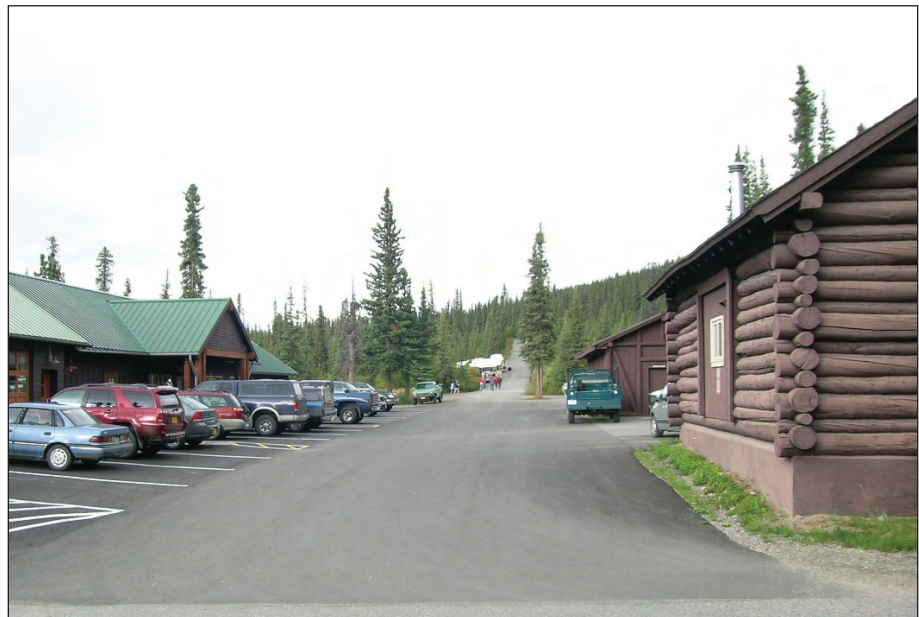
Figure 4.4. Preserving Service Area Character - Vehicular access to the historic service court will be limited by the installation of removable barriers, in order to eliminate through-traffic from the center of the historic district. This paved area will also be given a chip-seal surface treatment to better simulate the rustic gravel surface present during the pre-WWII period of significance (OCLP, 2006).

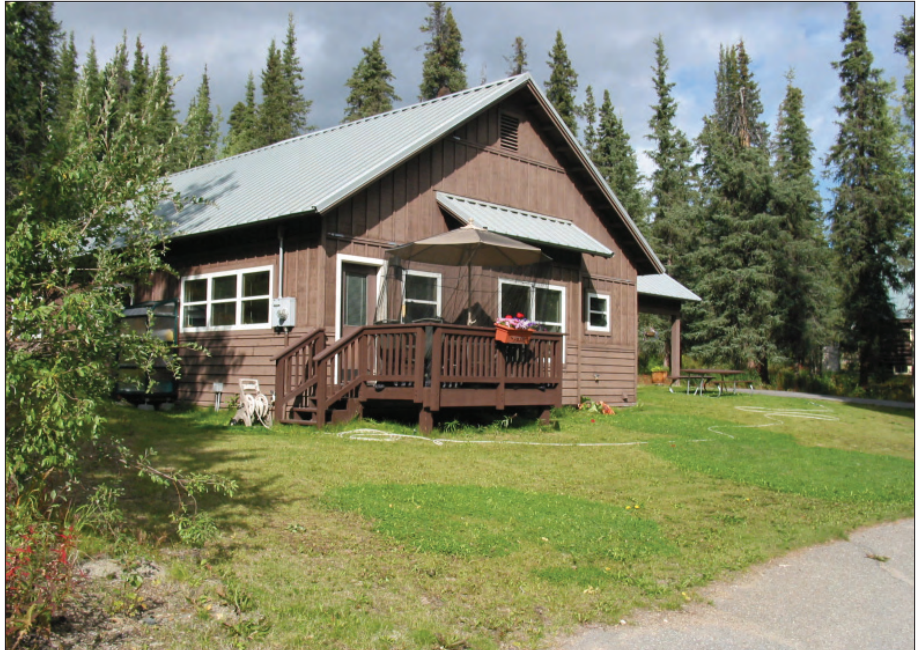
Figure 4.5. Preserving Residential Area Character - A narrow buffer strip of native vegetation is recommended where the lawns of residences in the headquarters district meet the adjacent roadway. This strip of native vegetation may be encouraged by mowing or cutting the vegetation within the strip only at the end of each growing season (OCLP, 2006).

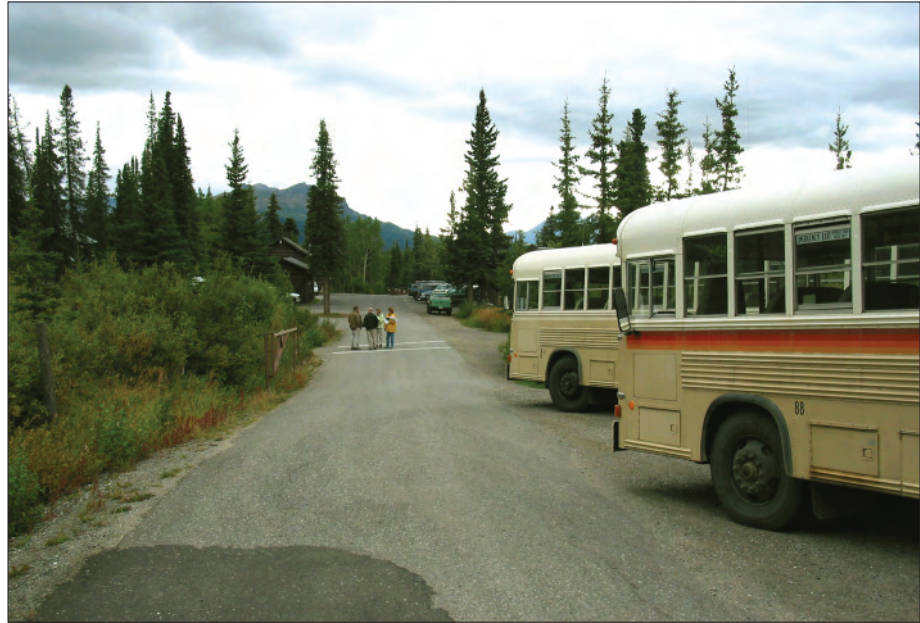
Figure 4.7. Rehabilitating Sled Dog Demonstration Area - A new bus loop improving service to those with mobility issues, is proposed for the sled dog demonstration area. This measure will also facilitate the elimination of shuttle bus through traffic from the center of the historic district. Bus passengers, a disproportionate number of whom are elderly, currently disembark for the popular sled dog demonstration on the steep and uneven footing of the gravel road shoulder (OCLP, 2006).

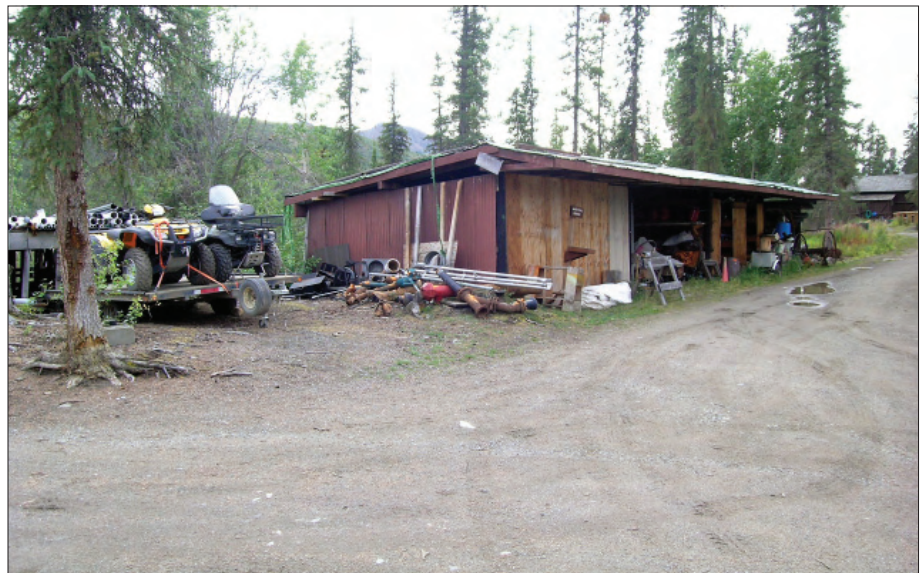
Historically, the headquarters entry road terminated at its southern end with a tree-filled wagon-turn providing access to the headquarters area dump. This area is within the Historic District. Extending east, outside of the district is a small unpaved road leading to a large level area about 70 by 80 feet in size that is currently used for materials storage of bulk materials. The park may choose to develop the materials storage site in the future to meet new requirements. Perched on the southeastern corner of the headquarters area, this natural bench or terrace would be an excellent site for a structure, parking area, or campsite. The area is currently used for storage of wood and composting. Just to the west of this area is the boundary for the Historic District. The abandoned wagon-turn overlooking the former headquarters area dump is an important design terminus of the headquarters entry drive or “Main Street.” Although the area has long been used for materials storage, this area should be considered as an important node in a walking tour of the Headquarters Historic District, and although the area was historically used as a dumping ground, some housekeeping and clean-up appears to be well-justified. Any development of the site at the Southeast corner of the headquarters area should be visually compatible with this terminus of the Headquarters Road (Figure 4.8).

Figure 4.8. Enhancing Historic Character of Headquarters Road Terminus - Although the terminus of the central Headquarters Road has long been used for materials storage. Clean-up and improvement of storage facilities in this area appears well justified (OCLP, 2006).

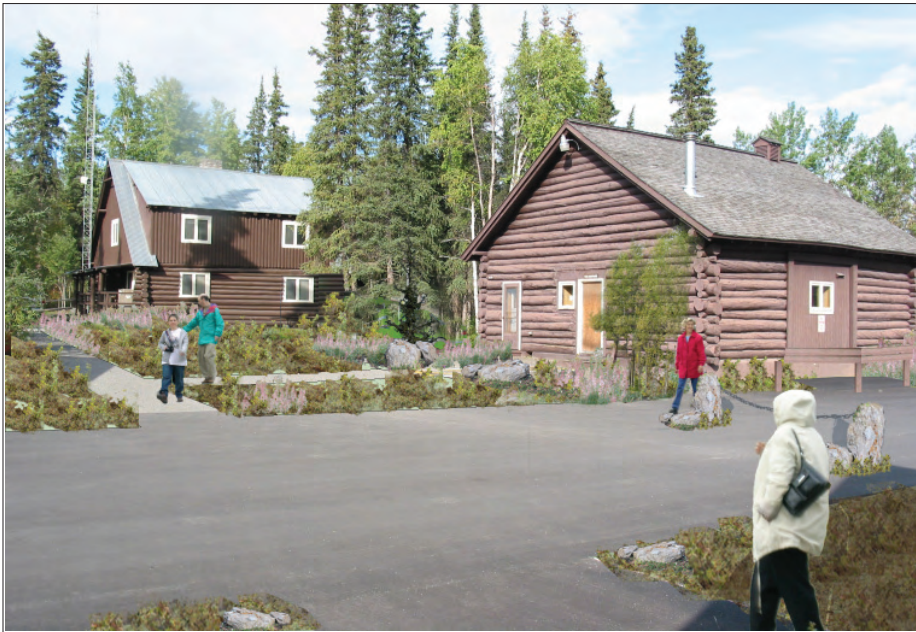
Figure 4.9. Circulation and Parking - Eliminate central parking and through-traffic - Treatment Tasks 1.A and 1.C - Remove bituminous pavement proliferating at the center of the district after WWII. Existing conditions shown above detract greatly from the historic character of the property (OCLP, 2006).

- A. **Remove** bituminous pavement proliferating at the center of the district after WWII, and replace formerly paved surfaces with native vegetation (Figures 4.9 and 4.10).

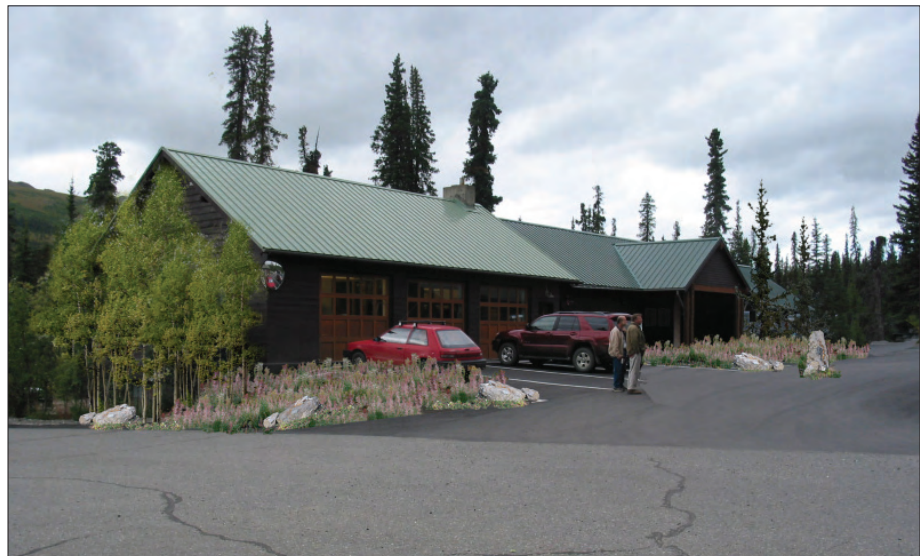
Figure 4.15. Circulation and Parking - Eliminate central parking and through-traffic. Treatment Tasks 1.A and 1.C - Eliminate parking and through-traffic from the center of the historic district; install traffic control measures. Existing conditions shown above include an abundance of bituminous concrete installed after 1945 to facilitate staff parking. These conditions detract greatly from the historic character of the property (OCLP, 2006).

- C. **Install** traffic control measures, optionally consisting of removable bollards, or rustic boulder/chain gates, or rustic timber cross-buck stanchion, in order to eliminate all but emergency vehicles from the center of the historic headquarters district. Installing these barriers as recommended will render the center of the historic district as a pedestrian zone, making it practical for visitors to visit and tour this cluster of historic rustic buildings on foot, and minimize requirements for snowplowing and sanding which have contributed to the degradation to roadside vegetation (Figures 4.11 through 4.16).

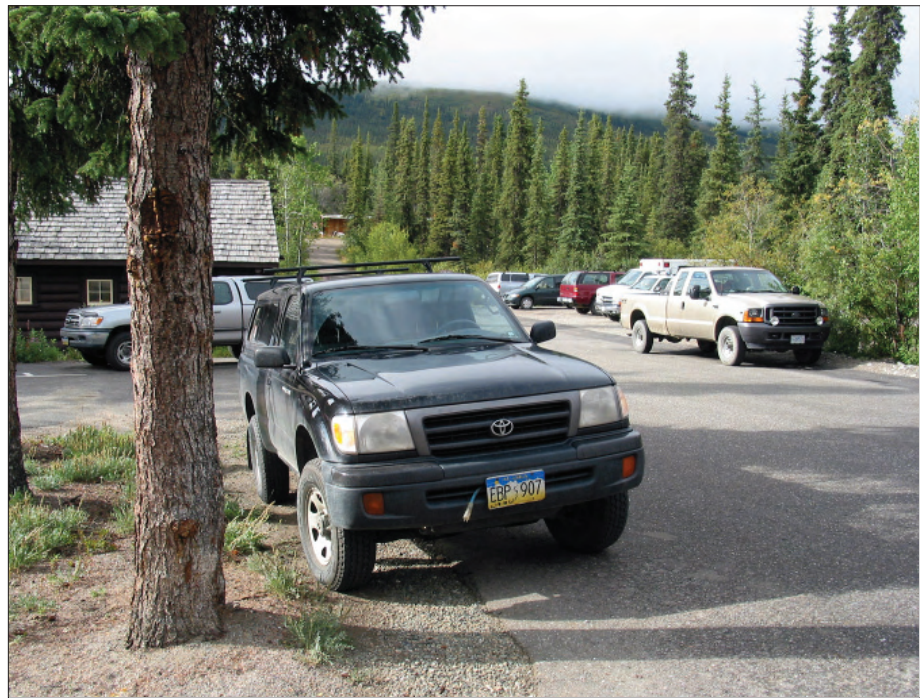
Figure 4.19. Circulation and Parking - Enhance Roadside Character and Vegetation - Treatment Task 2B - Protect roadside trees and vegetation by installing limited numbers of non-historic boulder barriers. Unrestricted roadside parking within the Denali Park Headquarters District is the cause of soil compaction and mechanical damage to roadside vegetation (OCLP, 2006).

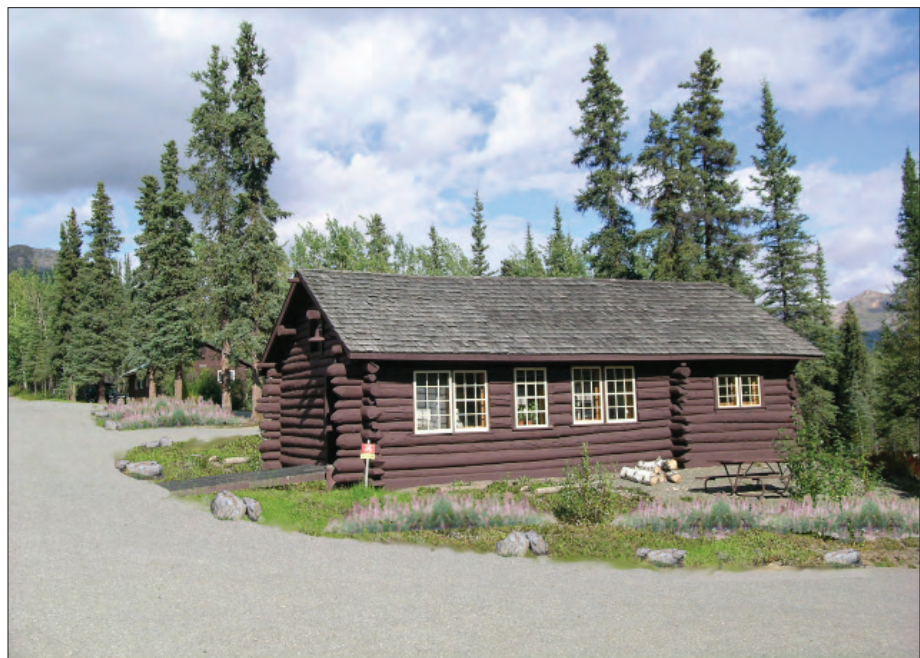
Figure 4.22. Circulation and Parking - Enhance Roadside Character and Vegetation - Treatment Tasks 2.B, 2.C and 2.D - The piecemeal widening of roadways and paved surfaces as illustrated by this photograph, have encroached on the setting of historic log buildings and compromises the historic character of the Denali Park Headquarters District (OCLP, 2006).

D. **Resurface** the drainage swale at the west façade of Bldg. 106 (The Barn) to replacing bituminous pavement in the swale with stone rubble pavement (Figures 4.22 and 4.23).
