TUGBOAT *HERCULES*

Historic Structure Report

San Francisco Maritime National Historical Park

Prepared by
Tri-Coastal Marine, Inc.
200 Burrows Street
San Francisco, California 94134

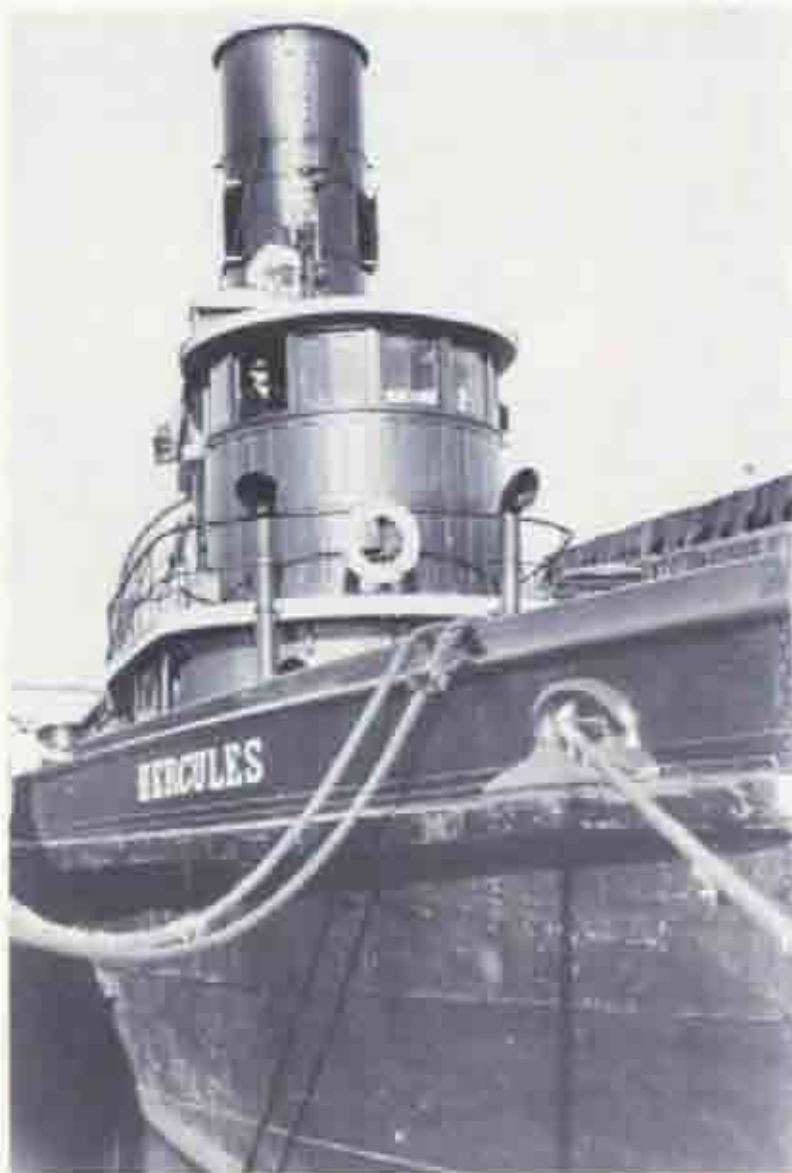
Fig. 11. The first attempt at a doghouse, or raised viewing position, can be seen just above the pilothouse top, on the starboard side.

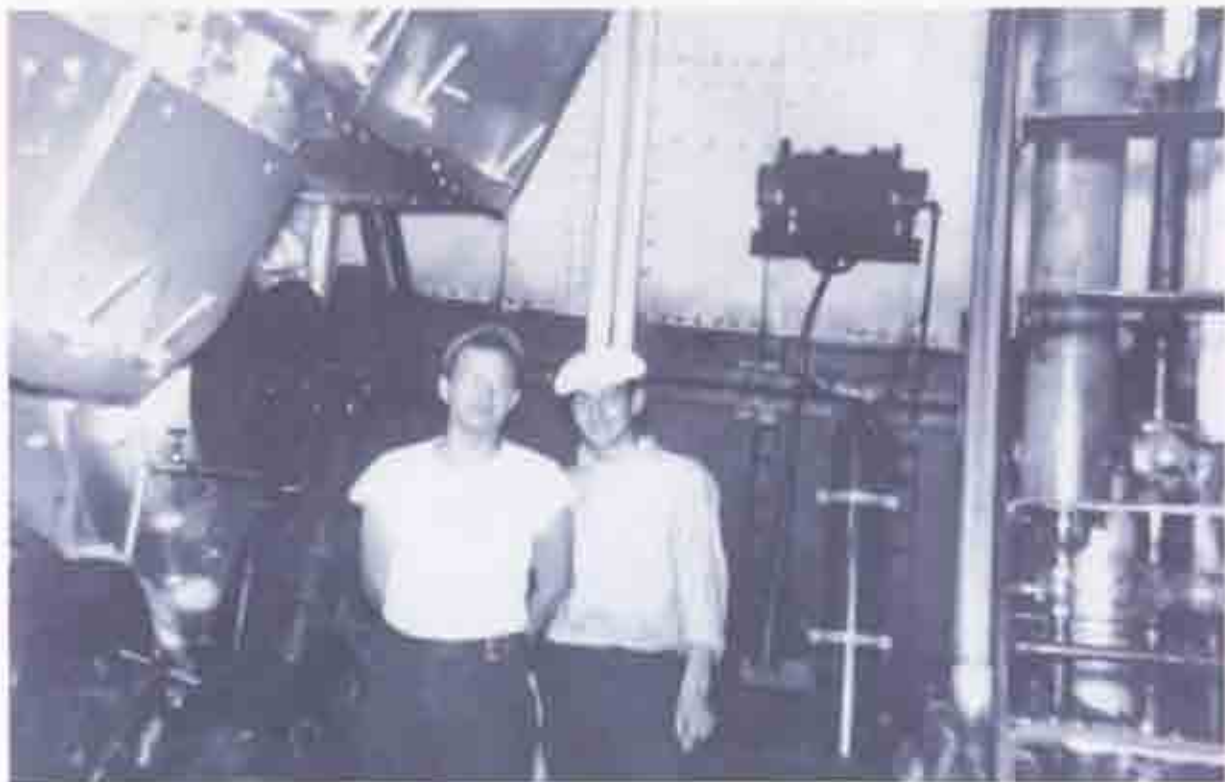
Fig. 16. Boiler room, ca. 1954-1961. Note absence of donkey boiler.

HERCULES was originally equipped with a steam donkey boiler, a small boiler used to provide a limited amount of steam for auxiliary machinery and heating when the main boiler was shut down (*Nautical Gazette*, 1908). The donkey boiler, which was located at the starboard aft end of the boiler room, was removed sometime between 1935 and 1961 (see Figures 15 and 16). This item was an important feature of the vessel's original configuration. It is therefore recommended that a working replica of the boiler be installed in its original location.

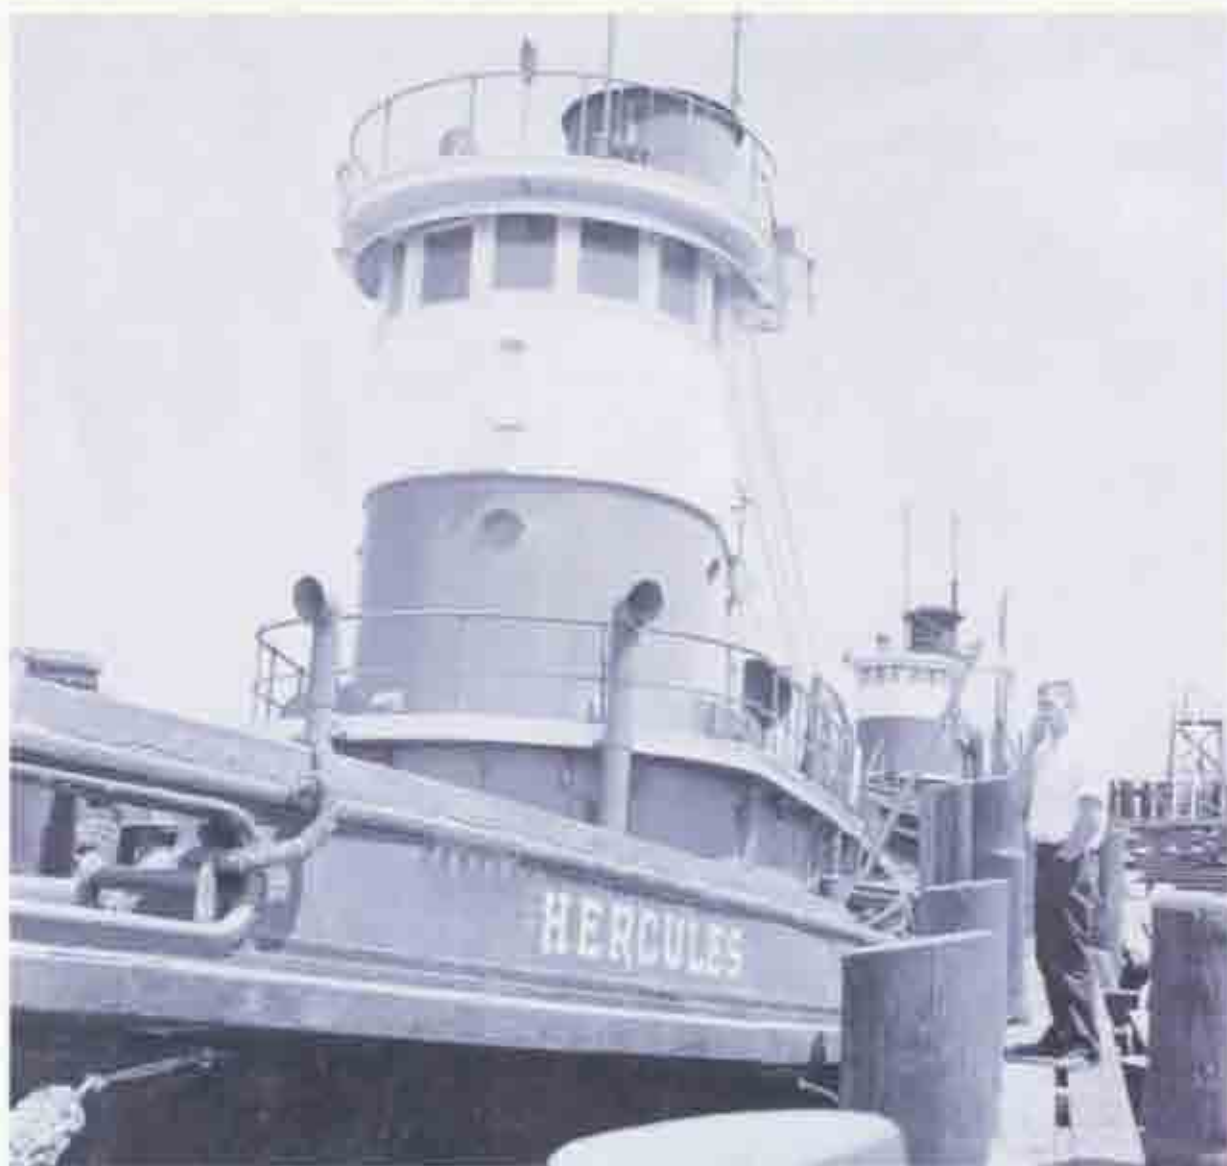
Fig. 18. HERCULES and HUMMACONNA at Western Pacific pier, August 1957. Roller chocks added during Western Pacific Railroad years are visible through enlarged bow hawse, as is the attachment of rope bow fender.

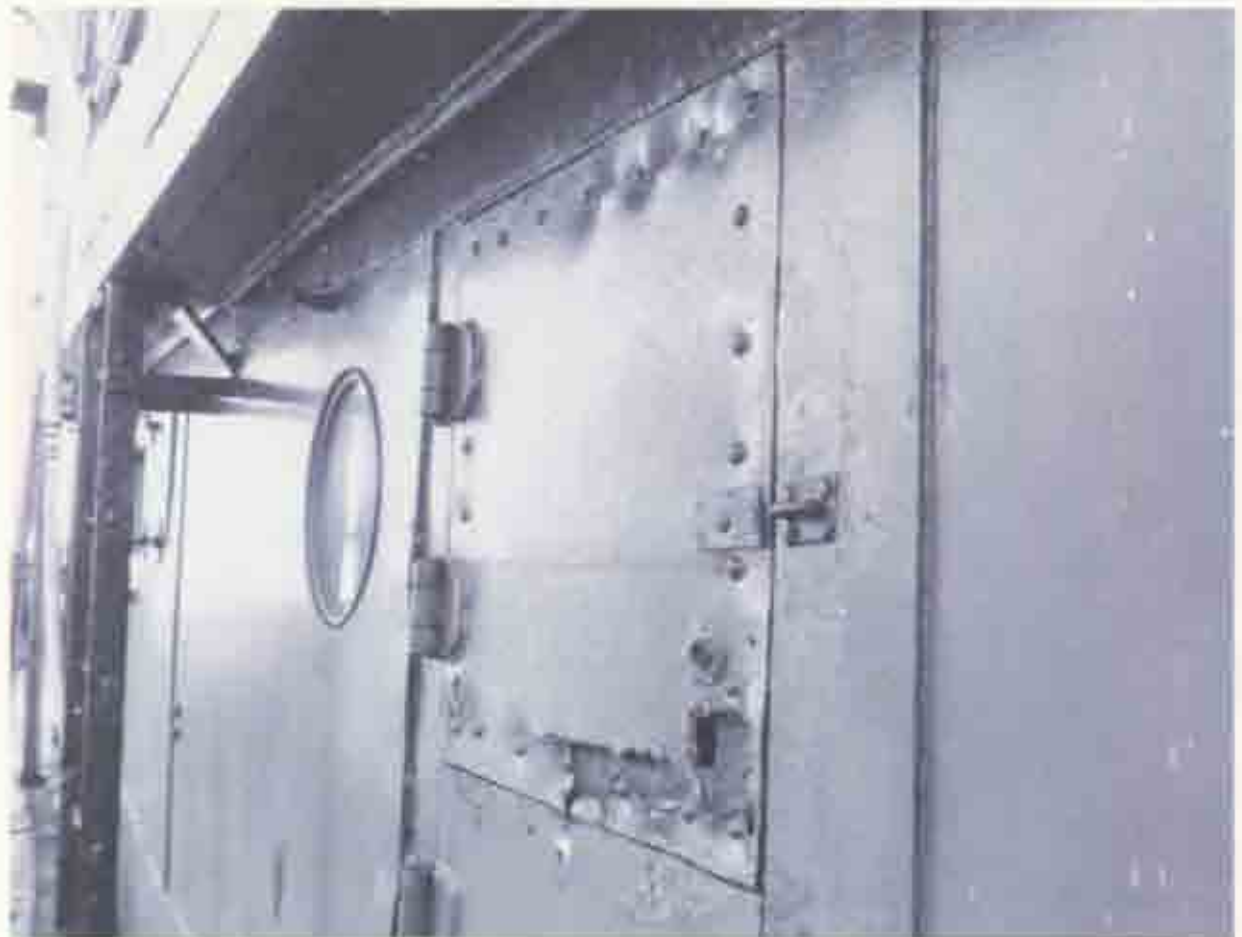
Fig. 21. Wastage typical of that seen in local areas of HERCULES' deckhouse.

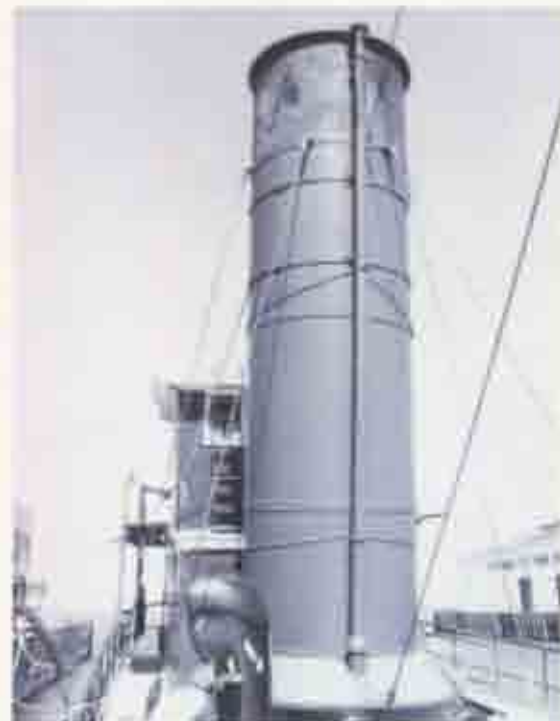
Fig. 25. The smoke stack as viewed from aft. The stack has been rebuilt at least once during HERCULES' working life, as evidenced by a combination of welded and riveted construction, but retains its original form. The tall stack is a significant feature of steam tugs.

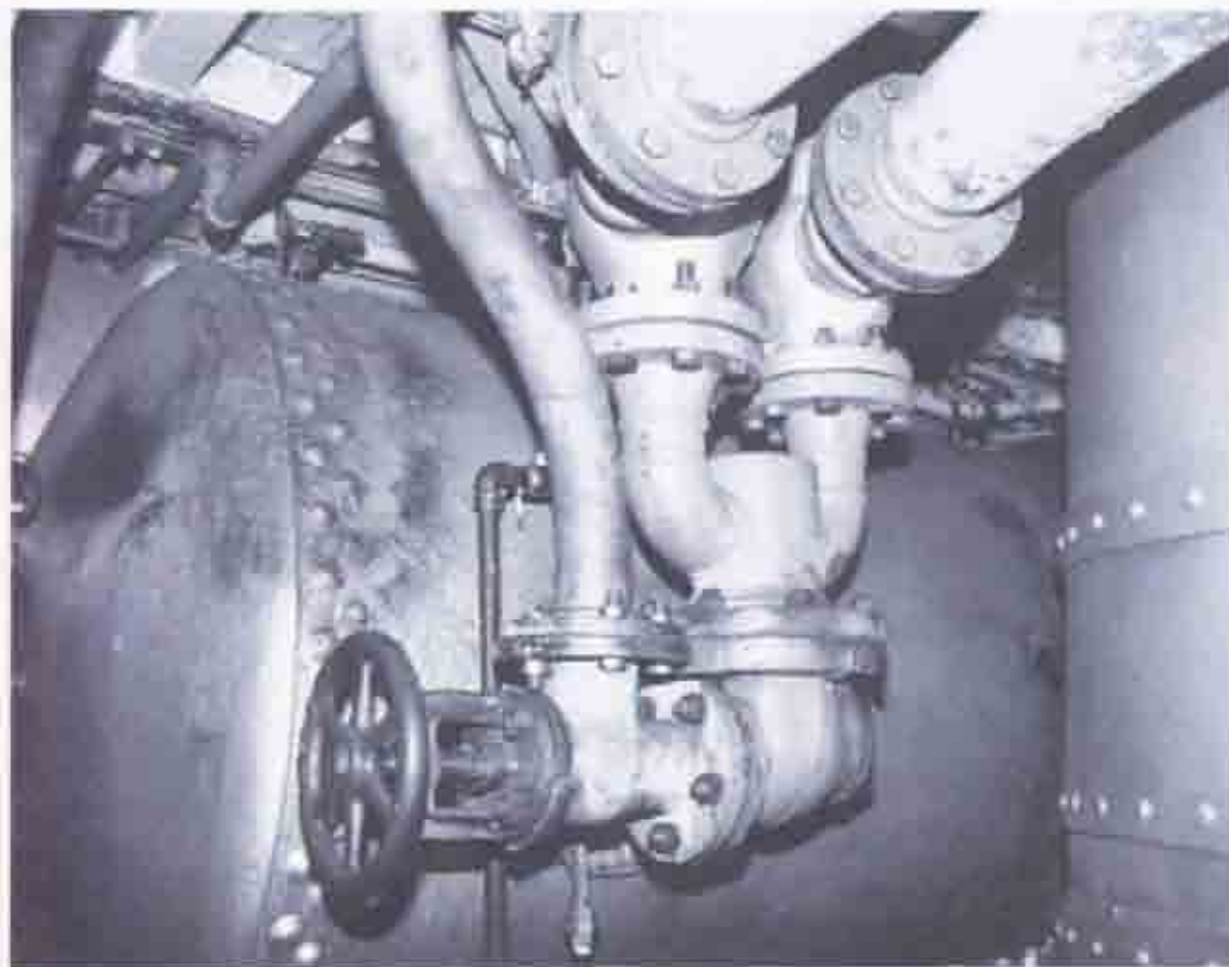
Fig. 27. The boiler safety valves, part of the complex system of steam piping. The riveted steam drum can be seen beyond, and the smoke stack is at right.

Due to safety concerns, the steam piping and fuel oil piping will have additional requirements:

Steam Piping: The potential hazards associated with live steam warrant adherence to established stand-

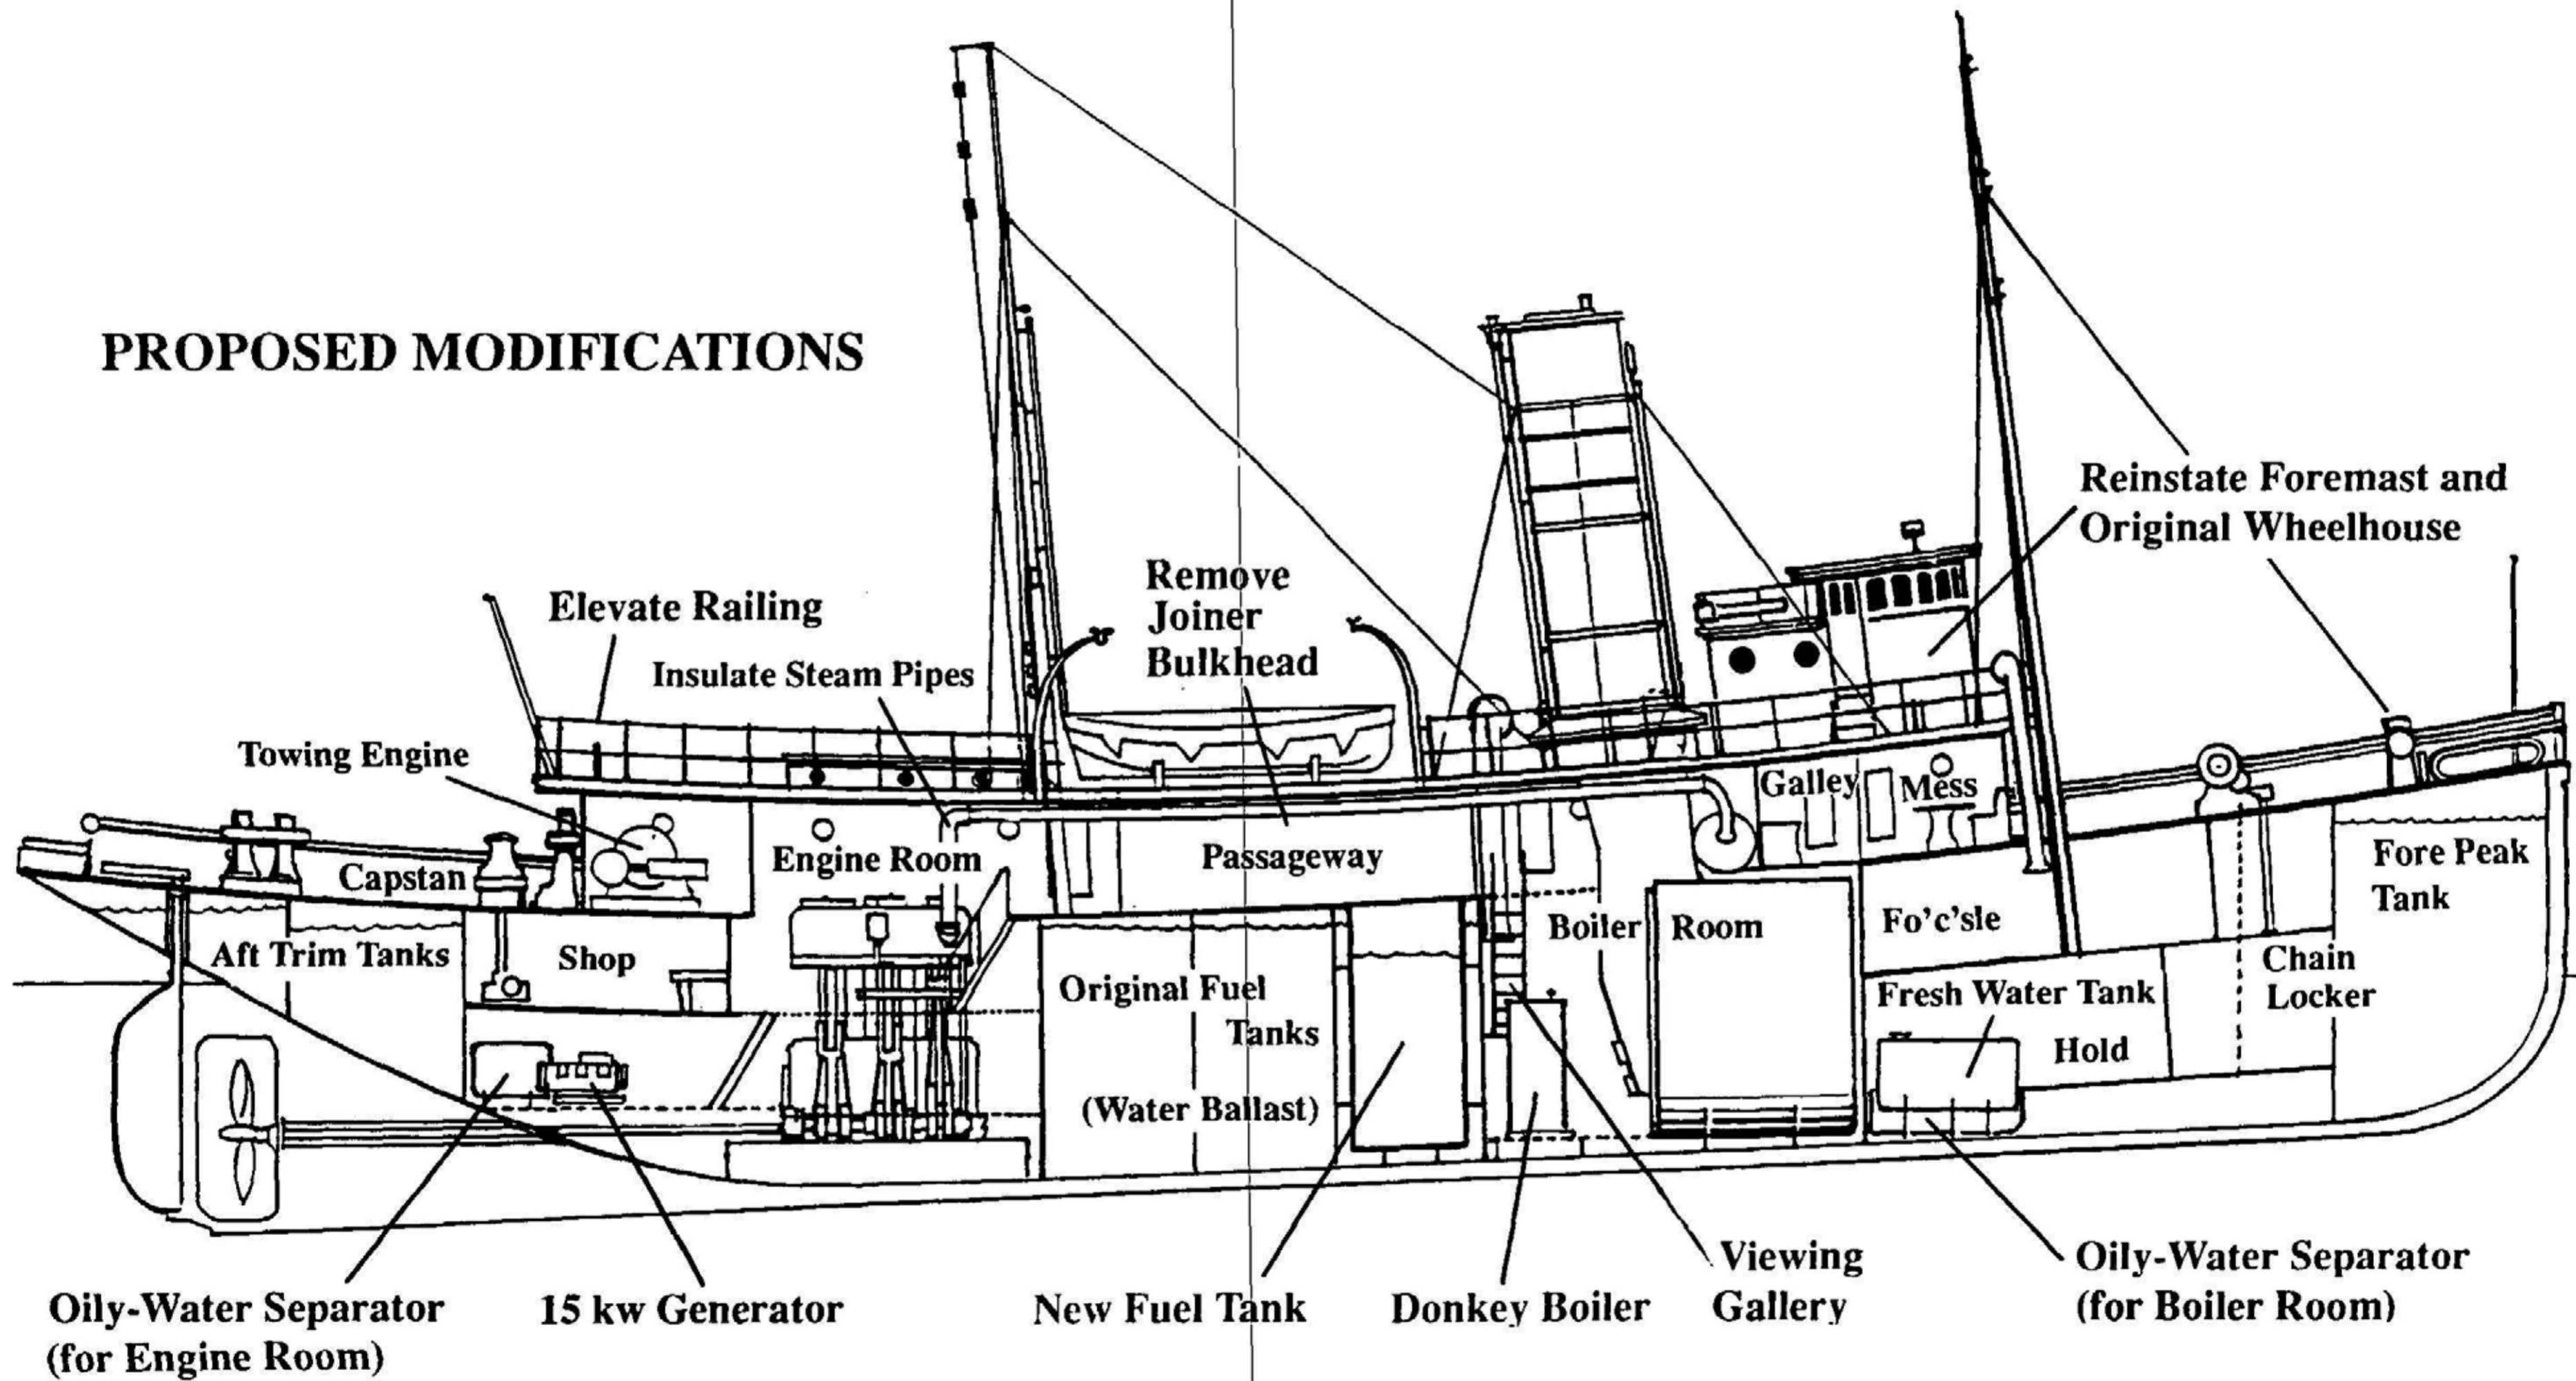
Fig. 29. Proposed Modifications

To meet these requirements, the emergency generator will have to provide at least 15 kilowatts of power. The location for the generator set should be selected to minimize visual impact. One possible arrangement would be to mount the generator set on a platform at the aft end of the engine room (see Figure 29).

Access to the platform would be via the existing ladder, and a hatch in the platform would allow the crew to enter the boiler room. Although visitors would have to negotiate the steep ladder to enter and exit the platform, the vertical distance would be much less than the existing 15' descent to the boiler room. From the standpoint of safety, this arrangement is not substantially different from existing visitor access on other vessels in the historic fleet.

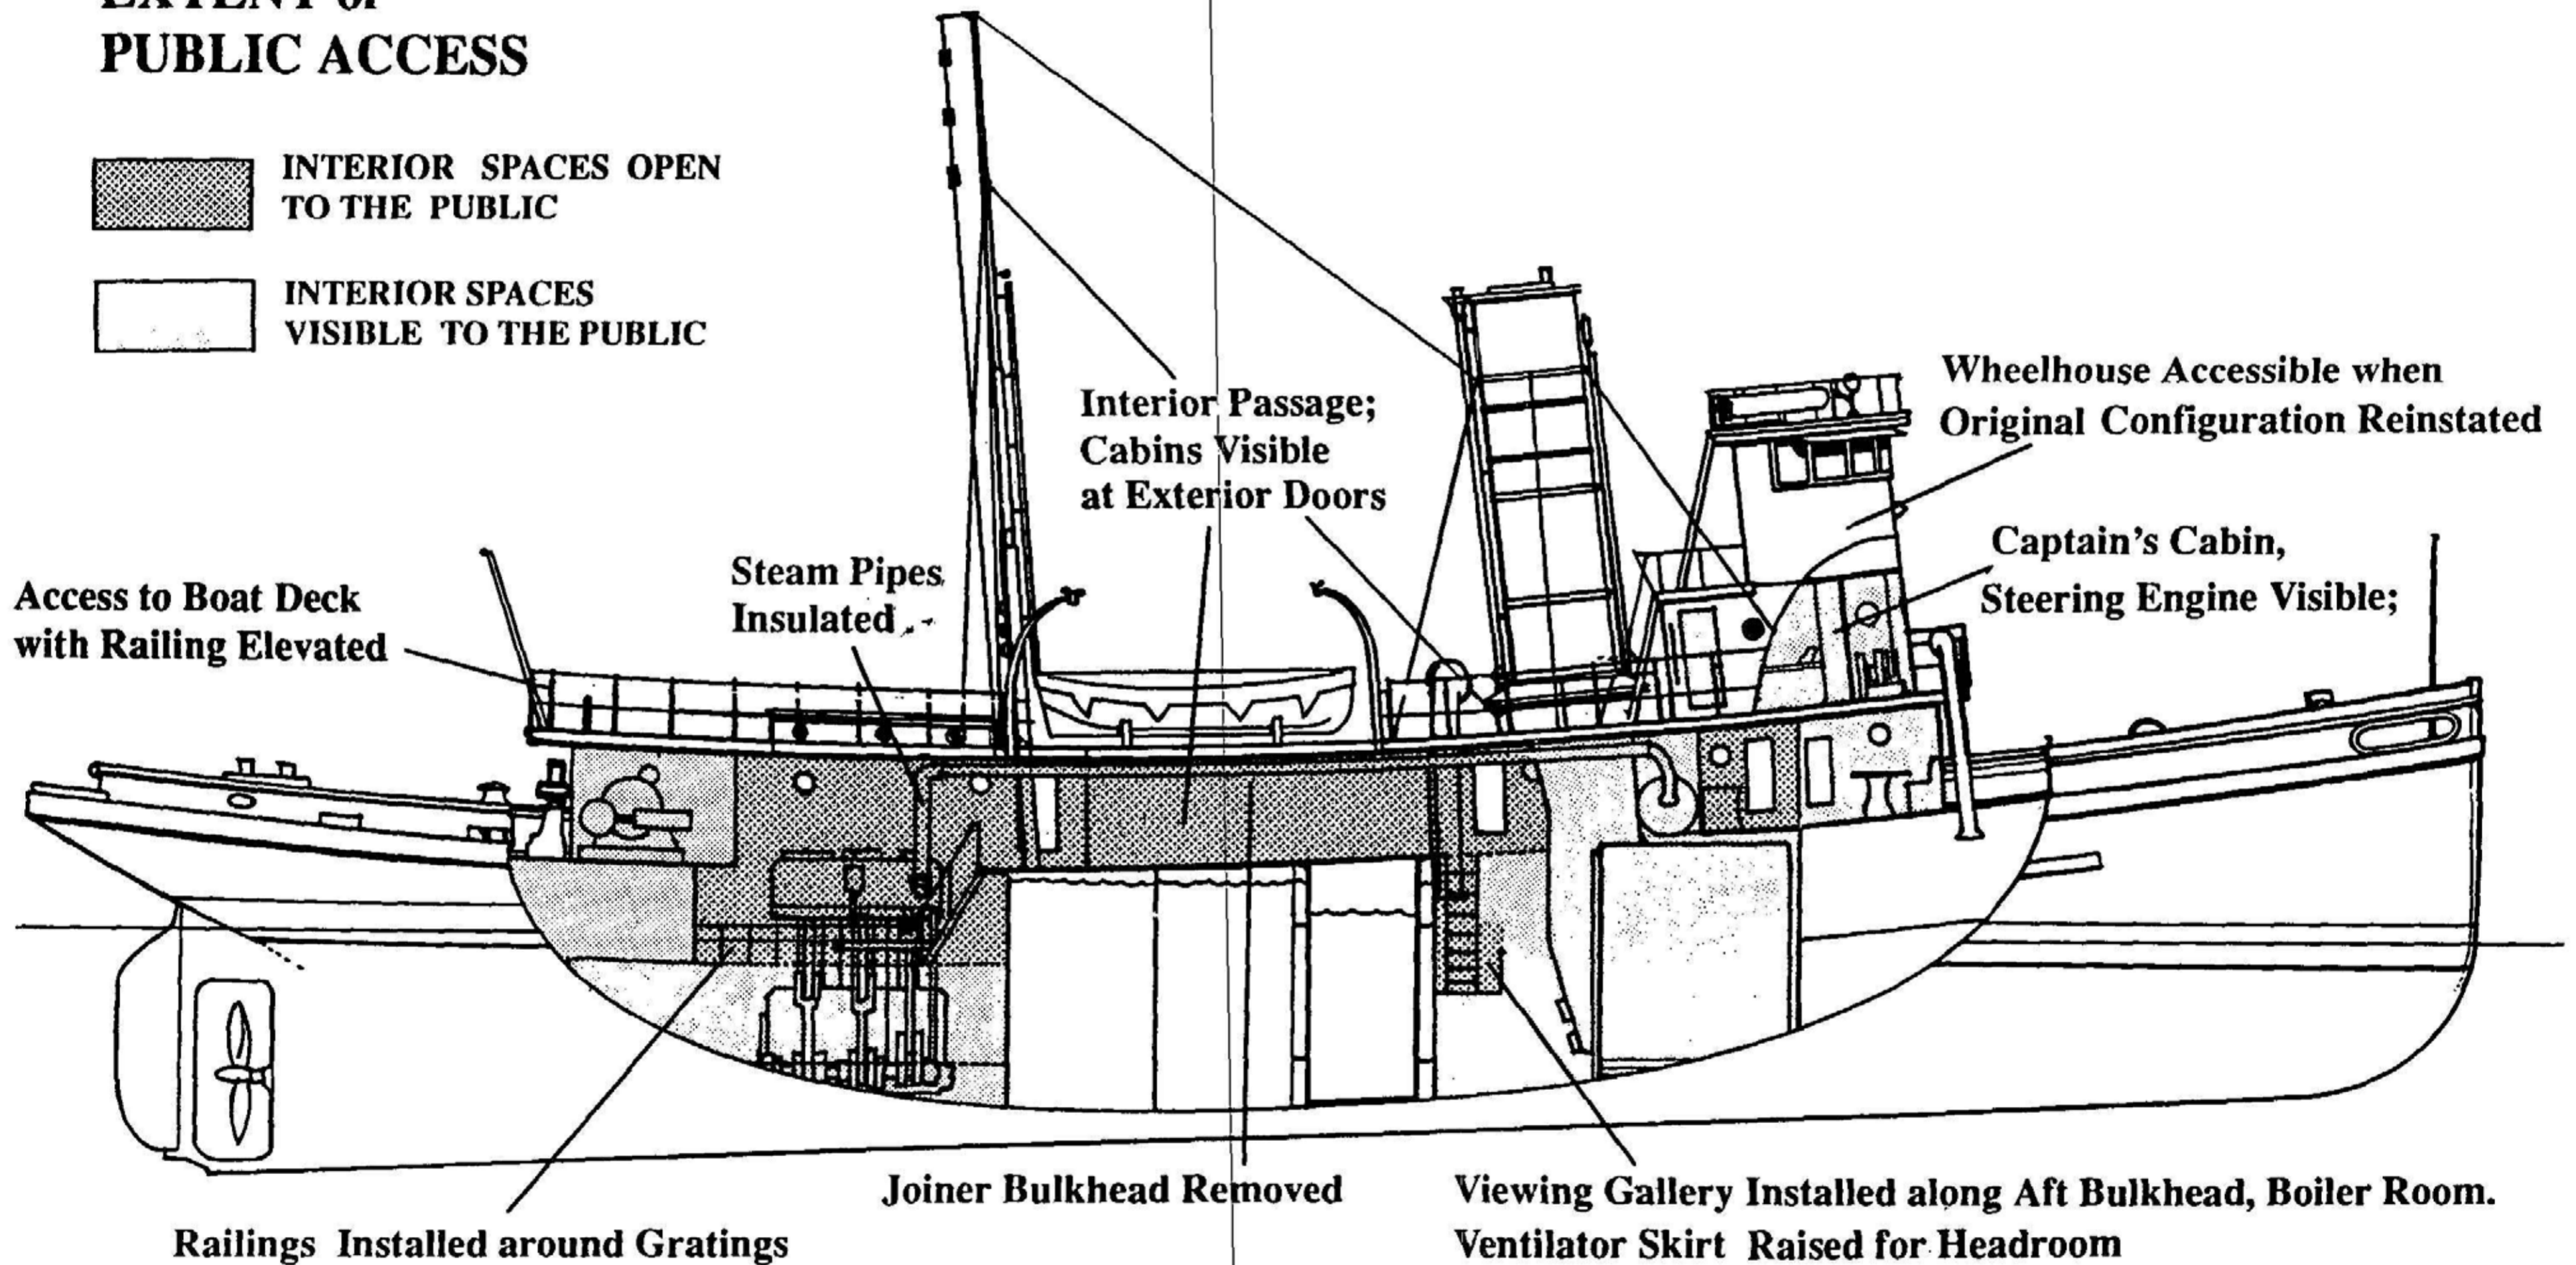
Fig. 30. Modifications for public access.

Galley: The galley forms an athwartships passageway through the deckhouse, and should be left open to the public. The galley has been maintained in operating condition by the volunteers. This use is the best interpretation of the space and should continue. The potential conflict between use and exhibit can be resolved by good shipkeeping practice and locking cabinets.

Forecastle: It is not recommended that the forecastle be opened for general public access—it can only be reached by a steep and narrow stairway, and cannot be made safe for unattended access without undue alteration of the historic arrangement. It is nevertheless important to convey the fact that HERCULES, as an oceangoing steam tug, carried a much larger crew than a modern tug, and required more accommodations than are evident on the main deck. The forecastle should be restored and might be interpreted by special guided tour.

of which open onto the main deck. It is recommended that all cabins be restored, though it might be beneficial to assign one for staff use as an administrative or maintenance space. At least two cabins on each side of the deckhouse should be dressed and opened for viewing, with access limited by a barrier at the doorway.
